CALVERT CLIFFS UNIT 1
CYCLE 4

November 12, 1979

PRELIMINARY REPORT OF POWER DISTRIBUTION EPISODE

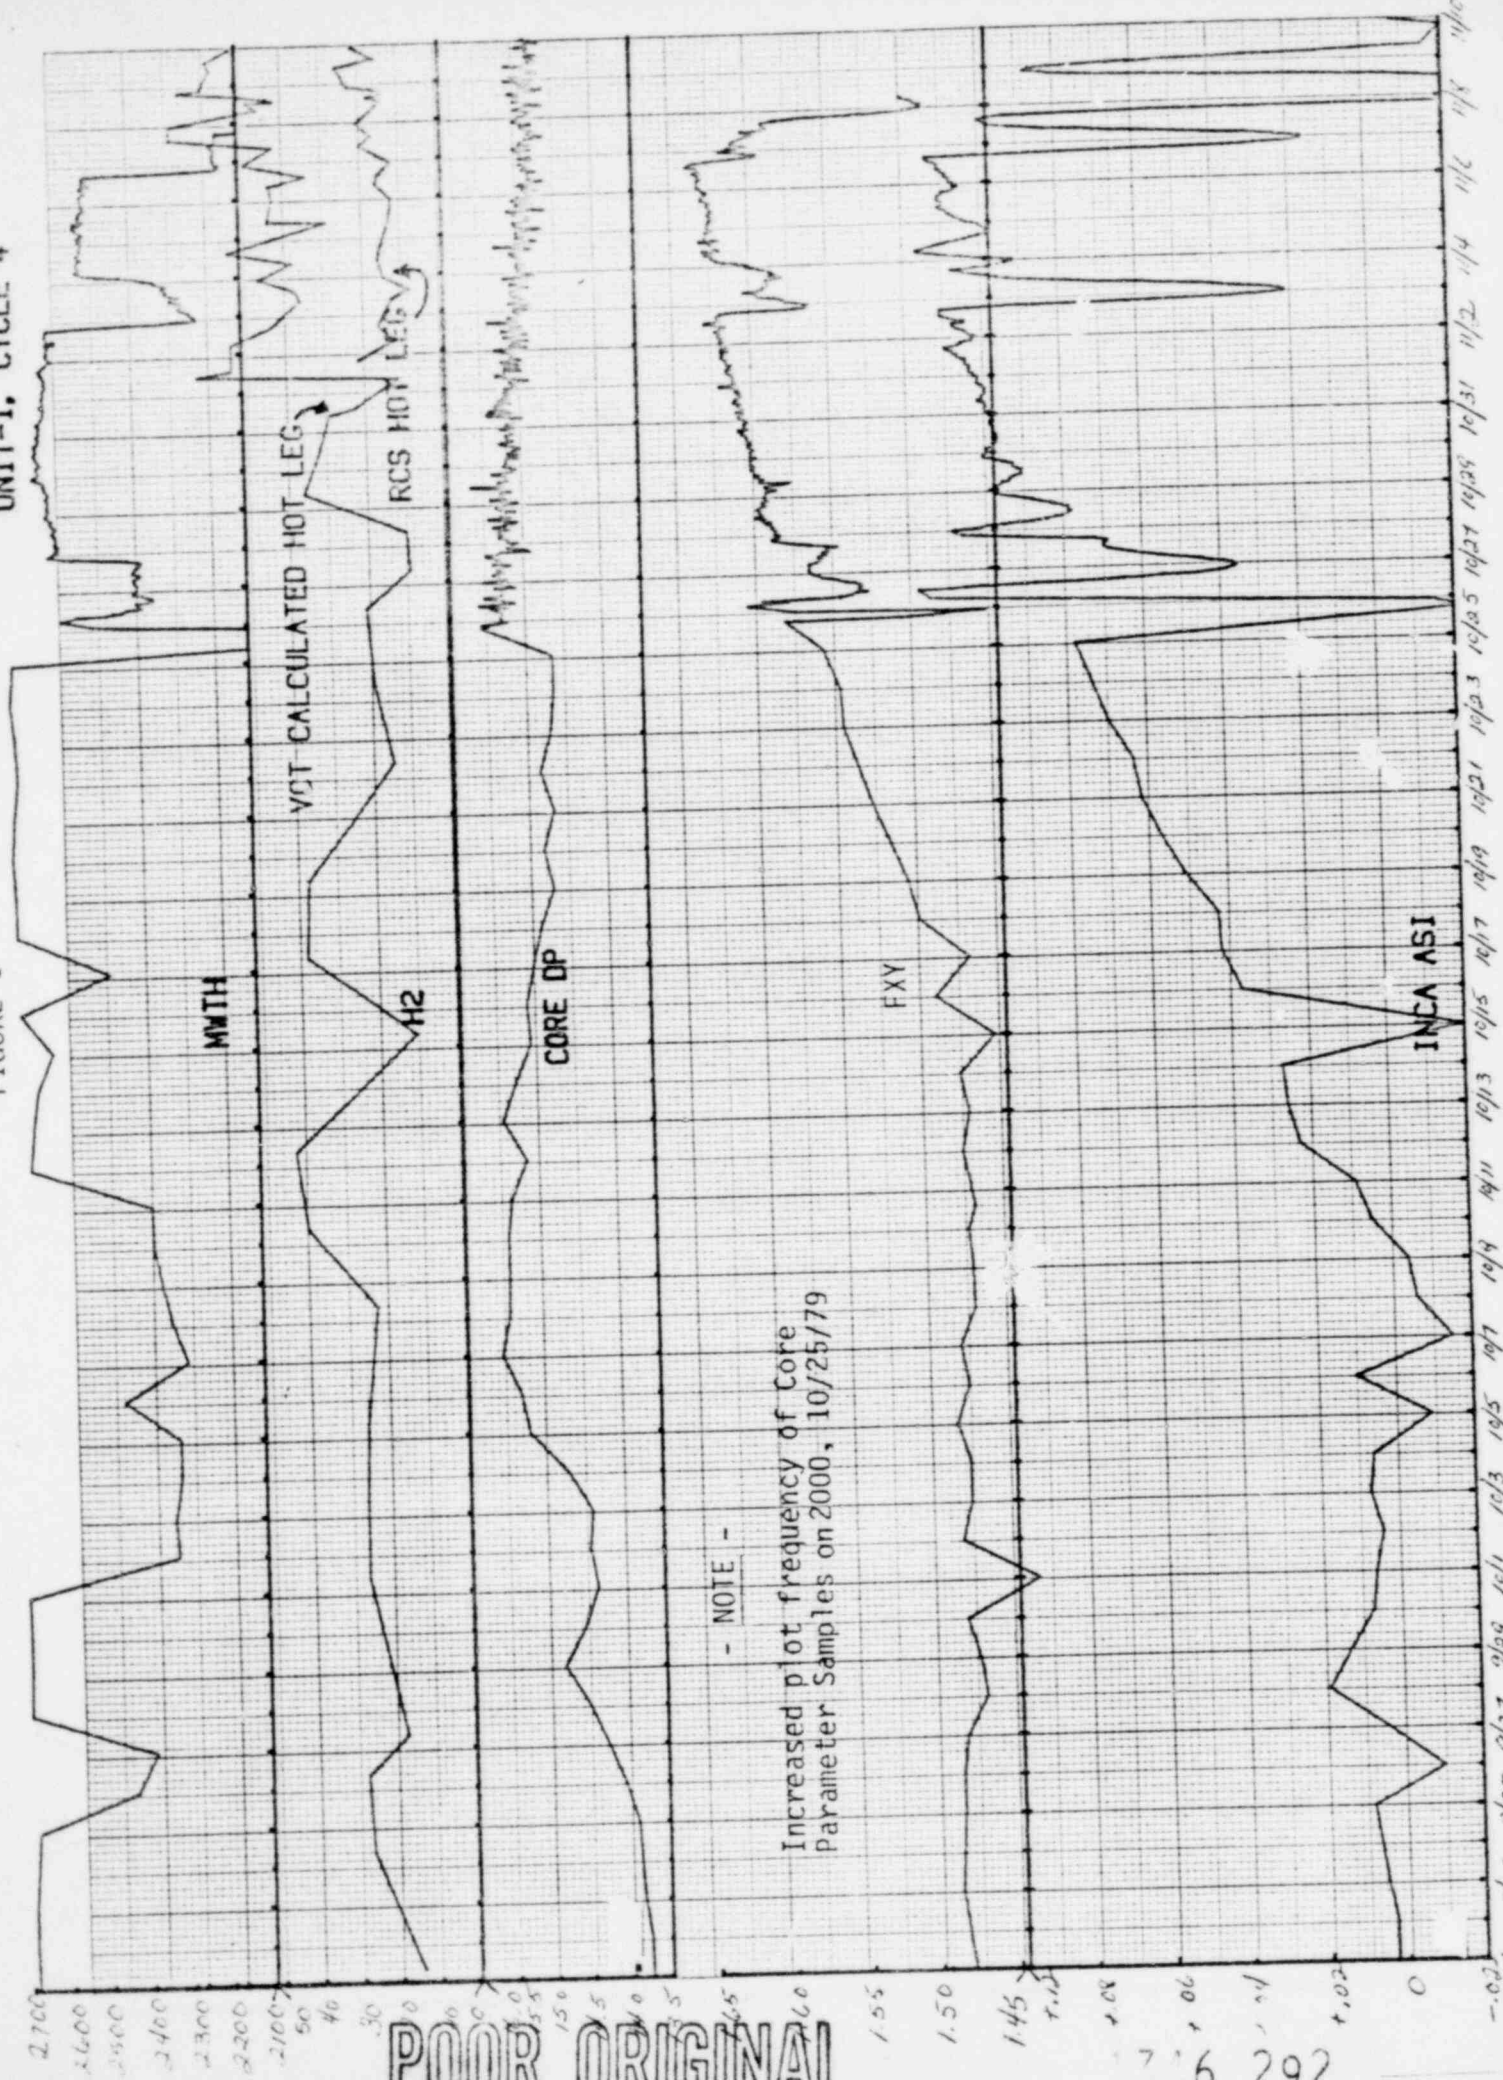
FIGURE 1

On October 26, the Plant Nuclear Engineer began a periodic transmittal of core parameter trend data to CE. See Figures 1 and 2.

The most limiting core parameters observed to date have been F_{xy}^T equal to about 1.655 and F_z equal to 1.24 at 1410, November 6, 1979. The peak increase in the differential pressure across the core occurred on October 25 and was about 1.7 psi above a nominal value of about 13.8. See Figures 1 and 2. Note that the differential pressure across the core has slowly decreased since then. Since the source of Oxygen has been isolated from the Reactor Coolant System and the Hydrogen concentration in the Reactor Coolant System has been increased, this decrease in core DP is postulated to be caused by a reduction in the oxidization state of the crud layer which has smoothed the crud surface thereby reducing resistance to water flow.

CORE PARAMETERS
UNIT-1, CYCLE 4

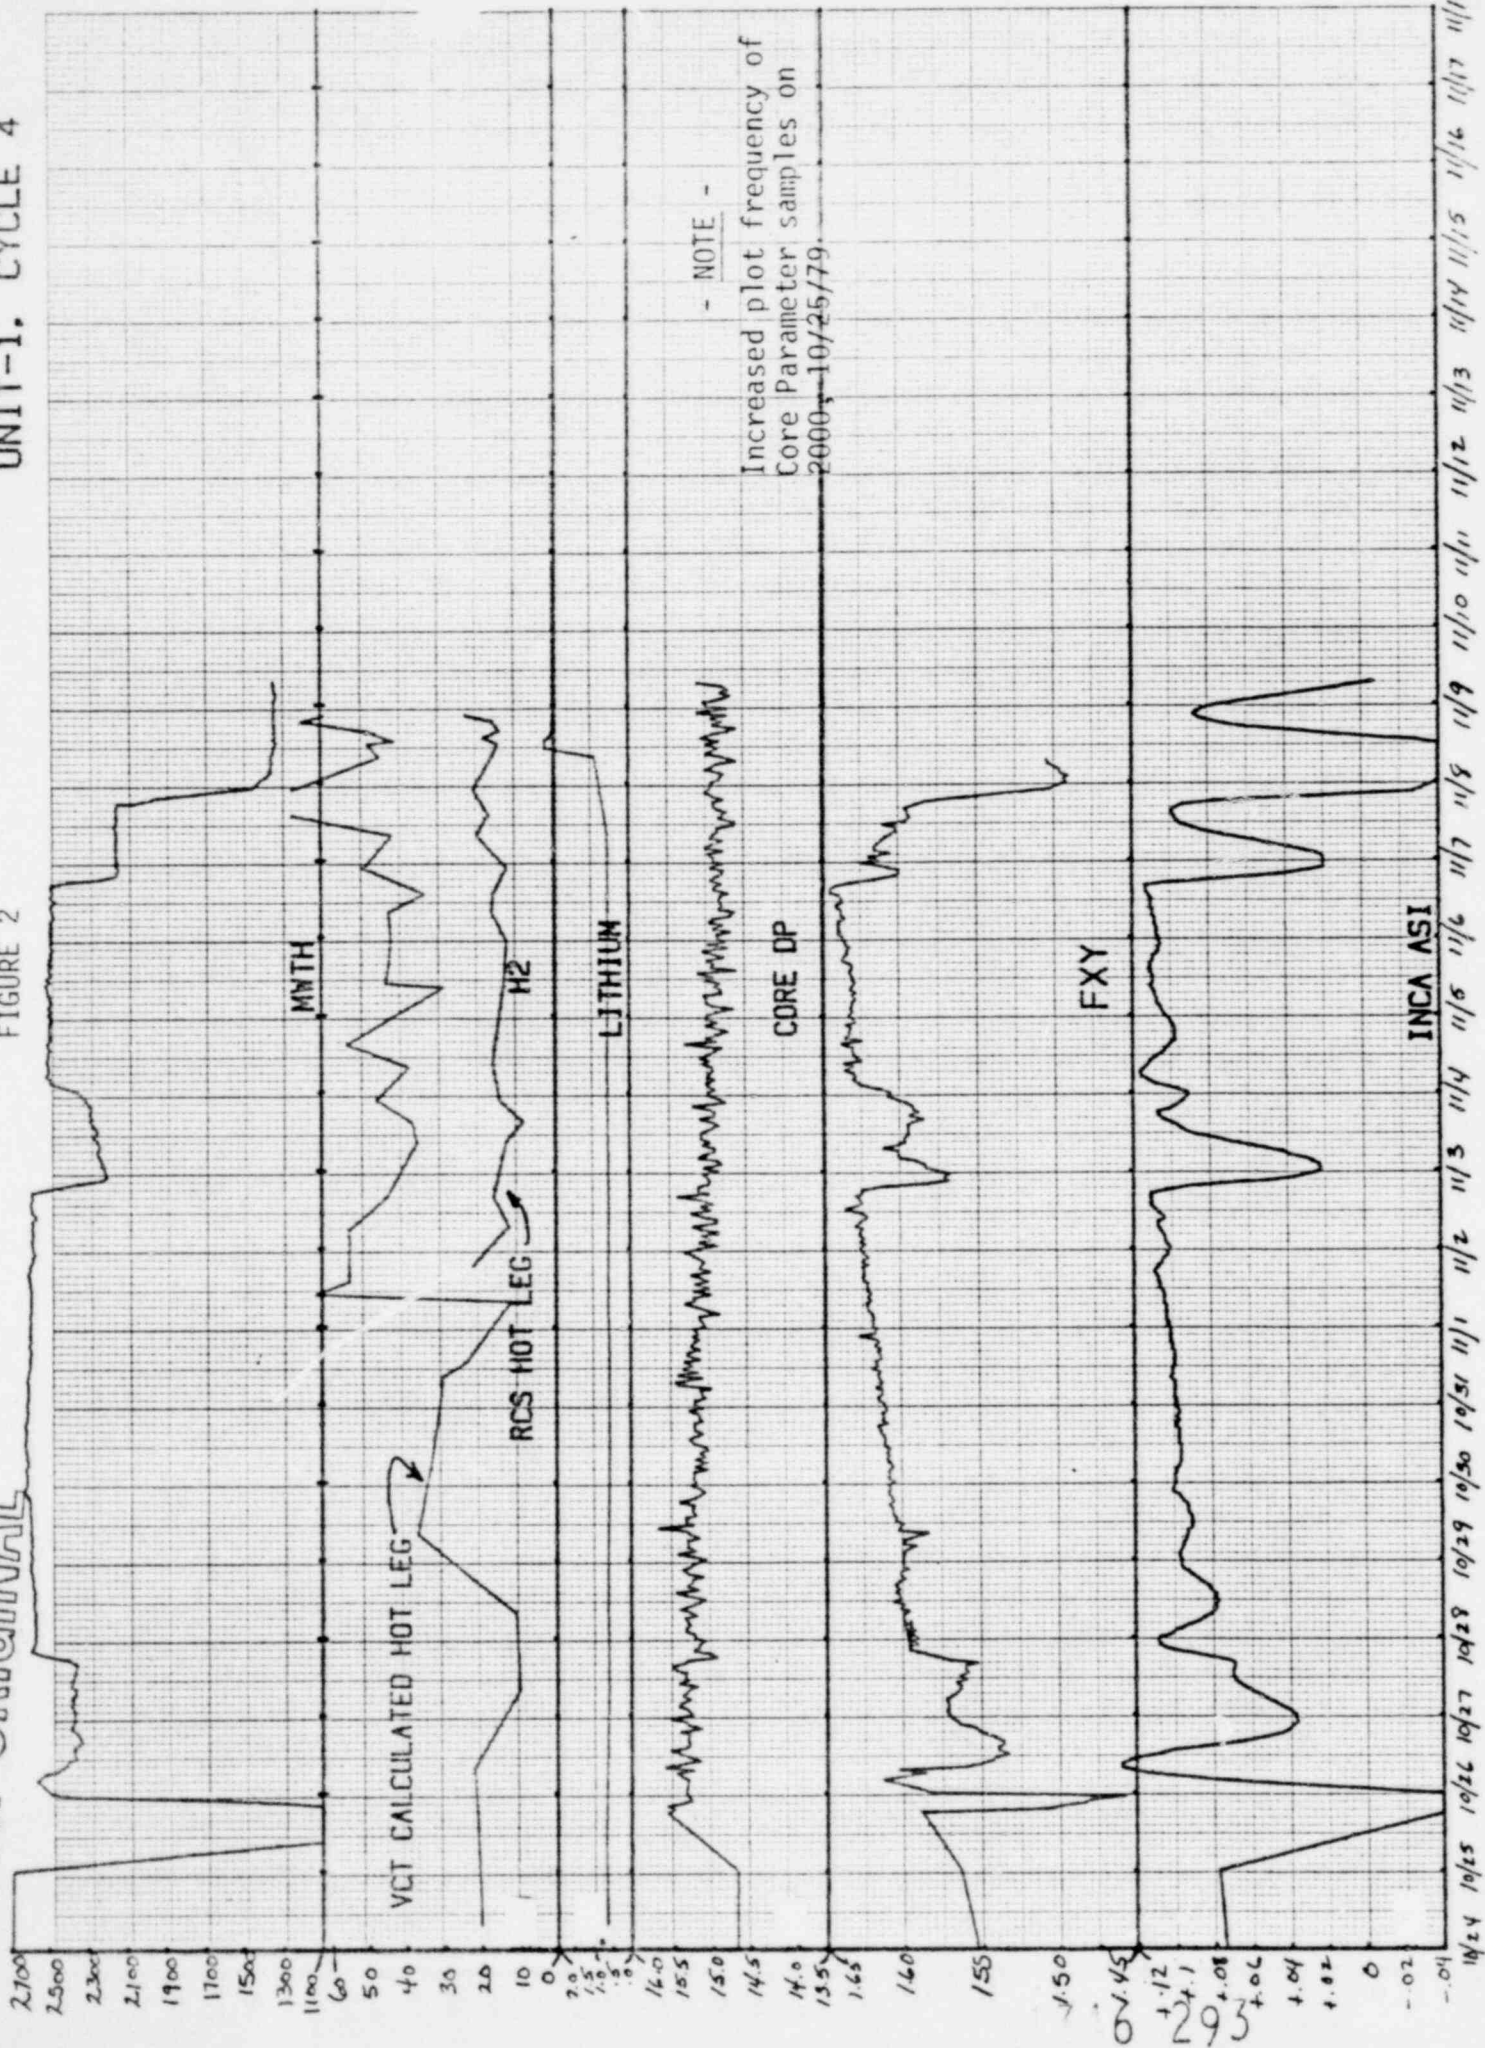
FIGURE 2

CORE PARAMETERS UNIT-1, CYCLE 4

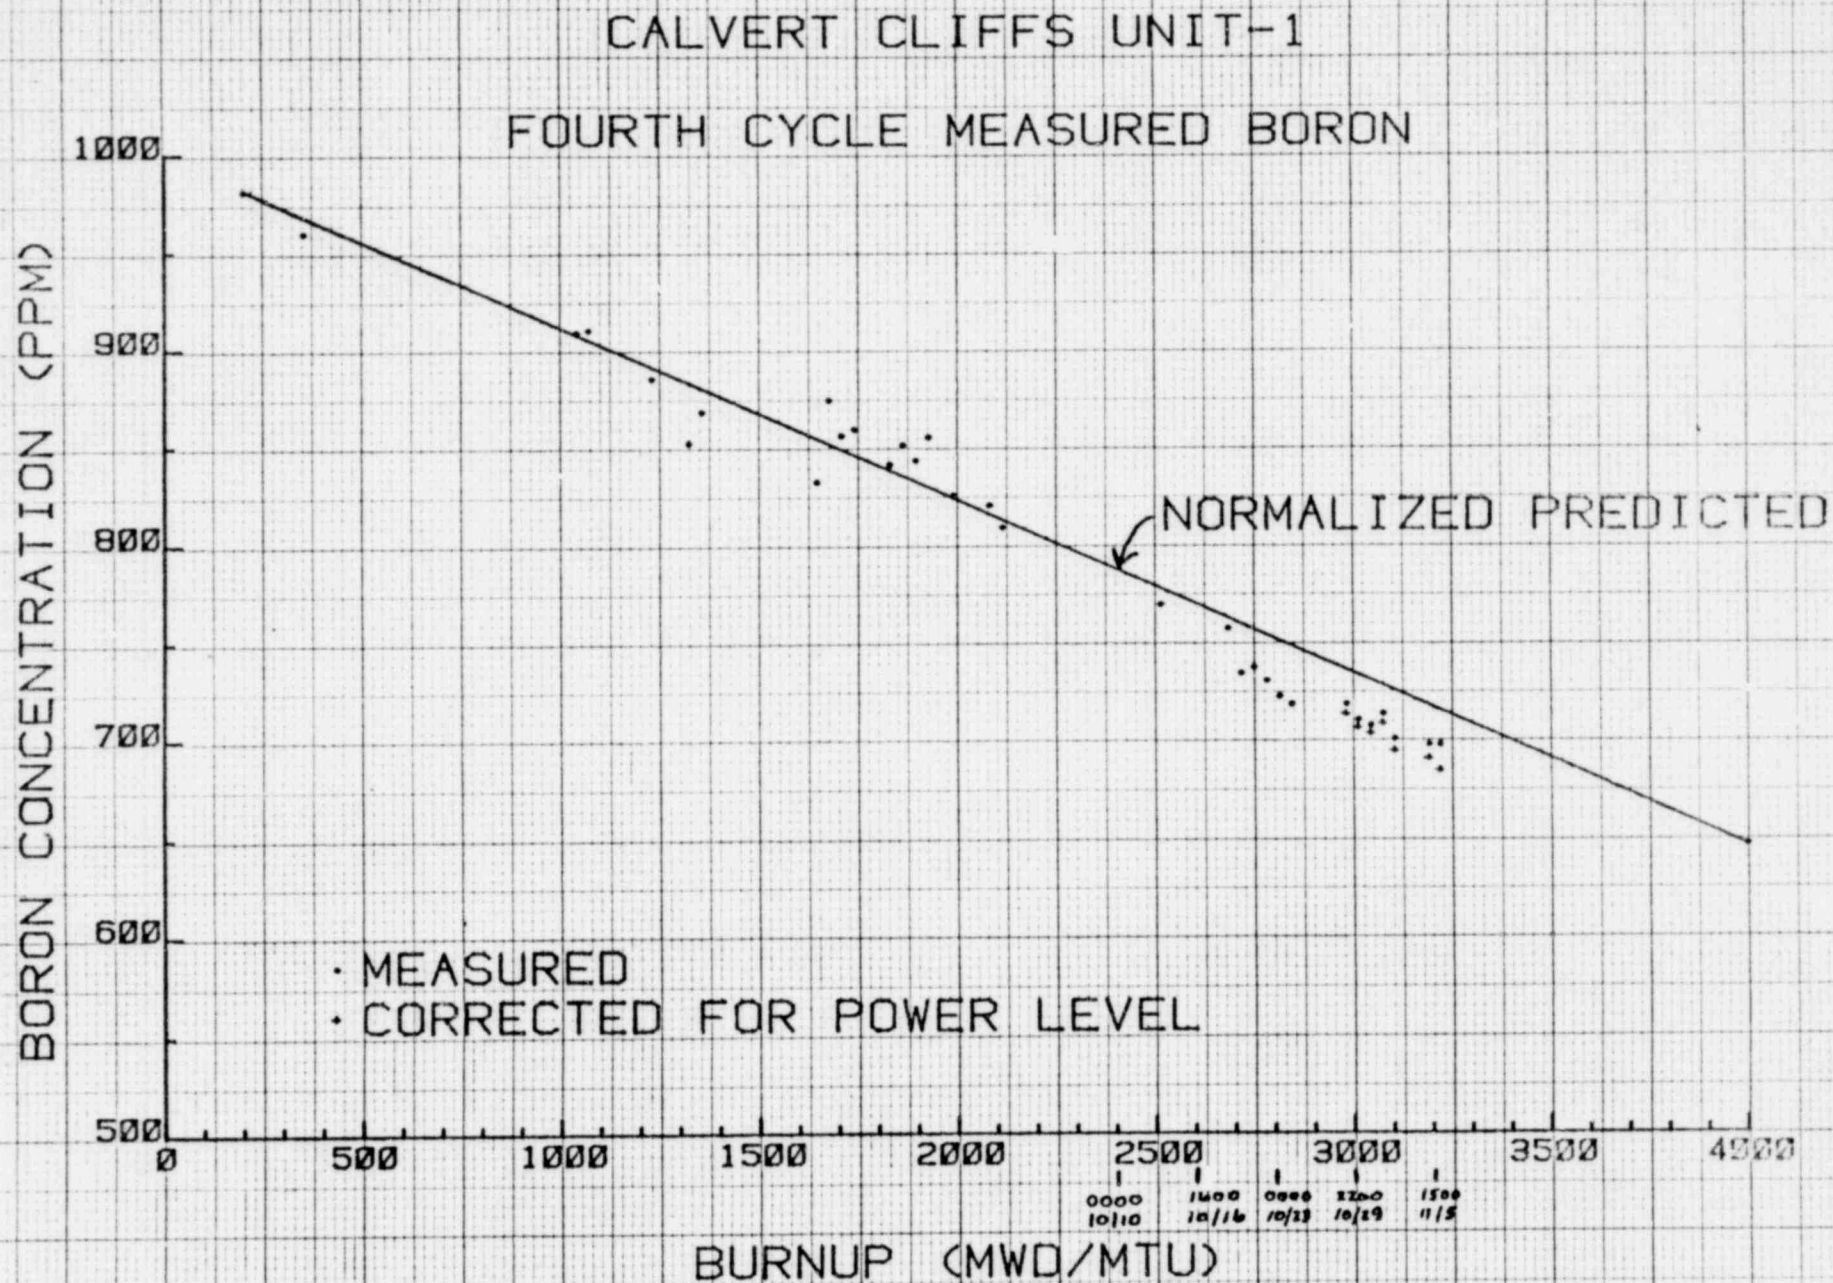
FIGURE 4

Early the week of October 29, the Plant Staff and CE concluded that the cause of the power redistribution was a crud buildup on the fuel rod surfaces, preferentially to the top of the core. The crud would contain iron and other oxidized constituents of stainless steel which would act as a mild poison to the fission reaction; and in addition, the crud may change the heat transfer characteristics across the fuel rod resulting in an increasing Doppler feedback effect. This conclusion was also consistent with a small reactivity anomaly evident in a trend of measured versus predicted boron concentration in the Reactor Coolant System. See Figure 4.
