November 9, 1979  
Fort St. Vrain  
Unit No. 1  
P-79267

REPORTABLE OCCURRENCE 79-46

FORT ST. VRAIN NUCLEAR GENERATING STATION  
PUBLIC SERVICE COMPANY OF COLORADO  
16805 WELD COUNTY ROAD 19 1/2  
PLATTEVILLE, COLORADO 80651

REPORT NO. 50-267/79-46/03-L-0

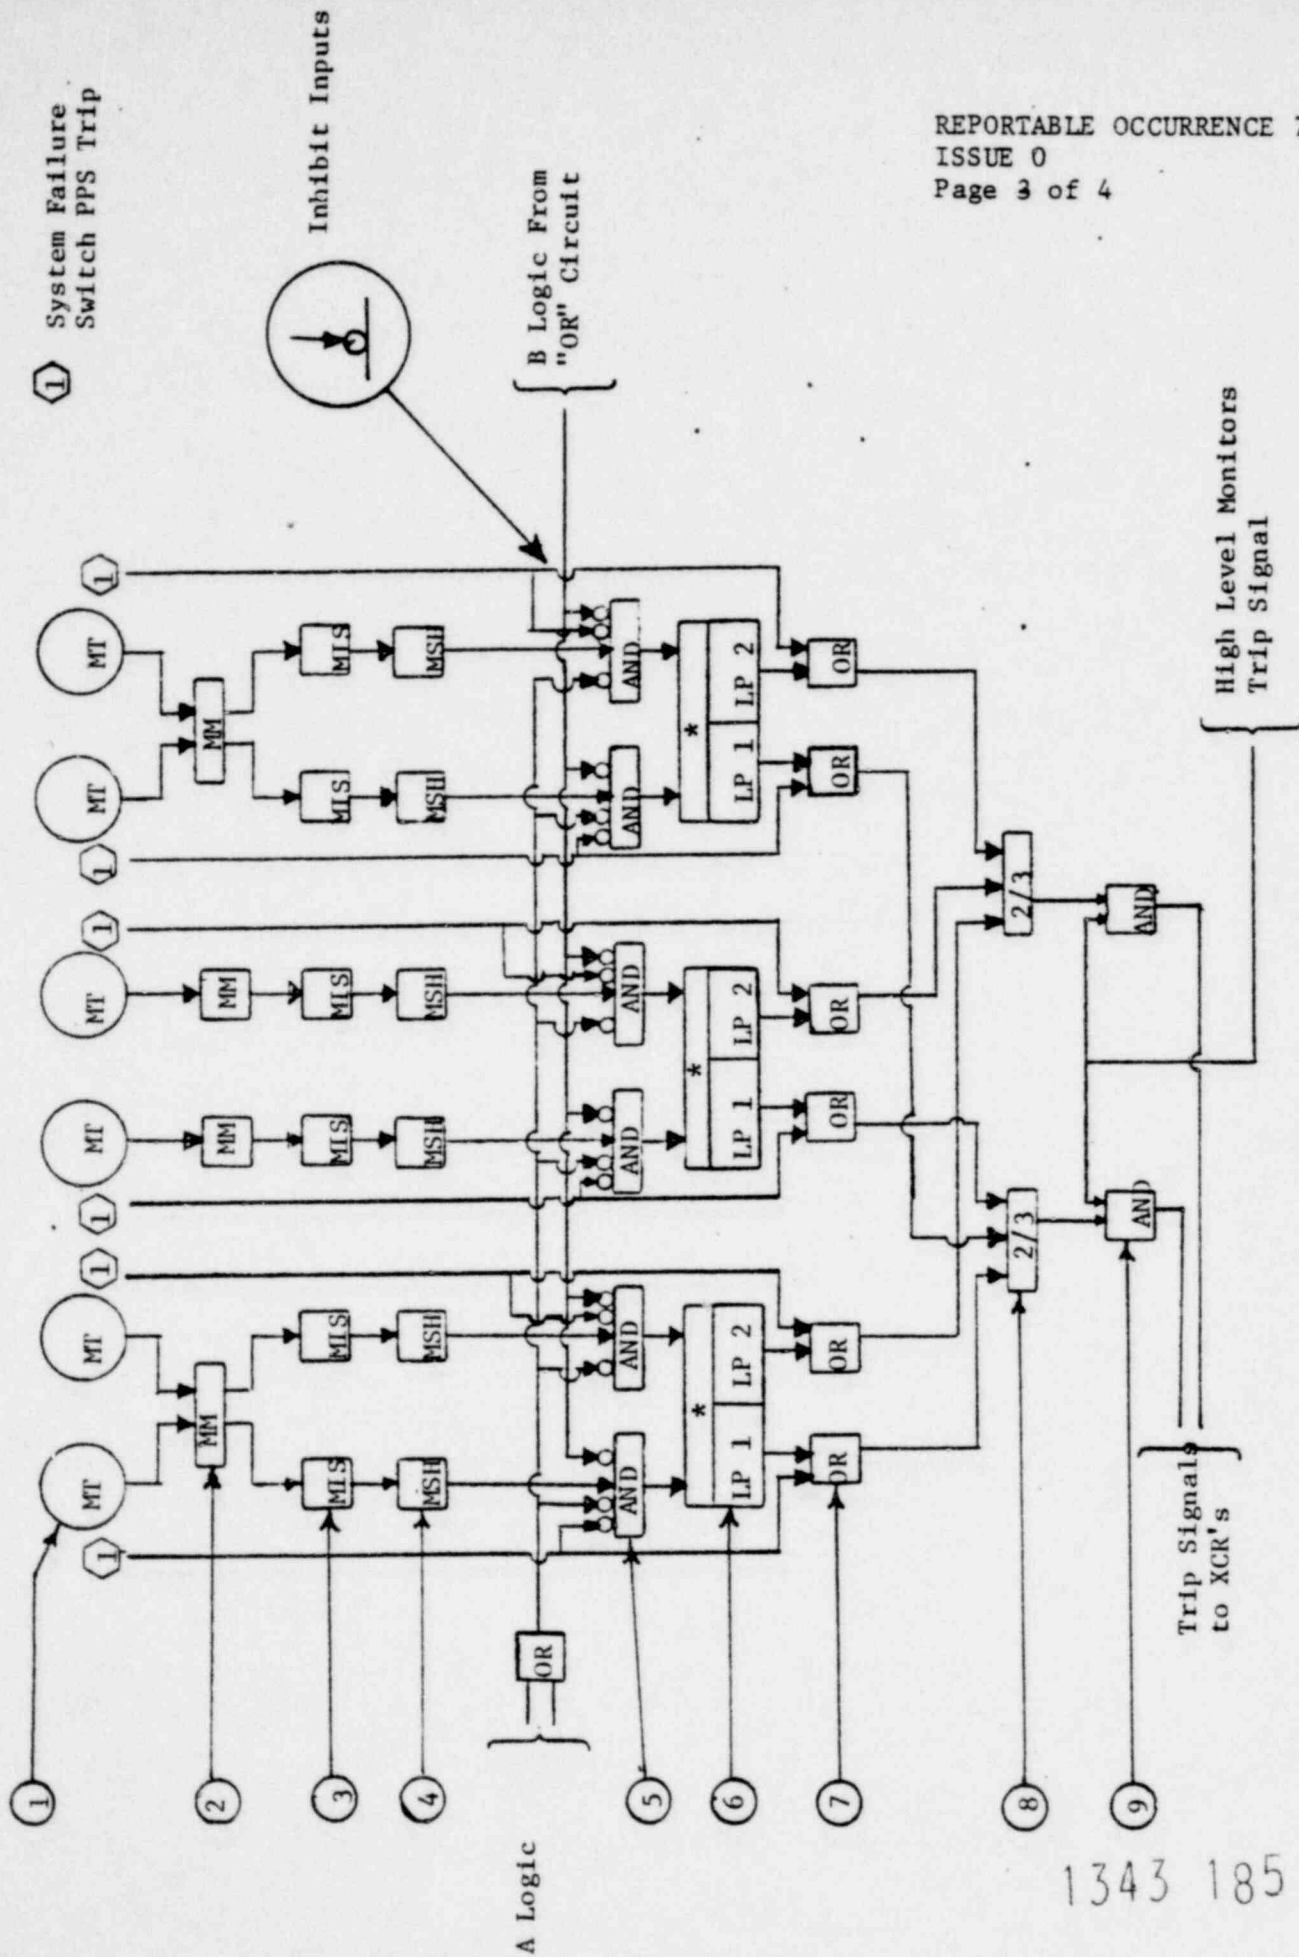
FIGURE 1

See Figure 1. The normal operation of a moisture monitor on high moisture in the primary coolant would be a low reflected light level at the moisture transmitter (MT), (1), which would transmit a trip signal to the moisture monitor (MM), (2), moisture indicating switch (MIS), (3), and the moisture switch high (MSH), (4). This trip signal then goes to "and" circuits, (5), where if no inhibits are present the signal passes to the first in with lockout circuit, (6), which will allow the first trip signal to pass, but locks out any subsequent trip signals from the other loop instrumentation. This circuit prevents both loops from tripping on high moisture in the primary coolant. The trip signal then passes through an "or", (7), circuit and into the "two out of three" trip circuit, (8). If two out of three signals are present the trip signal is transmitted to the "and", (9), circuit where a two out of three low level moisture monitor trip and a high level moisture monitor trip is required to transmit a trip signal to the XCR's for a loop shutdown.

When using the moisture monitors to indicate the primary coolant moisture levels, the usual method was to trip the moisture monitor, normally MM-1118 and/or MM-1122, by going to light ground on the light control circuit, which simulated a low reflected light level and tripped the instrument channel by the above action. This locked out the complementary moisture monitor (the complementary monitors are those which share the same first in with lockout circuit). With one moisture monitor in the other loop locked out it would now require two of the remaining two moisture monitors to trip for a protective action to occur. This is not acceptable as LCO 4.4.1 requires a minimum degree of redundancy of one for these moisture monitor trips.

An approved change (Field Change Notice 3738B) made the automatic trip upon moisture monitor system failure a manual action and revised the logic to permit individual manual trip of the associated moisture monitor (as opposed to disabling by pairs). This change added a switch to the system failure and test module which in the Plant Protective System trip position, (1), (see Figure 1) would place an inhibit on the "first in with lockout" circuit, (5), and a trip into the 2 out of 3 trip circuit, (8). This would prevent the complimentary monitor from being locked out when a monitor was in the tripped condition. However, with the revised circuit configuration, if the monitor was tripped before the system failure and test switch was placed in the Plant Protective System trip position, the complimentary monitor would be locked out.

To correct this problem the system operating procedure was revised to show the correct switching sequence to trip the moisture monitor and prevent the first in with lockout circuit from locking out the other loop's instrument. See Figure 1. The system failure switch, (1), for whichever moisture monitor is to be tripped, is put in the Plant Protective System trip position which puts an inhibit on the "and" gate, (5), preventing the trip signal from locking out the complimentary monitor while putting a trip signal into the "or" gate, (7), and then into the 2/3 trip circuit.
