INCIDENT REPORT  
Fifteenth Lift Concrete Voids

I. SUMMARY

On October 20, 1978, Houston Lighting and Power Company (HL&P) notified the Nuclear Regulatory Commission (NRC) of a reportable deficiency under 10 CFR 50.55(e). This deficiency concerned the existence of concrete voids within Lift 15 behind the liner plate in the Unit I Reactor Containment Building exterior wall from El. 127'-0" to El. 138'-0". On November 20, 1978, an interim report regarding this deficiency was submitted to the NRC. Investigations have been conducted to determine the extent and location of all unacceptable areas. Repairs to restore the structure to the original level of safety have been completed. The repair methods were tested and the results analyzed prior to their implementation. This deficiency was caused by the compounded effects of inadequate planning for a large and complex pour, an unusually long pour time, longer than normal slick lines and concrete pump breakdowns. If left uncorrected, these voids could have compromised the structural integrity of the containment in that the containment as built could not have met its design load criteria.

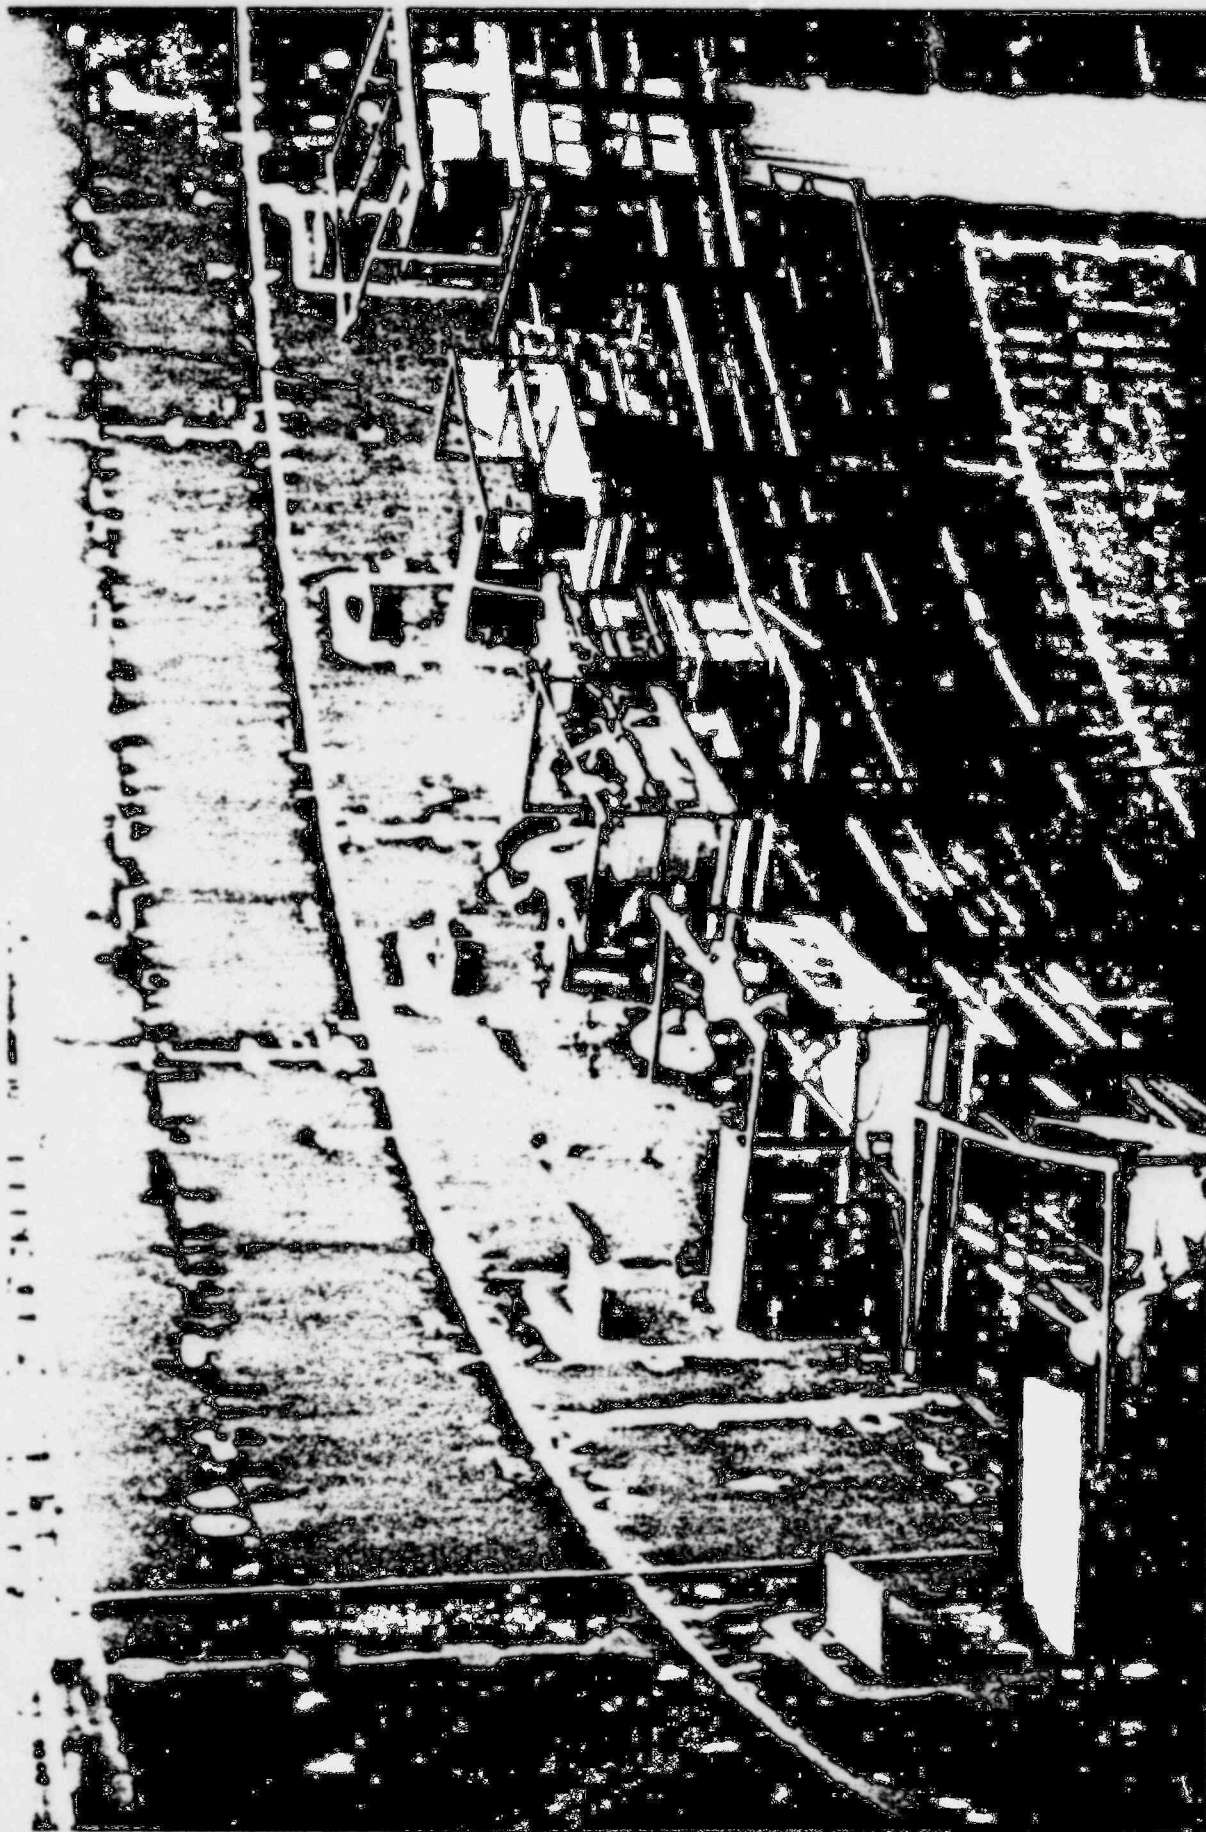
Figure 1

A photograph of a typical area, including the grouting work platforms, is shown in Figure 1.

Typical Area, Grouting Work Platforms
