LICENSEE EVENT REPORT

REPORTABLE OCCURRENCE 79-16
ISSUE 0
Page 1 of 4

PORT ST. VRAIN NUCLEAR GENERATING STATION
PUBLIC SERVICE COMPANY OF COLORADO
P. O. BOX 361
PLATTEVILLE, COLORADO 80651

REPORT NO. 50-267/79-16/01-T-0

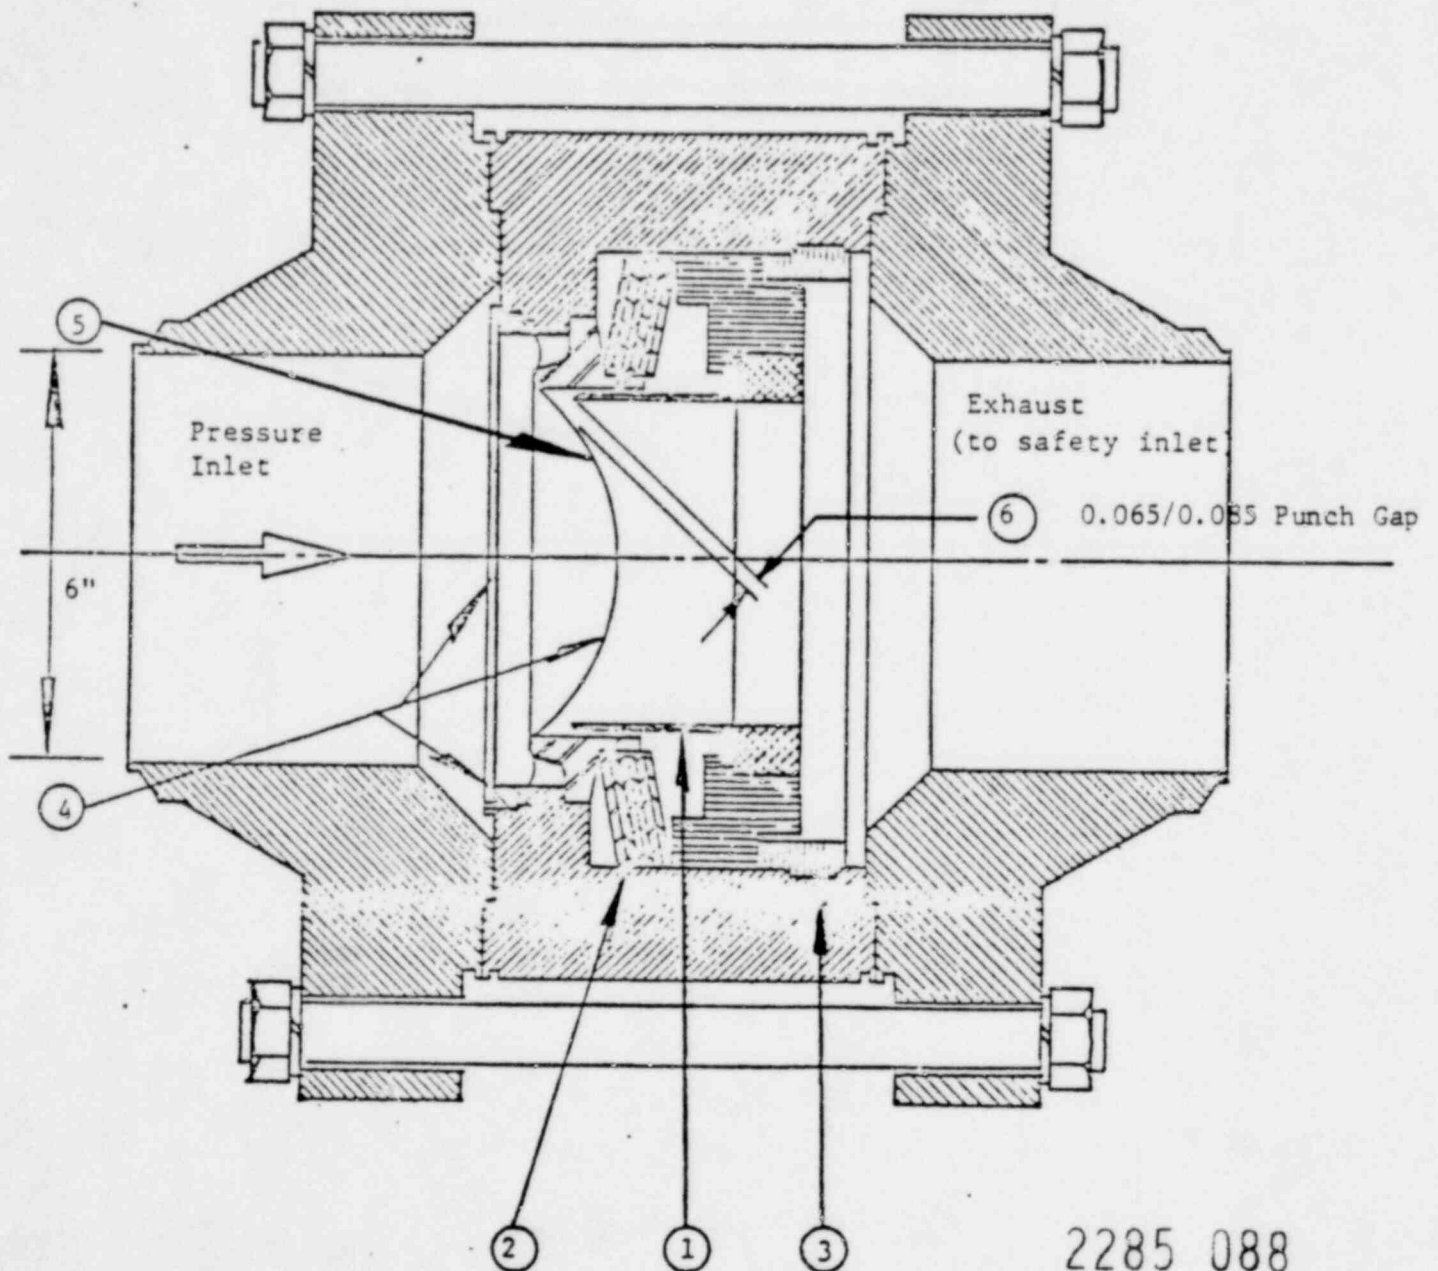
FIGURE 1 - RUPTURE DISC ASSEMBLY

On May 21, 1979, while the reactor was shutdown and depressurized for refueling, surveillance testing and preventive maintenance was being performed on the PCRV relief valve system. The cutting edge for the rupture discs was found out of tolerance, which could have prevented either relief valve from fulfilling the functional requirements of the system.

While the reactor was shutdown and depressurized for refueling the low set rupture disc, M-11702, was removed from service for a scheduled surveillance bench test. See Figure 1. During this test the punch gap, (6), was found out of tolerance. The cutting edge, (1), was farther from the rupture disc, (5), than allowed by manufacturer's specifications. Since the low set rupture disc punch gap was out of tolerance, the high set rupture disc, M-11701, was also removed and bench tested. Its punch gap, (6), was also out of tolerance with the cutting edge, (1), being farther from the rupture disc, (5), than allowed by manufacturer's specification. The punch gap tolerances and actual measurements are listed below.

<u>Punch Gap</u>	
		<u>Allowed*</u>	<u>Actual</u>
Low Set Rupture Disc	M-11702	0.065/0.085 in.	0.111 in.
High Set Rupture Disc	M-11701	0.065/0.085 in.	0.105 in.

The manufacturer's representative was contacted and indicated that because of the large size and movement of these discs the punch would have probably cut the disc in both cases.

During initial installation and testing, and subsequent surveillance testing of these rupture discs, the punch gap was checked per approved procedures. However, during the initial installation and testing some confusion resulted over the correct punch gap tolerances. Some of the procedures were changed from the original 0.065 to 0.085 inch punch gap to allow a 0.100 to 0.120 inch punch gap. This was apparently done on a verbal authorization of the technical representative present as no authorizing documentation can be found. These undocumented limits were still present on some of the approved procedures. The problem was discovered when the engineer supervising the surveillance this year used a procedure having the original tolerances as listed in the manual.

Because the manufacturer has gone out of business and all records are in storage, it would be extremely difficult to document the higher specifications at this time. Therefore, the punch gaps have been decreased to a maximum of 0.085 inches.

The punch has been machined to produce a punch gap of 0.085 inches on both M-11701 and M-11702.

The procedures concerning these rupture discs have been reviewed and the correct specifications for the punch gap verified.
