METALLURGICAL INVESTIGATION OF CRACKING IN A REACTOR VESSEL NOZZLE SAFE-END

FINAL REPORT

SwRI Project 02-5389-001

To
Iowa Electric Light and Power Co.
IE Tower
200 First Street S.E.
Cedar Rapids Iowa 52406

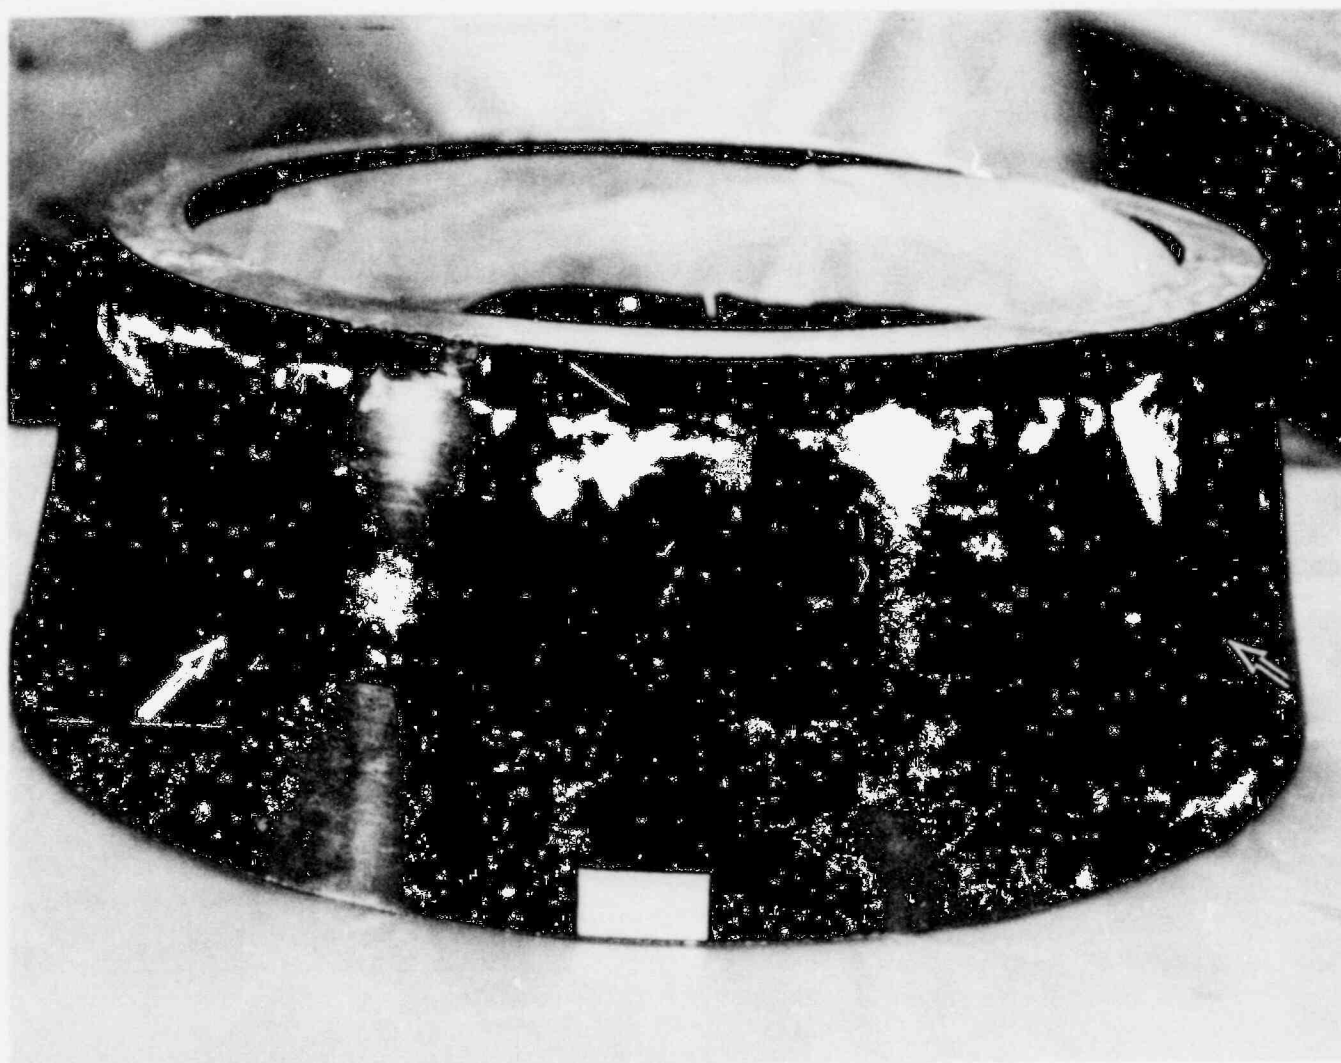
2-34314

The safe-end sample, shown in Figure 1-2, was identified as recirculation inlet nozzle 2A. Penetration of the wall of the safe-end had occurred over approximately 85° of the outside surface (from 75° clockwise to 160°). The appearance of the crack on the outside surface is shown in Figure 1-3.

FIGURE 1-2. SAFE-END SAMPLE. Arrows mark the ends of the through-wall crack.

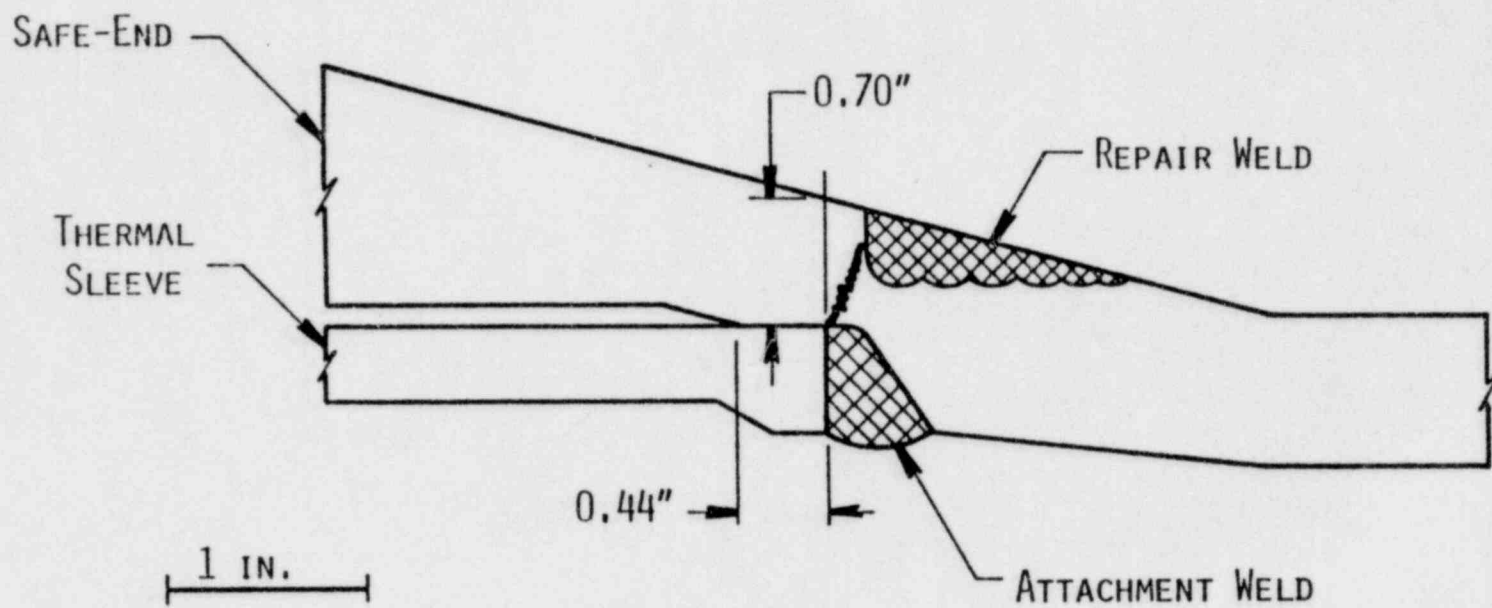
A diagram of a typical longitudinal section, showing the relative positions of the attachment weld, crevice, and repair weld is shown in Figure 2-1. Macrographs of representative sections are shown in Figures 2-2 through 2-5. Additional macrographs are included in Appendix B.

FIGURE 2-1. TYPICAL LONGITUDINAL SECTION THROUGH THERMAL SLEEVE ATTACHMENT AREA

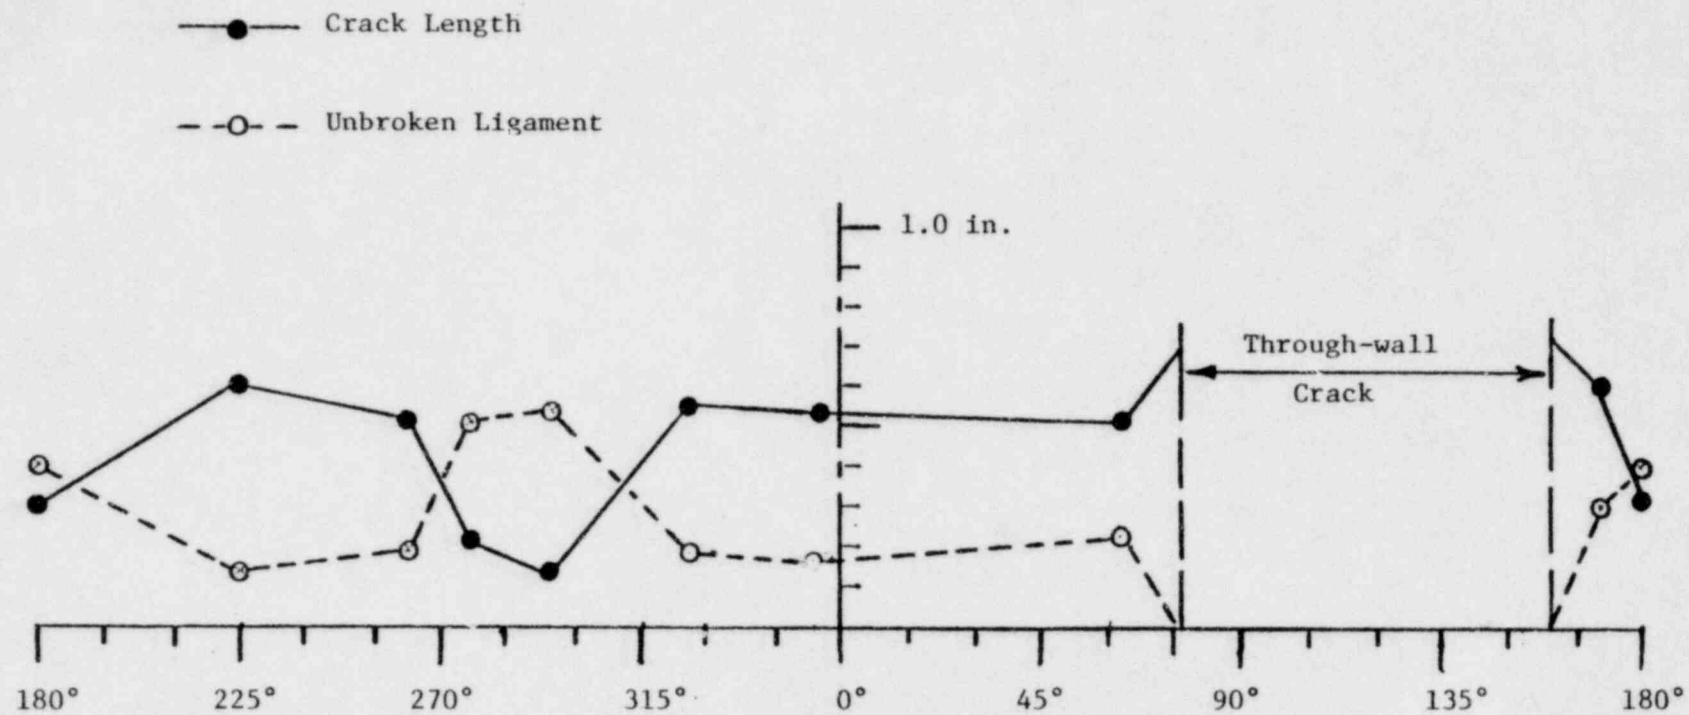
The crack length and remaining ligament (radial distance from the crack tip to the outside surface) were measured in all eleven sections. The results are plotted in Figure 2-6. Examination of sections 5-5, 8-8, 9-9, 10-10 and 11-11 verified the existence of major cracking in the zone from 270° to 330°. The radiographic inspection of this area did not reveal definite crack indications.

FIGURE 2-6. CRACK LENGTH AND UNBROKEN LIGAMENT VS ANGULAR POSITION

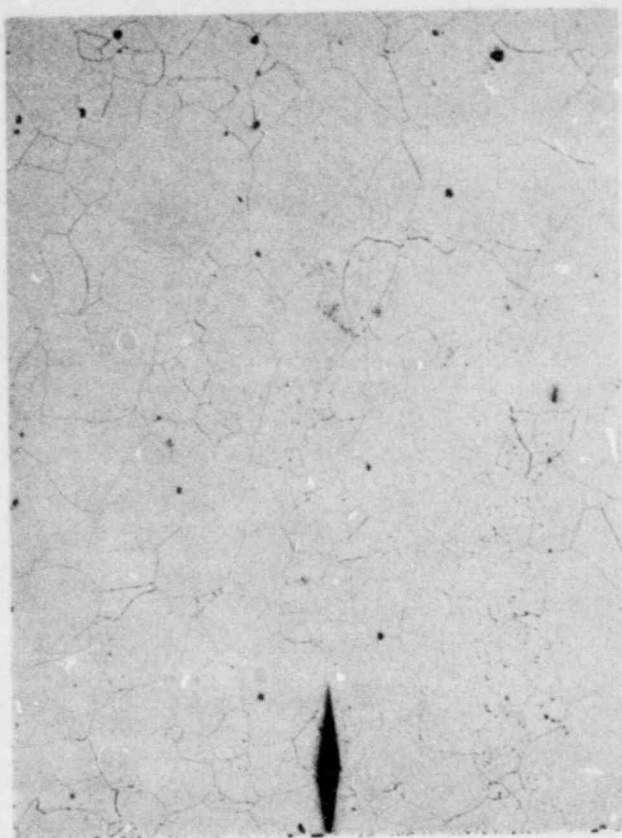
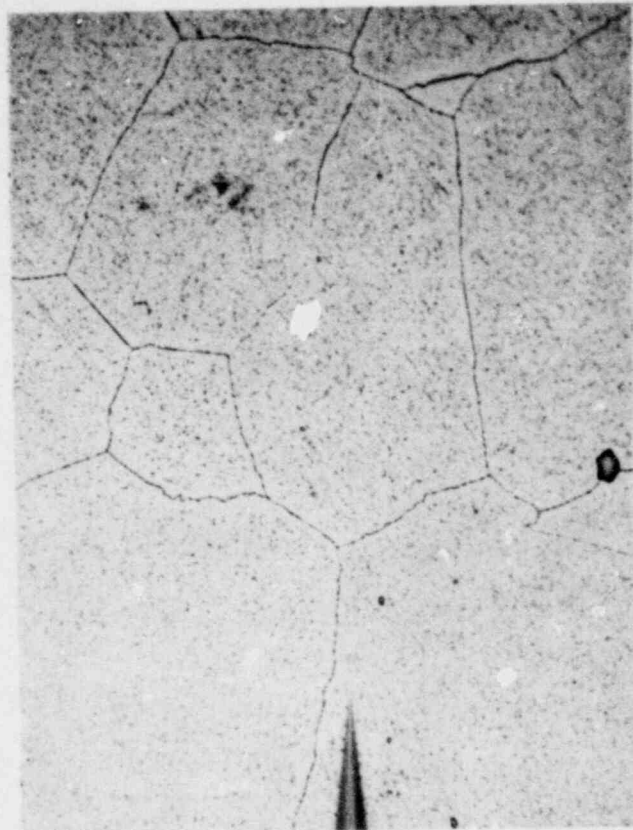
FIGURE 3-1. MICROSTRUCTURE OF SAFE-END.
Location 1, Figure 3-3.

The safe-end material exhibits clearly delineated grain boundaries after the phosphoric etch, (See Figure 3-1). At some grain boundary locations, relatively large, discrete carbide particles are evident. Extensive matrix carbides are also resolved after the phosphoric acid etch. This observed condition is consistent with the fact that the safe-end was subjected to two 1100°-1175° stress relieving operations with a total time at temperature of approximately 16 hours.

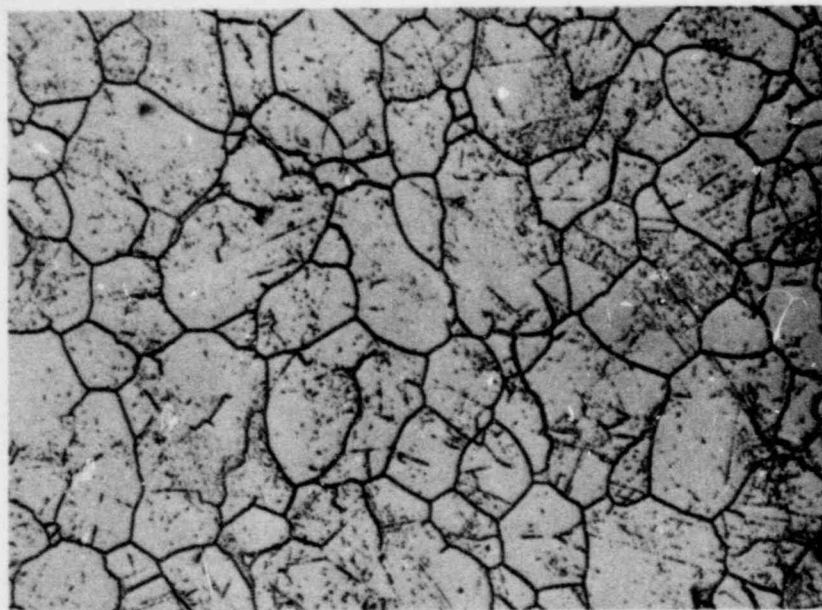
The microstructure of the thermal sleeve is shown in Figure 3-2. It is evident from the features shown in these micrographs that the thermal sleeve is sensitized (carbides precipitated at grain boundaries). Apparently the material was furnished in a sensitized condition since no stress relief treatments were performed after installation of the thermal sleeve [Figure 3-2(b)]. The more extensive grain boundary carbide precipitation evident at locations near the weld is attributed to the thermal cycle experienced during the welding operation.

FIGURE 3-2. MICROSTRUCTURE OF THERMAL SLEEVE.
Location 2, Figure 3-3.

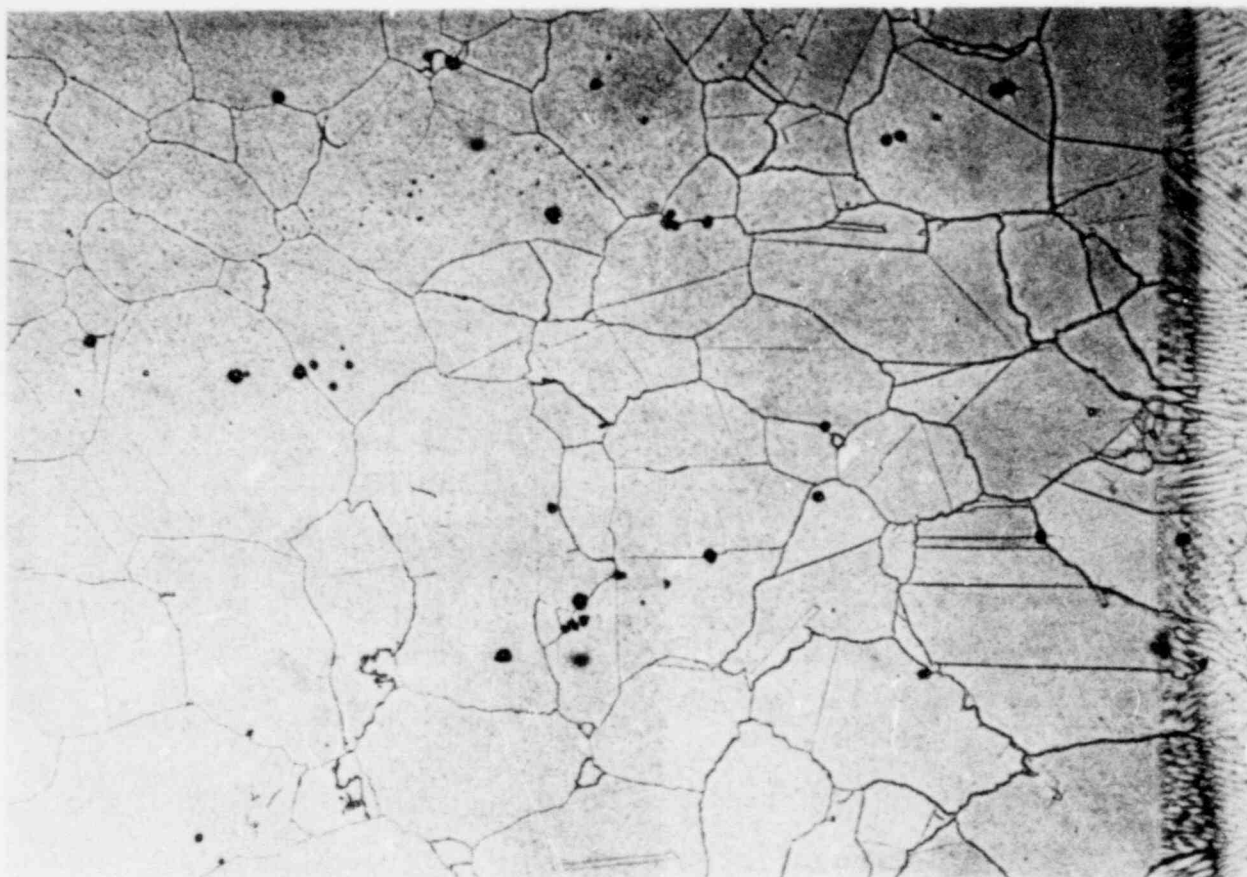
2-34398-399

Micrographs illustrating the microstructure of the heat-affected zones (HAZ) associated with the repair weld are shown in Figures 3-4 and 3-5. In each case, a zone of more pronounced grain boundary sensitization is apparent immediately adjacent to the fusion line. This feature is normal for the fabrication sequence employed, since sensitization in the HAZ is inherent

FIGURE 3-4. MICROSTRUCTURE OF HAZ AT REPAIR WELD.
Location 3, Figure 3-3.
Etchant: 10% Nital, electrolytic. 200X

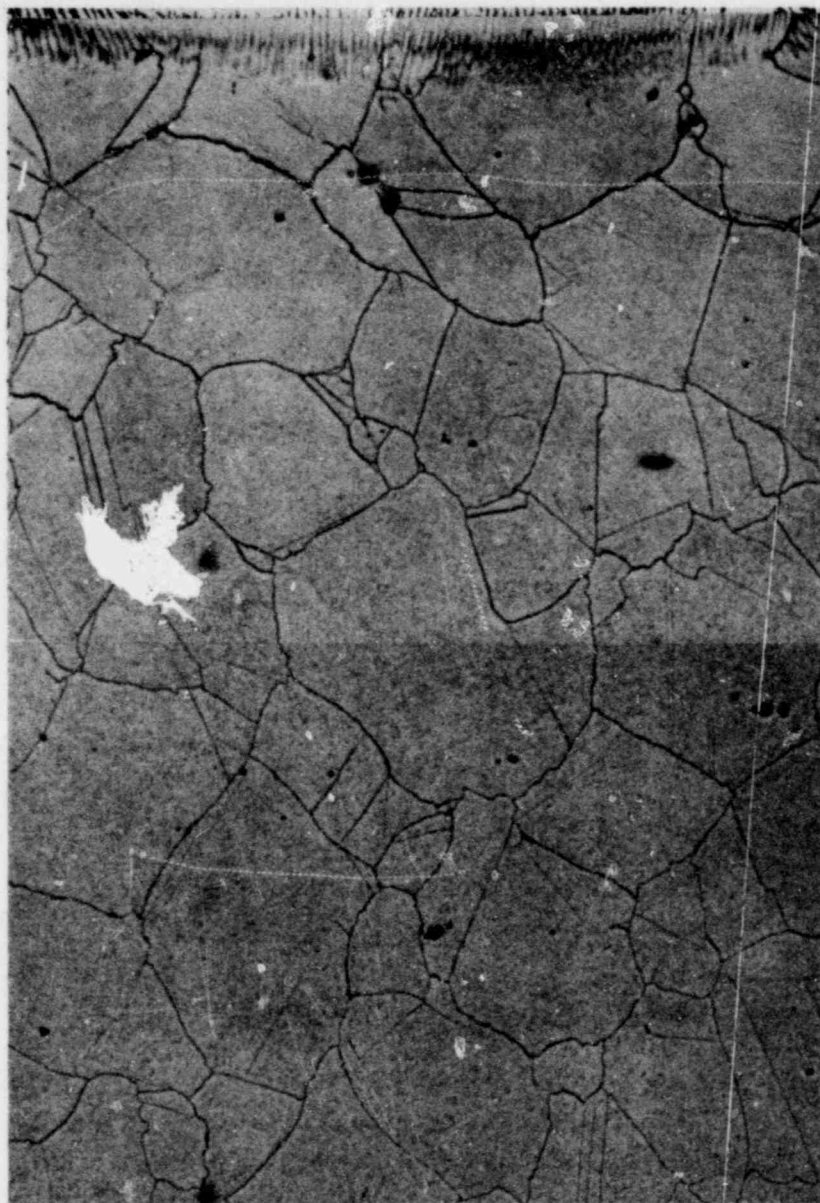
2-34396-397

FIGURE 3-5. MICROSTRUCTURE OF HAZ AT REPAIR WELD.
Location 4, Figure 3-3. Etchant:
10% Nital, electrolytic. 200X

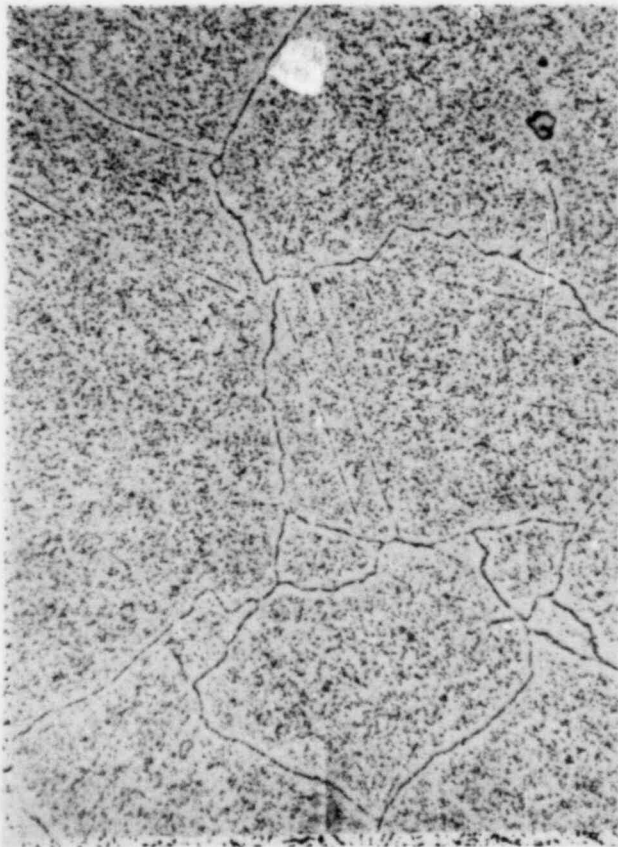
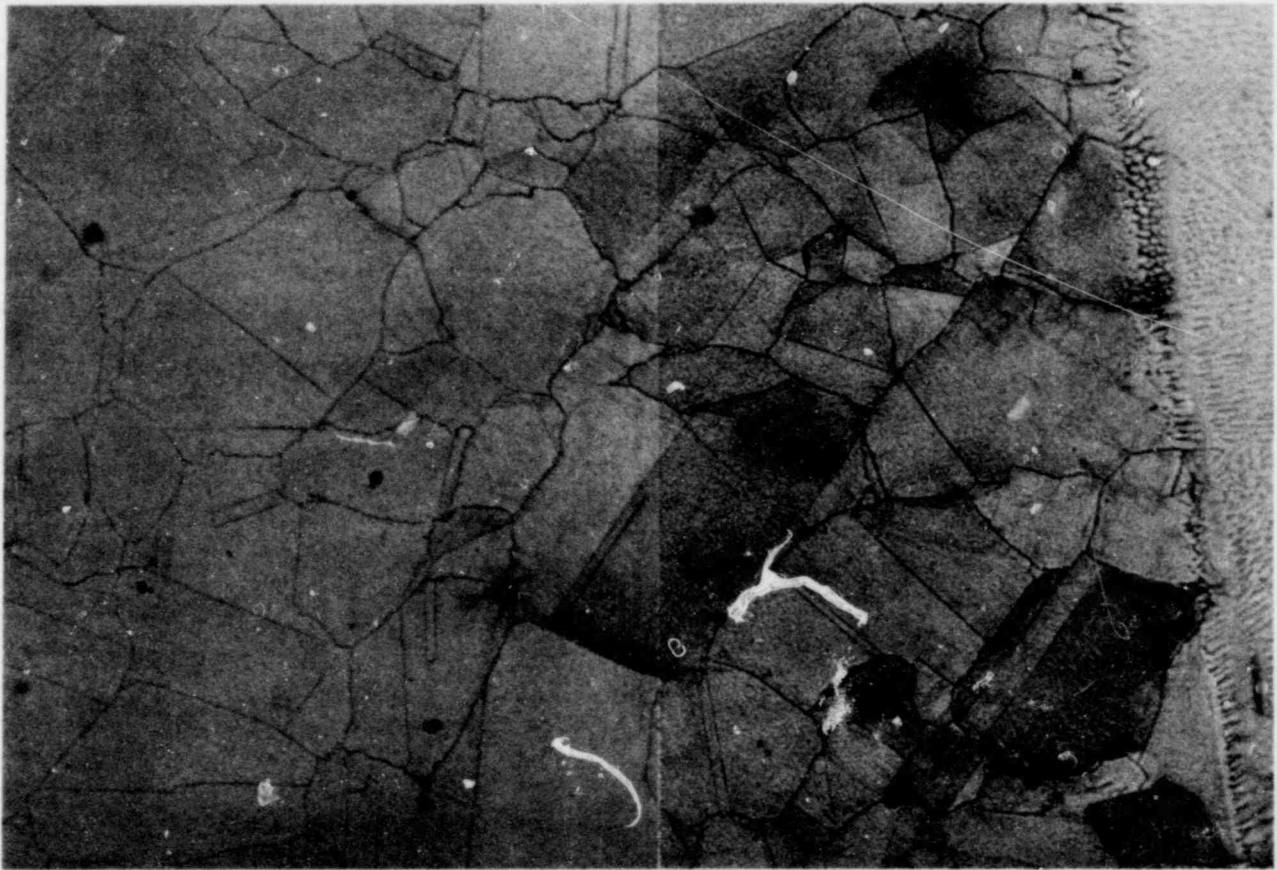
The microstructure midway along the line of closest approach of the repair weld and the thermal sleeve attachment weld is shown in Figure 3-6(a). This structure is comparable to that at remote locations [compare with Figure 3-1(b)] indicating that the repair welding operation did not alter the microstructure in the vicinity of the thermal sleeve attachment.

The HAZ at the thermal sleeve attachment weld is shown in Figure 3-6(b). The microstructural features are similar to those of the repair weld HAZ and are normal for this situation. This zone was not involved in the cracking but the normal microstructure serves to indicate normal welding practice.

FIGURE 3-6. MICROSTRUCTURE OF HAZ AND BASE METAL
AT THERMAL SLEEVE ATTACHMENT WELD.
See Figure 3-3 for locations.

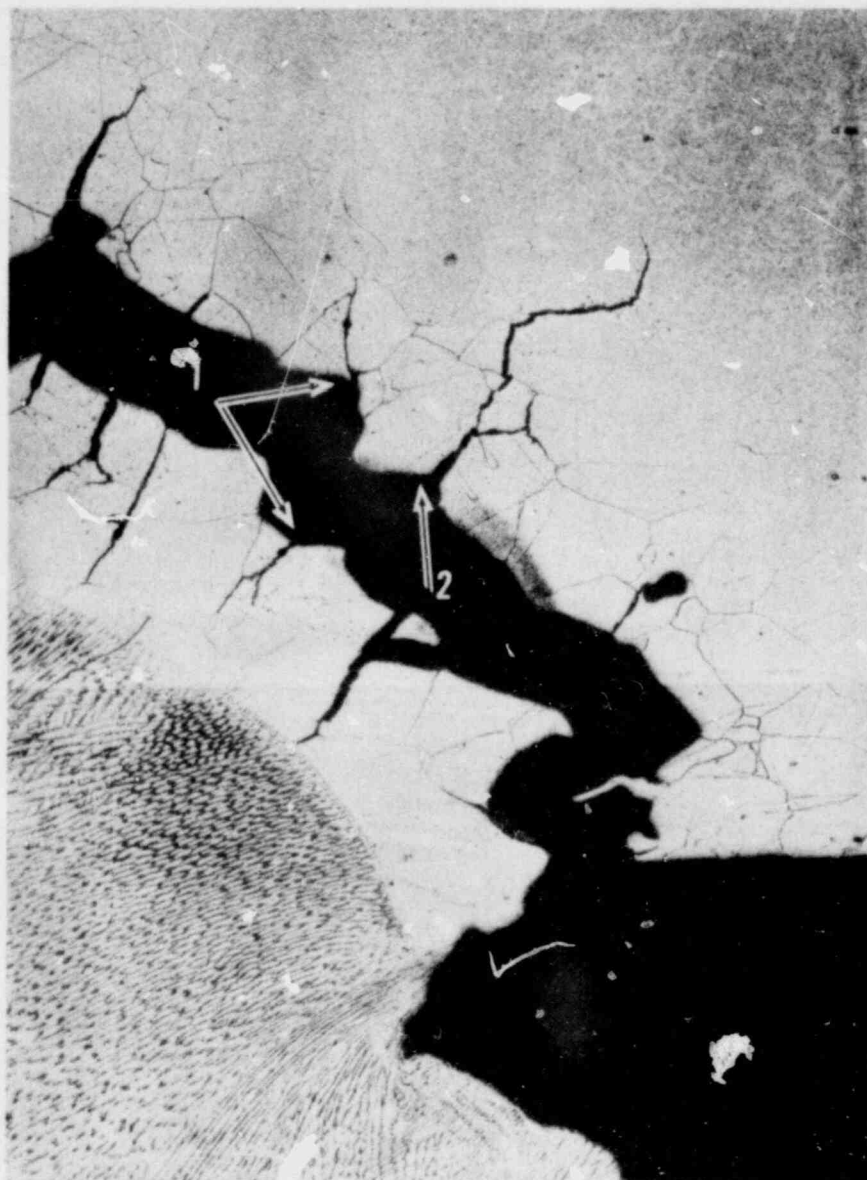
$2-34434, -435$

FIGURE 4-1. SECTION THROUGH THERMAL SLEEVE ATTACHMENT AREA.
Section 1-1, Figure 1-4, Etchant: 8:1
Phosphoric acid. 100X

The location of the initial portion of the crack path within the heat-affected zone varied around the circumference. At Section 1-1 crack initiation and early propagation occurred within the carbide free zone between the fusion line and the zone of heaviest grain boundary carbide precipitation, see Figure 4-1. At other sections crack initiation occurred within the region of heaviest grain boundary precipitation, and in some cases the initial stage of cracking extended across this region into unaffected base metal, Figures 4-4 and 4-5.

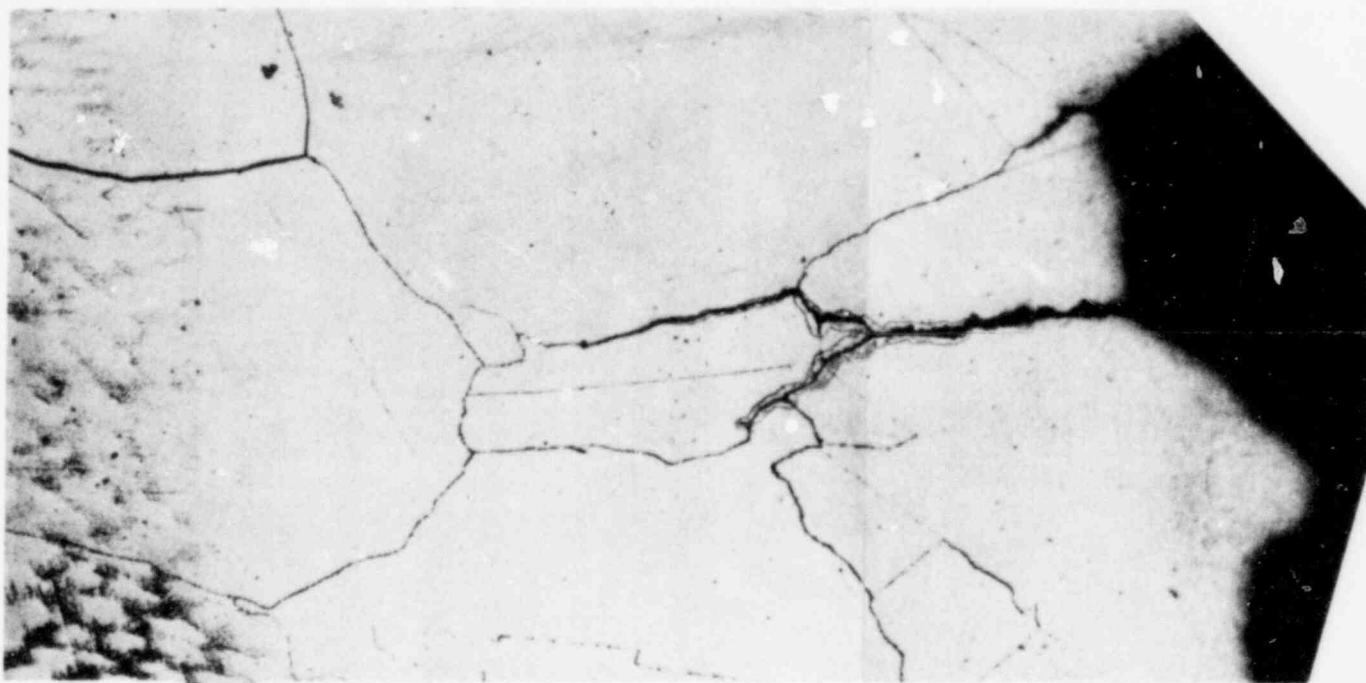
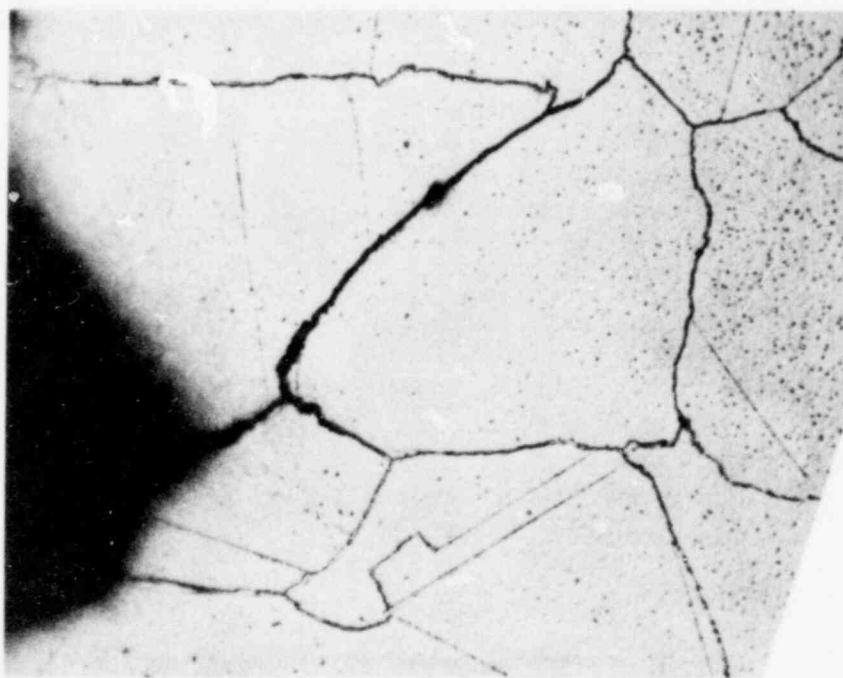
FIGURE 4-2. MICROSTRUCTURE AT POINTS ON OPPOSITE SIDES OF CRACK. Section 1-1, Location 1, Figure 4-1. Etchant: 8:1 Phosphoric acid. 500X

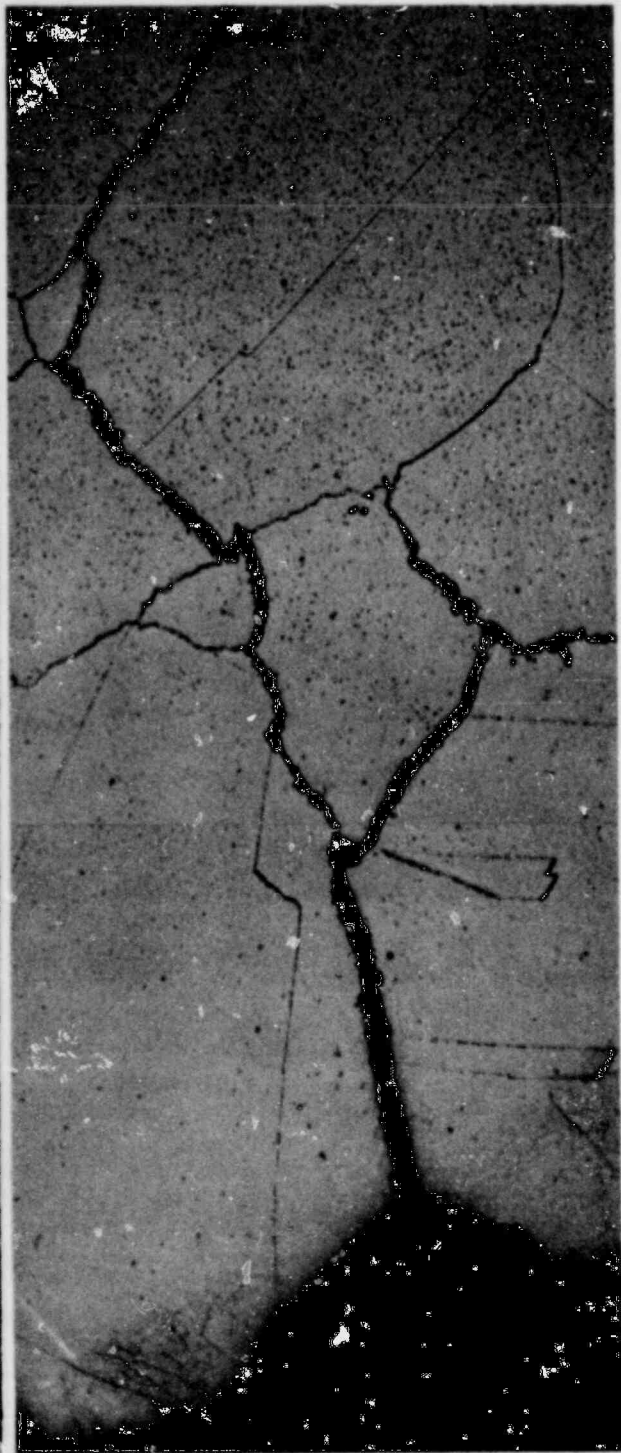
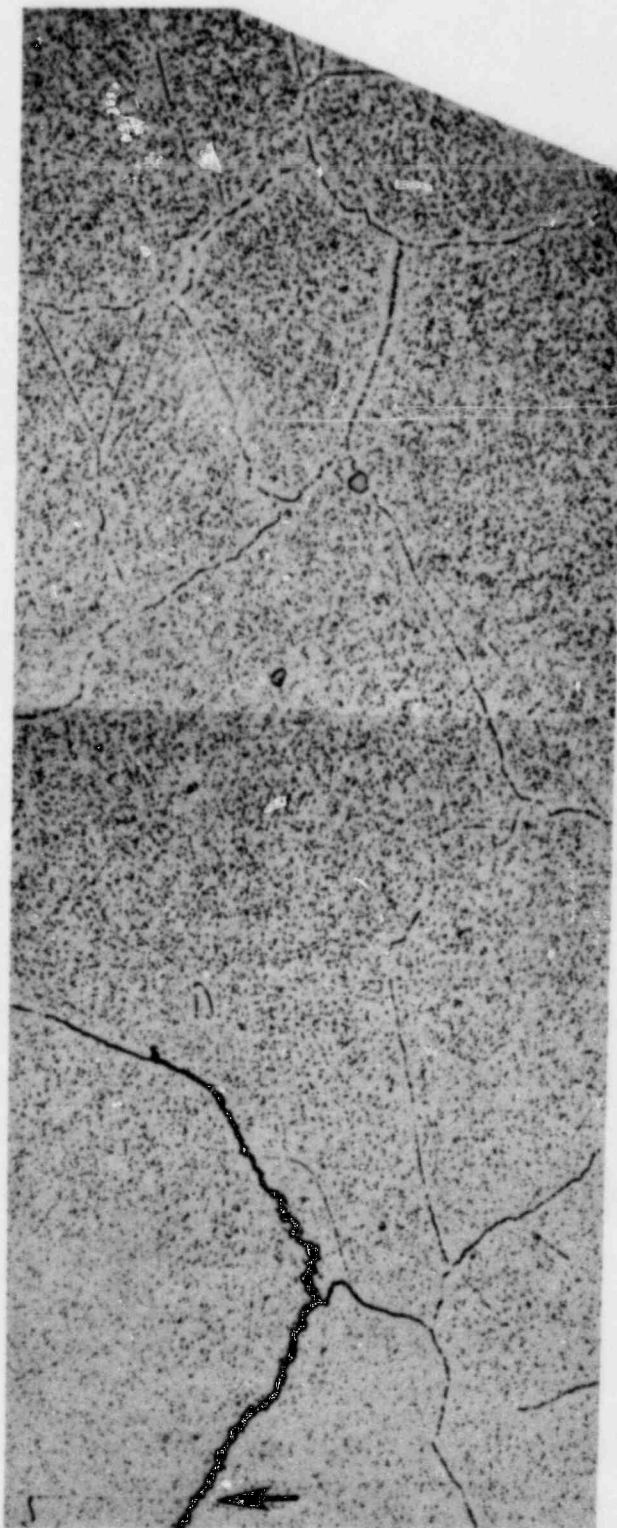
FIGURE 4-3. MICROSTRUCTURE AT MAIN CRACK. Section 1-1, Location 2, Figure 4-1. Arrows indicate match points. Etchant: 8:1 Phosphoric acid. 500X

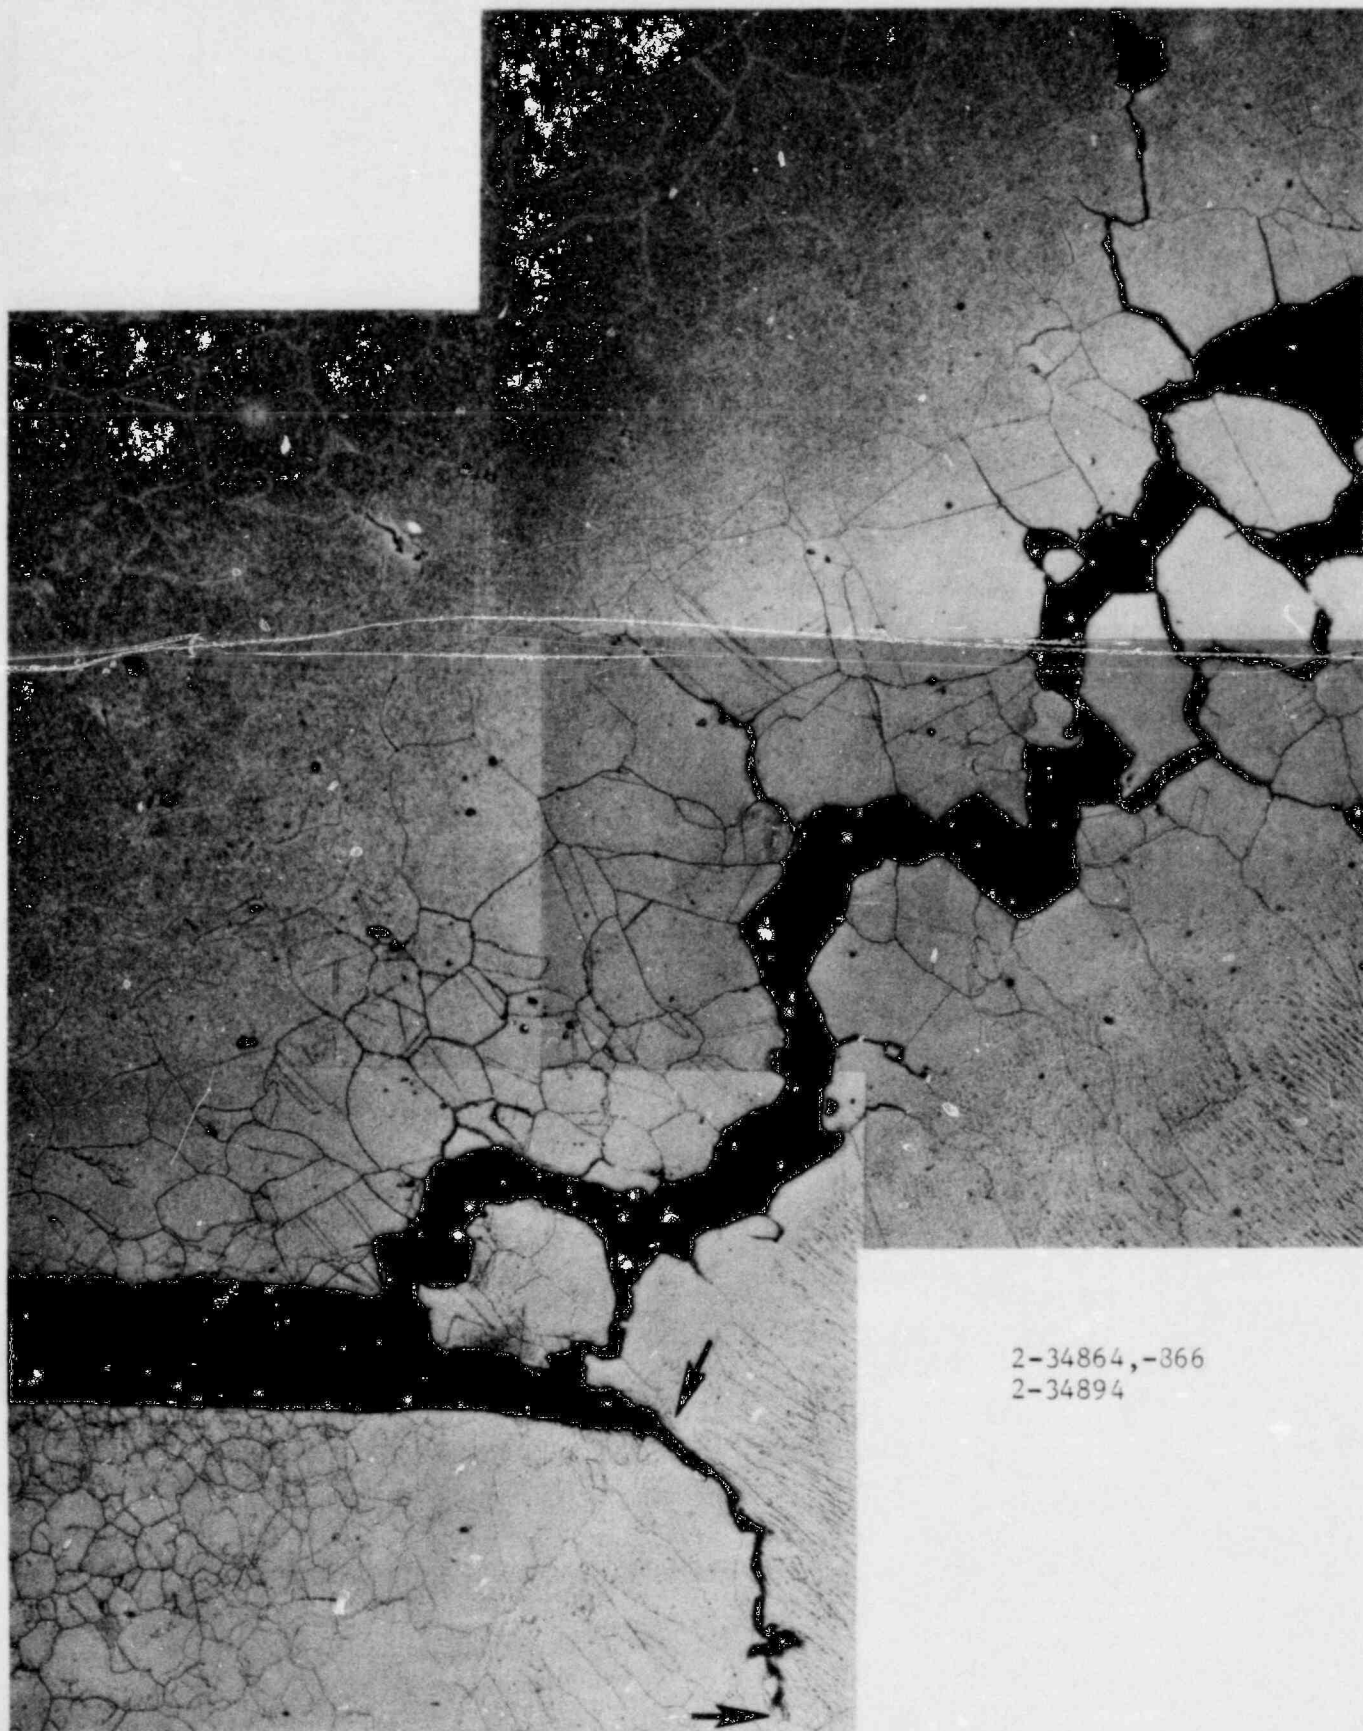
FIGURE 4-4. SECTION THROUGH THERMAL SLEEVE ATTACHMENT AREA.
Section 2-2, Figure 1-4. Etchant: 8:1
Phosphoric acid. 100X

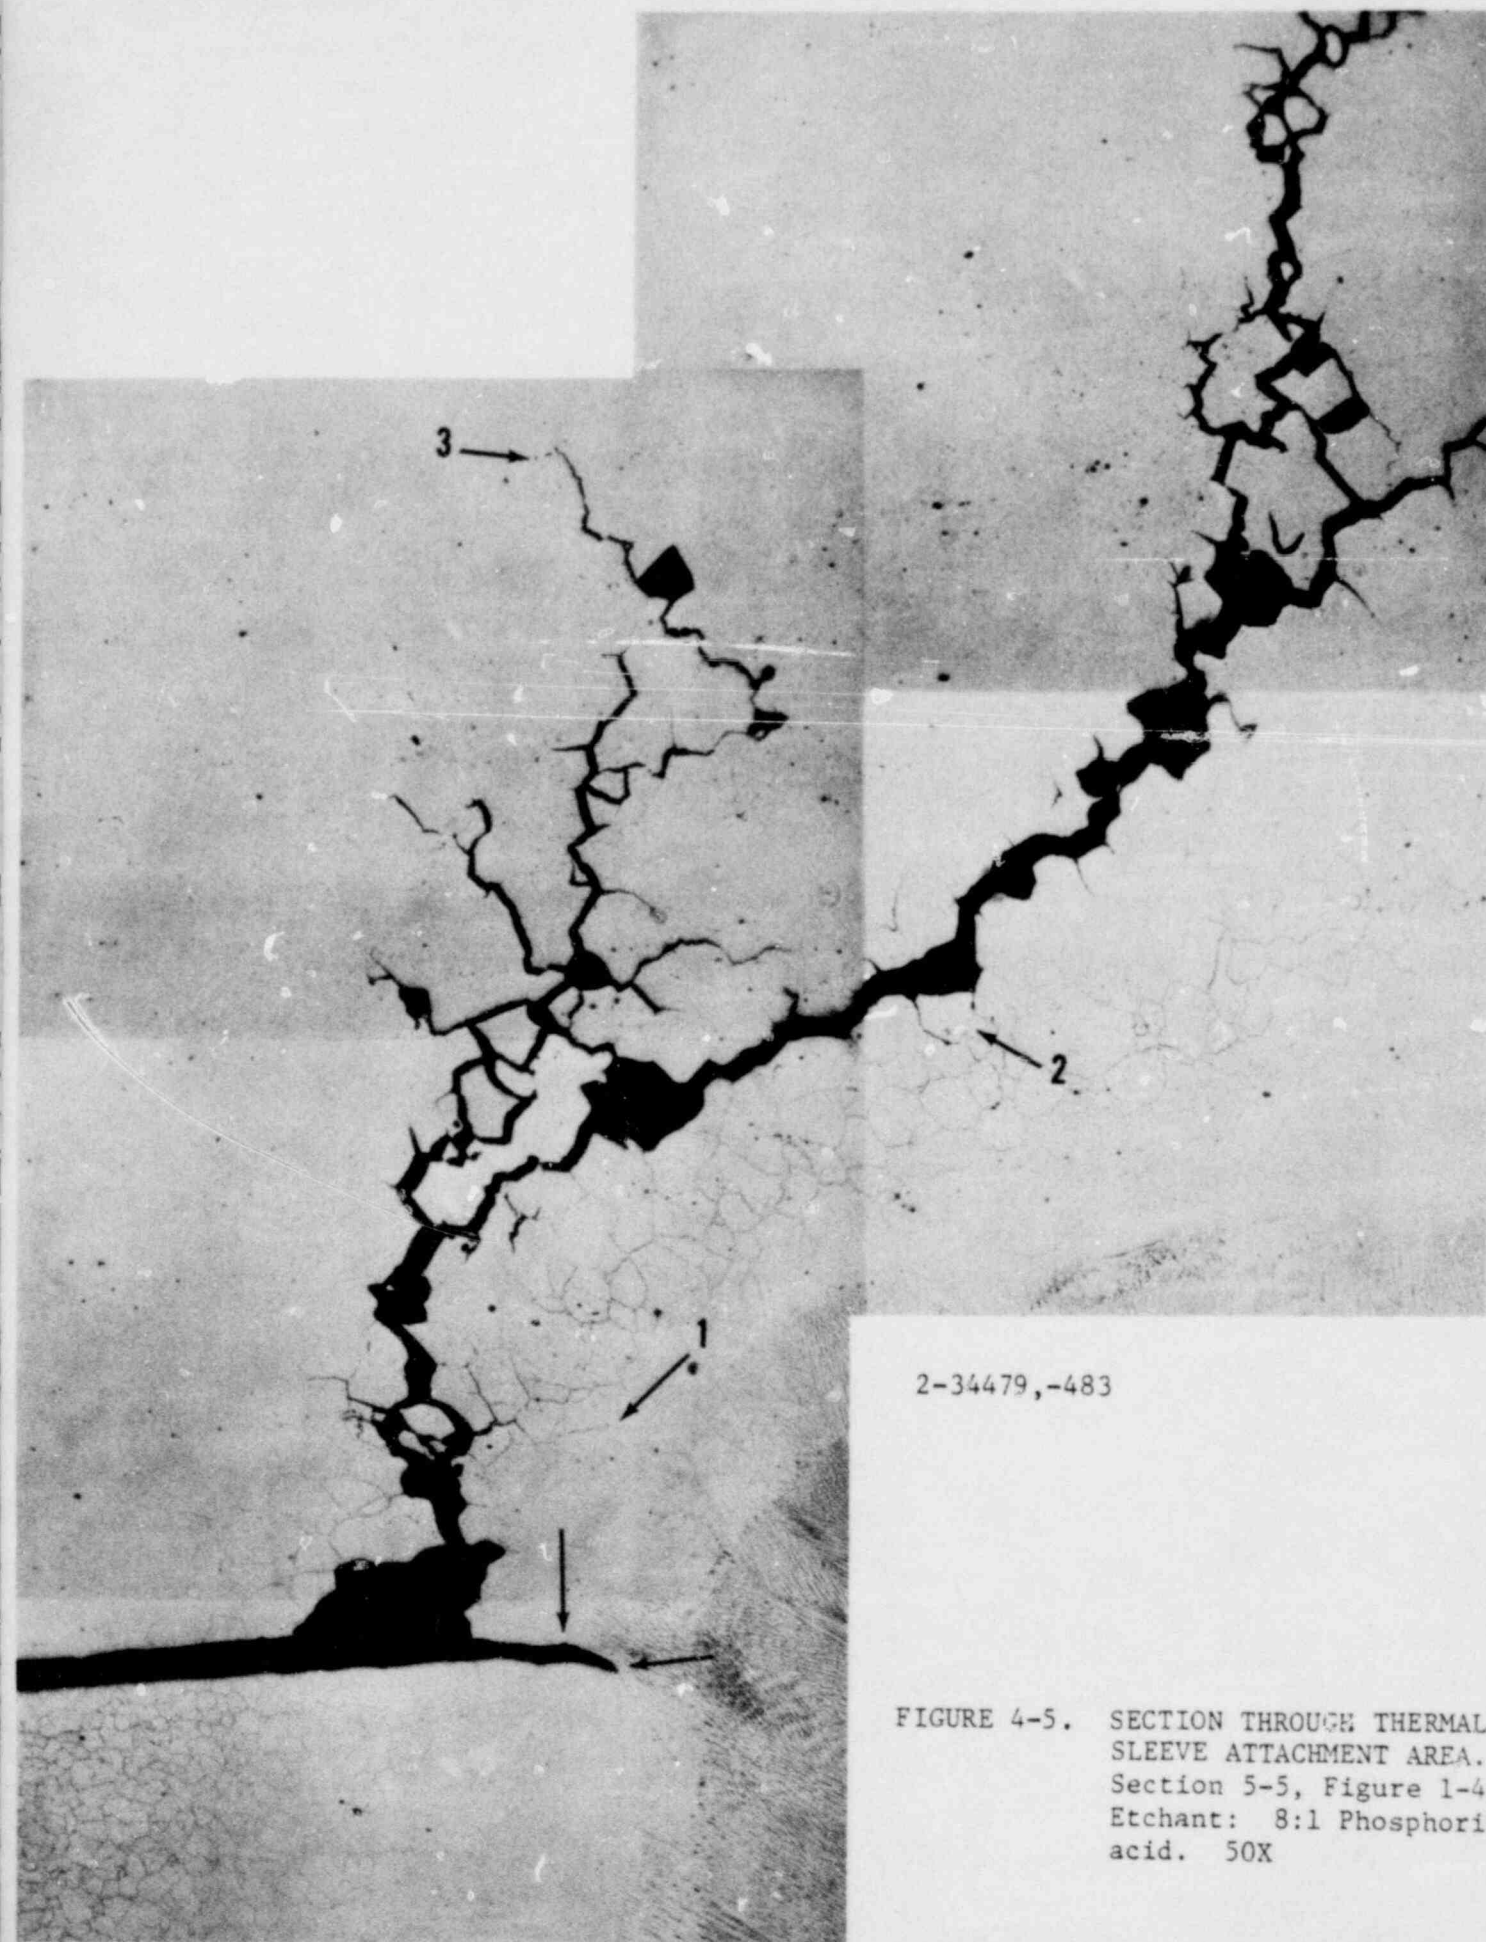
2-34479,-483

FIGURE 4-5. SECTION THROUGH THERMAL SLEEVE ATTACHMENT AREA. Section 5-5, Figure 1-4. Etchant: 8:1 Phosphoric acid. 50X

later stages of propagation the crack diverts from the thermal sleeve attachment weld into unaffected base metal, see Figures 4-5, D-3 and D-5.

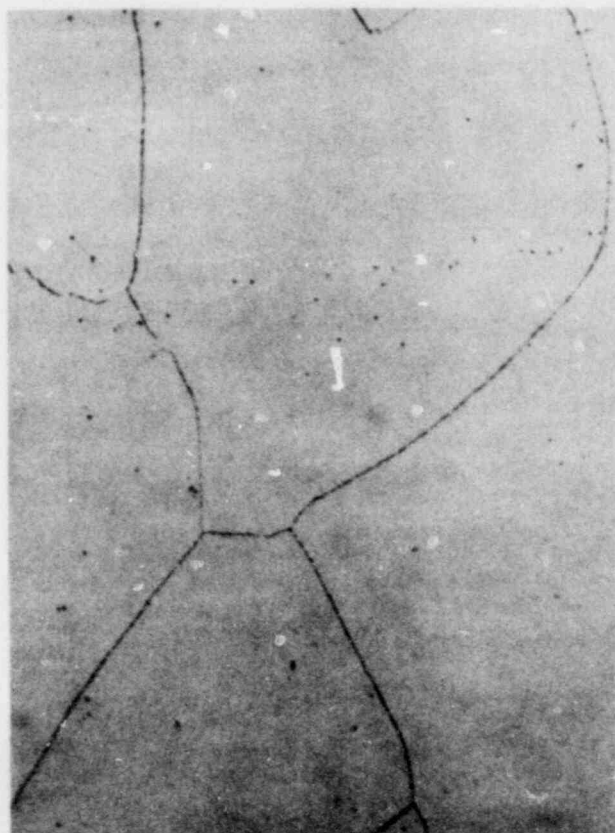
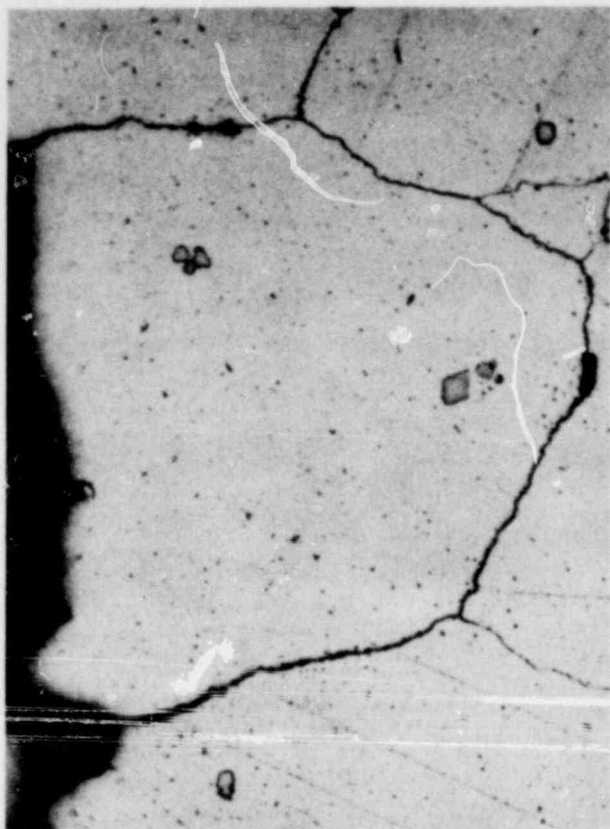
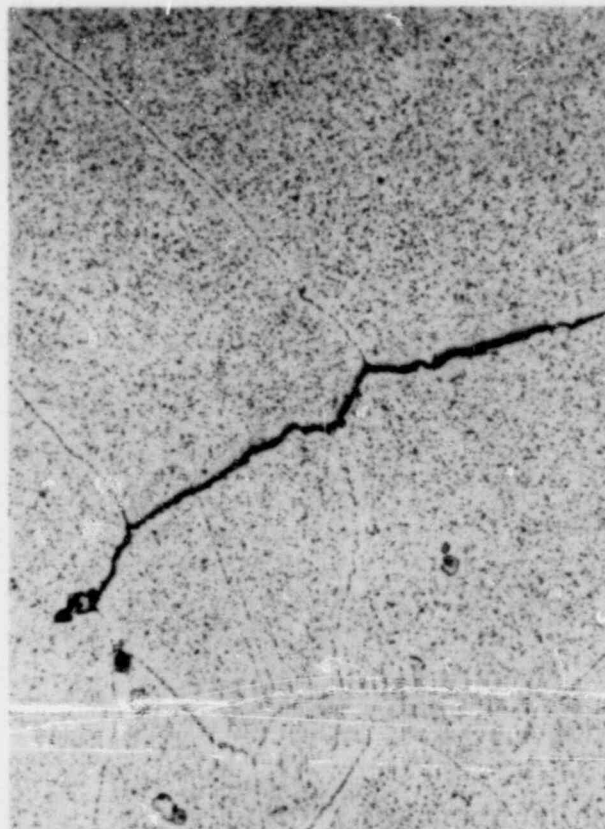
FIGURE 4-6. MICROSTRUCTURE IN VICINITY OF MAIN CRACK. Section 5-5, See Figure 4-6 for locations. Etchant: 8:1 Phosphoric acid. 500X

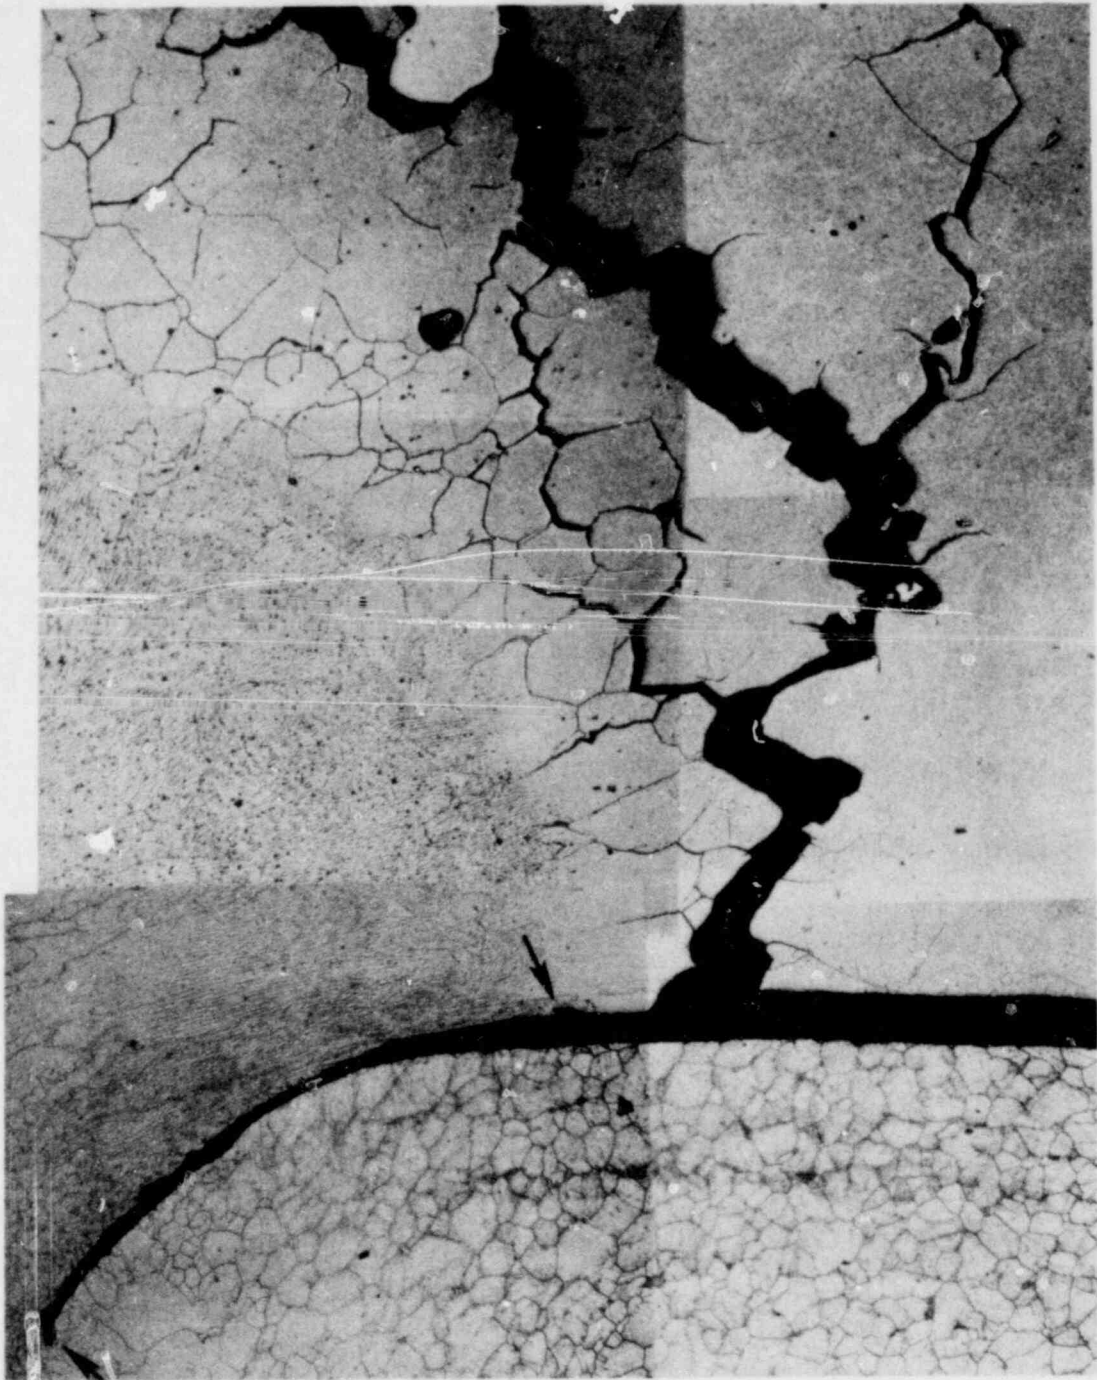
FIGURE 4-7. SECTION THROUGH THERMAL SLEEVE ATTACHMENT AREA. Section 11-11, Figure 1-4. Etchant: 8:1 Phosphoric acid. 75X
