METALLURGICAL INVESTIGATION OF CRACKING IN A REACTOR VESSEL NOZZLE SAFE-END

FINAL REPORT

SwRI Project 02-5389-001

To
Iowa Electric Light and Power Co.
IE Tower
200 First Street S.E.
Cedar Rapids Iowa 52406

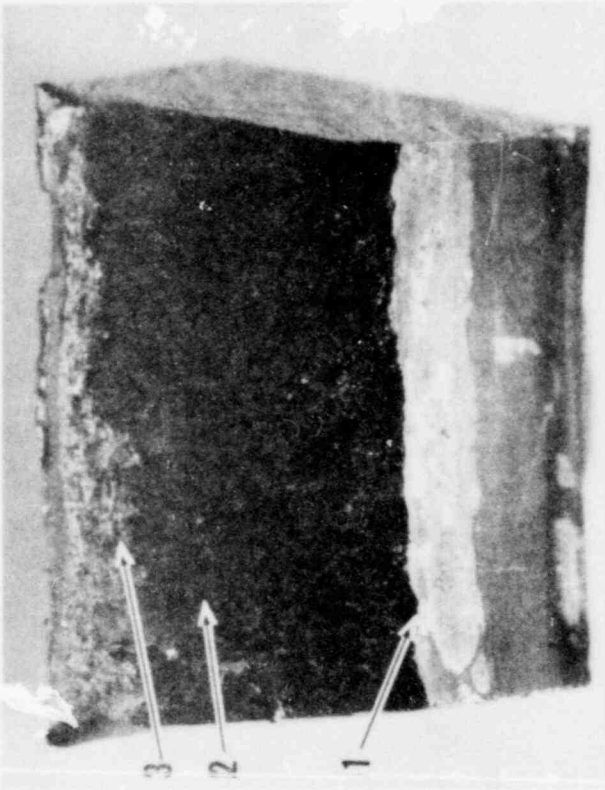
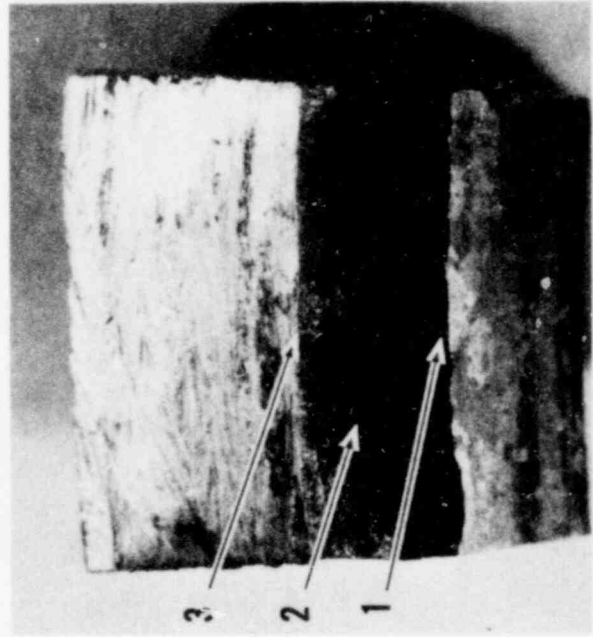
Specimen No. 1 was taken from a location where the final stages of cracking passed through the repair weld. A transition in surface topography, marking the line of intersection of the crack with the repair weld is apparent in Figure 4-8(a). The fine-scale features at this transition are shown in Figure 4-11 and fractographs from the crack surface within the repair weld are shown in Figure 4-12. Distinct intergranular features are evident in the portion of the surface corresponding to crack propagation in base metal. The features of that portion of the surface corresponding to the repair weld demonstrate that crack propagation in this zone occurred in an intercolumnar mode. The transition in surface topography at the intersection of the crack with the repair weld is strictly due to the different microstructures characteristic of the weld metal and the base metal.

FIGURE 4-8. CRACK SURFACE SPECIMENS. See Figure 1-4 for locations. Crevice surface is at bottom of each photograph. 3X

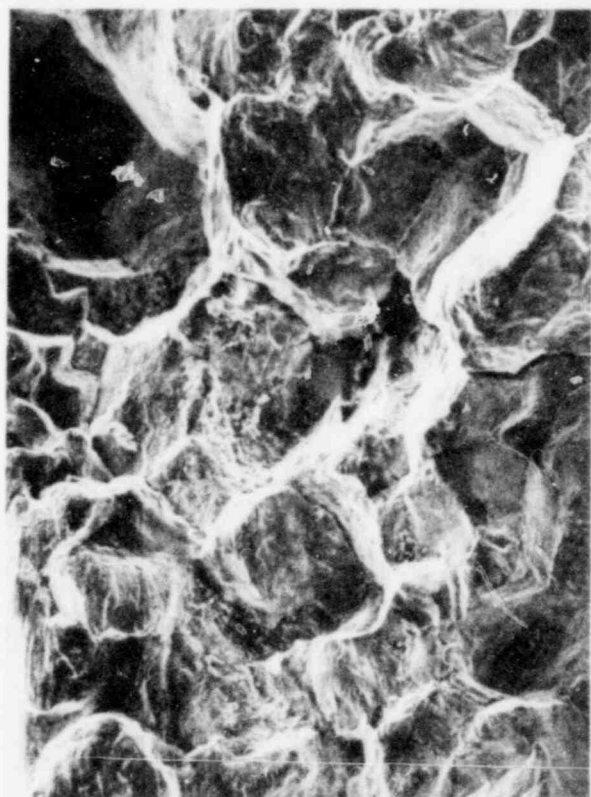
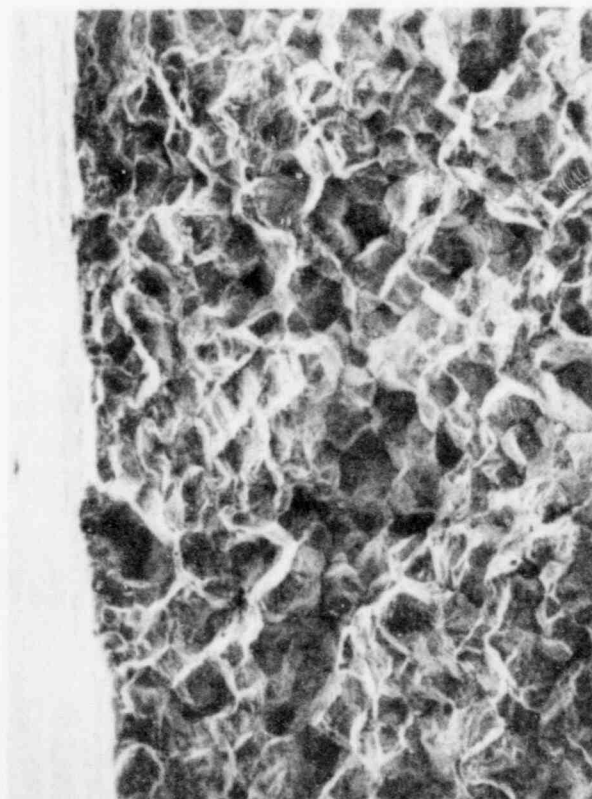
The crack surfaces of all three specimens were characterized by distinct intergranular facets at all locations examined. Figures 4-9, E-1 and E-4 are representative of the fractographic features observed at the intersection of the crack surface with the inside surface of the safe-end. The crack surface was completely intergranular along this edge and there were no features to identify any discrete initiation sites. The features of the crack front, at locations where partial penetration occurred are shown in Figures E-3 and E-5. The transition from the service-induced crack to the laboratory overload fracture is apparent and in each case, intergranular features are evident at the extremities of the crack.

FIGURE 4-9. SEM FRACTOGRAPH FROM CRACK SURFACE, Specimen No. 1, Location 1, Figure 4-8(a).

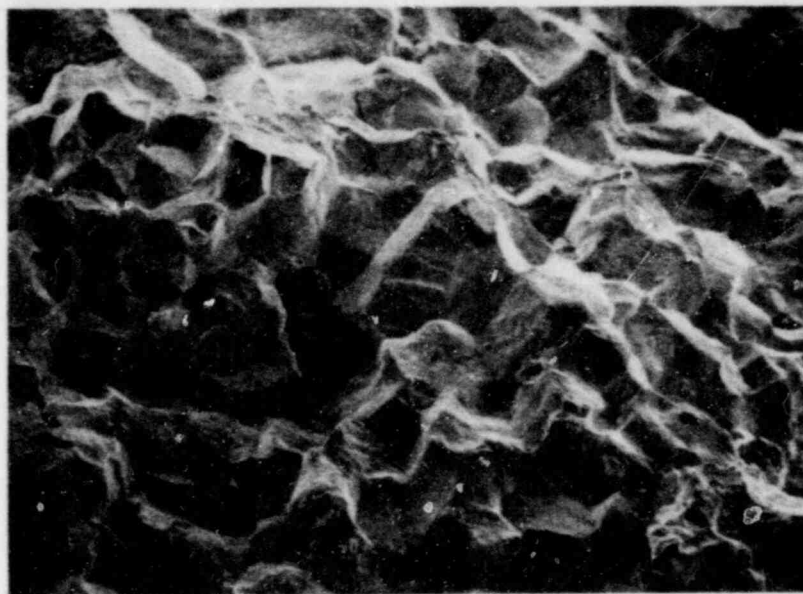
FIGURE 4-10. SEM FRACTOGRAPHS FROM CRACK SURFACE.
Specimen No. 1. See Figure 4-8(a)
for locations.

The fractographic features at the particular points described above, together with those at locations in the central portion of the crack surface (Figures 4-10, 4-11 and E-2) demonstrate that the cracking was completely intergranular. No evidence of any form of step-wise crack propagation was observed in the fractographic examination.

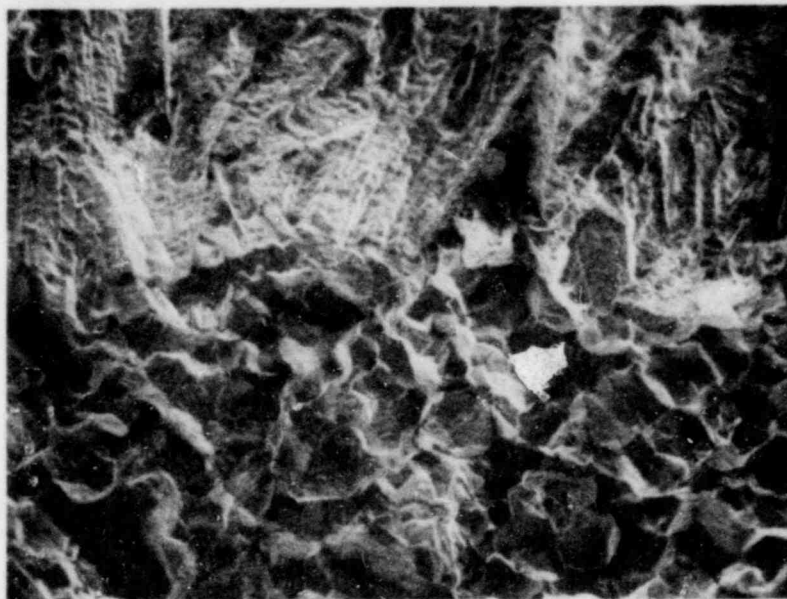
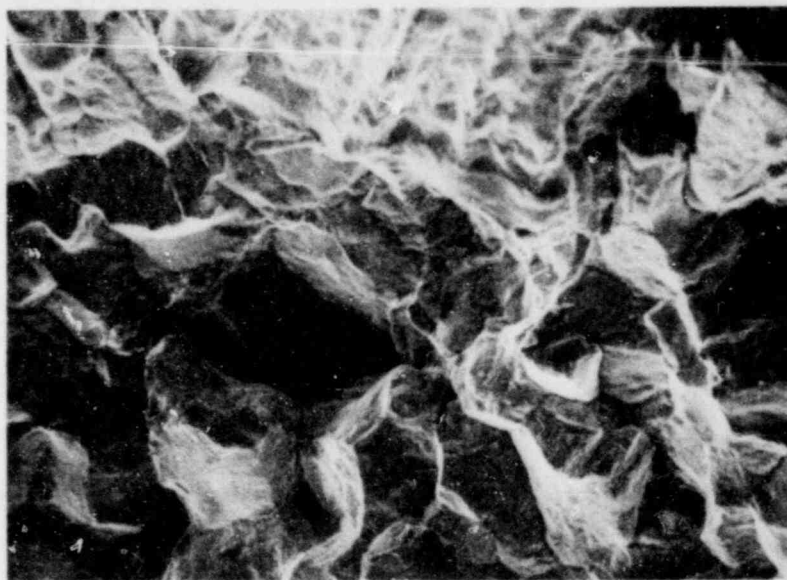
FIGURE 4-11. SEM FRACTOGRAPHS FROM CRACK SURFACE.
Specimen No. 1, Location 4, Figure
4-8(a).

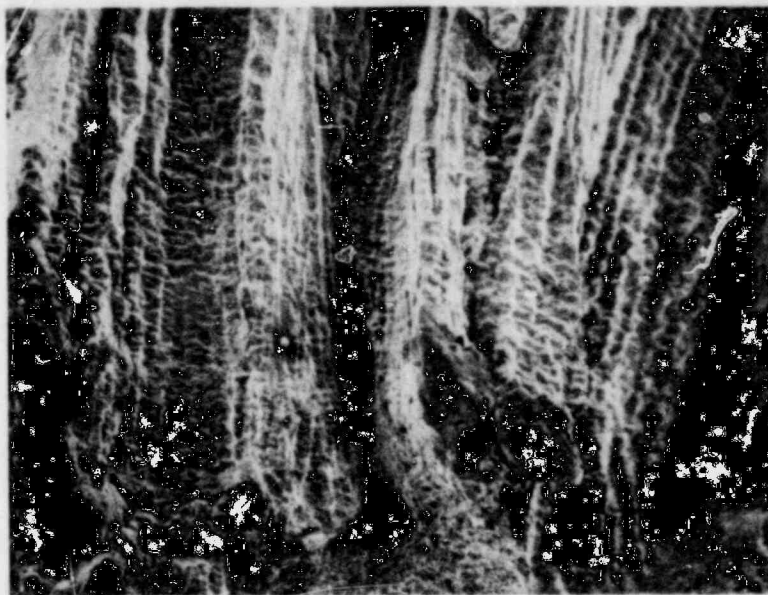
FIGURE 4-12. SEM FRACTOGRAPHS FROM CRACK SURFACE.
Specimen No. 1, Location 5, Figure
4-8(a).

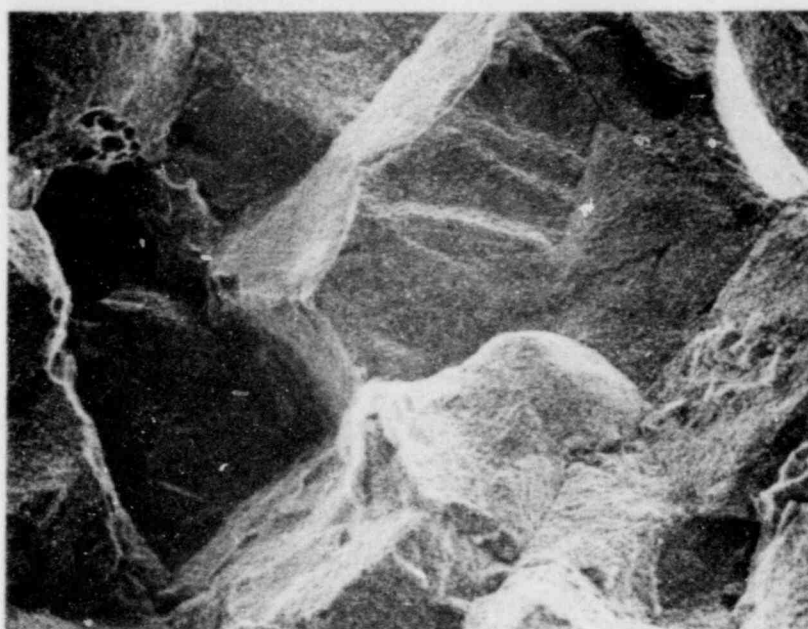
In the examination of the various crack surface specimens, deposits were evident on the intergranular crack surfaces and on the crevice surfaces. Distinctly crystalline deposits, such as shown in Figure 5-1, and a fibrous appearing materials, Figure 5-2, were noted at several locations on the crack surfaces. The particular examples, shown in Figures 5-1 and 5-2, represent small amounts of deposit materials remaining on the crack surface of fractographic Specimen No. 1 after decontamination by gentle washing and brushing. X-ray energy spectra for these particular surface deposits are compared with the spectrum from a clean area in Figure 5-3. Pertinent features of these spectra are as follows:

FIGURE 5-1. DEPOSIT ON CRACK SURFACE.
SEM fractographs. Specimen
No. 1. Location 6,
Figure 4-8(a).

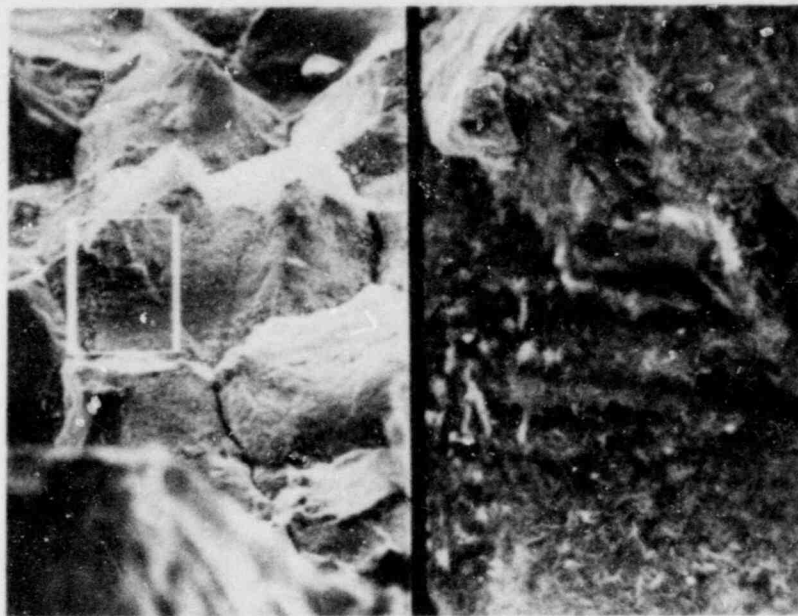
1. The fibrous type material (Figure 5-2) was the only recognizable deposit evident in examinations of crack surfaces in the original condition. This deposit material was particularly evident at points remote from the crevice and was not present at locations in the immediate vicinity of the crevice.

FIGURE 5-2. DEPOSIT ON CRACK SURFACE.
SEM fractographs. Specimen
No. 1. Location 4,
Figure 4-8(a).

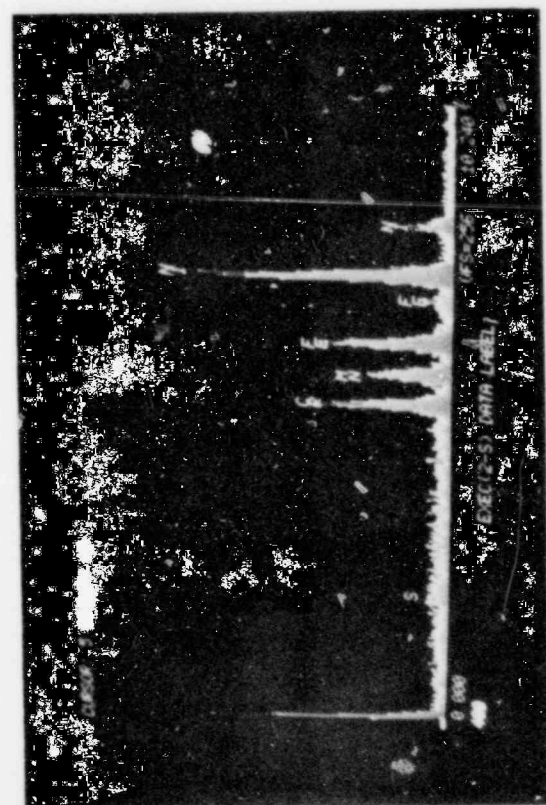
FIGURE 5-3. X-RAY ENERGY SPECTRA.
Crack surface, Specimen
No. 1.

2. The crystalline deposit material on the crack surfaces was evident only after partial cleaning.
3. The fibrous deposit material on the crack surface contained sulfur.
4. The crystalline deposit material on the crack surface is iron-rich compared to the base metal.
5. Iron was the predominant element detected in the crack surface deposits near the crevice. No sulfur was detected in this material.
6. Deposits on the crevice surface presented a distinctly different appearance from those on the crack surface.
7. Iron was the predominant element detected in the deposit material on the crevice surface. No sulfur was detected in these deposits.
8. The presence of chlorine was indicated at one location on the crevice surface.

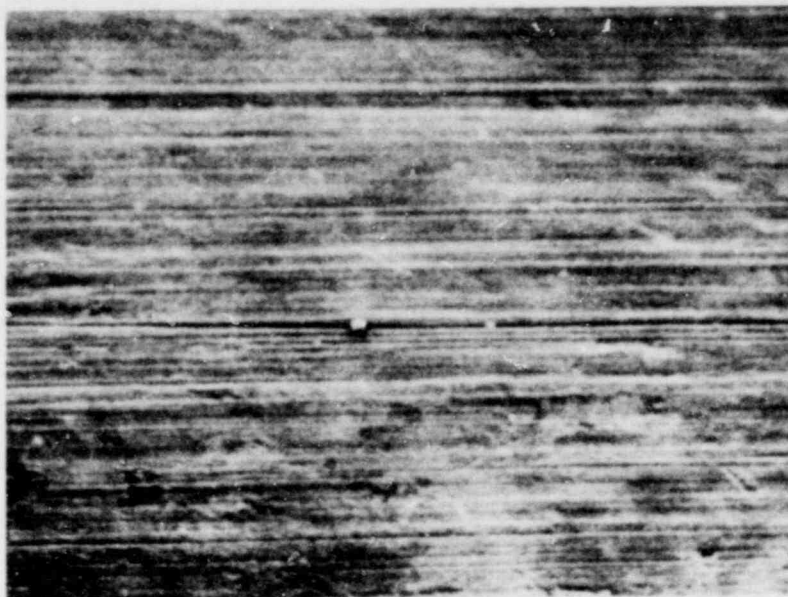
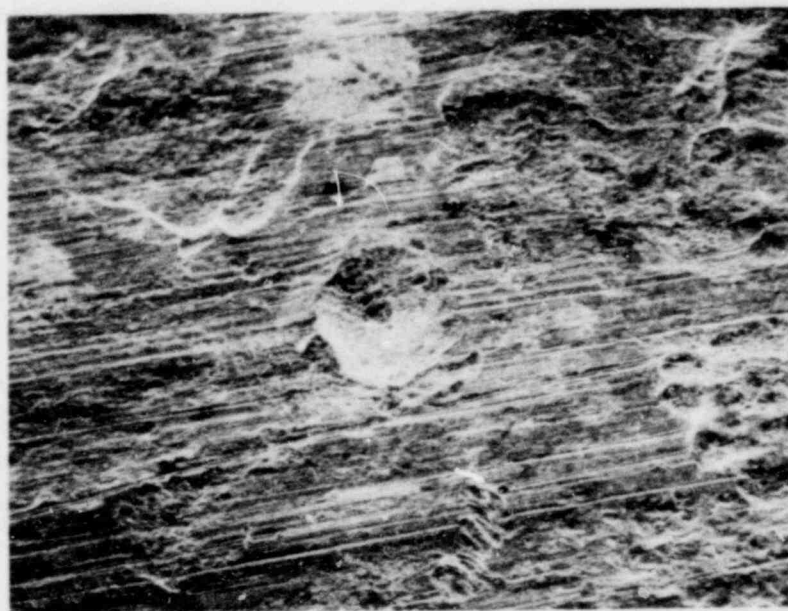
SEM examination of the portion of the crevice surface contained in the fractographic specimens, (Specimen Nos. 1, 2, 3 and 4, Figure 1-4) revealed an essentially as-machined condition (original machining marks evident) over the majority of the area. Evidence of limited corrosive attack was noted in a few localized regions. SEM micrographs illustrating the condition of the crevice surface are shown in Figure 5-4.

FIGURE 5-4. SEM MICROGRAPHS FROM SURFACE OF TIGHT CREVICE.
Specimen No. 4, Figure 1-4. 100X

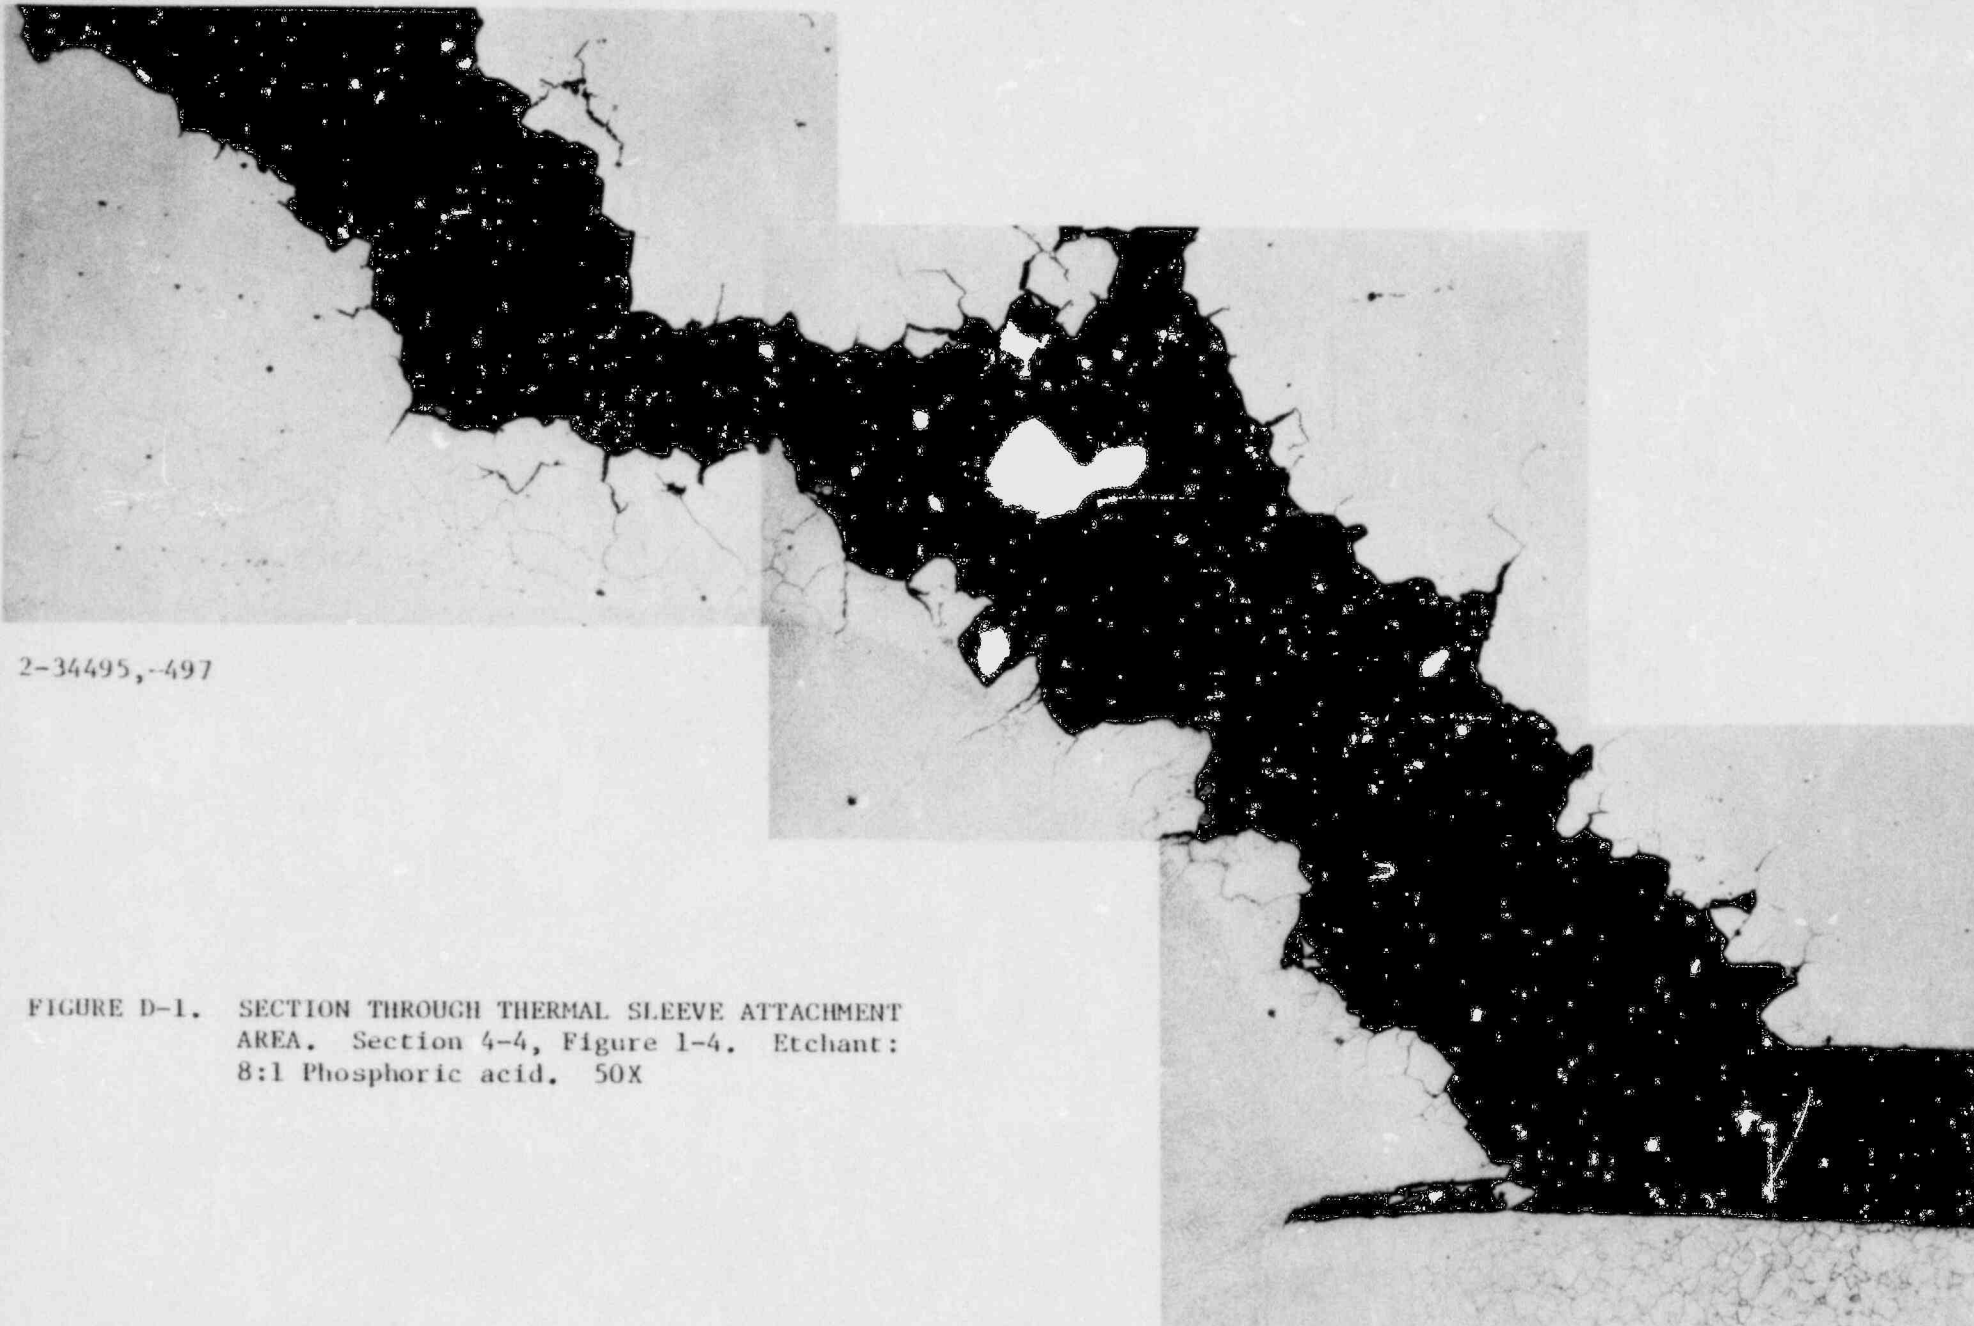
FIGURE D-1. SECTION THROUGH THERMAL SLEEVE ATTACHMENT AREA. Section 4-4, Figure 1-4. Etchant: 8:1 Phosphoric acid. 50X

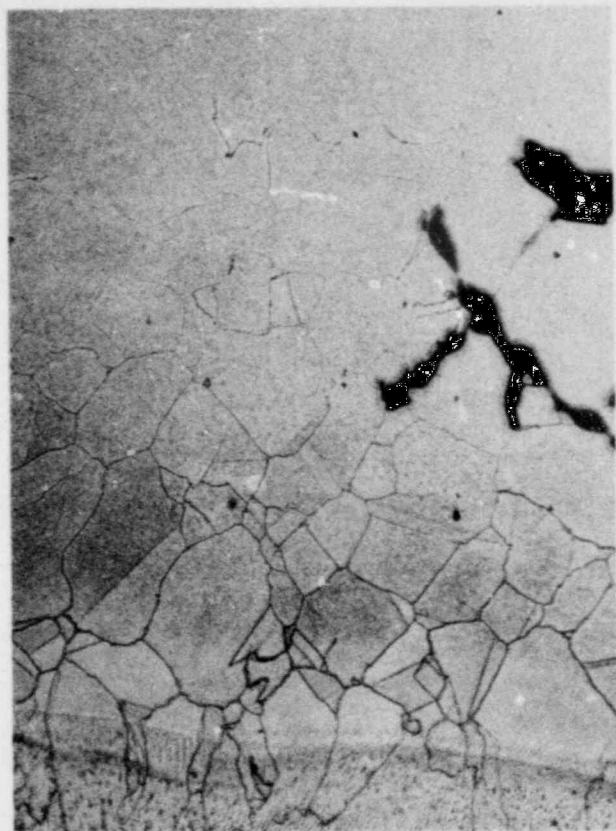
Micrographs at the tip of the crack in Section 4-4 where the crack approaches the repair weld are shown in Appendix D, Figure D-2. At this location, crack propagation has continued within unaffected base metal in spite of the proximity of the more heavily sensitized HAZ.

FIGURE D-2. MICROSTRUCTURE AT CRACK TIP. Section 4-4.
See Figures 2-3 and 4-4. Etchant: 8:1
Phosphoric acid.

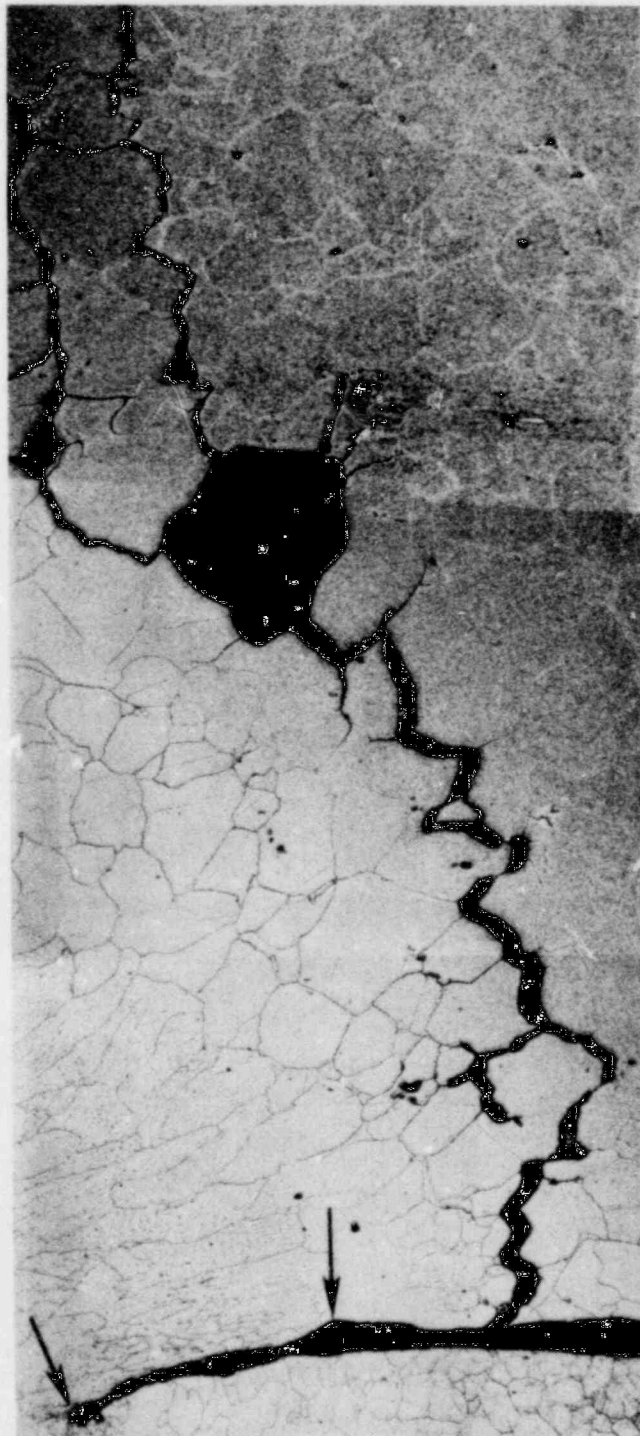
later stages of propagation the crack diverts from the thermal sleeve attachment weld into unaffected base metal, see Figures 4-5, D-3 and D-5.

FIGURE D-3. SECTION THROUGH THERMAL SLEEVE ATTACHMENT AREA. Section 9-9, Figure 1-4. Etchant: 8:1 Phosphoric acid. 75X

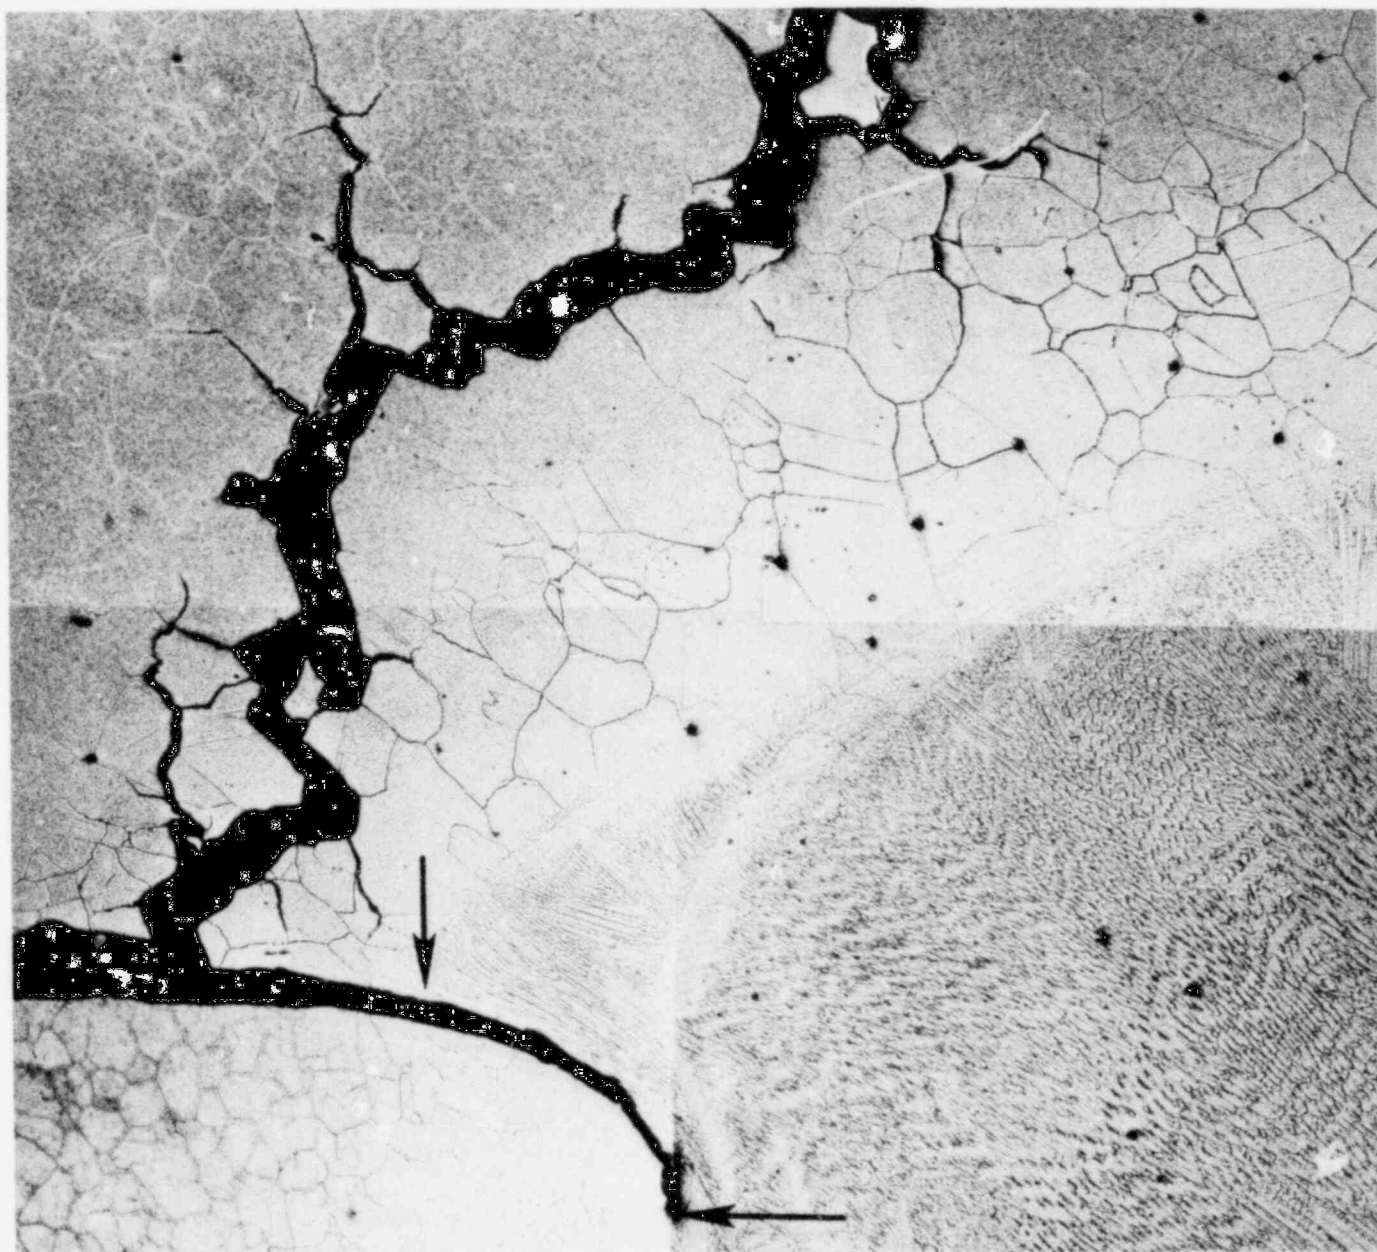
FIGURE D-4. SECTION THROUGH THERMAL SLEEVE ATTACHMENT AREA. Section 10-10, Figure 1-4. Etchant 8:1 Phosphoric acid. 100X

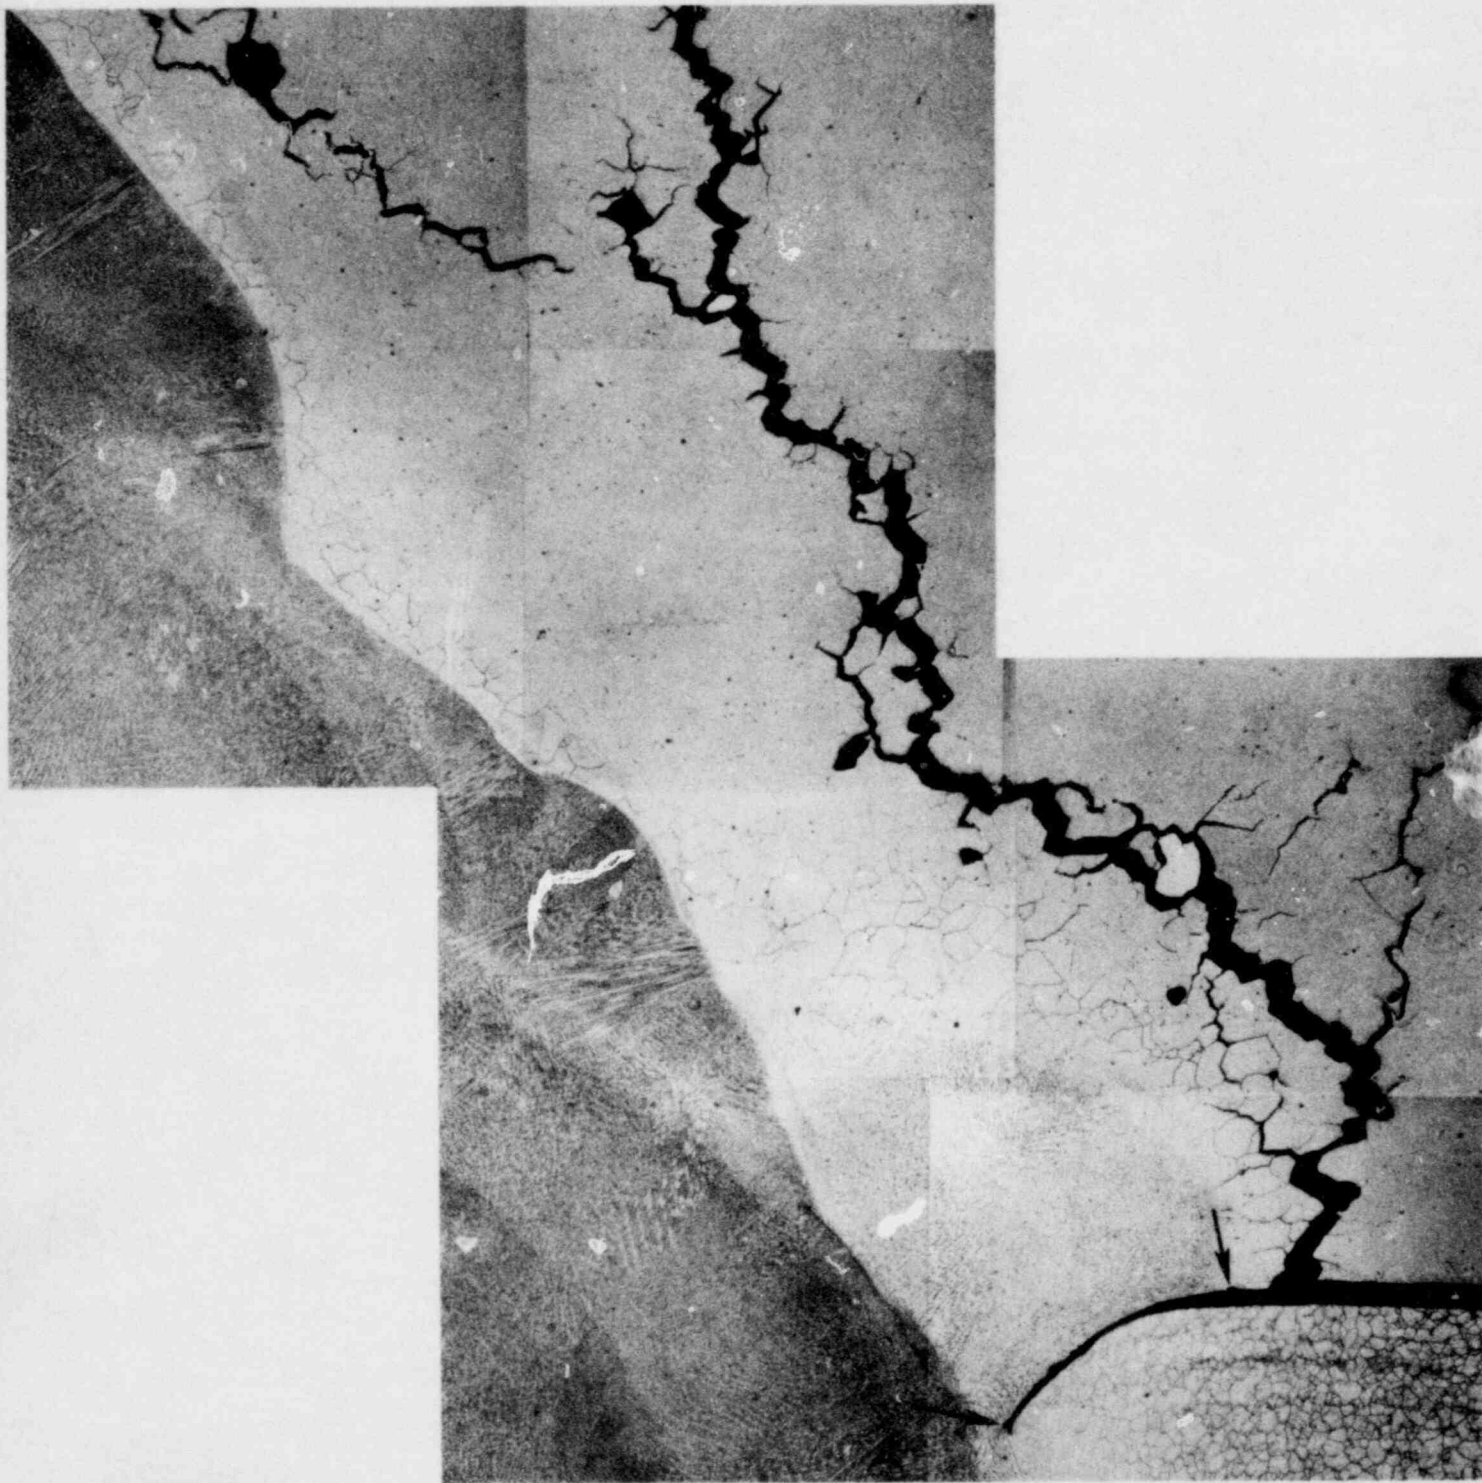
FIGURE D-5. SECTION THROUGH THERMAL SLEEVE ATTACHMENT AREA.
Section 11-11, Figure 1-4. See Figure 4-7.
Etchant: 8:1 Phosphoric acid. 37.5X
