Exhibit A to Report No. IE-116
by PARAMETER, Inc.
NRC Contract 05-77-186
PAR: NRC-IE-78/79, Task 03

EXAMINATION OF INCONEL
SAFE END FROM DUANE ARNOLD

January, 1979

V. Pasupathi, G.P. Smith, D.R. Farmelo, and J.S. Perrin

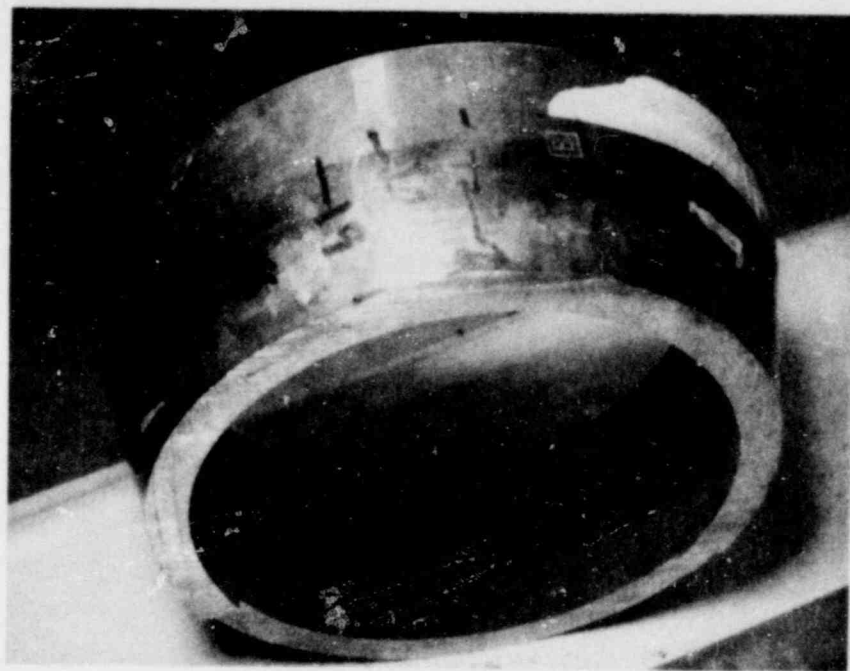
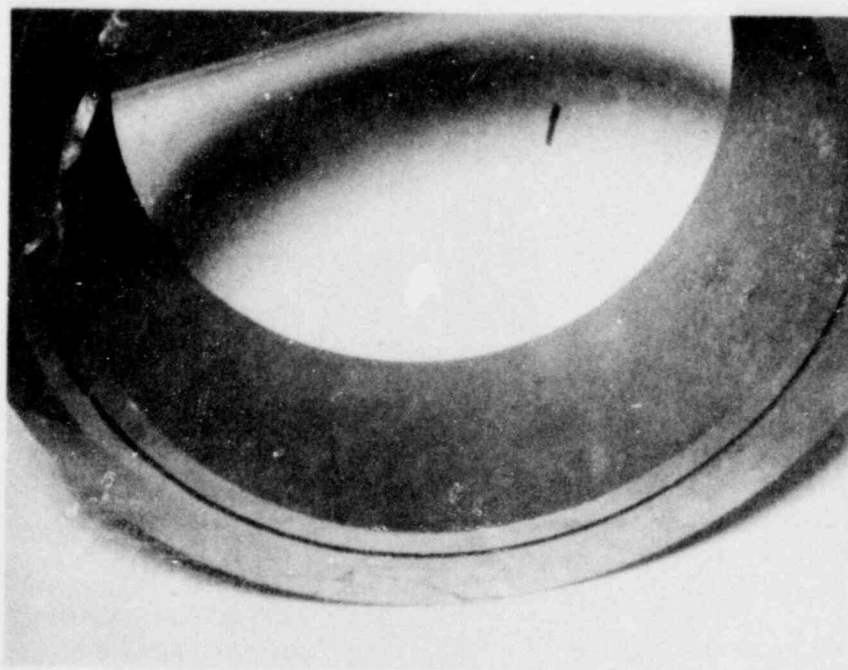
FIGURE 1. APPEARANCE OF DUANE ARNOLD INCONEL SAFE END IN THE AS-RECEIVED CONDITION

In addition to these marks, the piece also contained a hose clamp containing the specimen identification number plate showing N2E. The location of the repair weld could be clearly seen on the outer surface. The inner surface of the specimen had a rust colored coating of loose powder. This powder could be easily scraped off. Careful examination of the inner surface failed to reveal any cracks. The as-received condition of the specimen was documented by photography in detail. Figures 1a and 1b show the appearance of the specimen.

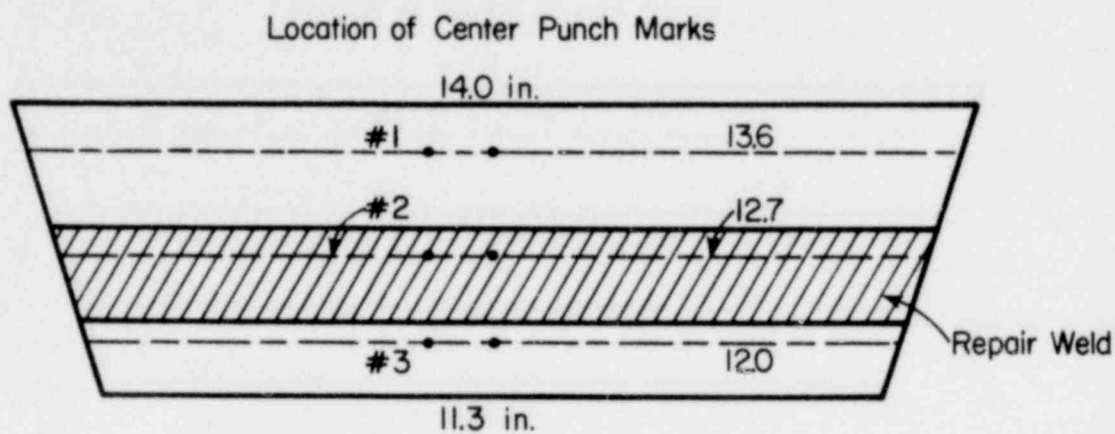
FIGURE 4. CHANGE IN OUTER CIRCUMFERENCE DURING
SECTIONING OF DUANE ARNOLD SAFE END

While the first cut for Sample No. 1 was being made, it was found that the cut closed tightly and the band saw blade could not be pulled out. The frame was removed and the blade was left in the cut. A new blade was inserted and the second cut made. After completing this cut the sample had to be pried loose. The distance between the centerpunch marks was measured after the sample was cut out. The measurements obtained before and after are shown in Figure 4. Also shown are the locations of the marks.

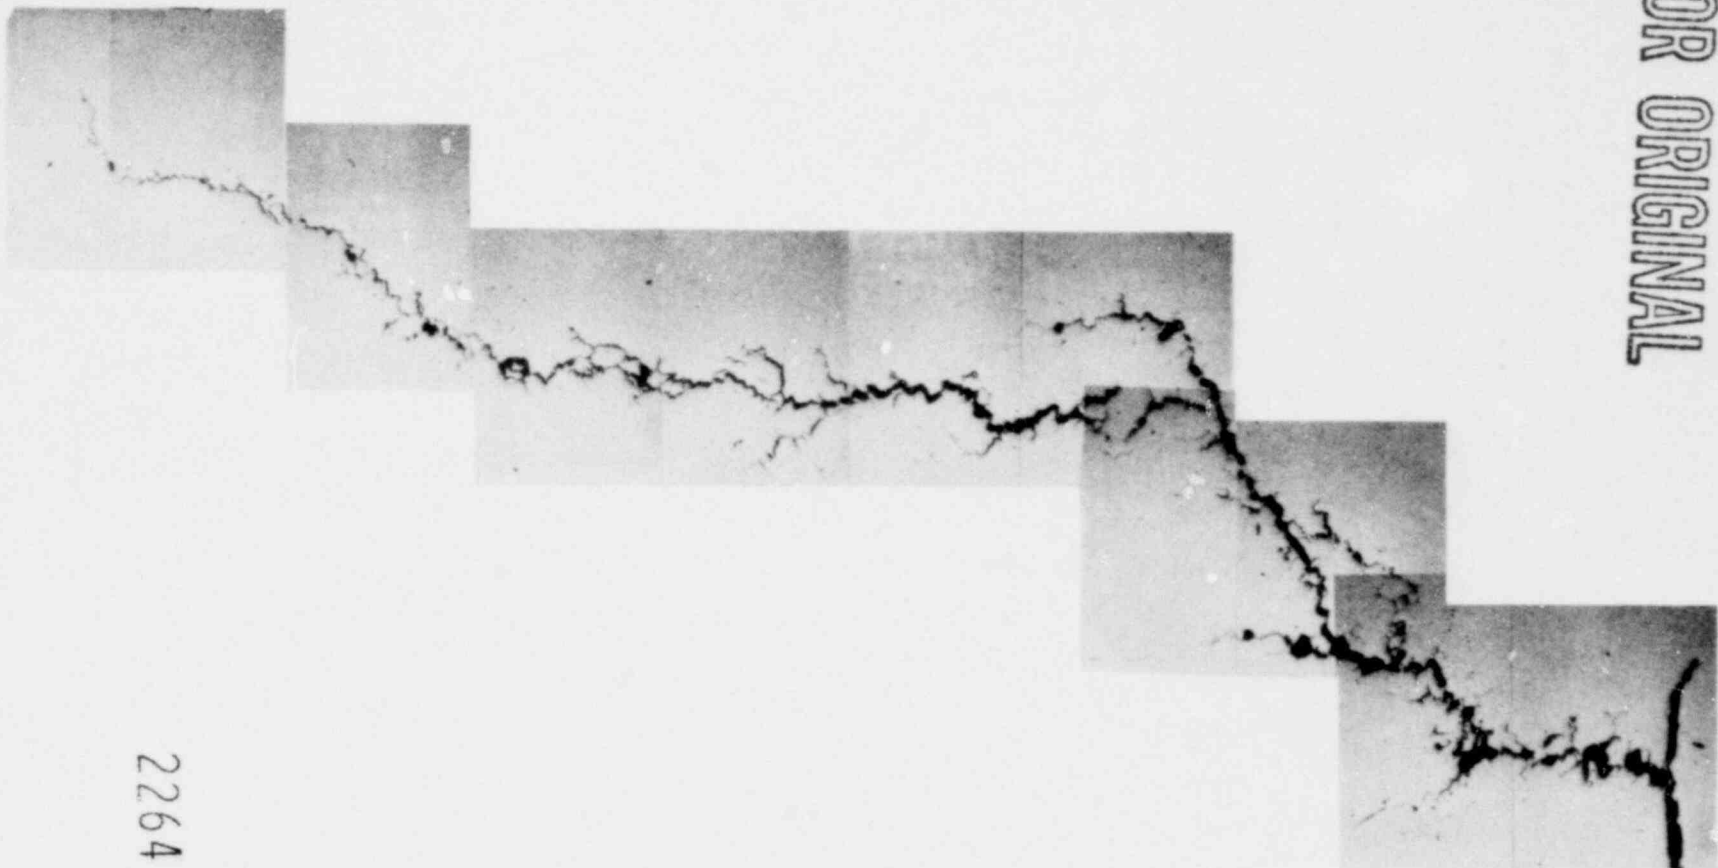
FIGURE 5. MICROGRAPH MONTAGE OF CRACK IN SAMPLE 2

All three samples contained cracks. The cracks were all intergranular in nature. In all samples, the initiation site of cracks was in the region of tight crevice between the sleeve and the safe end and radiated outward. The length of the tight crevice was found to be in the range 0.2-0.3 in. and the width was 0.002-0.005 in. No cracks were observed in the sleeve. In Samples 2 and 4 some grey areas were observed adjacent to tight branches of the cracks. These areas appeared to be of different composition. Similar areas were also observed along "tunnels" radiating from the cracks. The source of this grey phase area is not known.

The crack did not penetrate through the cross section of the safe end in any of the samples examined. In Samples 2 and 3 the crack had penetrated approximately 80% of the wall. In Sample 4, which was obtained

from the opposite quadrant, the crack penetration was about 30%. The crack characteristics were documented by photography. Figures 5 and 6 show the results from Samples 2 and 4, respectively.

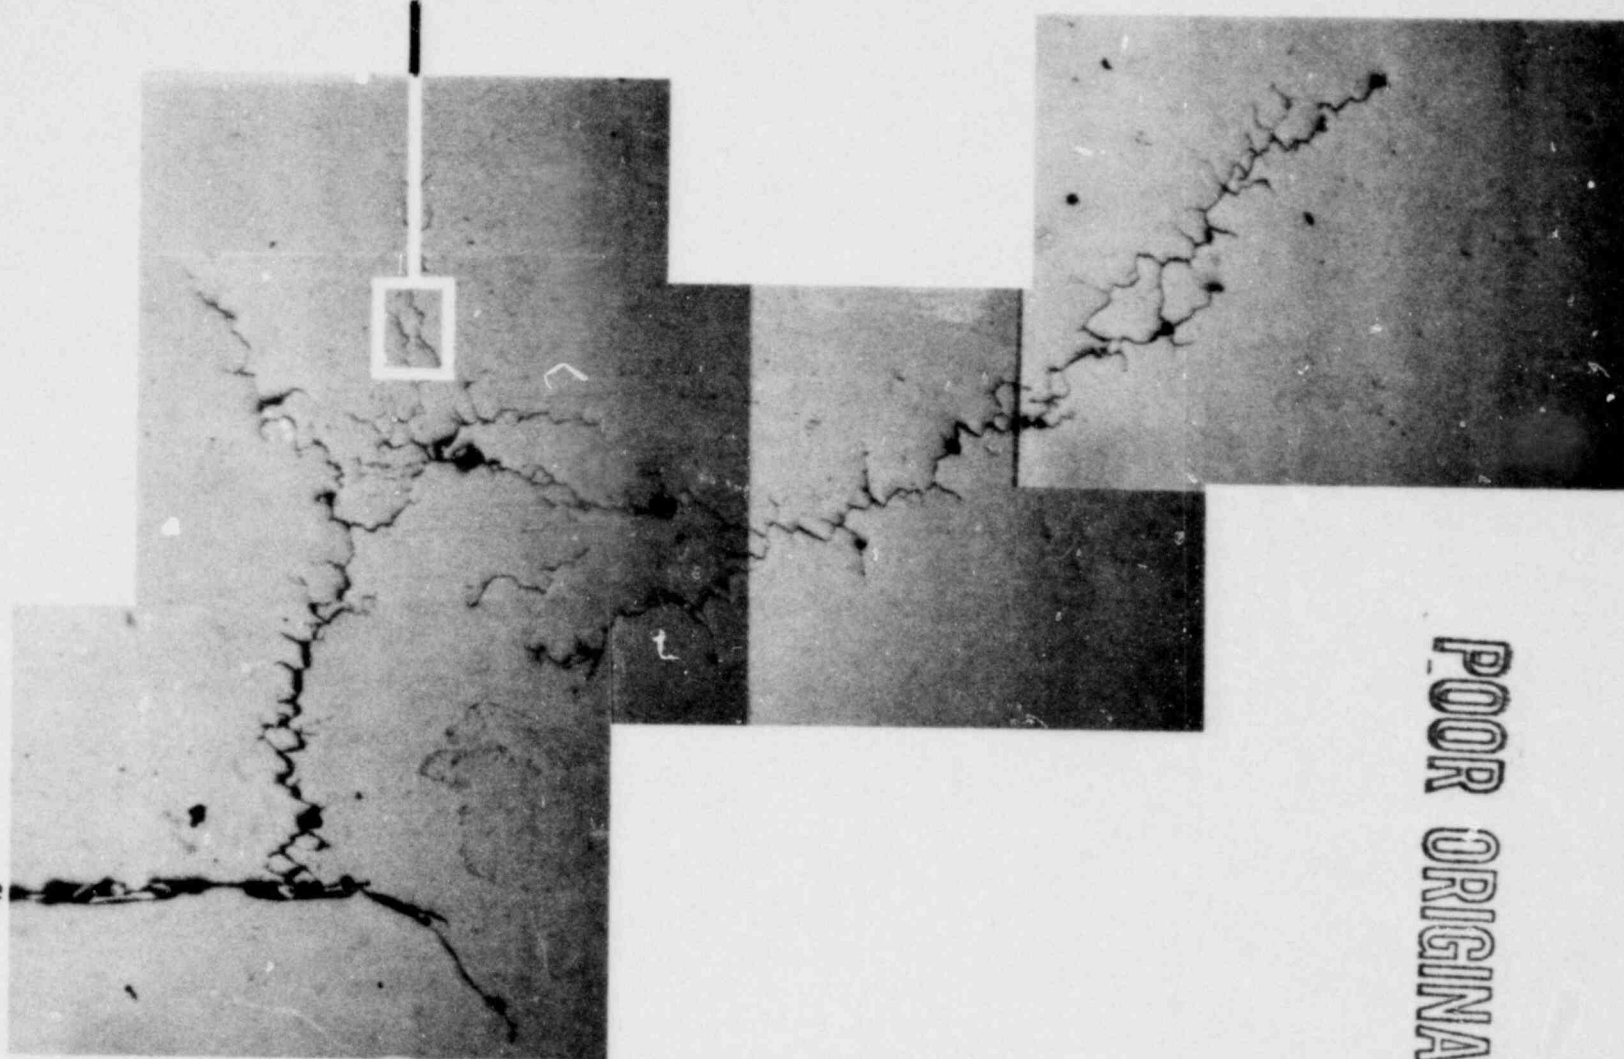
FIGURE 6. MICROGRAPH MONTAGE OF CRACK IN SAMPLE 4

2.7.1 Polished Samples, SEM Examinations. SEM examination and Energy Dispersive X-Ray Analysis (EDAX) of the fractures and fracture areas of Samples 2 and 4 provided several interesting results. As can be seen from Figures 5 and 6, the cracks observed in both samples contain numerous branches or tributaries. In addition, the cracks appear to originate in the weld heat affected zone at the crevice between the safe end and the thermal sleeve.

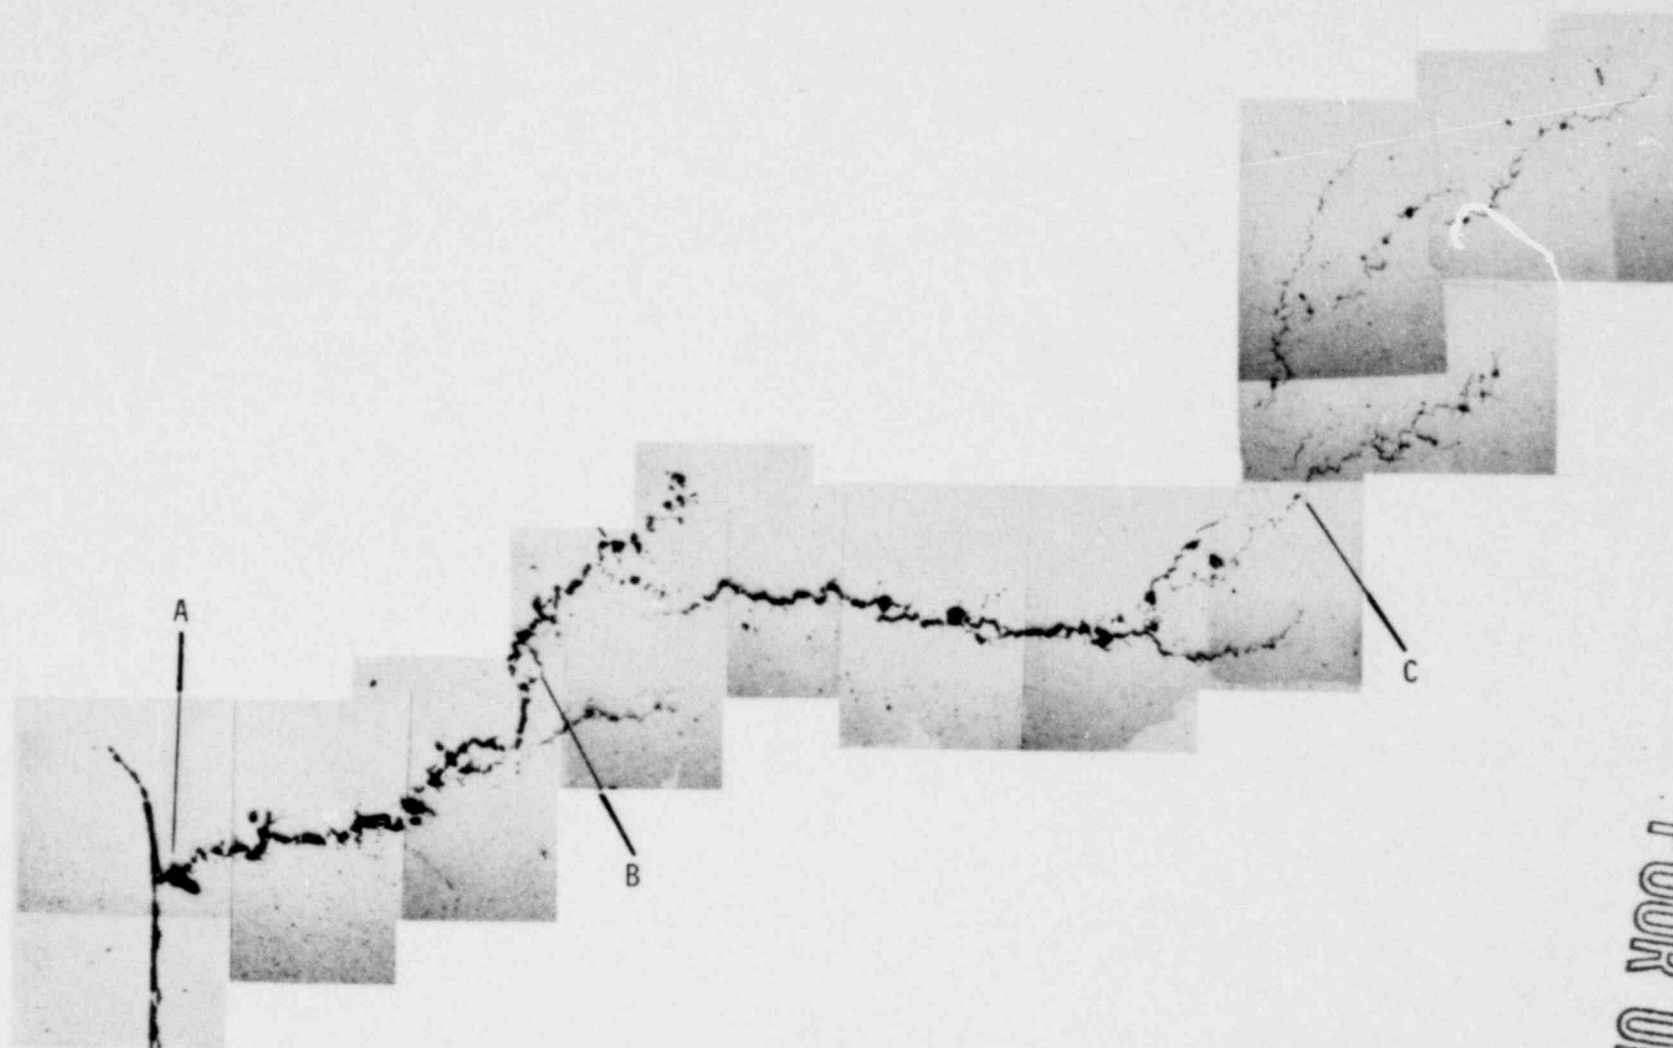
FIGURE 8. MICROGRAPH MONTAGE OF CRACK IN SAMPLE 3 AFTER ETCHING
Details of areas labeled A, B, and C are presented at
higher magnification in Figures 9 and 10.

Sample 3 was subsequently reprepared and etched with a mixture of 20 ml H_2O , 20 ml HNO_3 , and 80 ml HCl . The purpose of this procedure was to clearly identify the location of the crack with respect to the weld and heat affected region. With this technique, the crack initiation site was found to be in the re-solution treated region of the heat affected zone. Figures 8 through 10 show details of the crack location and crack characteristics.

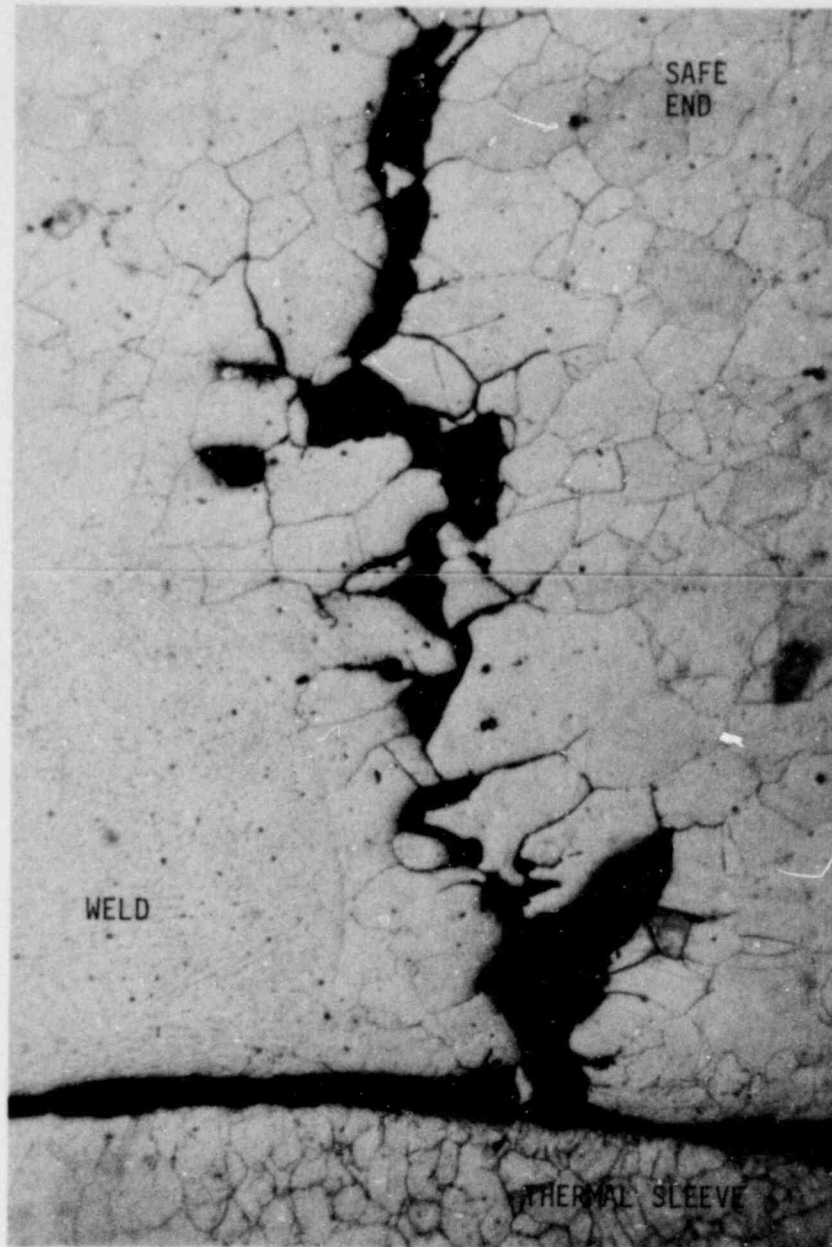
FIGURE 9. MICROGRAPH OF AREA A ON FIGURE 8
FROM ETCHED SAMPLE 3

- In all samples, the crack originated in the crevice between the sleeve and the safe end and radiated outward. No cracks were observed in the sleeve.
- The location of the cracks in all cases were in the re-solution treated region of the heat affected zone of the weld joining the safe end to the sleeve. See Figures 9 and 11.

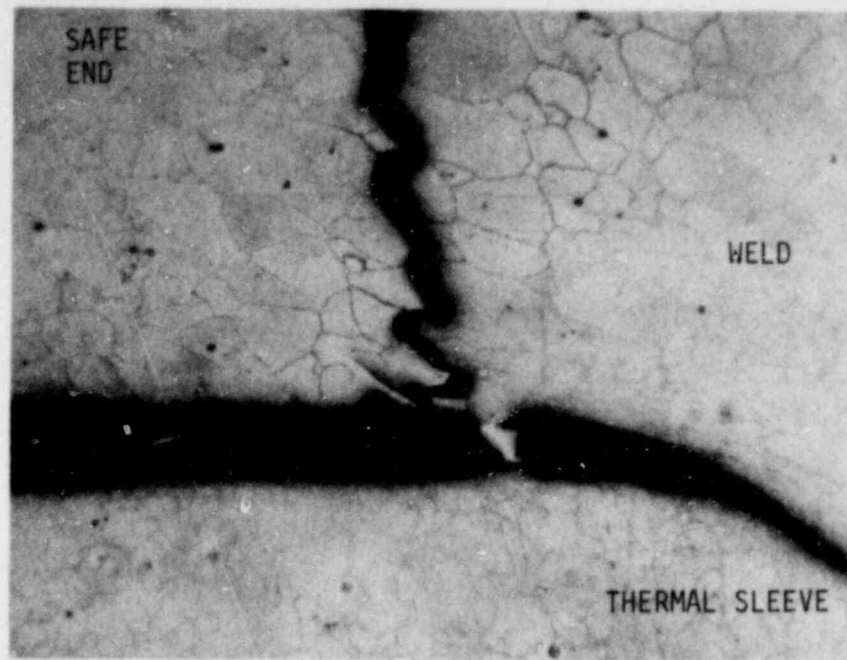
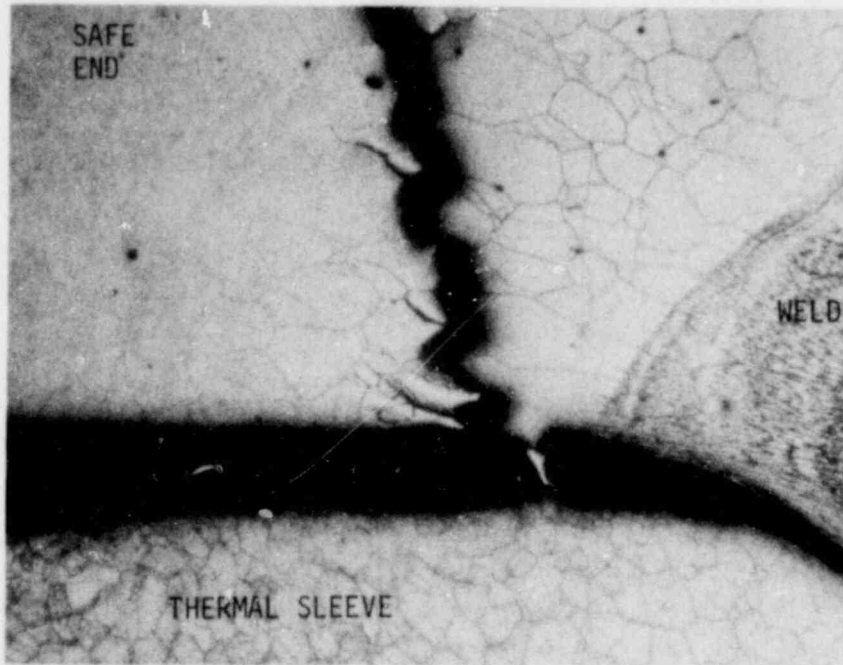
FIGURE 11. MICROSTRUCTURE OF THE CRACK INITIATION SITE
IN SAMPLE 4

In order to further characterize the extent of sensitization of the safe end in the vicinity of the crack, sample 4 was repolished and electrolytically etched with 10% Nital. This procedure is expected to show grain structure in the material regardless of the degree of sensitization. After examination, the sample was repolished and etched electrolytically with a 15% solution of phosphoric acid. This etching process preferentially attacks carbides in the grain boundaries and the matrix. Figure 11 shows a comparison of the microstructure at the crack initiation site with the two etching procedures. Examination of the photomicrographs shows that the sensitized region in the safe end is rather narrow and that the crack initiation site is located in the re-solution treated region adjacent to the weld. The thermal sleeve also appears to be sensitized to a greater extent in comparison to the safe end.

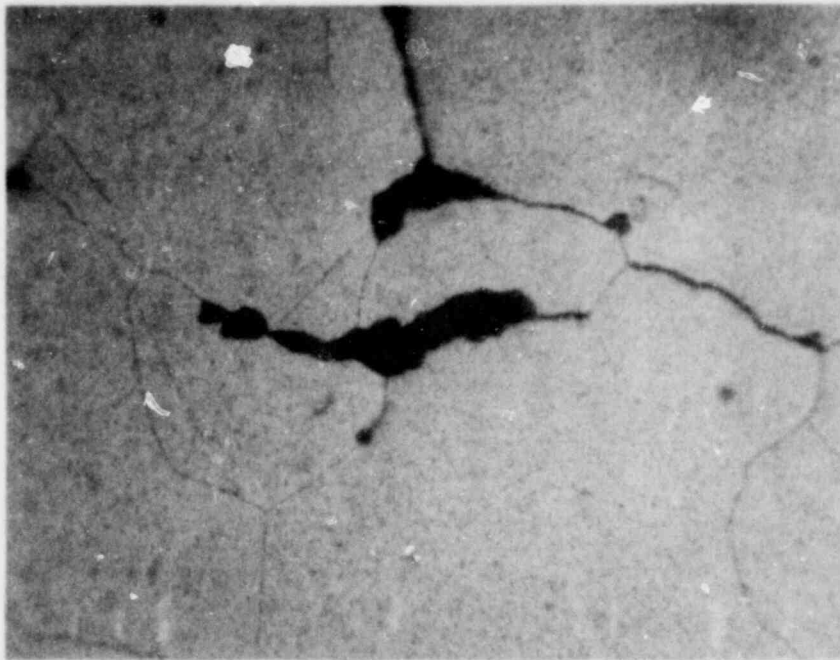
FIGURE 12. APPEARANCE OF THE GREY PHASE ADJACENT TO A TIGHT CRACK BRANCH

Examination of the specimens showed extremely narrow and barely discernible regions (probably chromium depleted areas) in the relief adjacent to the grain boundaries in the heat affected region. Initially, it was planned to analyze this region using the scanning electron microscope to determine if the composition was different from the grain matrix. This plan was abandoned because of the difficulty in discerning these regions. The etching procedure, however, was found to define more clearly areas previously identified as grey phase. Figure 12 shows one such area in the sample.

Sample was etched with aqua regia glycerine and acetic acid mixture to reveal chromium depleted regions.

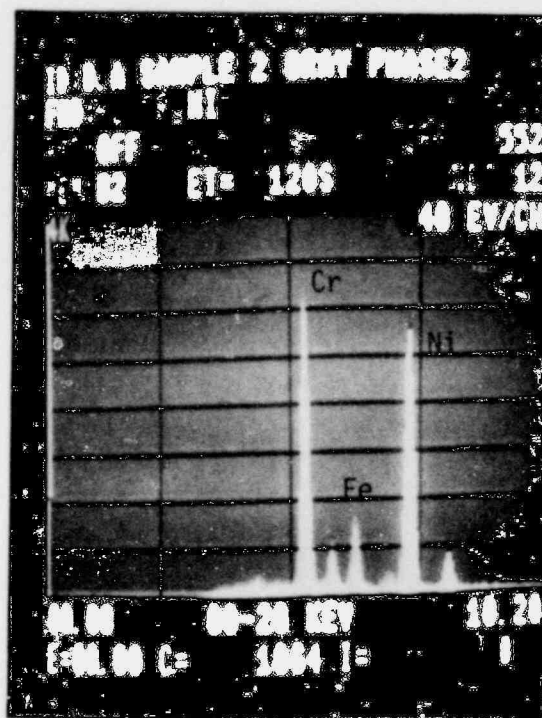
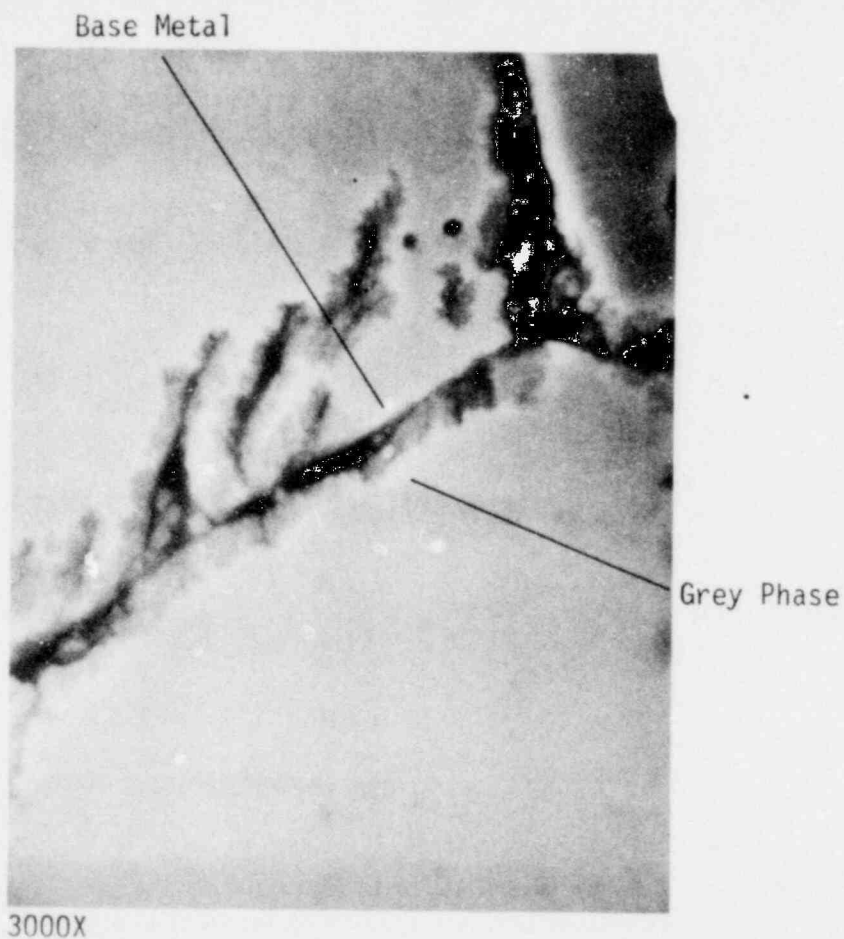
FIGURE 16. SEM MICROGRAPH OF GREY PHASE AND CORRESPONDING EDAX ANALYSES OF BASE METAL AND GREY PHASE

SEM examination of many of the tight crack tributaries in Samples 2 and 4 indicated that a phase different from the Inconel base metal was present directly adjacent to the crack. A typical SEM micrograph of this phase with its corresponding X-ray spectrum is presented in Figure 16. EDAX analysis indicated that this grey phase was chromium rich. The chromium enhancement of the grey phase was determined to be approximately 60-80% relative to the base metal material. In addition to the composition variation of the grey phase, numerous instances, of what appears to be transgranular tunneling (shown in Figure 16) were observed in areas where grey phase was found.

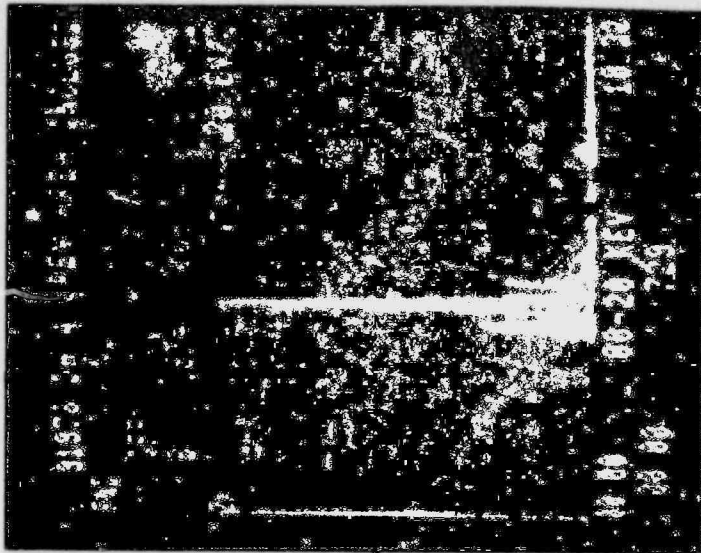
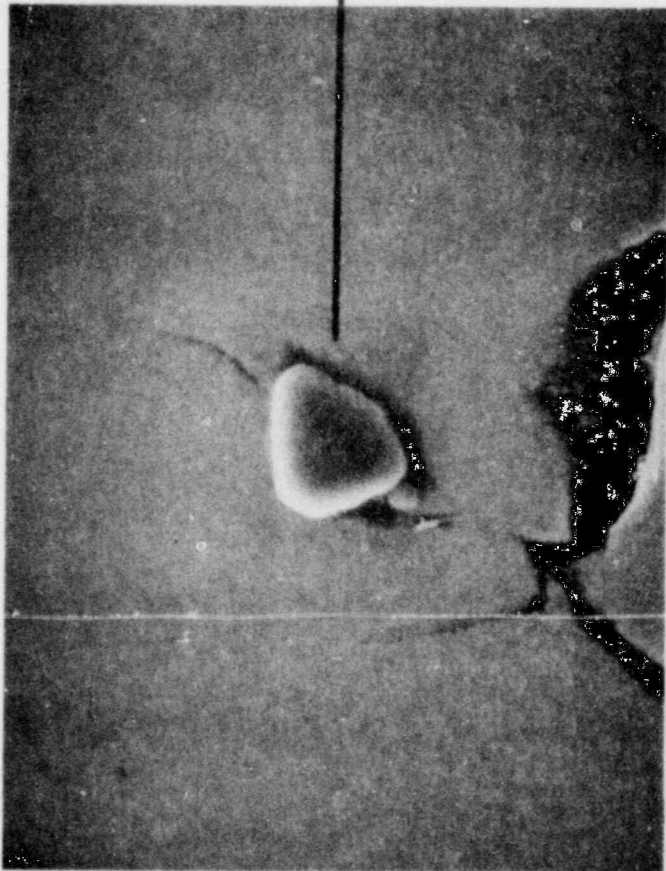
FIGURE 19. SEM MICROGRAPH AND CORRESPONDING EDAX ANALYSIS
OF TITANIUM INCLUSION FROM SAMPLE 4

Numerous titanium inclusions were observed throughout the base metal on Samples 2 and 4. A typical titanium inclusion observed in Sample 4 is illustrated by SEM micrograph in Figure 19 in conjunction with its X-ray spectrum.

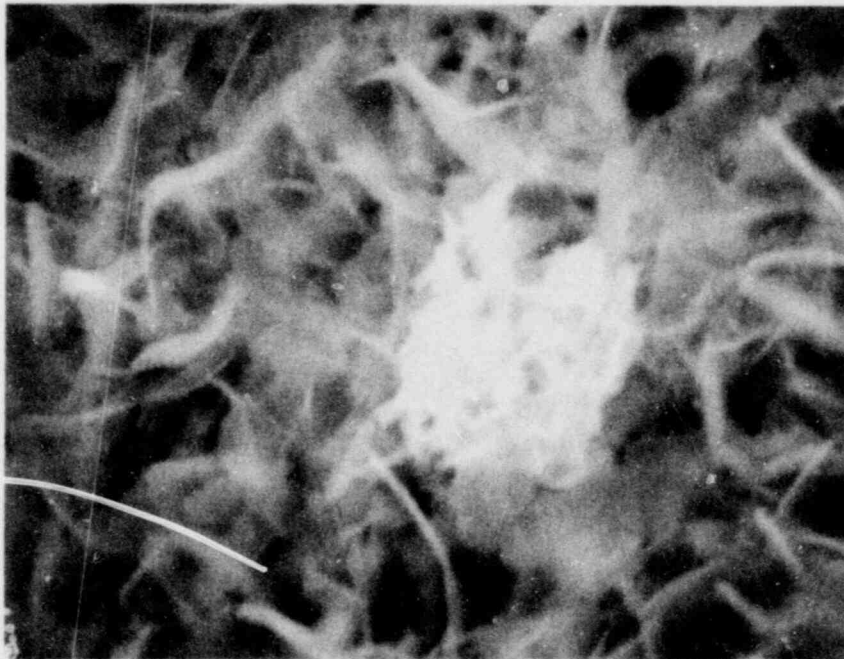
FIGURE 24. SEM FRACTOGRAPHS OF SAMPLE 5 AT MID FRACTURE

(b) Needle network of corrosion products on grain facet. Spot EDAX analysis indicated high sulfur content.

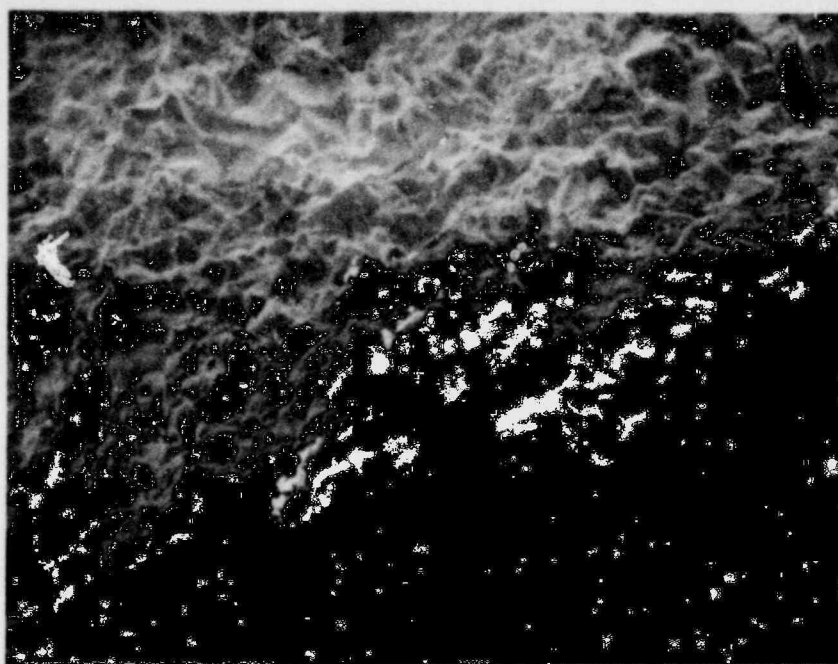
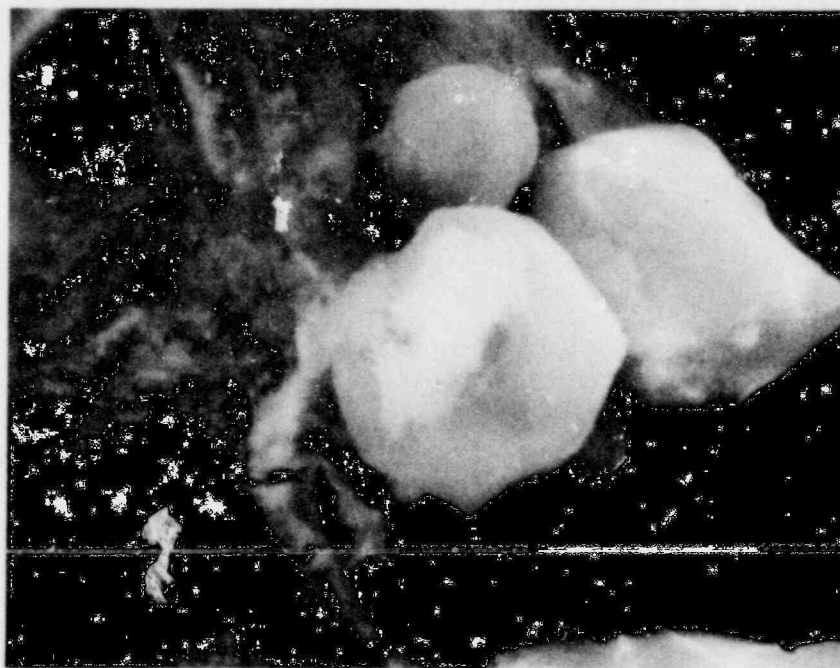
FIGURE 26. SEM FRACTOGRAPHS OF SAMPLE 5 NEAR CRACK TIP

Results from EDAX analysis of Figures 23, 24, and 25 and other areas not shown indicate no significant variations from base metal composition. However, small amounts of sulfur were detected in almost all of the fracture and crevice EDAX analyses. Figure 26 presents SEM micrographs taken on the fracture surface near the crack tip. The crystalline material, magnified to 2000X in Figure 26b, was subjected to spot EDAX analysis. Results indicate high sulfur contents (~8 times greater than the highest sulfur content detected in area EDAX scans on the fracture surface). Similar crystalline structures were observed and analyzed on the crevice surface, and they too indicated relatively high sulfur content.

(a) Cluster of crystalline material near crack tip.

(b) Crystalline material subject to EDAX spot analysis. Results indicate high sulfur content (>20%).

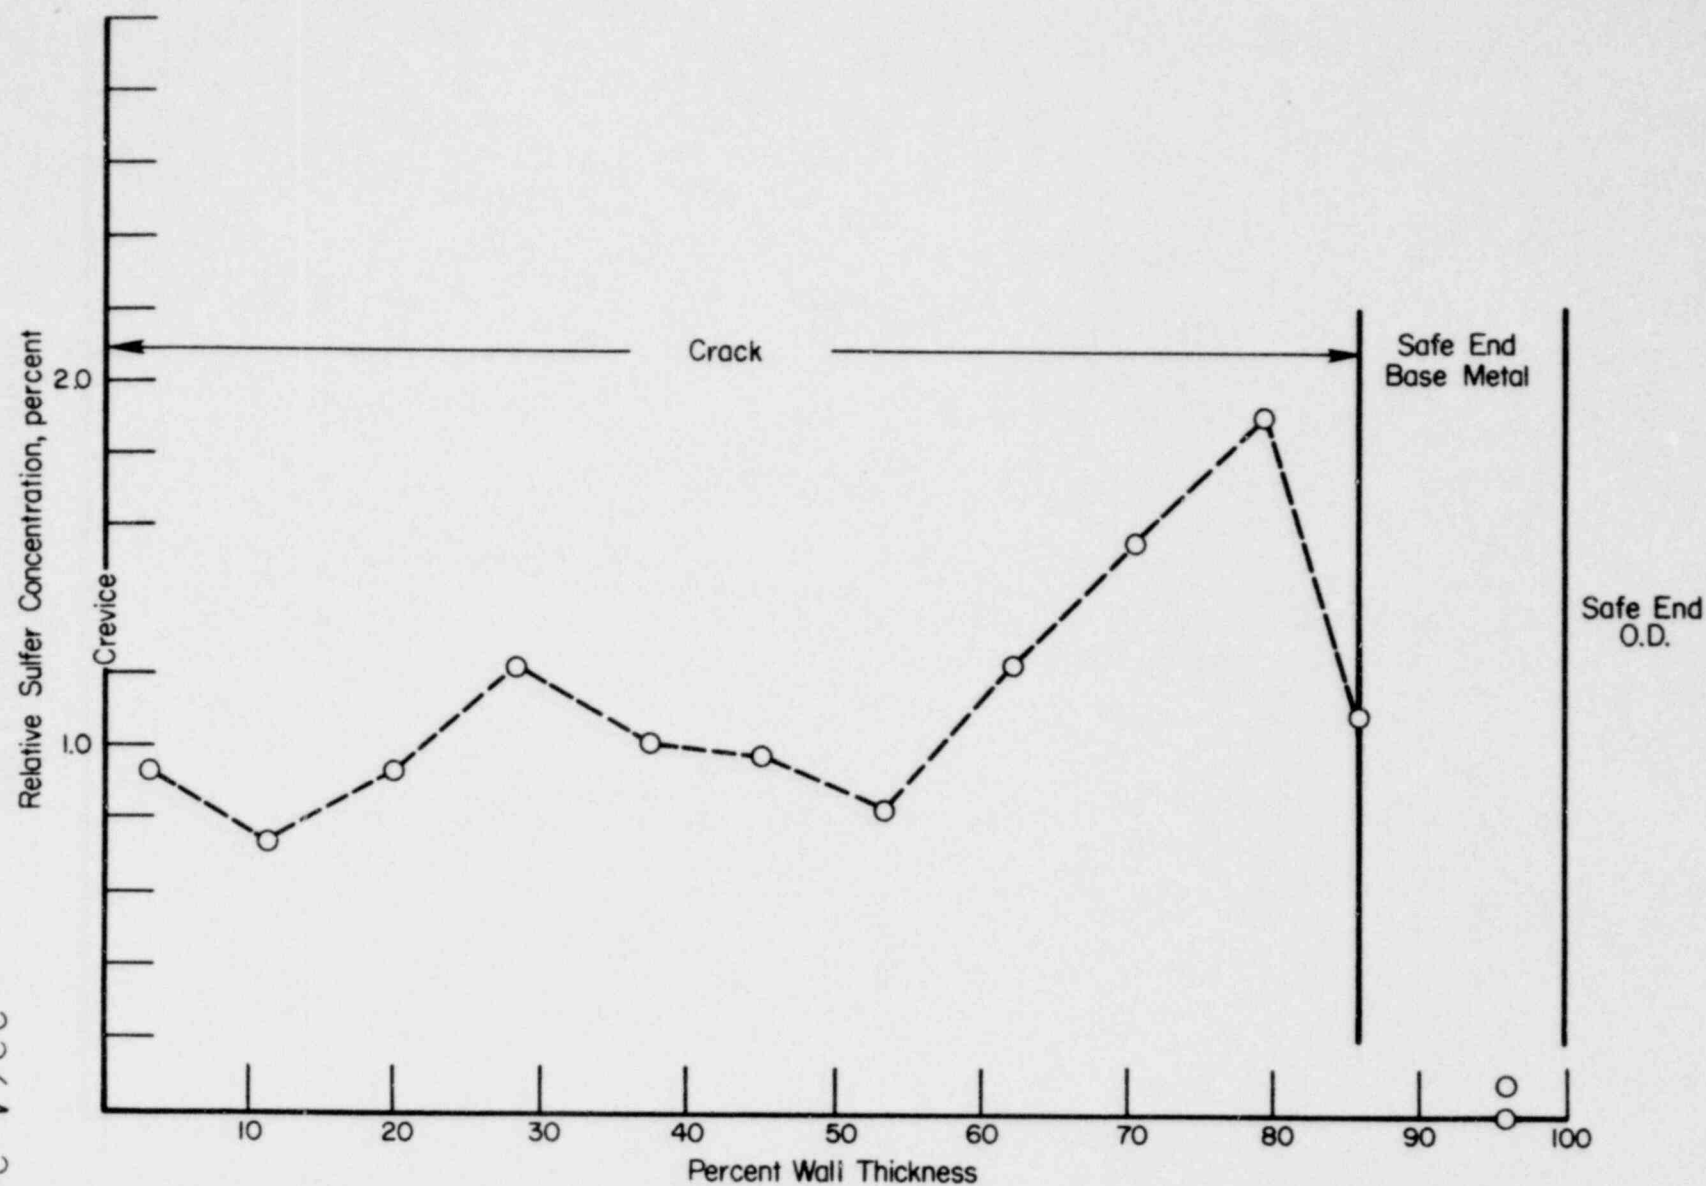
FIGURE 27. DUANE ARNOLD SAFE END SULFUR PROFILE ON FRACTURE SAMPLE No. 1

In order to characterize the sulfur distribution along a fracture surface and determine the source of the sulfur contaminants Sample 1 was mechanically fractured in the same manner as Sample 5 and examined by SEM. EDAX analyses were performed along the fracture surface at designated intervals to quantify local sulfur concentrations. A total of 11 EDAX scans were performed along a radial axis from the crevice to the tip of the crack. In addition, two EDAX analyses were performed on the mechanically broken ductile material. Each EDAX scan examined in surface area of approximately $1.6 \times 10^{-2} \text{ cm}^2$. The results of the EDAX analyses are presented as Figure 27. The relative sulfur concentration data presented in Figure 27 are plotted versus wall thickness. Based on this data an increase in relative sulfur concentration was observed with increasing crack penetration (with the exception noted directly at the crack tip). The relative sulfur concentrations measured in the ductile material beyond the crack tip indicate a significant concentration deviation from the fracture surface*. Based on the difference in relative sulfur concentrations on the fracture surface and the ductile material and the appearance of the sulfur rich particles and the high concentration of sulfur in them, it is believed that the source of sulfur in the cracks was external to the base metal material.
