LICENSEE EVENT REPORT

PLANT E. I. HATCH UNIT II
PRIMARY CONTAINMENT COOLING MODIFICATION

DRYWELL COOLING OUTAGE August 20 to September 15

DRYWELL COOLING SYSTEM PROBLEMS

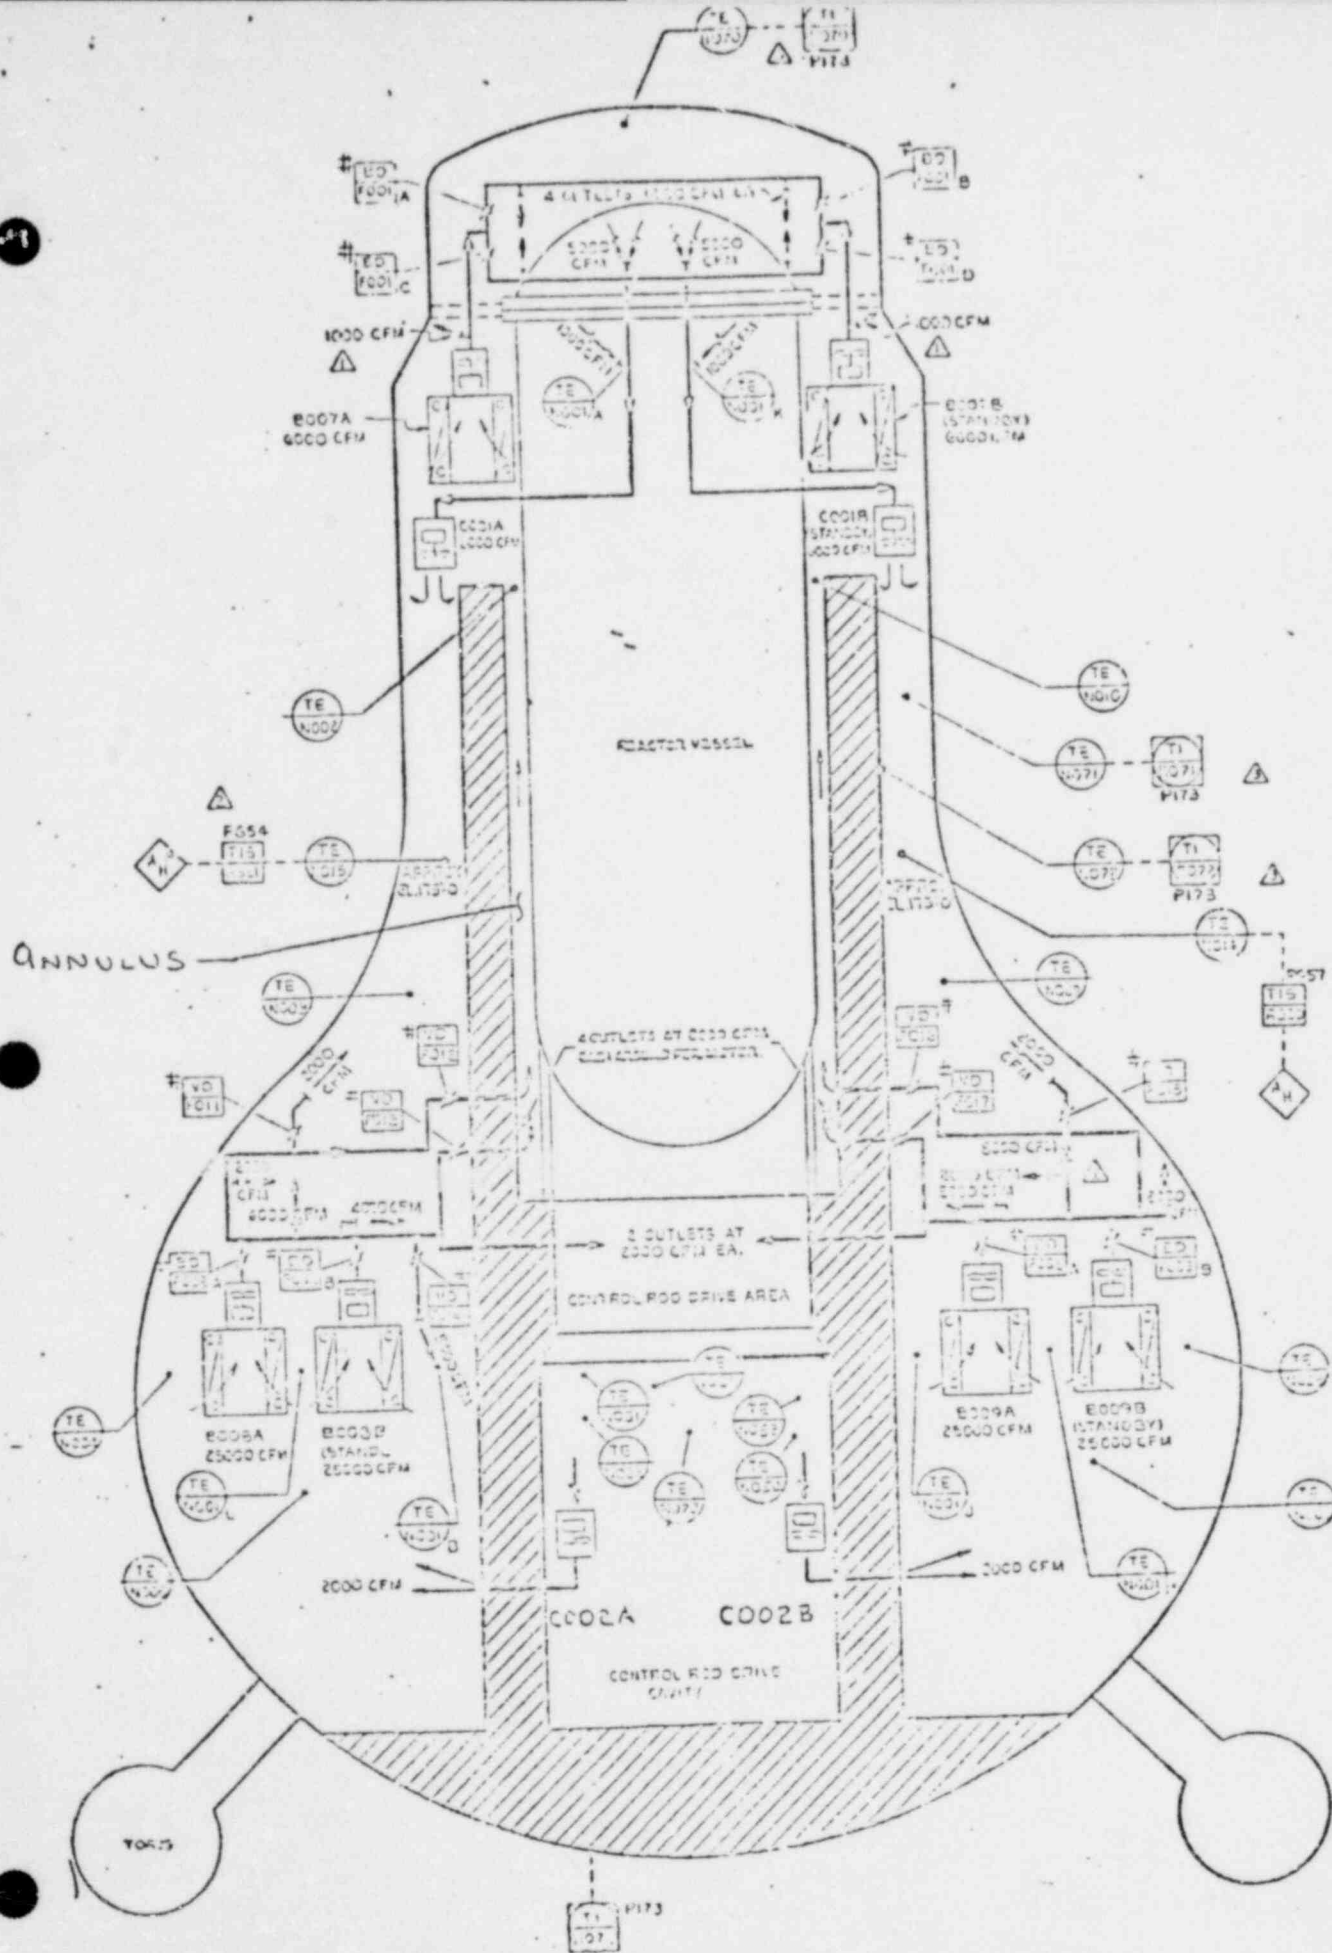
FIGURE 1

Figure 1 shows the original Drywell Cooling System design schematically. The original fan line up was to have the following fans running: 2T47-B007A, 2T47-B008A, 2T47-B009A, 2T47-C001A, 2T47-C002A and 2T47-C002B with the other four fans in standby. With this line up, 4000 cfm was being supplied to the CRD cavity area by 2T47-B008A and 2T47-B009A, 4000 cfm was being exhaust the CRD cavity area by recirculation fans 2T47-C002A and 2T47-C002B. Fans 2T47-B008A and 2T47-B009A were also to supply a total of 8000 cfm to the annular space between the sacrificial shield and the reactor vessel insulation. This 8000 cfm was to travel up the annulus picking up

heat lost from the RPV insulation, thus reducing sacrificial shield temperature, until it reached the top of the sacrificial shield where it would exit into the upper drywell region at elevation 185'. The remaining 38,000 cfm supplied by 2T47-B008A and 2T47-B009A was directed at other locations of drywell between the 130' and 158' elevations. Air movement between elevations 158' and 185' was to be by natural circulation. In the upper elevation of the drywell, 2T47-B007A supplied 5000 cfm through a ring header in the drywell dome and 1000 cfm into the drywell below the bellows at elevation 200'. Recirculation fan - C001A removed 5000 cfm from the drywell dome through a single inlet and 1000 cfm from below the bellows at elevation 200' and discharged the total 6000 cfm down the drywell at elevation 182' just below the - B007A intake. The four standby fans were only to come on if an operating fan failed or if the air temperature in the CRD cavity area exceed 148 degrees F.

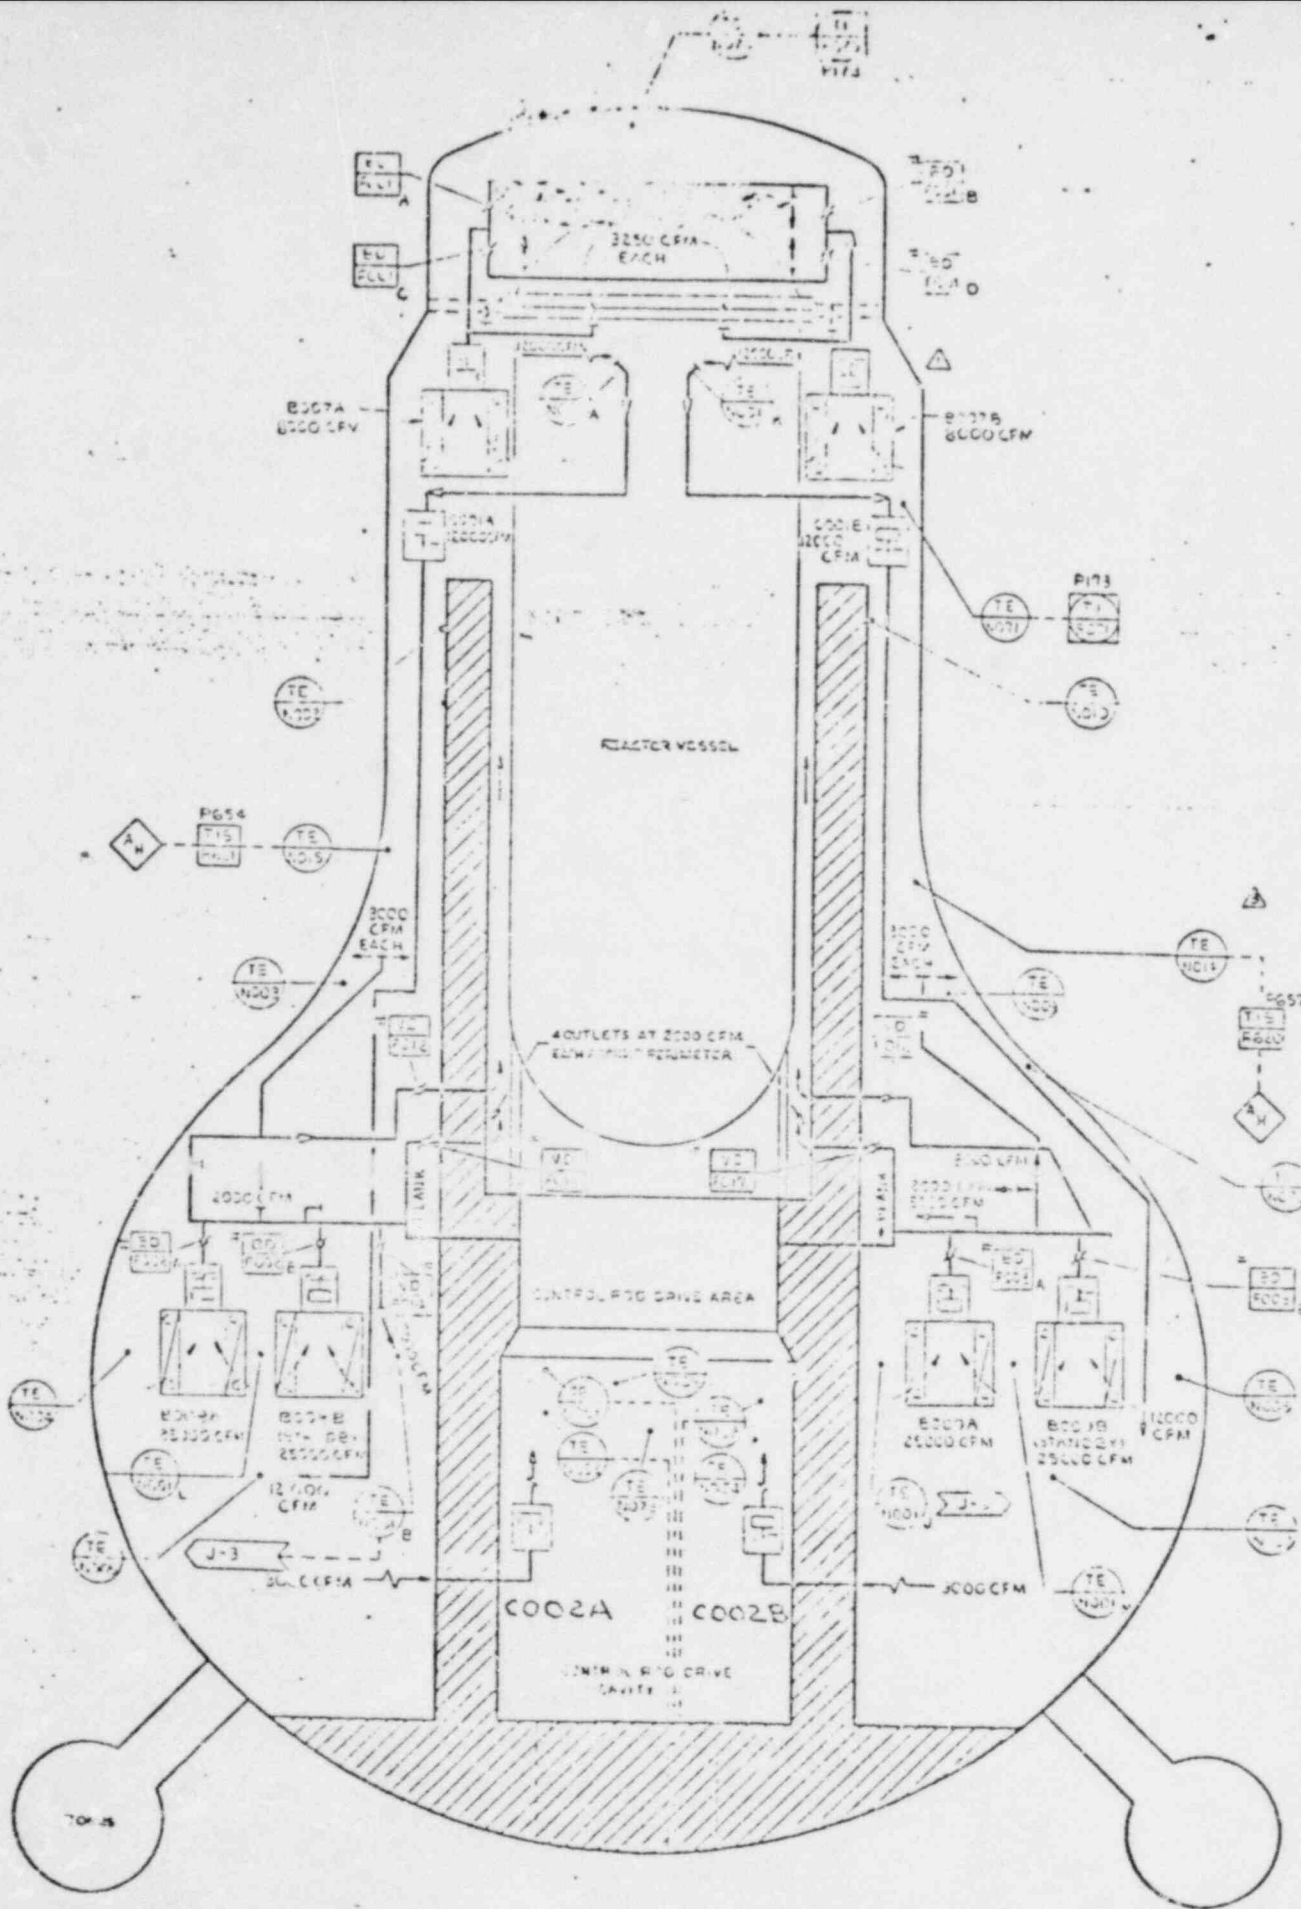
FIGURE 2

Figure 2 shows the resulting Drywell Cooling System design. The present fan line up is: 2T47-B007A, 2T47-B007B, 2T47-B008A, 2T47-B009A, 2T47-C001A, 2T47-C001B, 2T47-C002A, and 2T47-C002B running with 2T47-B008B and 2T47-B009B in standby. The only logic change needed to accomplish this was to remove the interlock between 2T47-B007A and 2T47-B007B which prevented both fans from running simultaneously.

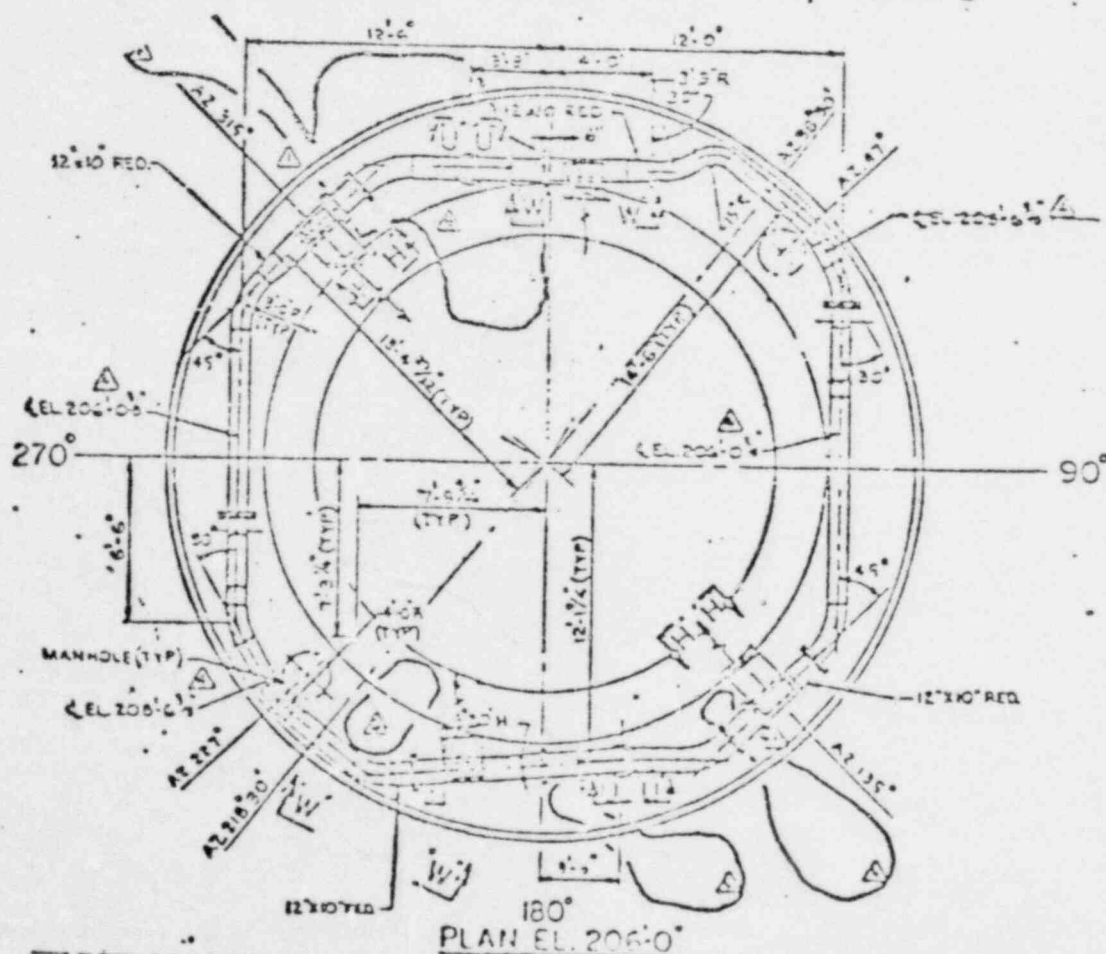
AS SHOWN ABOVE, MODIFIED TO ADD FOUR VENT
DUCT RISERS AND 180° ROLLED DUCT AT VIEW

- A. Additional modification will be required, during the first refueling outage, for the ductwork above the reactor well bulkhead, to enhance air distribution in the volume over the RPV head (see attached sketch) and,
- B. In order to regain cooler redundancy, the RPV insulation system problems must be corrected, at least for the insulation above the top of the sacrificial shield wall. (i.e. - above el. 188'0") Refer to problems report attached, for more information.
