LICENSEE EVENT REPORT

ATTACHMENT TO LICENSEE EVENT REPORT 79-008/01T-0

Wisconsin Electric Power Company
Point Beach Nuclear Plant
Dockets 50-266 and 50-301

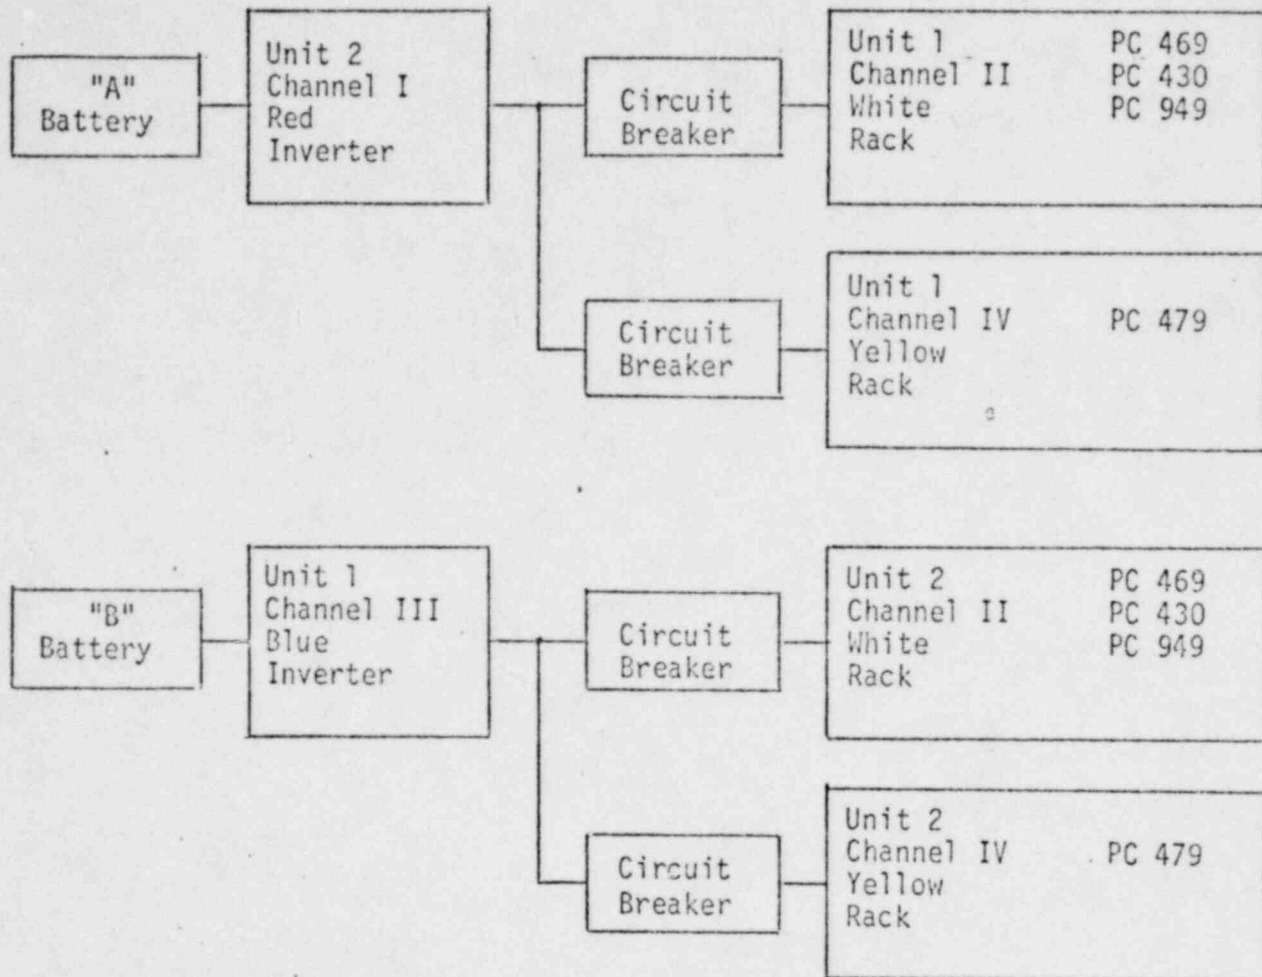
FIGURE 1

We agreed, however, that the placing of an instrument channel supplied from a battery source in a tripped condition had a small, but finite, probability which could potentially result in safety injection actuation when the AC-supplied instrument channel tripped on loss of power. In order to avoid this remote possibility, we proposed a modification in our letter to the NRC dated May 7, 1979, which changed the power supply of the AC-supplied instruments in the safety injection actuation circuitry to a battery power source. Refer to attached Figure 1 for details of the modification.

Following implementation of this modification, a loss of AC would not cause any safety injection actuation instrument to go to a tripped condition because the DC power supply would continue to power the instrument. A mechanistic single failure of an instrument, or having placed an instrument channel in a tripped condition due to testing or previous failure, would not cause safety injection actuation in the unaffected unit should loss of off-site AC power occur. No active single failure at the time of loss of off-site power will result in safety injection in the unaffected unit. We consider the probability of an instantaneous loss of a DC buss, at the time of an accident, coupled with loss of off-site power to both units or the probability of an instrument being in a tripped condition at the time of an accident in the other unit with a loss of off-site power to both units coupled with a single failure that makes up the remaining part of the safety injection actuation circuitry to be of such low probability that it need not be considered in the design of the plant.

The channel II and IV safety injection pressure circuits that are presently powered by plant AC will be powered from opposite unit inverters. The Unit 1 circuits will be on the "A" battery and the Unit 2 circuits will be on the "B" battery. These changes will involve four conduit runs and associated wiring from breaker panels to the analog racks. The additional wiring will be run to receptacles in the white and yellow analog racks. Circuits PC 469, PC 430, PC 949 and PC 479 will then be plugged into the newly wired receptacles.
