FINAL REPORT ON  
REACTOR CONTAINMENT LINER  
OVERLAY PAD FILLET WELD  
AT  
BEAVER VALLEY POWER STATION - UNIT NO. 2

STONE & WEBSTER ENGINEERING CORPORATION

METALLURGICAL EXAMINATION OF  
REACTOR CONTAINMENT LINER  
OVERLAY PAD FILLET WELD CRACK  
AT BEAVER VALLEY POWER STATION - UNIT NO. 2

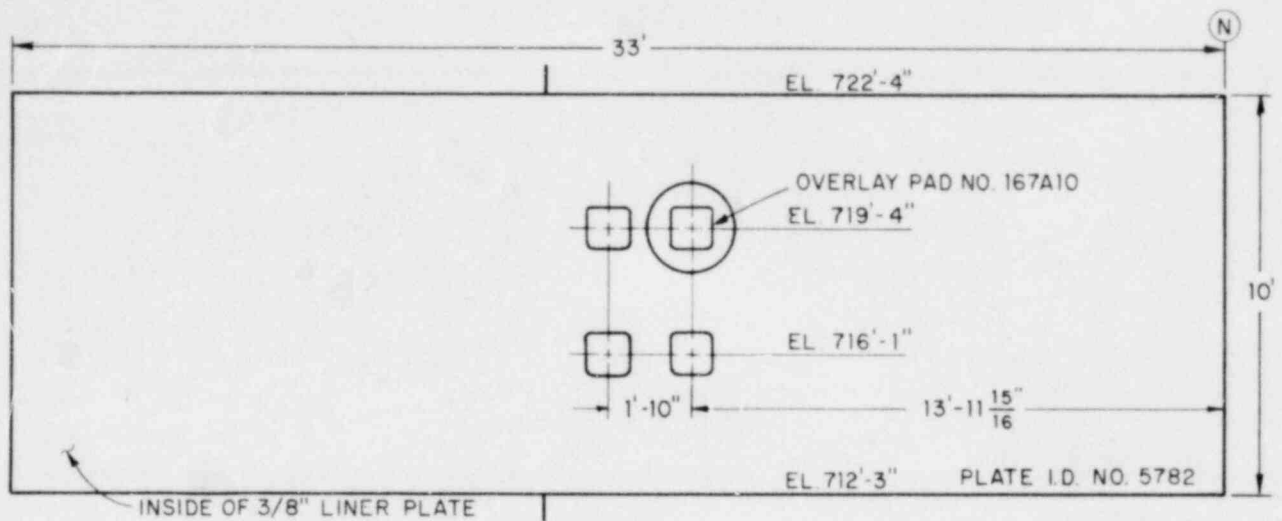
FIGURE 1  
OVERLAY PAD LOCATION

A section of metal, 6 in x 18 in containing the entire crack was removed from the liner and included approximately a 3 in portion of the pad. Figure 1 shows the location of the pad; Figure 2 shows the segment removed for metallurgical study, and Figure 3 contains a series of photographs taken during the sample removal. The removal procedure required locating the headed concrete anchor studs by ultrasonic techniques, hole-cutting around studs, and removal of the sample section by cutting dry with thin grinding wheels. Views of the sample as received at Stone & Webster, Boston, Massachusetts, are shown in Figures 4 and 5. Figure 4 is from the back side of the liner showing the two studs that were holed out, and Figure 5 is a view of the overlay pad weld area. Due to the geometry of the sample, which impeded ultrasonic detection of the stud, several hole cuts were required in the overlay plate to locate one of the studs precisely. Care was exercised so as not to destroy evidence or aggravate the crack during the sample removal operation.

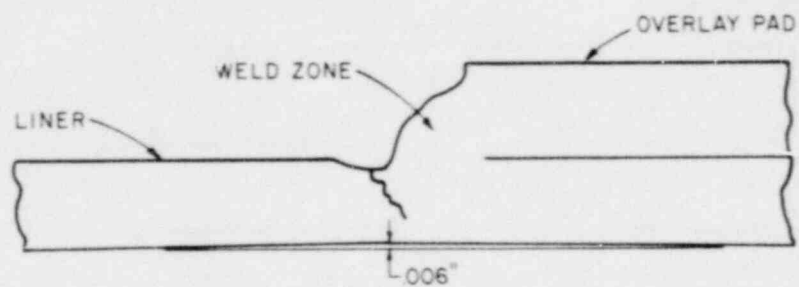
FIGURE 6  
PALPABLE DEPRESSION OPPOSITE WELD DEPOSIT  
(CROSS SECTIONAL VIEW)

A minor distortion in the liner on the reverse side of the liner opposite the weld deposit was noted, the depression measuring .006 in (see Figure 6). This deviation is attributable to the plastic deformation caused by the welding shrinkage. At the lower left-hand corner of the pad fillet weld there was a stud attached to the back of the liner, forming stud/liner/weld metal/pad/junction, all in line in the crack path. A cross sectional slice of metal through this junction was used for further evaluative studies which are discussed later in this report. The overlay plate was in direct contact with the liner plate over most of the areas cross sectioned. Various cross sections were polished and etched and showed six weld passes of uniform size and adequate penetration.

The palpable offset of the liner opposite the weld indicates that weld shrinkage stress exceeded the yield strength of the material to cause deformation. The liner material displayed the necessary ductility to absorb this stress without cracking, a behavior considered normal for the material.

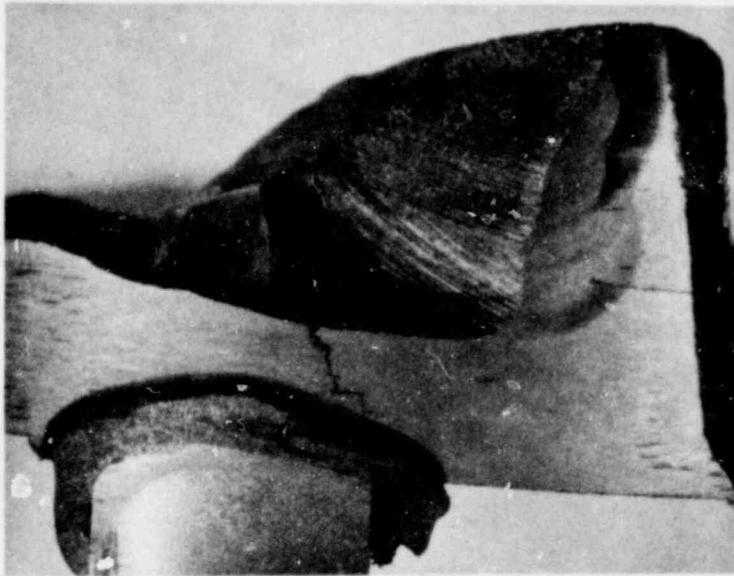
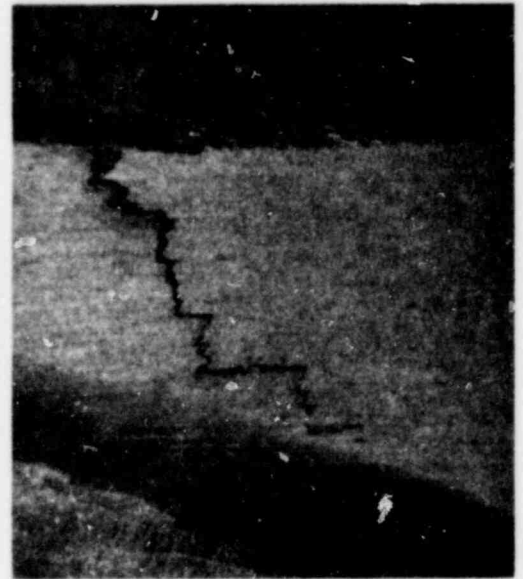
FIGURE 9  
VIEWS OF CRACK AT STUD/LINER/WELD/PAD JUNCTION

Examination of the defect in situ disclosed a crack along the lower portion of the overlay pad fillet weld. The jagged appearing crack opening was estimated at approximately .015 to .025 in at a location of minimum probe grinding. The crack appeared to be very tight at the area where probe grinding had proceeded beyond the mid-thickness of the liner. No other defect, such as gross inclusions, laps, seams, etc, were observed. The weld remaining and welds on other overlay pads in the immediate area displayed good workmanship.

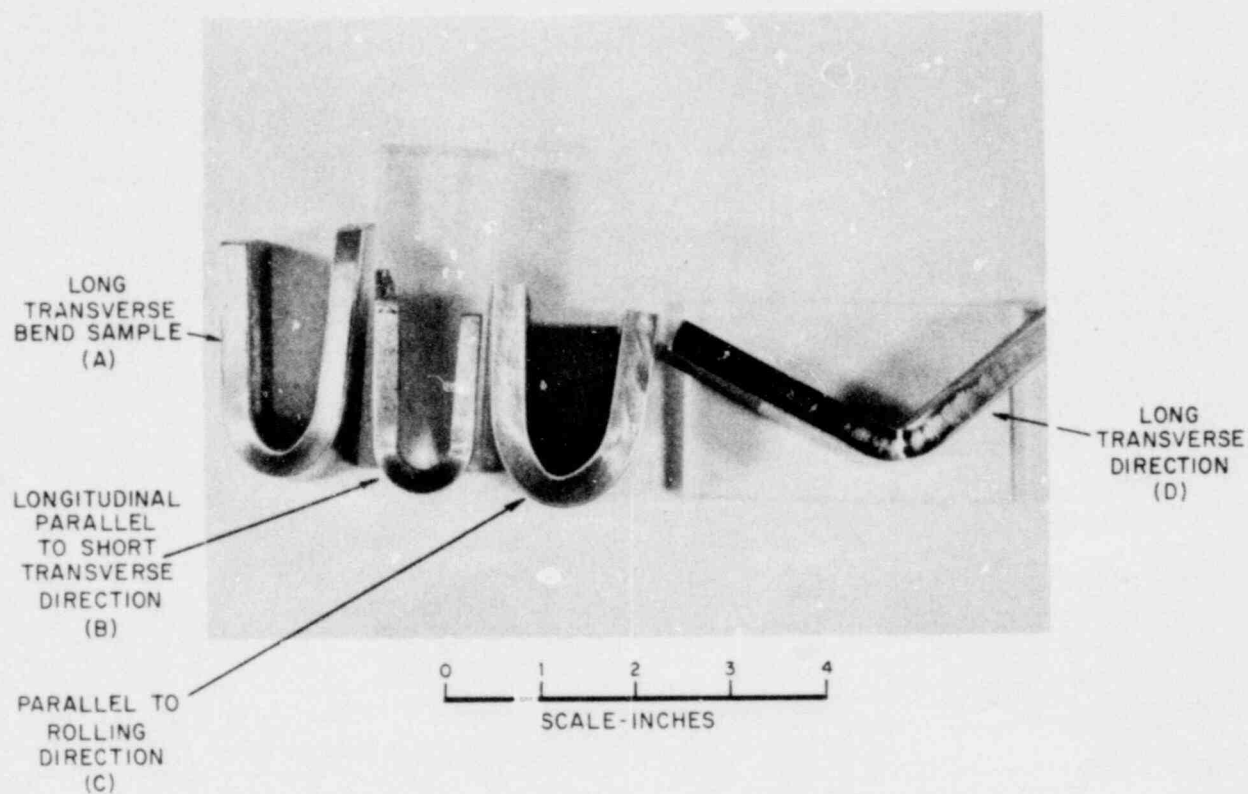
FIGURE 12  
SERIES OF SPECIMENS PLASTICALLY DEFORMED BY  
BENDING OVER A 2-THICKNESS RADIUS MANDREL

Several tests were made to observe the behavior of the material under conditions of severe plastic deformation. A total of 4 bend specimens were machined and bent over a mandrel having a diameter of 2 t (where t is equal to the specimen thickness).

Figure 12 shows these specimens after bending. Two specimens were taken in the long transverse direction (Figures 12a and 12d) with one specimen having the as received surface (12d) and the other (12a) having the as received surface machined off .010 in prior to bending. This latter specimen was bent 180 deg but displayed fine surface cracks at the bend tension side. Sample 12d failed prematurely after bending approximately 65 deg, with cracks initiating at surface defects (pock marks) on the tension side. Two other specimens (Figure 12c) in the direction of rolling with no surface preparation and the other (Figure 12b) bent parallel to the short transverse axis, were successfully bent 180 deg.

Tensile properties were all within code requirements, with elongation being low but within acceptable limits, and yield strength and ultimate strength well above the minimum code requirements. Of the four bend tests taken at different orientations, the transverse tests failed, one bend specimen whose skin was removed achieved a 180 deg bend with slight surface cracks developing during the tests; and the specimen with no surface preparation, achieved a 65 deg bend prior to cracks initiation and premature failure. Specimens taken in the longitudinal direction passed successfully.

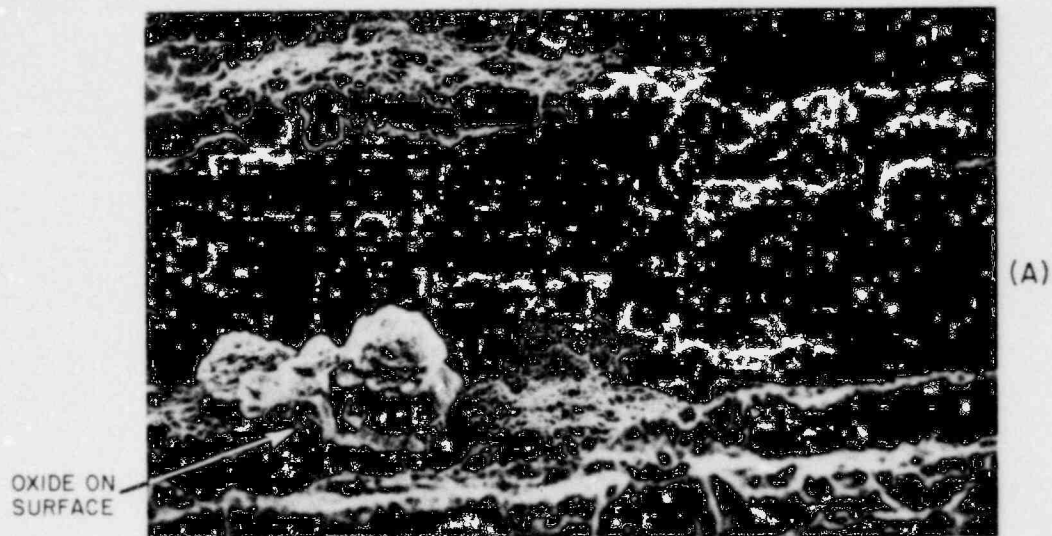
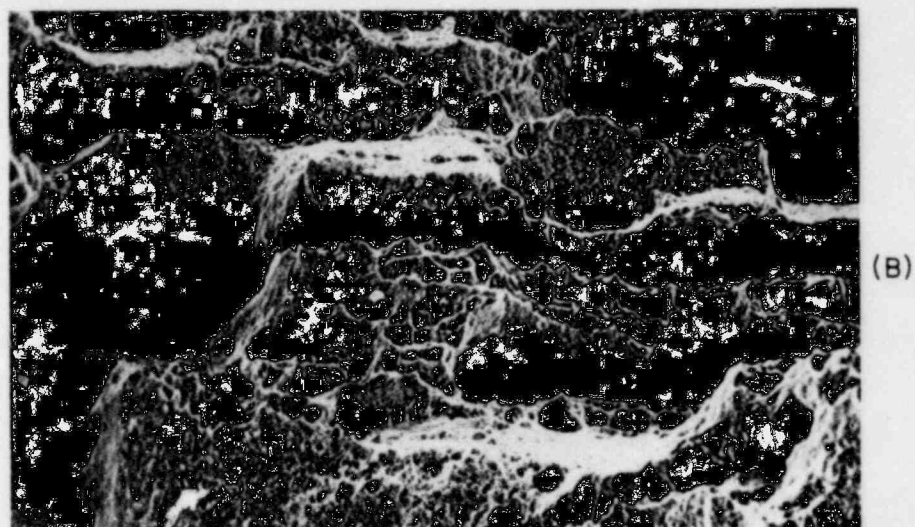
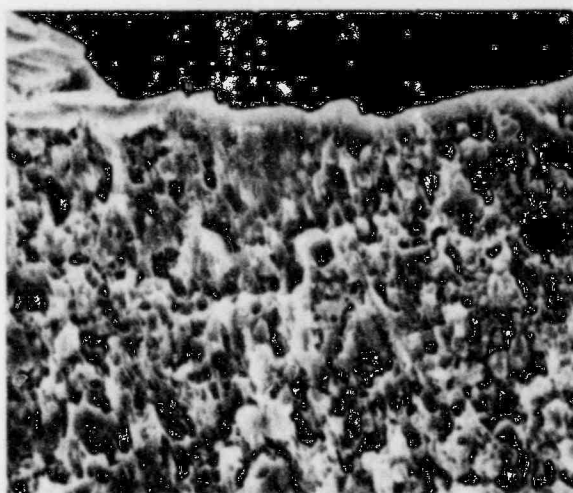
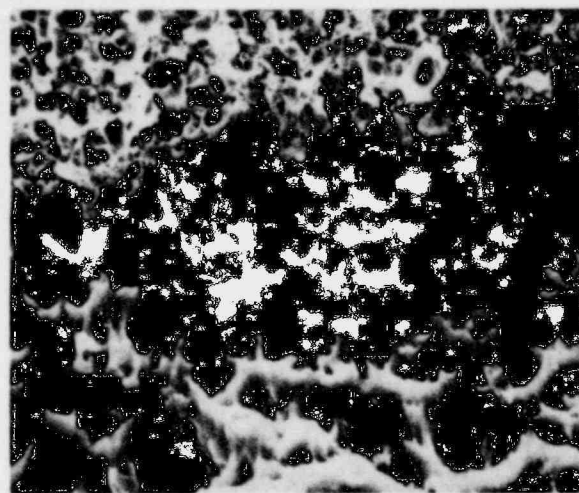
FIGURE 13

Fracture surfaces from (1) the original crack, (2) the failed bend specimen, (3) the tensile test specimen, and (4) laboratory fractured specimens were subject to electron microscopy study.<sup>1</sup> The original crack was heavily oxidized and was cleaned using a phosphoric acid-and-water mixture. It was then cleaned in acetone using an ultrasonic bath, followed by preparation for electron microscopy. All other specimens were examined in the "as-fractured" condition without surface preparation, except that required to enhance the electron microscopy. Specimens used for limited microprobe chemical determination received no preparation. A comparison was made of the phosphoric acid cleaned surfaces against the nonphosphoric acid cleaned surfaces and, essentially, the rust-removal operation did not show any adverse effect on the fracture surface. Figures 13 and 14 show a series of photographs obtained during this examination.

The original cracked surface showed no striations of the type which would indicate fatigue-type failure. The fracture exhibited a fibrous "woody" appearance, suggesting that the base material was heavily banded or contained a large number of stringer inclusions. For comparison purposes, tensile and bend test fracture surfaces were examined, and these exhibited a fibrous appearance containing shear dimples, indicating ductile failures. Inclusions were observed in all fractured surfaces and a microanalytical scan of one of the induced fractures indicated dispersions of inclusions high in manganese content.

- (A) FRACTURE OF CRACK SURFACE (PHOSPHORIC ACID CLEANED) MAG. 200X  
 (B) FRACTURE OF TENSILE SPECIMEN (NO CLEANING) MAG. 200X  
 (C) BEND TEST FRACTURE (TENSION SIDE) MAG. 1700X  
 (D) BEND TEST FRACTURE (COMPRESSION SIDE) MAG. 2100X

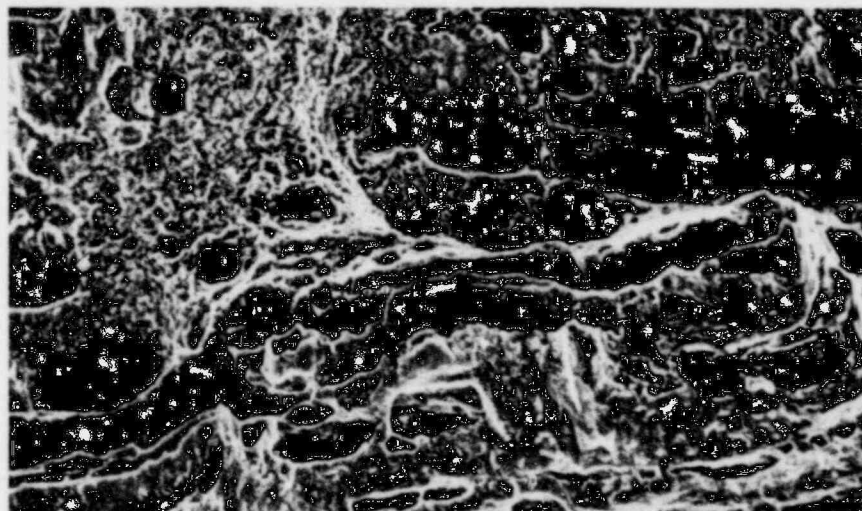
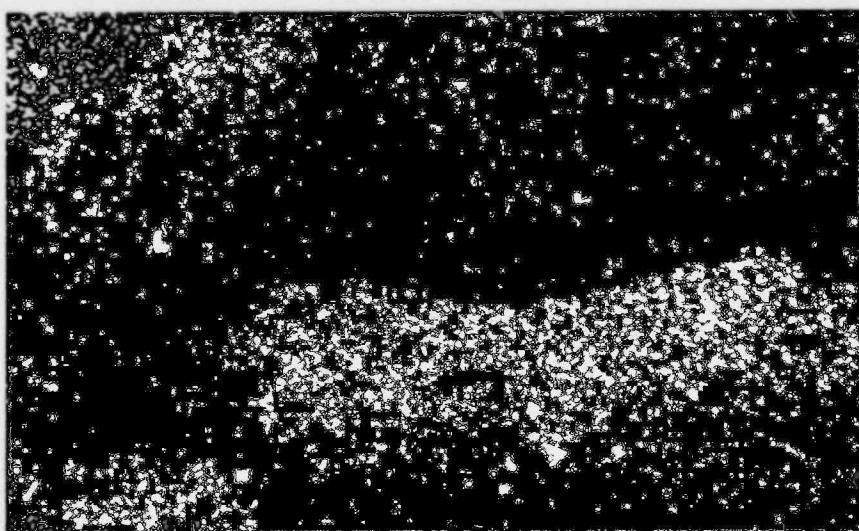
FIGURE 14

- (A) FRACTURE DETAIL OF BEND TEST FRACTURE - TENSION SIDE MAG 425X
- (B) MANGANESE X-RAY MAPPING OF AREA SHOWN IN FIGURE 14(A) WHITE DOTS DENOTE MANGANESE RICH AREAS MAG 425X
- (C) A NONMETALLIC INCLUSION (MANGANESE RICH) OBSERVED IN TENSILE TEST FRACTURE SHOWN IN FIGURE 13(B) MAG 5000X

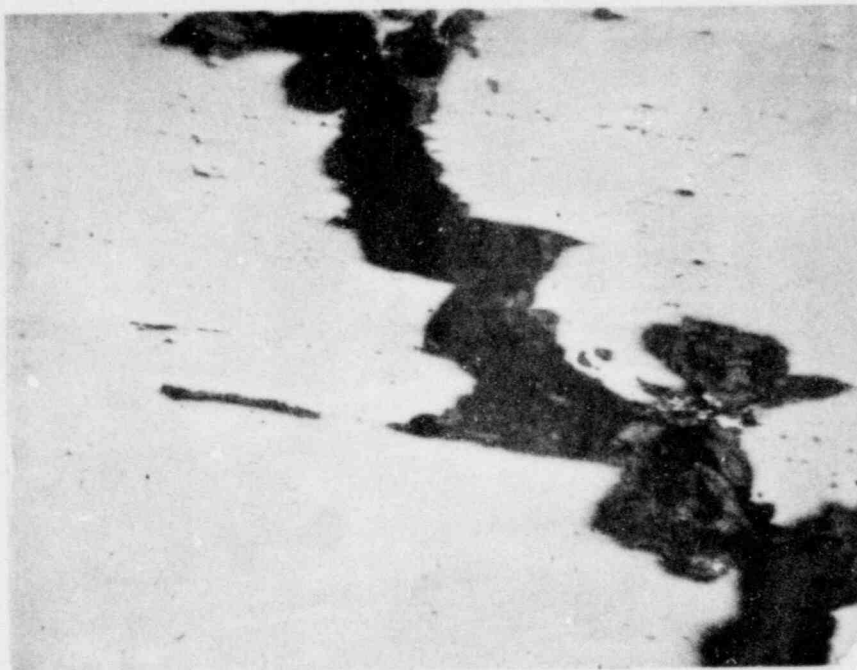
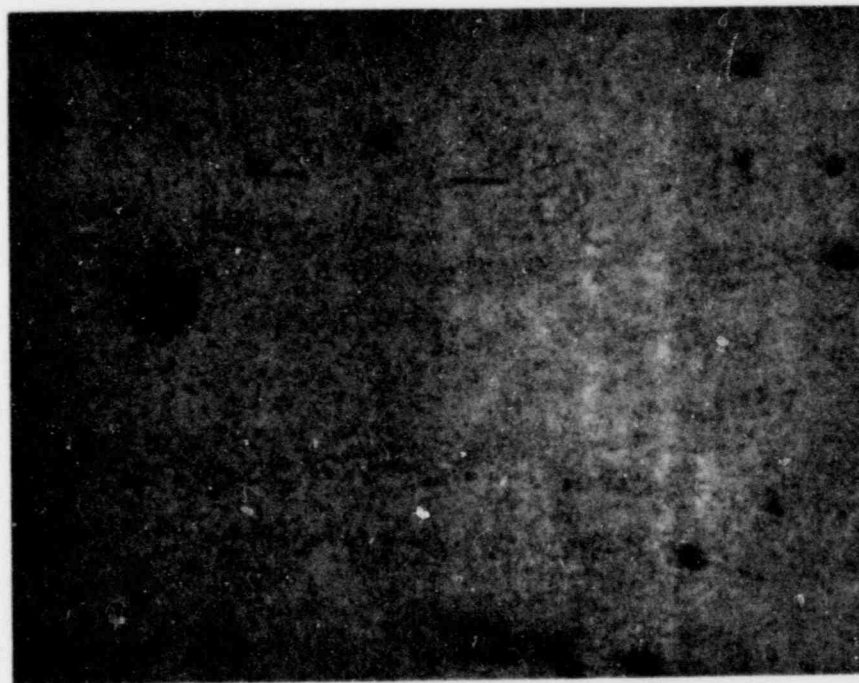
FIGURE 15  
PHOTOMICROGRAPHS  
(LOCATION C - FIG.8)

Metallographic examinations were conducted at several locations to study (a) base material, (b) crack geometric appearance, and (c) selected indications from the ultrasonic test. Photo micrographs are contained in Figure 15. The liner base material displayed a fine-tempered martensitic structure typical for the quench and tempered heat treatment given A537 Grade B steel. A segregated structure of nearly parallel bands aligned in the direction of rolling (banding) was pronounced, and inclusions both stringer-type and globular appeared at a higher frequency than normally encountered in average quality hot-rolled steel of this grade. Banding, a condition normal to such plate

materials, was aggravated somewhat by the inclusion content. Propagation followed planes of weakness caused by the banding and cut across metal laminates in a ductile fashion, creating the step-like appearance.

PORTION OF CRACK AND INCLUSIONS  
UNETCHED MAG. 50X

CARBIDES IN A TEMPERED MARTENSITIC MATRIX  
NITAL ETCH MAG. 500X
