**Please find Attached a Part 21 notification from Rotork Controls Inc.  
concerning a safety related "Outer Clutch Ring", part number N40039.**

Subject: NA Actuator, Model NA1, Outer Clutch Ring Anomaly

Rotork has identified a potential concern as defined under 10CFR Part 21 with model NA1 and NA5 nuclear safety related actuators manufactured between January 1<sup>st</sup> 1979 and December 31<sup>st</sup> 1982. Switch mechanism in these actuators utilize an Outer Clutch Ring (N40039) made from beryllium copper. A customer has reported (4) instances of Outer Clutch Ring failure between 2000 and 2019. All failures occurred in Outer Clutch Rings made from beryllium copper.

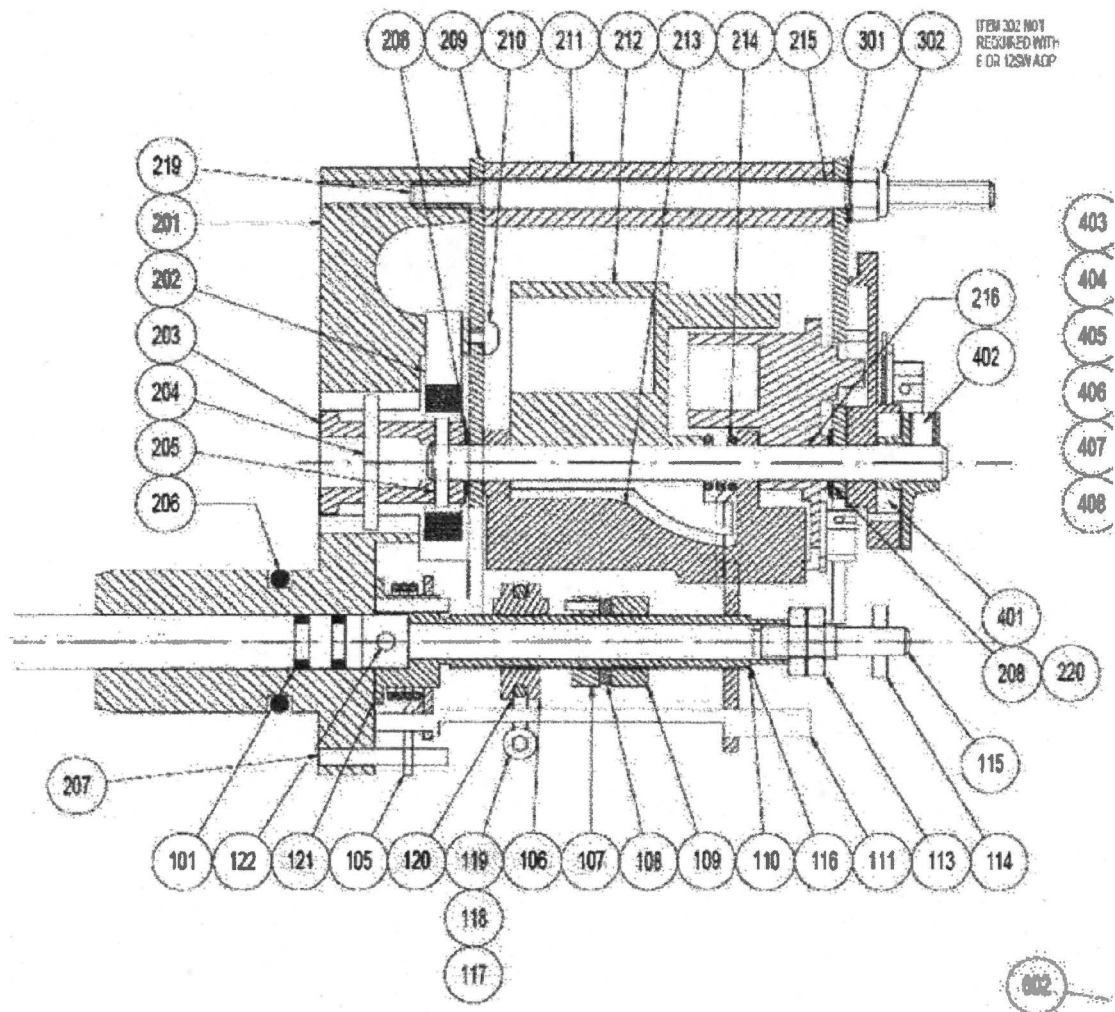
Fig 1

The Outer Clutch Ring is part of the Switch Mechanism; an assembly designed to stop the actuator on either travel limit or rated output torque limit. Indication of these limits is provided through the operation of electrical switches within the switch mechanism. The Outer Clutch Ring is part of the mechanism that applies and maintains force to switch plungers once limits are reached. If the Outer Clutch Ring fractures, the force needed to depress and hold the switch plungers cannot be applied causing the observed loss of indication that alerted the licensed operator.

Failure of the Outer Clutch ring prevents the actuator from stopping on travel limit. Should this occur the actuator will over travel and eventually stop on output torque limit set by the customer. The Outer Clutch Ring (Fig1, 120) wraps around a component called the inner traveler (Fig 1, 106) and prevents it rotating until it reaches the set travel limit position (Fig 1, 107 & 121). The Outer Clutch Ring slips on the inner traveler if necessary. Slip in service should not occur. Slip may occur during commissioning and test.

Rotork have developed a repair kit (WN 84122) which replaces the beryllium copper Outer Clutch Ring with a spring steel version.

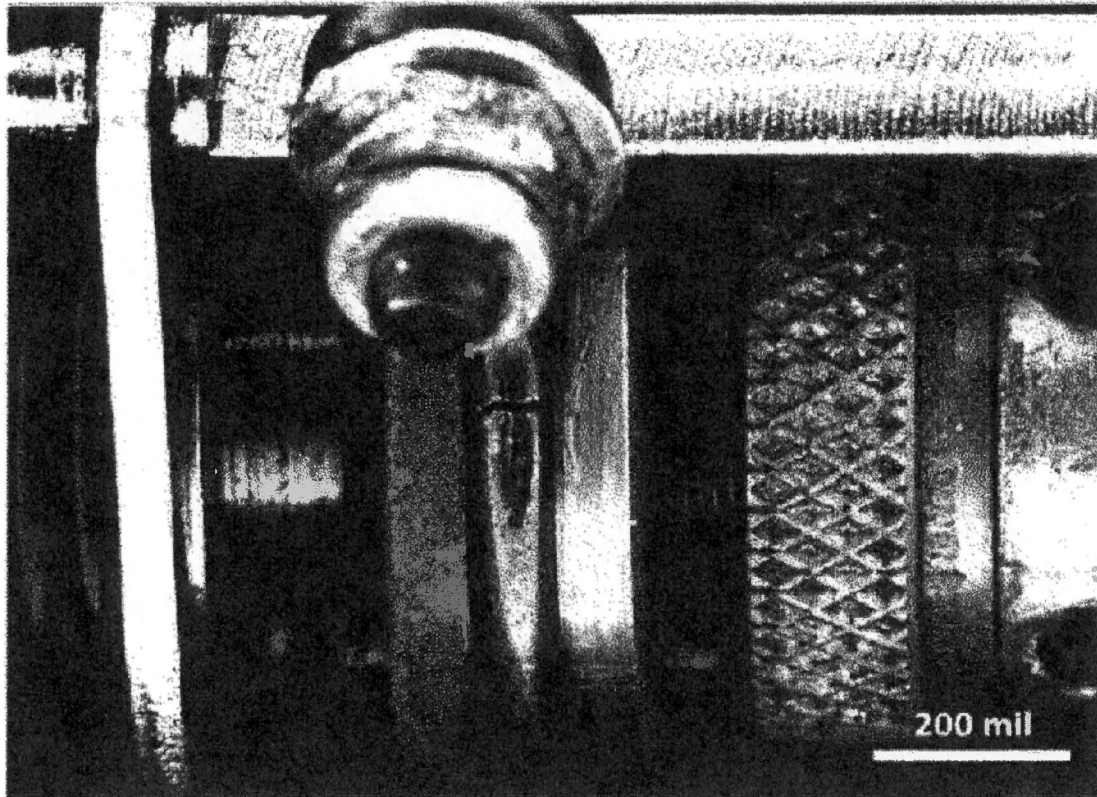
Fig 2

The cause of the component failure is not understood. All failures occurred at the same point in the component. The form of the fractures are similar (Fig 2). The Outer Clutch Ring is seated onto the inner traveler by initially over tightening the cap-screw (Fig 1, 119) used to set the torque at which the Outer Clutch Ring slips on the inner traveler. Over tightening to seat may have introduced a weakness. The same method is used to seat spring steel Outer Clutch Rings. There are no records of

spring steel Outer Clutch Ring failures by either licensed utilities or from within Rotork's NCR system. No other licensed utility has reported failures in beryllium copper Outer Clutch Rings.

U.S Licensees with either installed or in storage actuators and spare switch mechanisms provided within the stated dates should evaluate the impact of an Outer Clutch Ring failure on safety related systems.
