**PERRY NUCLEAR POWER PLANT**

Geologic Map of  
Tunnel Excavations

Figure 2D-2 (Sheet 1 of 24)

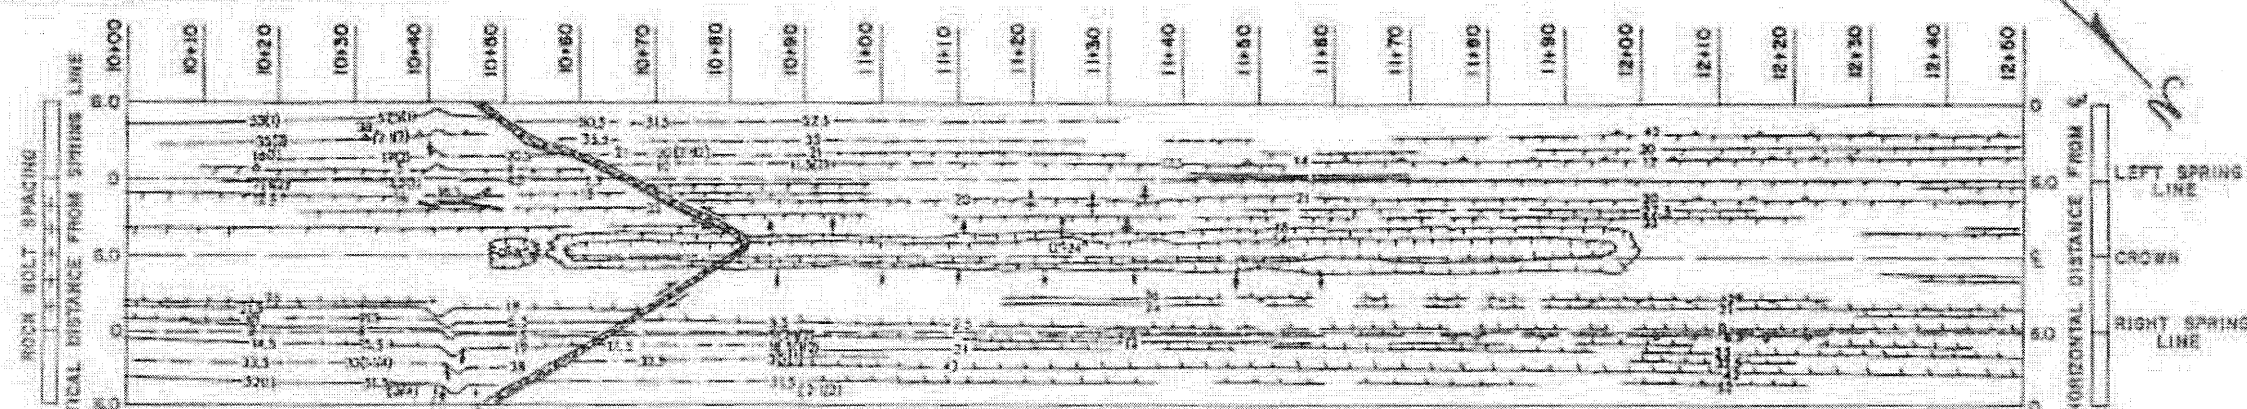
- FAULT SEOMETRY**
- a.) Apparent displacement - 22"
  - b.) Actual vertical displacement - 12"
  - c.) Strike - N 47° E
  - d.) Dip - approx 17°
  - e.) Width of broken rock (1 1/2" - 18")

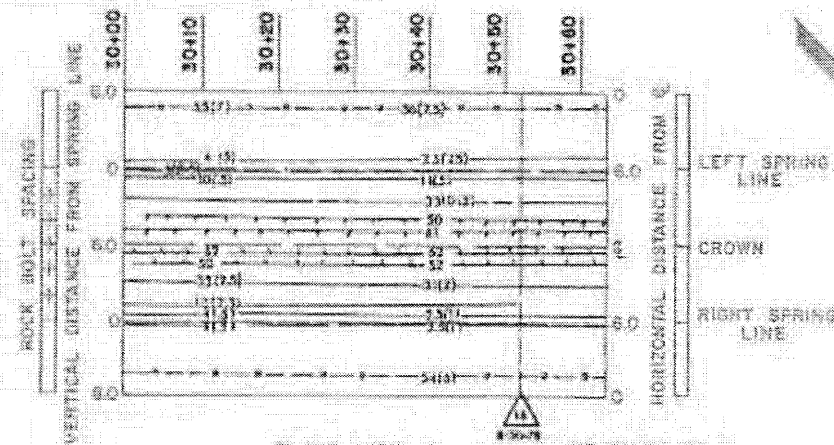
PLANE VIEW A

EXCAVATION PROGRESS	ESTIMATED ROCK CONDITION (TERZAGHI NO.)
1-4	1-4
Slight overbreak along entire section	1-4
3 rock bolts at 2' centers in steel ribs at 4' centers spaced by wire mesh	1-4
4'-6"	1-4
Bedding fractures only, spaced as above	1-4
Slight moisture along all bedding fractures	1-4
22.5' water	22.5'
91.5' subsurface (scale)	91.5'

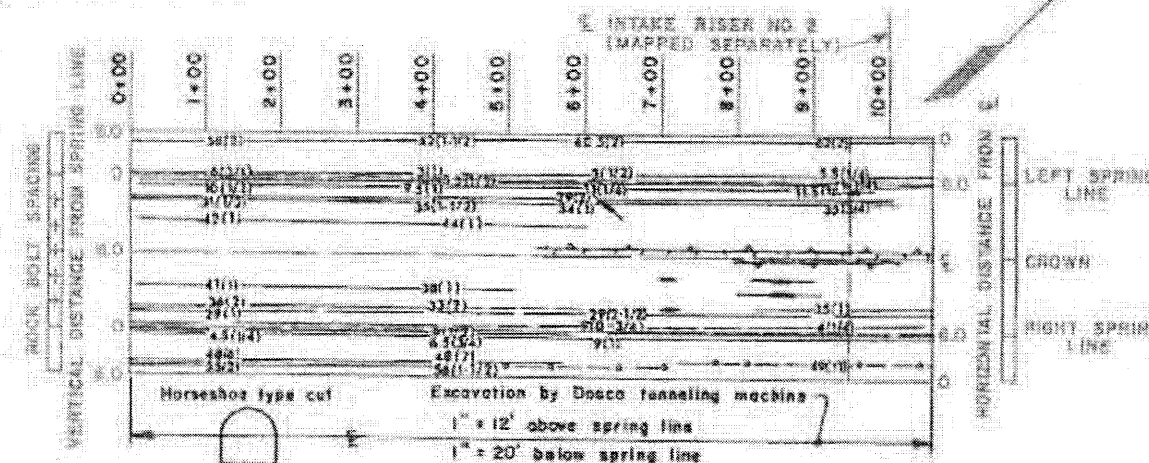
PLANE VIEW B

EXCAVATION PROGRESS	ESTIMATED ROCK CONDITION (TERZAGHI NO.)
1-4	1-4
Slight overbreak along entire section	1-4
3 rock bolts at 2' centers in steel ribs at 4'-6.5' centers, spaced by wire mesh	1-4
3'-8"	1-4
Bedding fractures only, spaced as above	1-4
Slight moisture along all bedding fractures	1-4
22.5' water	22.5'
91.5' subsurface (scale)	91.5'

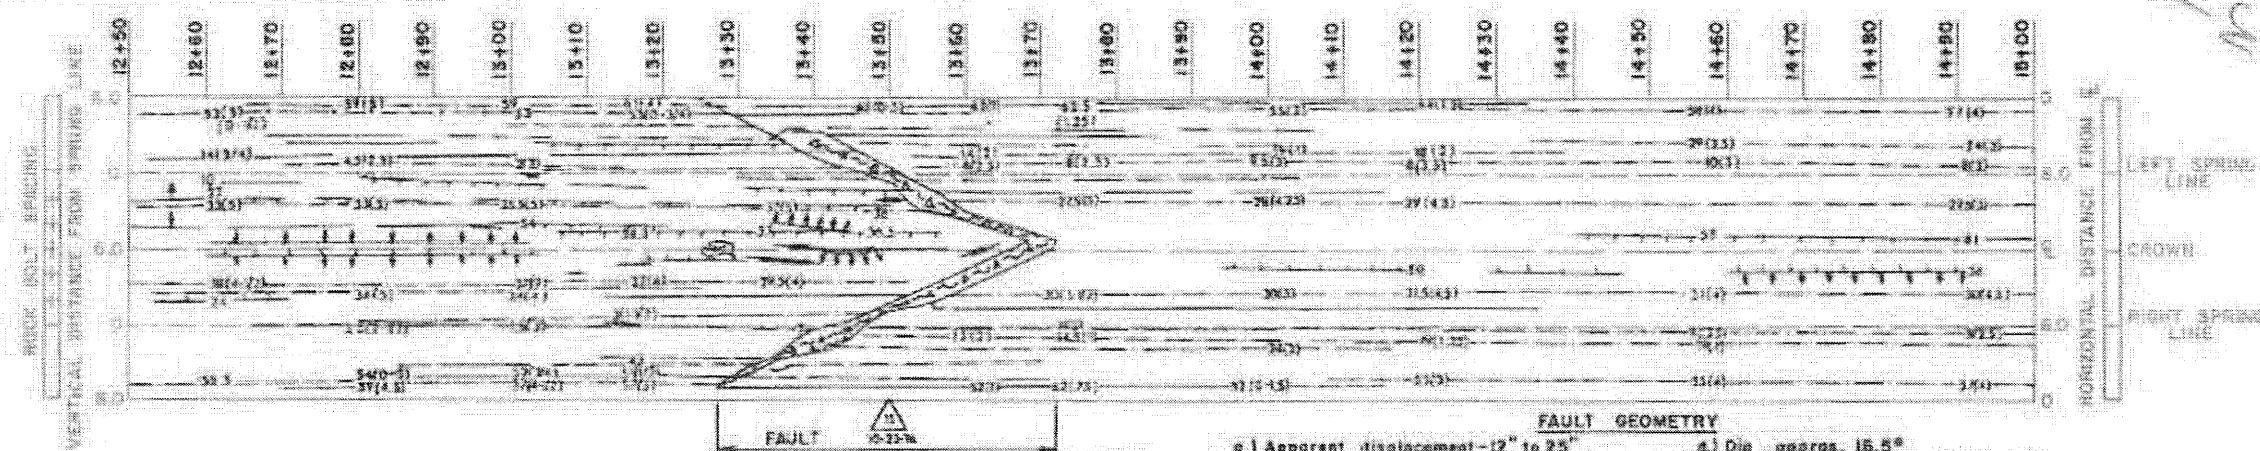
a.) Apparent displacement - 12" to 25" d.) Dip approx. 15.5°  
 b.) Actual vertical displacement - 8 1/2" to 11 1/2" e.) Width of broken rock (1 1/2" to 24")  
 c.) Strike - N66°E
