Callaway Plant

ULNRC-06538

**DOCKET NUMBER 50-483  
CALLAWAY PLANT UNIT 1  
UNION ELECTRIC CO.  
RENEWED FACILITY OPERATING LICENSE NPF-30  
LICENSEE EVENT REPORT 2019-001-01  
EMERGENCY AC ELECTRICAL POWER ACTUATION**

<b>1. Facility Name</b> Callaway Plant Unit 1				<b>2. Docket Number</b> 05000483			<b>3. Page</b> 1 OF 5			
<b>4. Title</b> Unplanned Loss of Switchyard Bus B Results in System Actuation										
<b>5. Event Date</b>			<b>6. LER Number</b>			<b>7. Report Date</b>			<b>8. Other Facilities Involved</b>	
Month	Day	Year	YEAR	Sequential Number	Rev No.	Month	Day	Year	Facility Name	Docket Number
4	17	2019	2019	- 001	- 01	11	7	2019	Facility Name	Docket Number
										05000
										05000
<b>9. Operating Mode</b>			<b>11. This Report is Submitted Pursuant to the Requirements of 10 CFR §: (Check all that apply)</b>							
N			<input type="checkbox"/> 20.2201(b)		<input type="checkbox"/> 20.2203(a)(3)(i)		<input type="checkbox"/> 50.73(a)(2)(ii)(A)		<input type="checkbox"/> 50.73(a)(2)(viii)(A)	
			<input type="checkbox"/> 20.2201(d)		<input type="checkbox"/> 20.2203(a)(3)(ii)		<input type="checkbox"/> 50.73(a)(2)(ii)(B)		<input type="checkbox"/> 50.73(a)(2)(viii)(B)

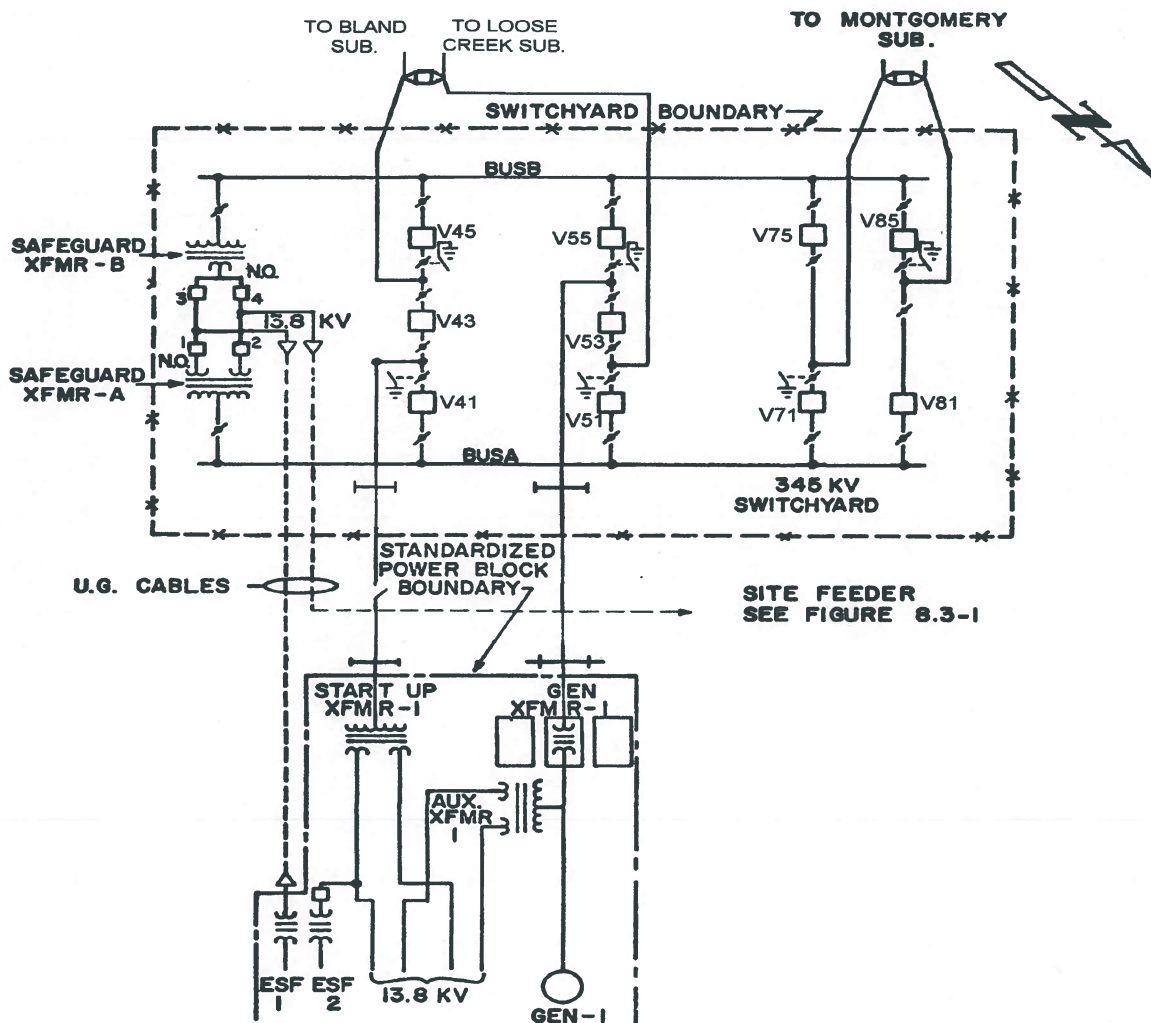
**FIGURE 8.2-5  
345 KV ONE LINE AND  
GENERAL ARRANGEMENT  
CALLAWAY PLANT**

As depicted in the figure provided on page 5 of this LER, the 345-kV Callaway switchyard [EIS System: FK] consists of circuit breakers, disconnect switches, buses, transformers, and associated equipment. The offsite circuit connections to the onsite switchyard for Callaway are arranged such that there are four transmission lines incoming and connecting to the switchyard via two physically separated rights of way (i.e., each with two 345-kV circuits). Versatility for connecting these offsite circuits to the onsite plant power system is provided via a dual bus arrangement within the switchyard (i.e., 345-kV Bus A and 345-kV Bus B [EIS Component: BU]) for which a breaker-and-a-half arrangement is utilized. A 345/13.8-kV safeguard transformer [EIS Component: XFMR] is connected directly to each 345-kV bus through a disconnect switch which is capable of interrupting magnetizing current. Each transformer has two low-side breakers connected so that either transformer may supply (via underground duct) a 13.8/4.16-kV engineered safety feature (ESF) transformer at the plant. The safeguard transformers are sized so that either transformer "A" or "B" has the capacity to handle the design shutdown or the design basis loss of coolant accident load.

It should be noted that there are two breakers that feed the main generator step-up transformers in a backfeed lineup, i.e. MDV53 and MDV55. A set of current transformers (CTs) on MDV53 are wired to a set of current transformers on MDV55 so that current to the main generator step-up transformers can be determined. These main CTs also feed the breaker failure and breaker flashover protection circuitry. For the backfeed that was attempted on April 17, 2019, MDV53 was closed to energize the main generator step-up transformers while MDV55 was still not closed. Due to a ground jumper associated with the MDV55 breaker (explained further in section 6 of this LER), the current in the MDV53 CTs was fed over to a set of CTs on the MDV55 breaker which was still open. This current flow in the MDV55 breaker CTs looked like a breaker failure and flashover since the open breaker was not supposed to be allowing current to flow through the open set of main contacts (breaker failure) or from the main contacts to the breaker outside tank (breaker failure). This protection then cleared another set of 345-kV breakers to isolate MDV55.

A ground wire was inadvertently added on circuit breaker MDV55 as part of a design change under modification package 16-0021 that was implemented in the fall of 2017 (during Refueling Outage 22) in which several switchyard breakers were replaced with a new and different type manufactured by Mitsubishi. When MDV53 was closed for the backfeed on April 17, 2019, this additional ground created a path for current to flow through the protective relays associated with MDV55, and this caused the protection circuitry for MDV55 to detect an unexpected current surge due to the main transformer windings drawing current in order to charge the transformer's field windings. The protective relay actuated on this inrush and initiated a "B" Bus fault clearing of the other breakers. Specifically, the activation triggered circuit breakers MDV45, MDV75, 52-3, and 52-4 to open and clear the bus of load. The opening of 52-3 isolated the "B" safeguard transformer from the "B" switchyard bus, which in turn de-energized ESF transformer XNB01 which was powering the NB01 bus and caused an actuation of Engineered Safety Features equipment.

The added ground wire that was part of the newly installed Mitsubishi breakers was removed from MDV55. In addition, drawings of the switchyard were reviewed for duplicate current transformer (CT) grounds of recently modified switchyard breakers. That review confirmed no similar situations exist that would lead to a similar plant event.
