Annual Radioactive Waste Tank Inspection Program – 2018

June 2019

Savannah River Remediation
Savannah River Site
Aiken, SC 29808

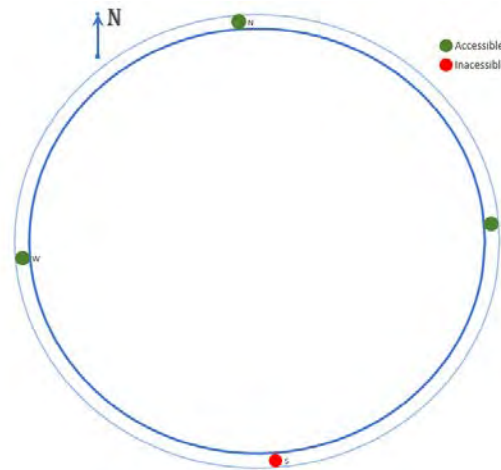
Annulus Inspection Location

Number of Known Leak Sites	Date of Discovery	Waste on Annulus Floor	Location	Elevation from Tank Bottom
≥ 1	Feb 1969	Small deposits on floor	Unknown	Unknown

Summary of Visual Inspections: No changes were noted since the inspections in 2017.
