Humboldt Bay
Independent Spent Fuel Storage Installation
Site-Specific License Renewal Application

Pacific Gas and Electric Company

Revision 4 November 2019

NRC Docket No. 72-27

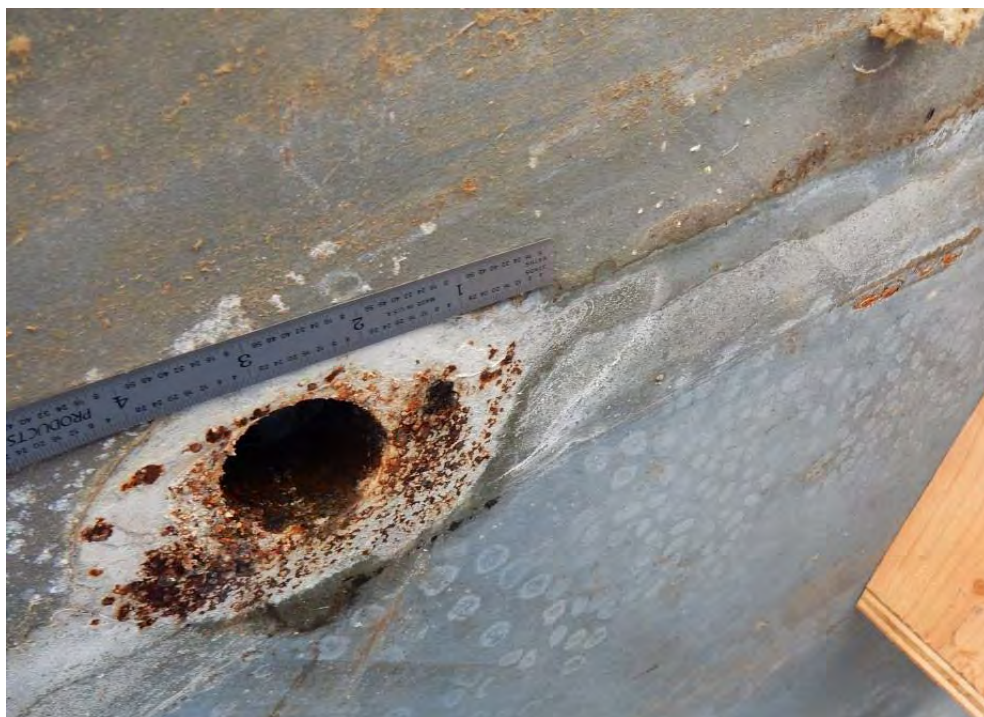
7. Underside hole #3 showing corrosion prior to cleaning

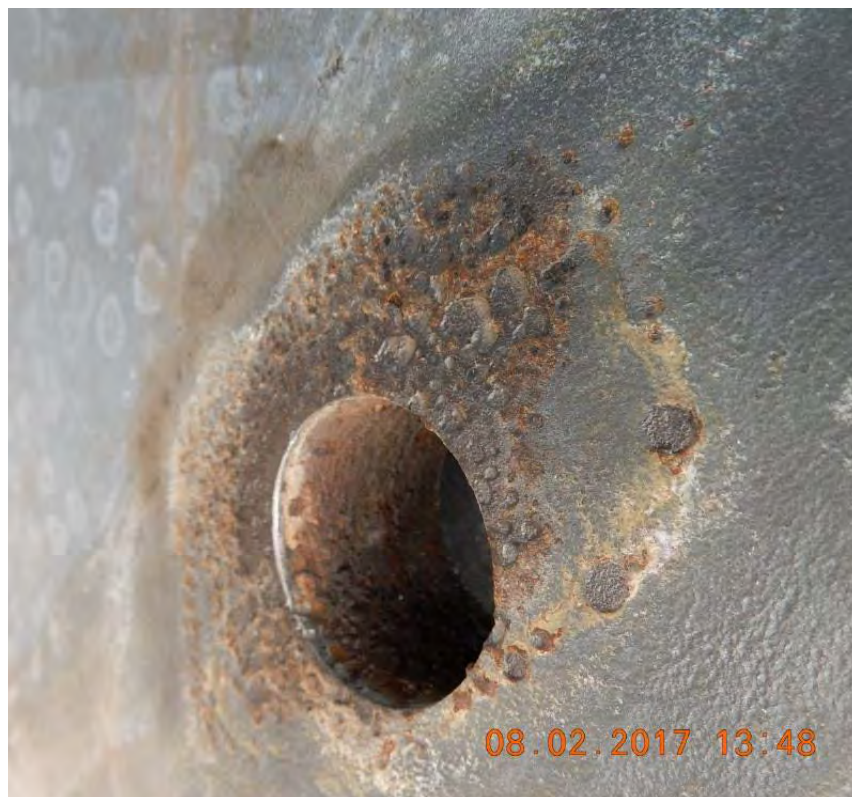
8. Underside hole #5 showing corrosion prior to cleaning

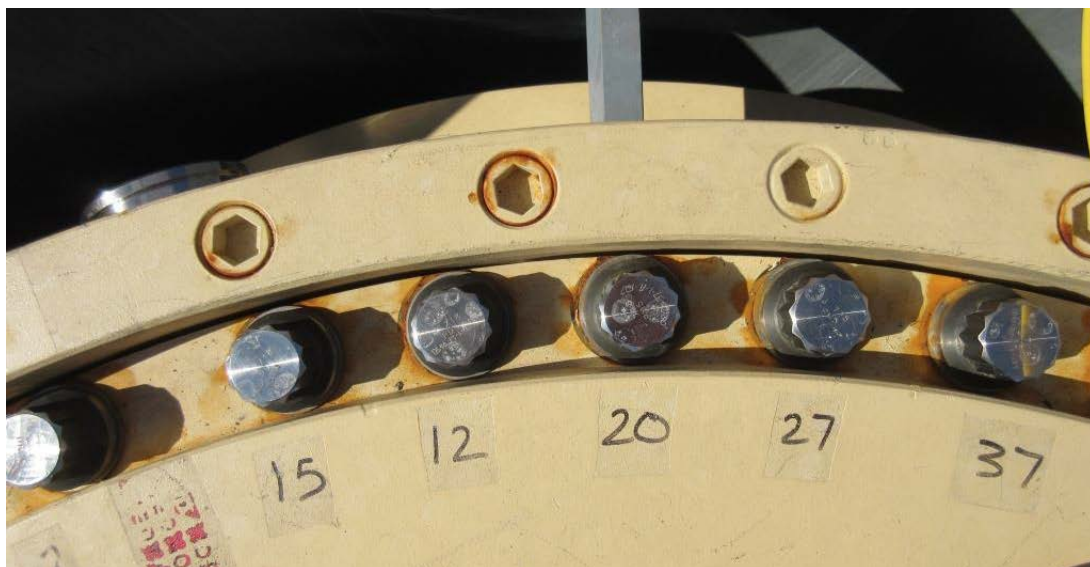
15. Rust staining around overpack lid closure bolting

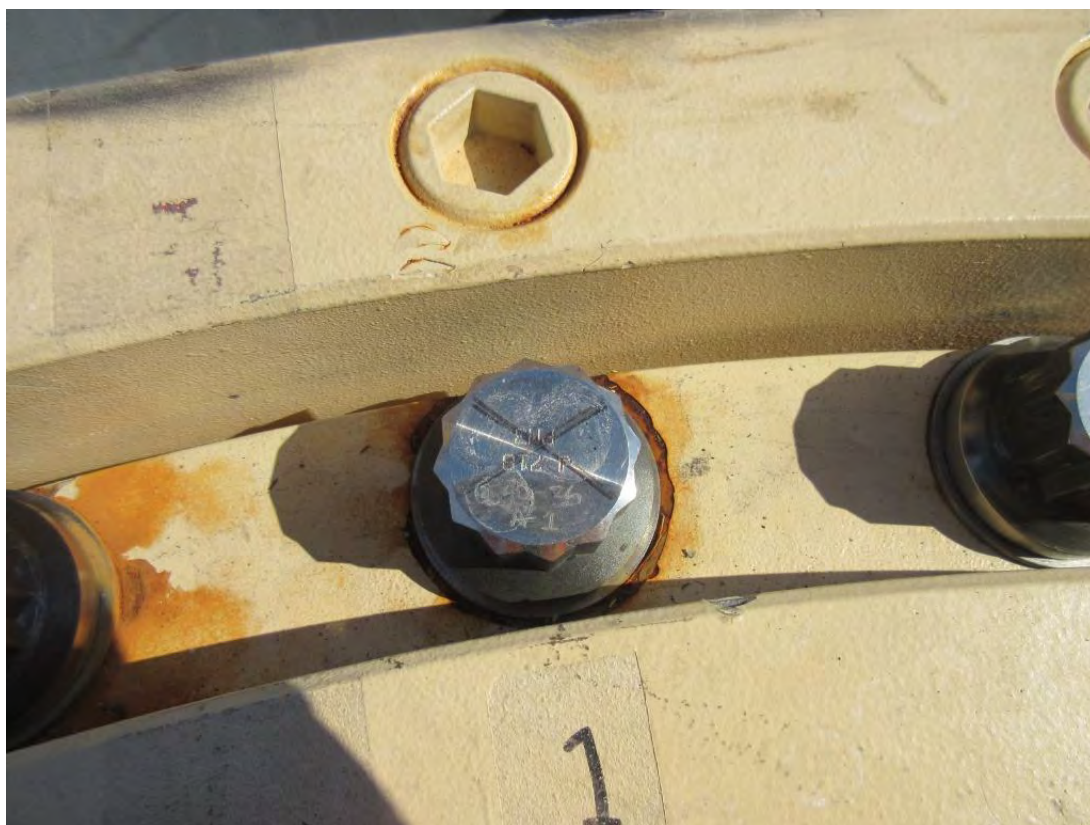
16. Rust staining around overpack lid closure bolting and around top flange plug set screws

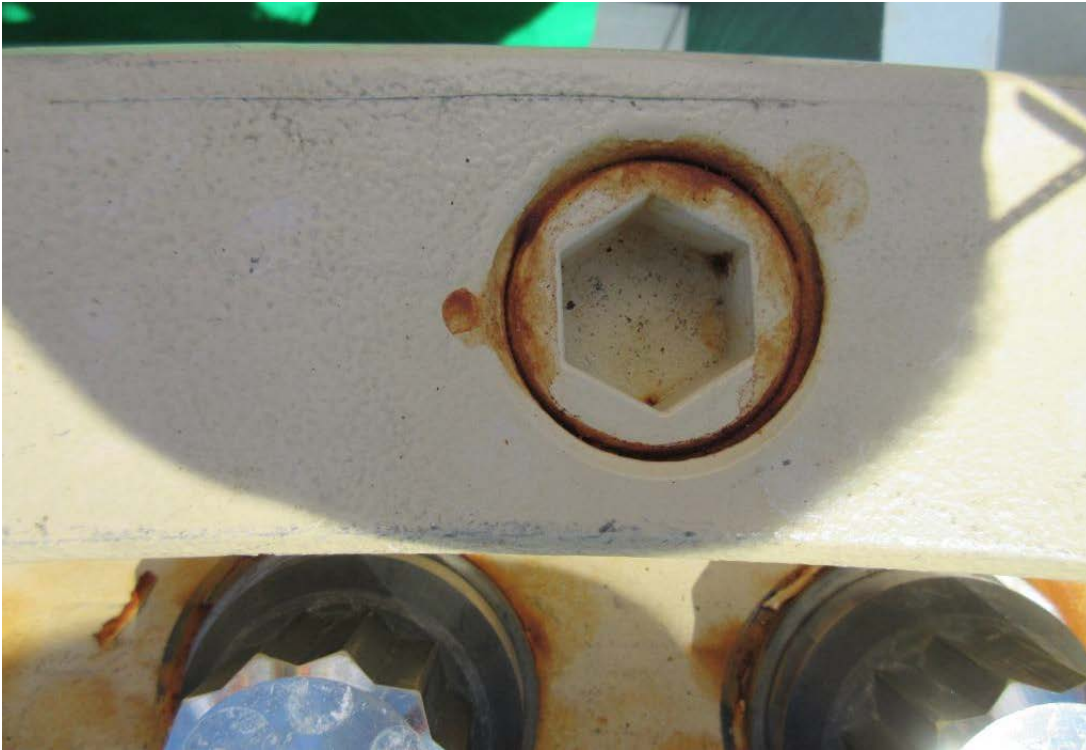
17. Rust staining around overpack lid closure bolting

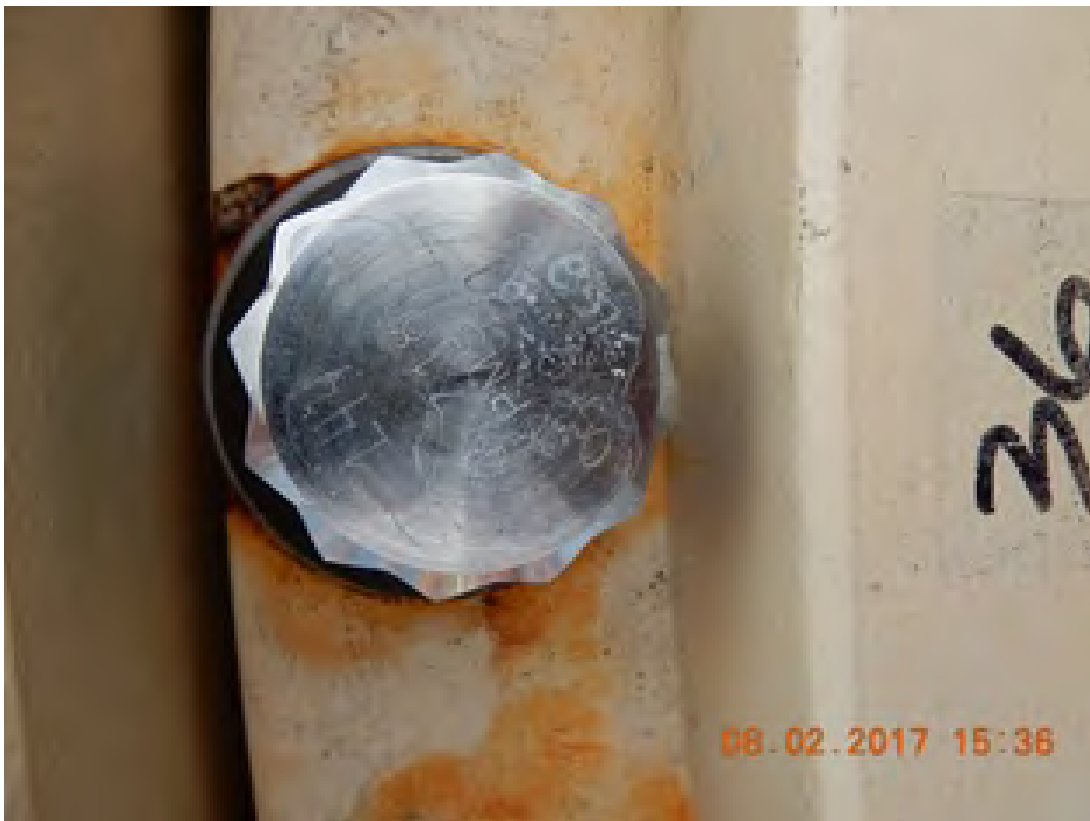
18. Typical rust staining around top flange closure plug set screws

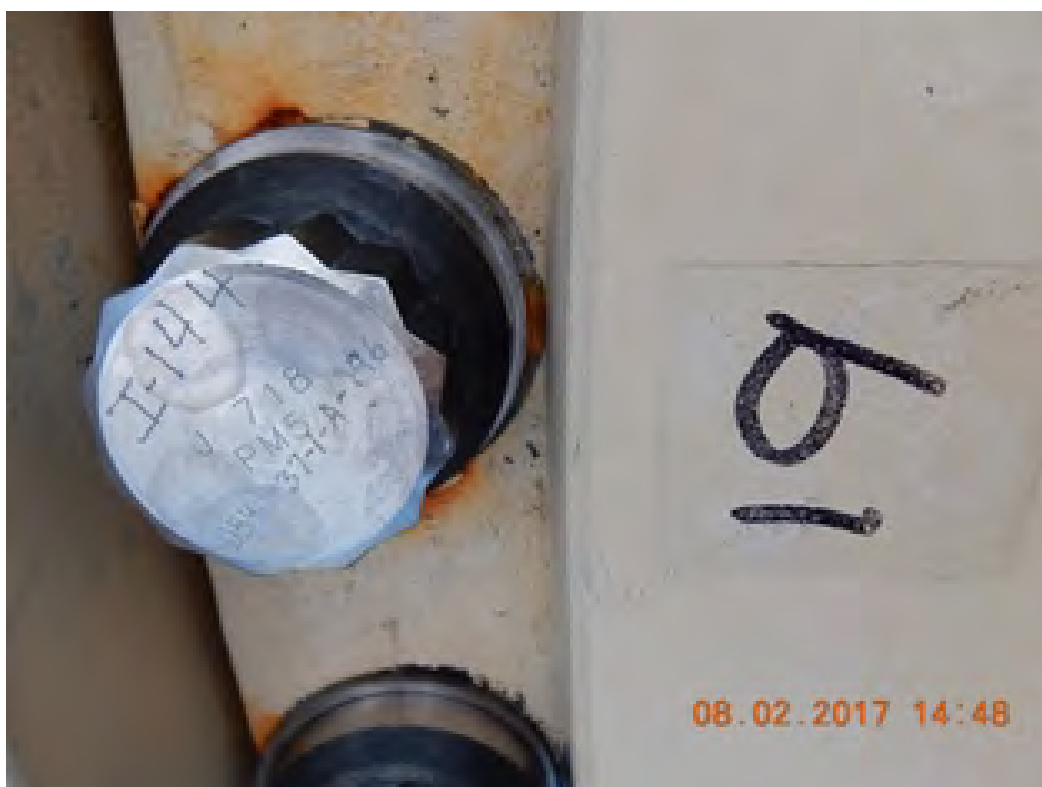
19. Chipped coating under overpack closure lid bolt (at 10 o'clock)

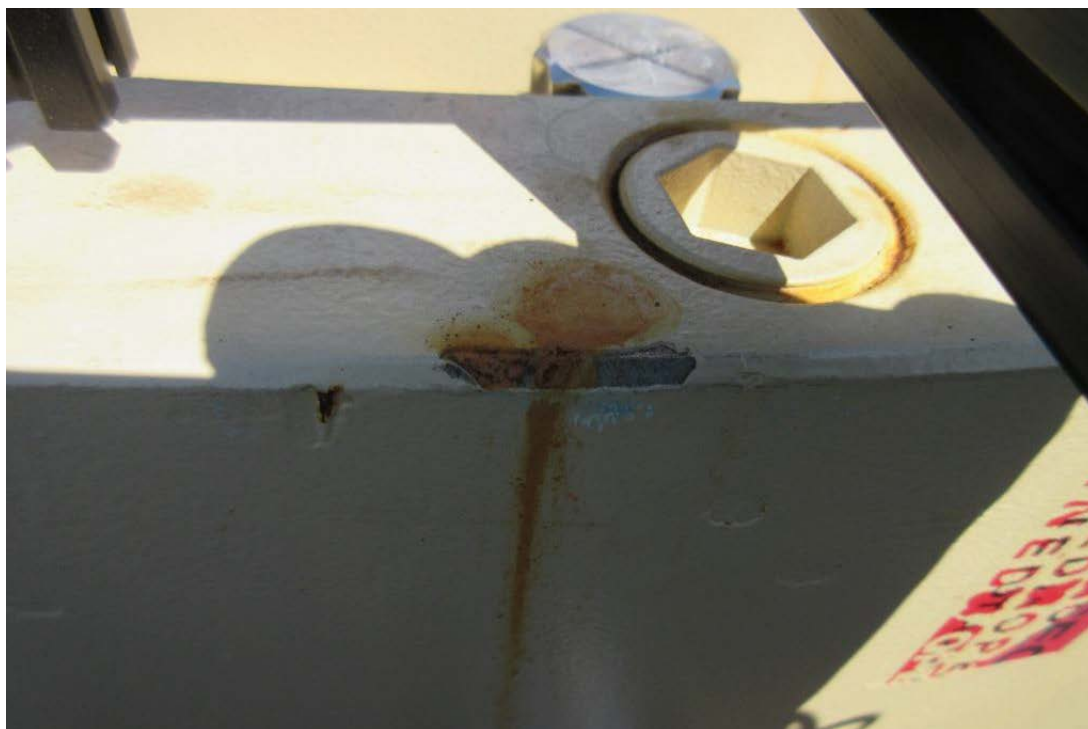
20. Cracked coating under overpack closure lid bolt

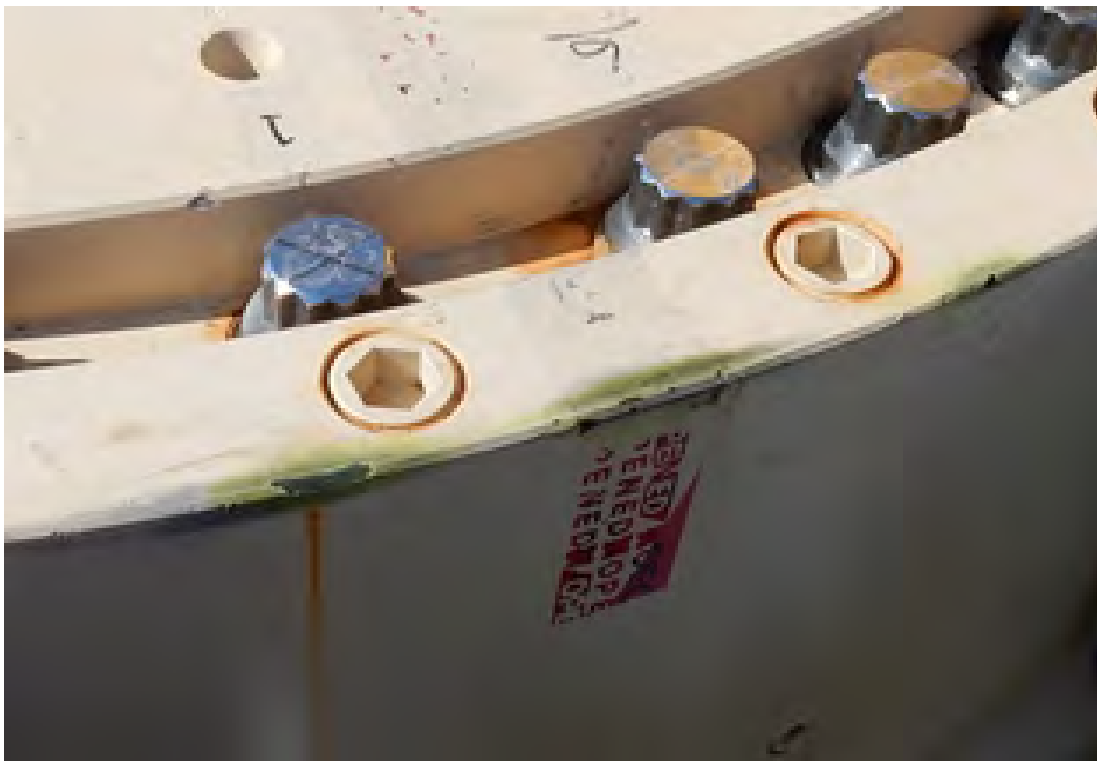
21. Coating chip with rust staining

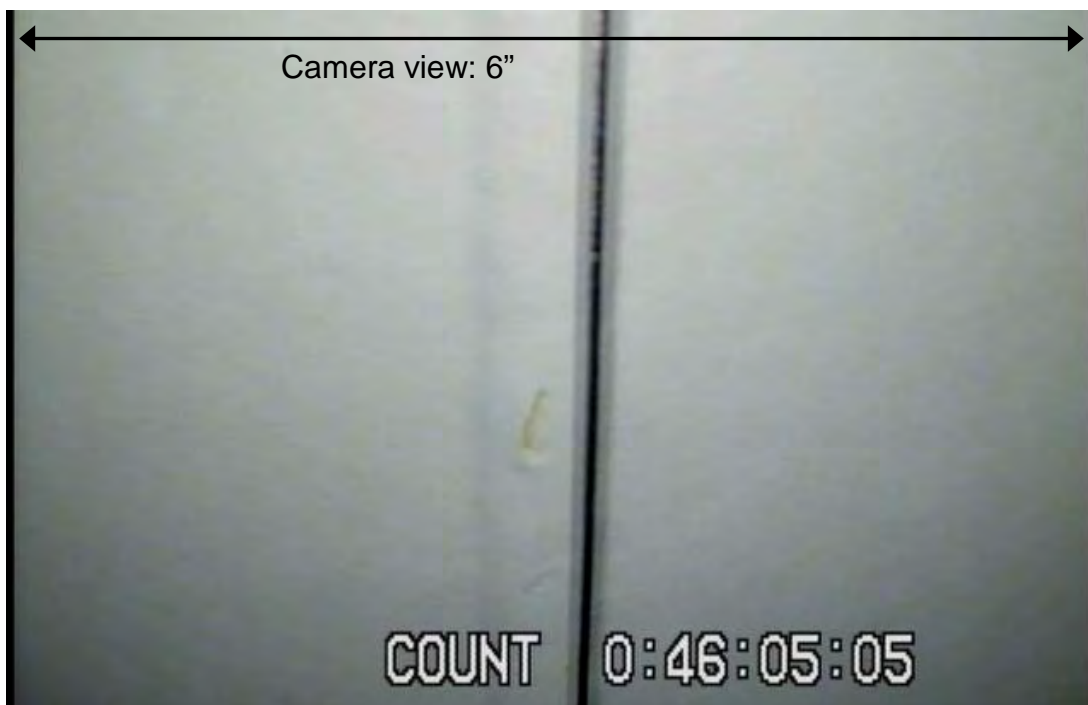
26. Scan 22 rub mark

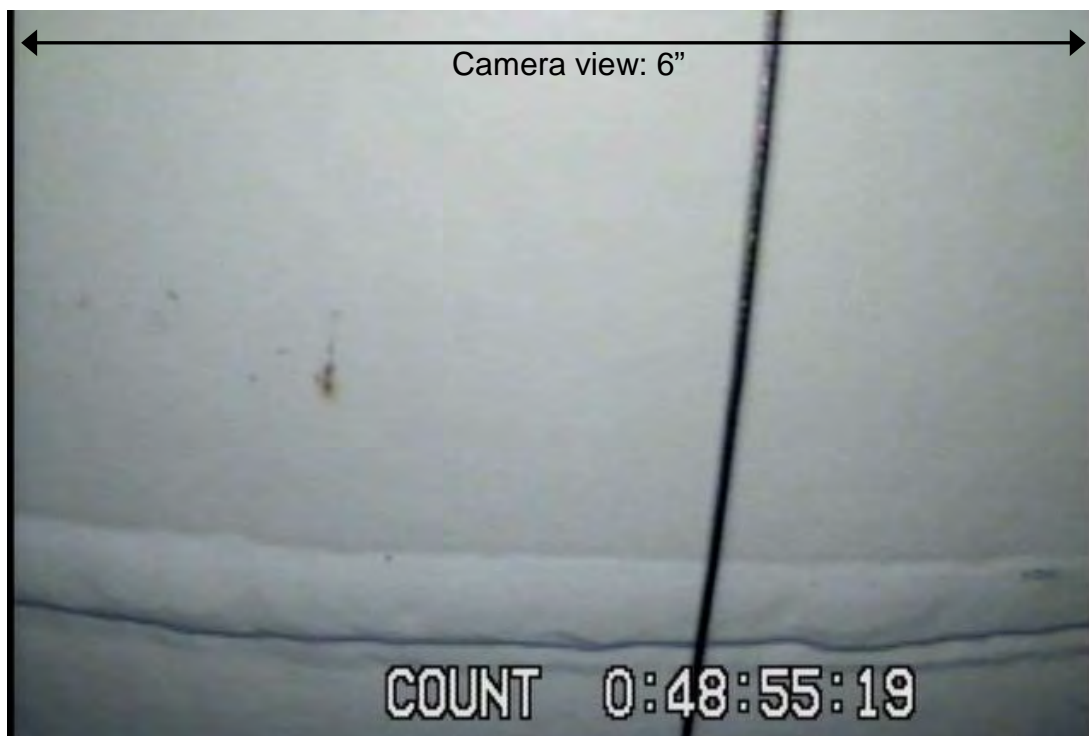
27. Scan 26 coating chip with slight rust discoloration

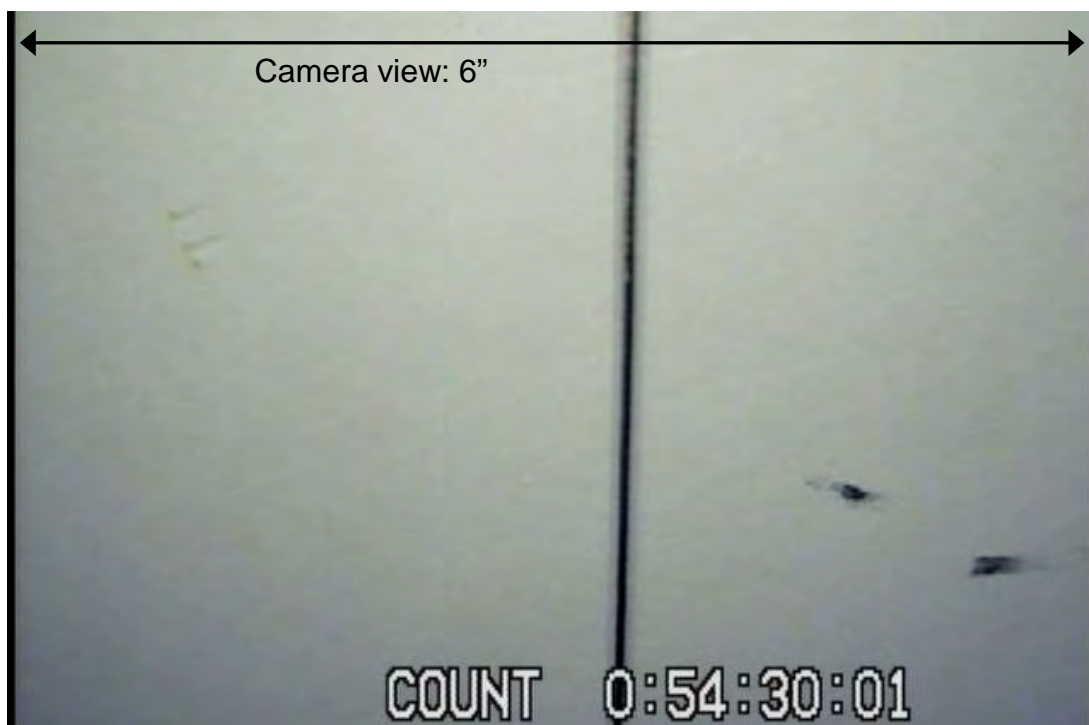
28. Scan 28 slight rust discoloration

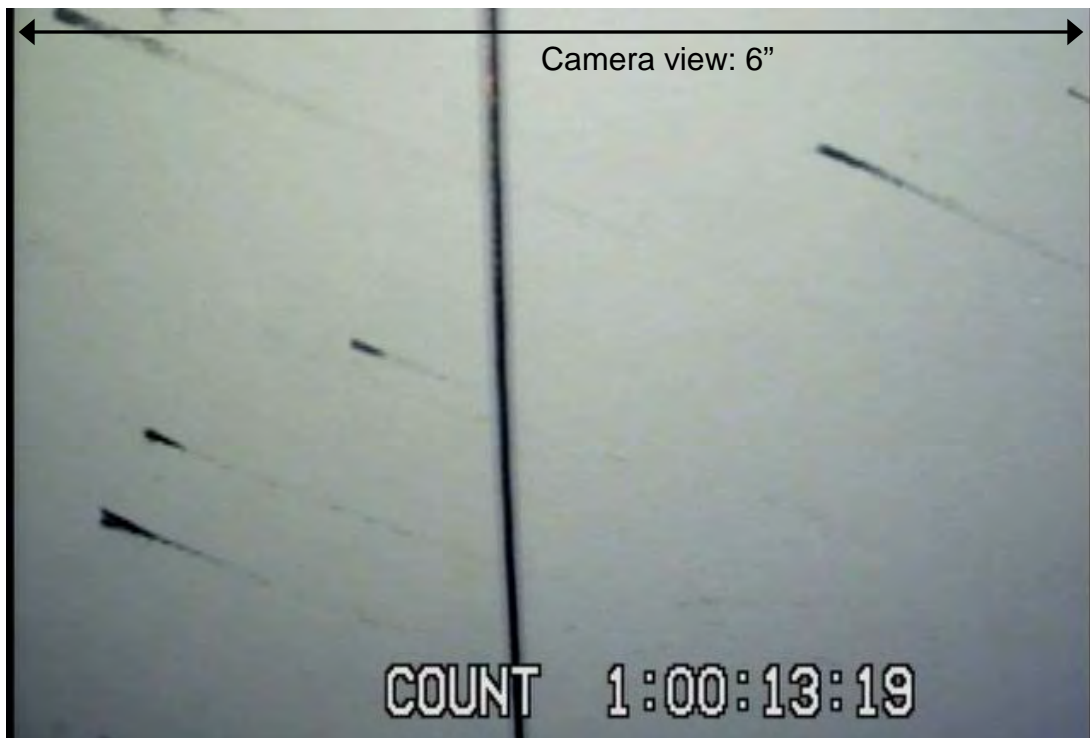
29. Scan 30 slight rust discoloration and black stains

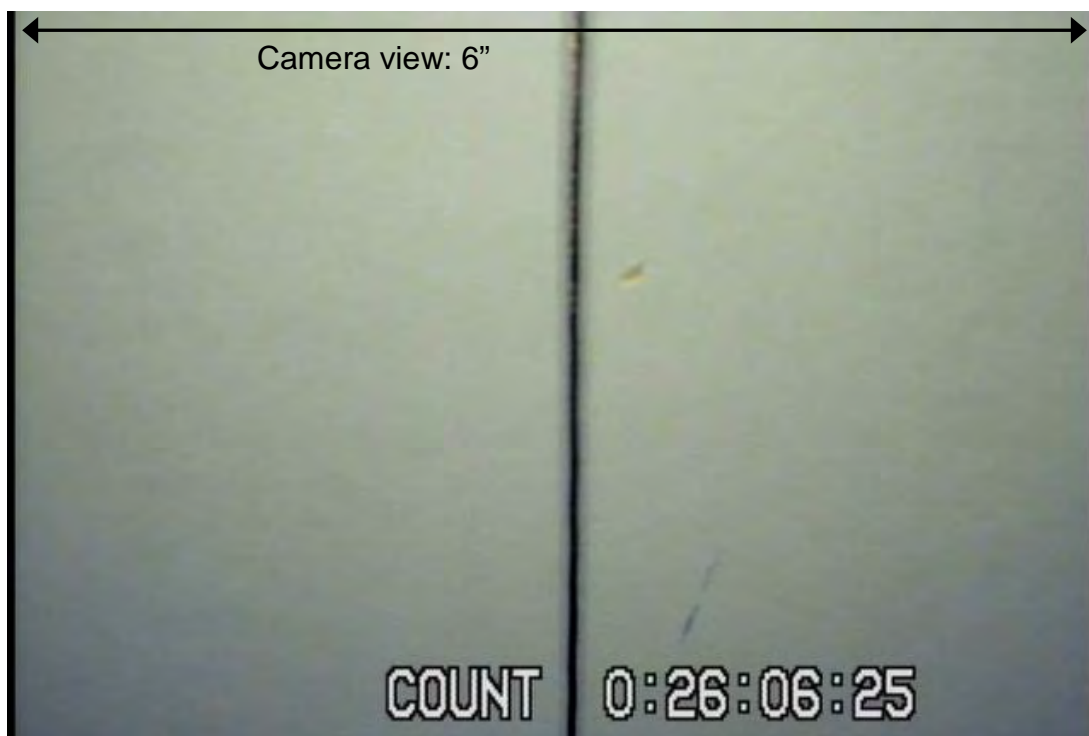
34. Scan 42 coating scrape

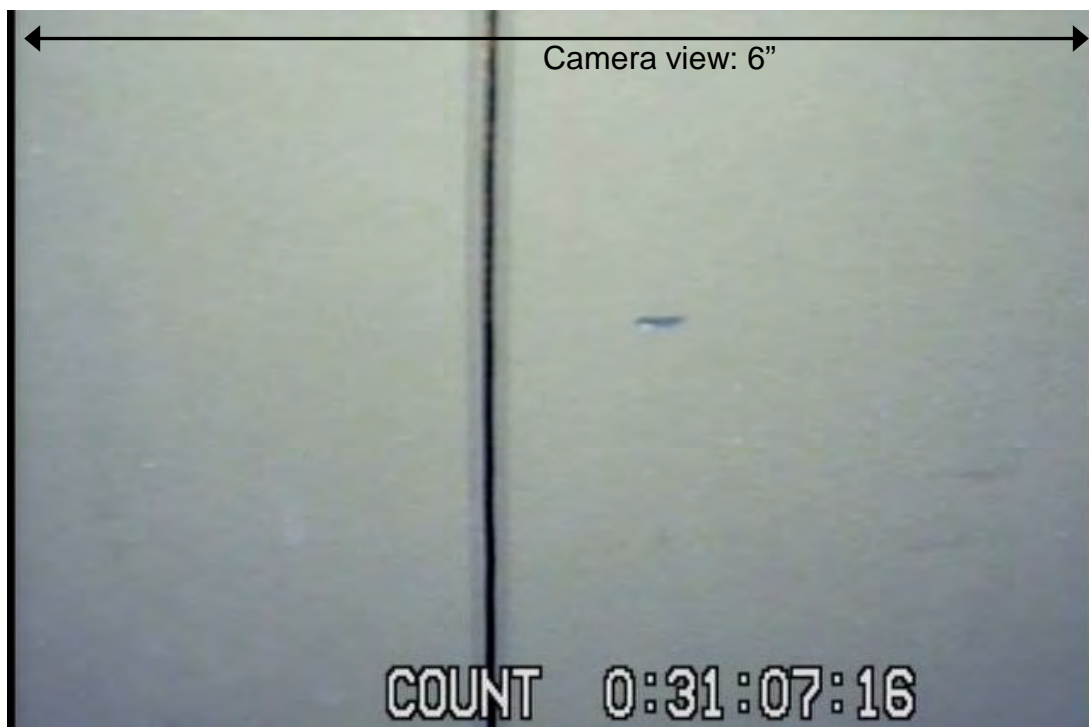
35. Scan 55 slight rust discoloration

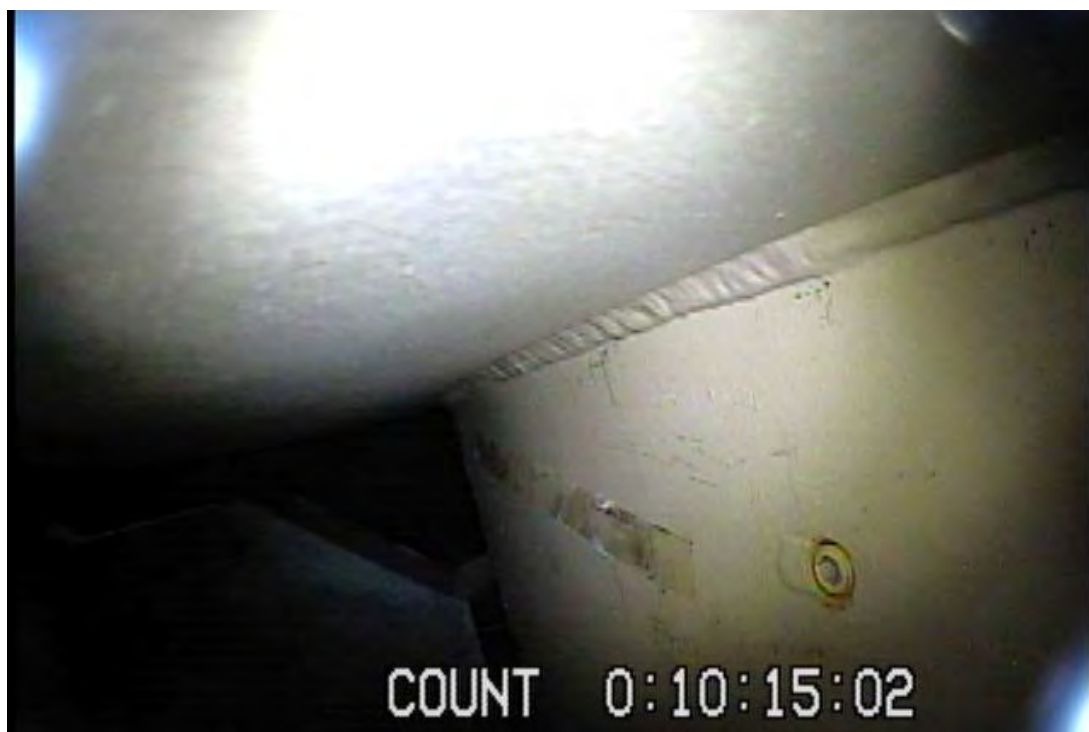
42. Overpack south east section coating scrape adjacent to seismic shim

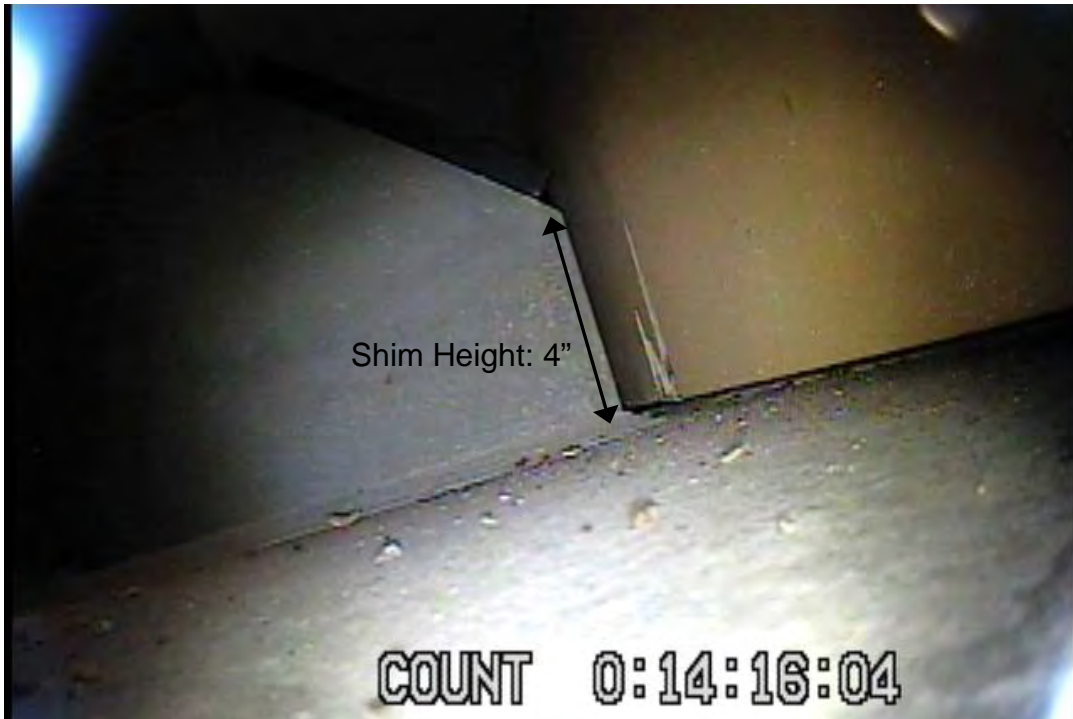
43. Overpack south east section (light rust around set screw)

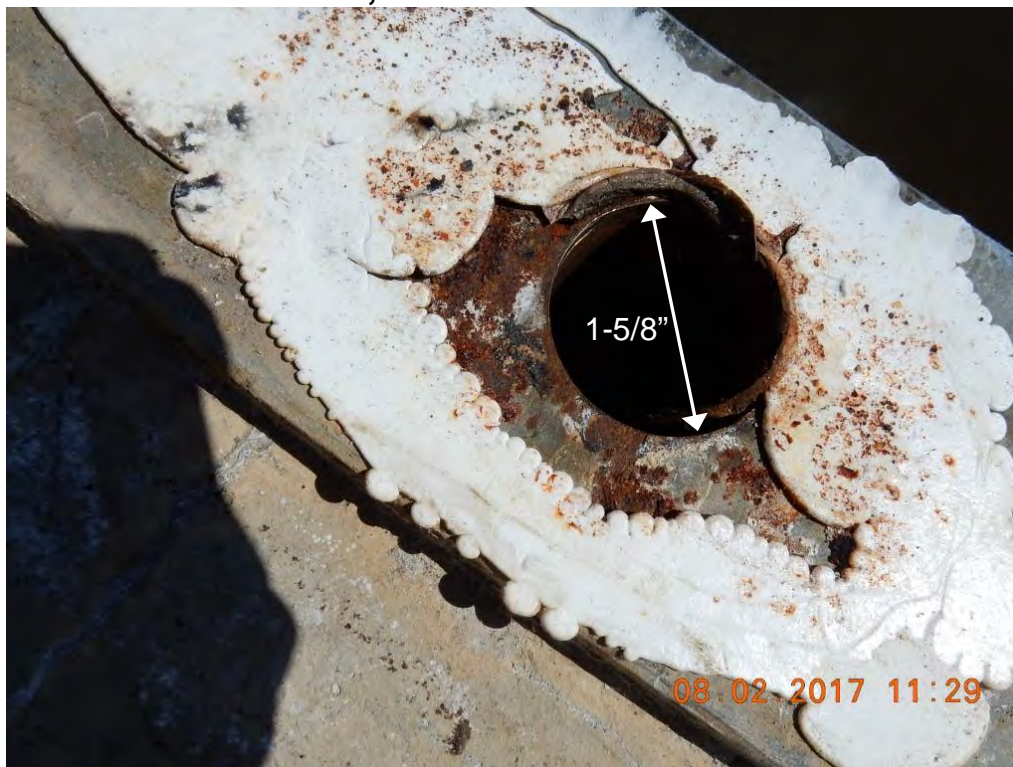
46. Vault lid ring bolt hole #3 corrosion products

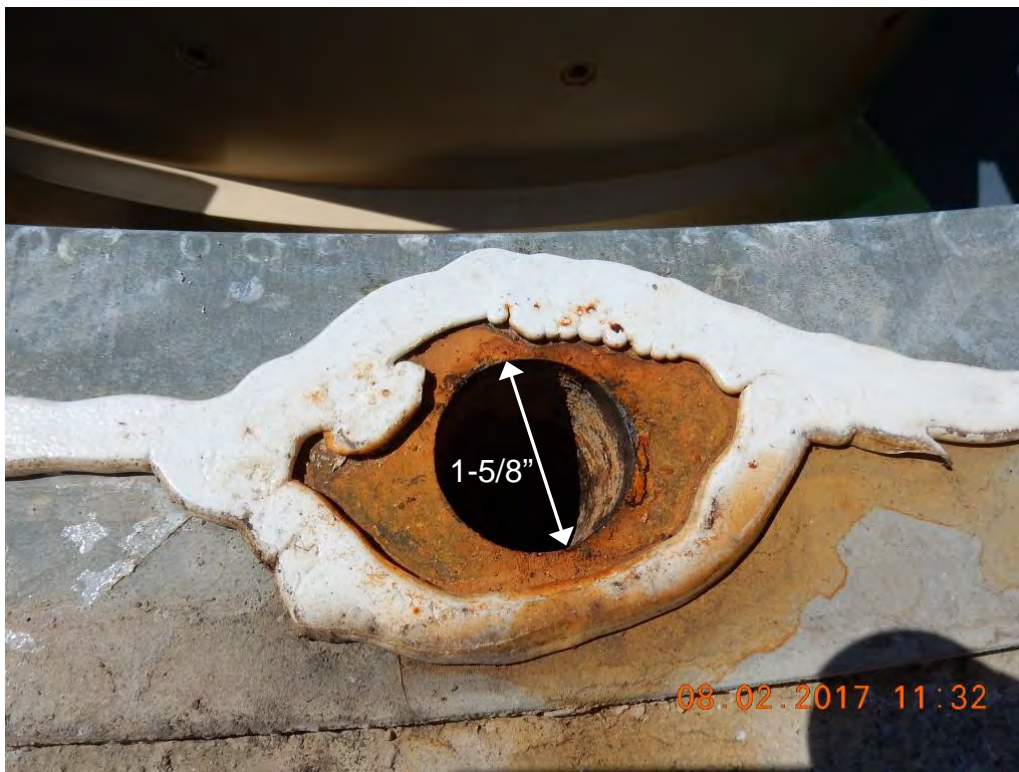
47. Vault lid ring bolt hole #6 corrosion products

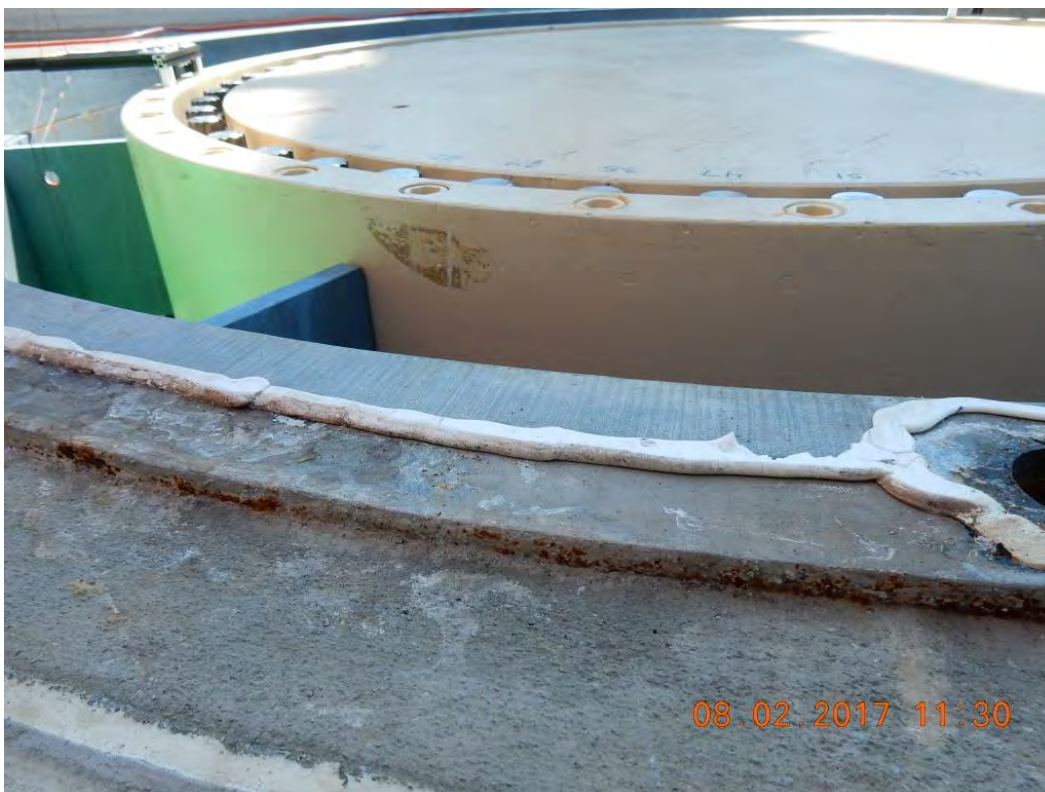
48. Rust at vault lid ring to concrete interface

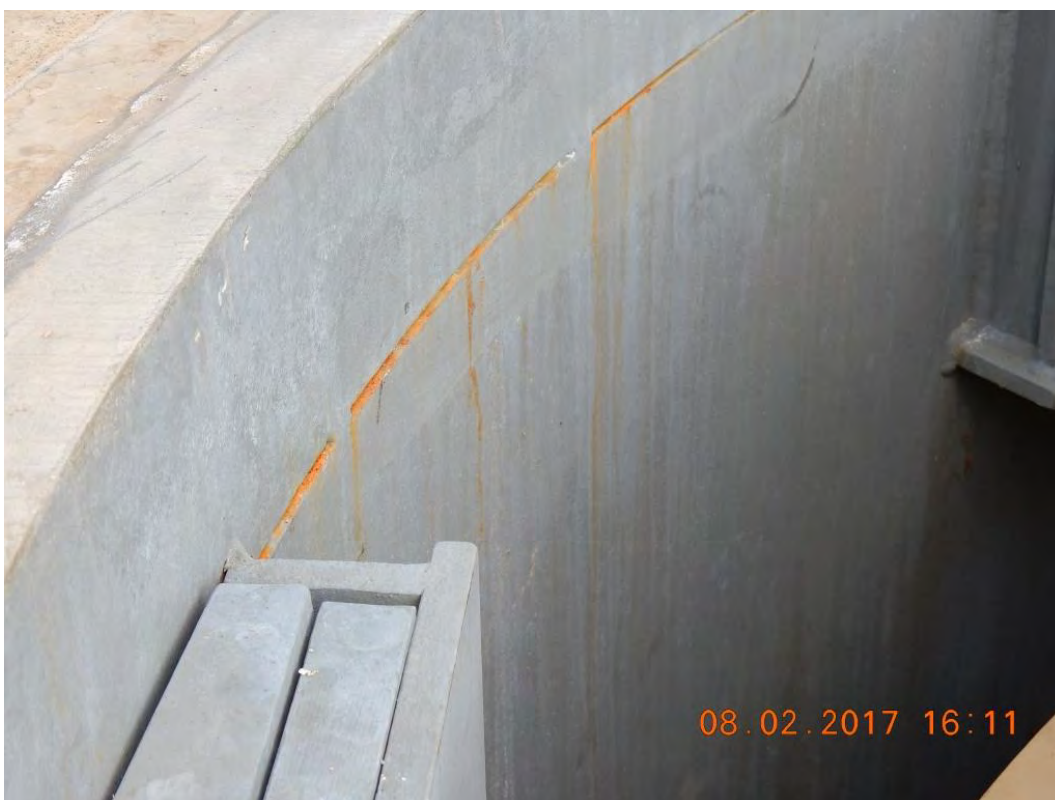
49. Rust staining at vault lid ring to vault liner interface

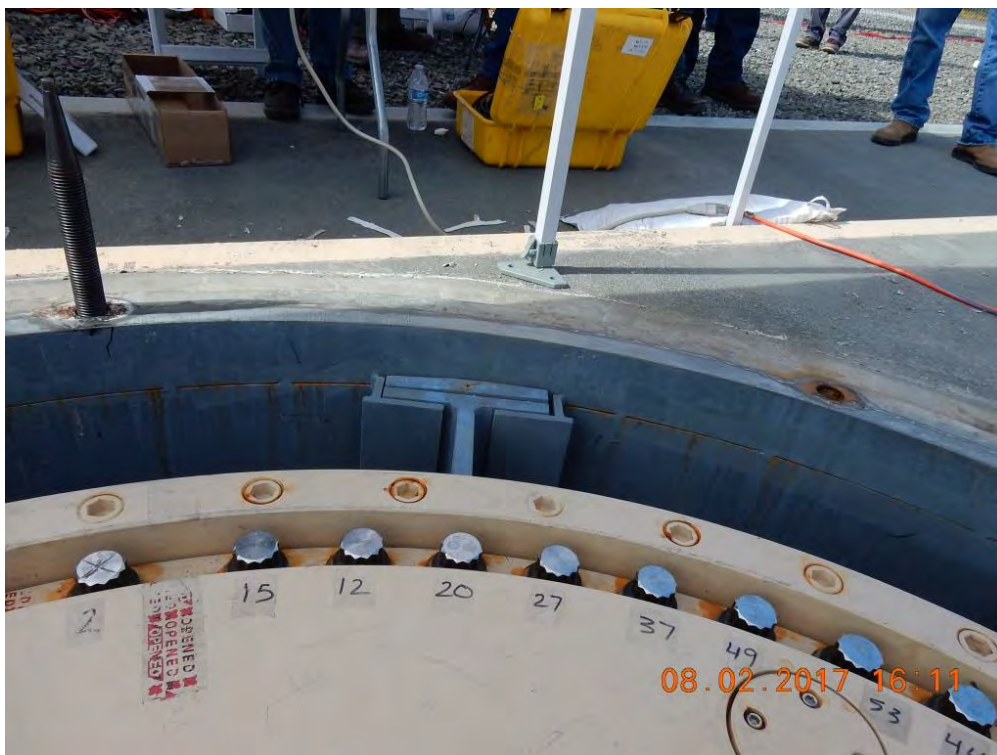
50. Rust staining at vault lid ring to vault liner interface

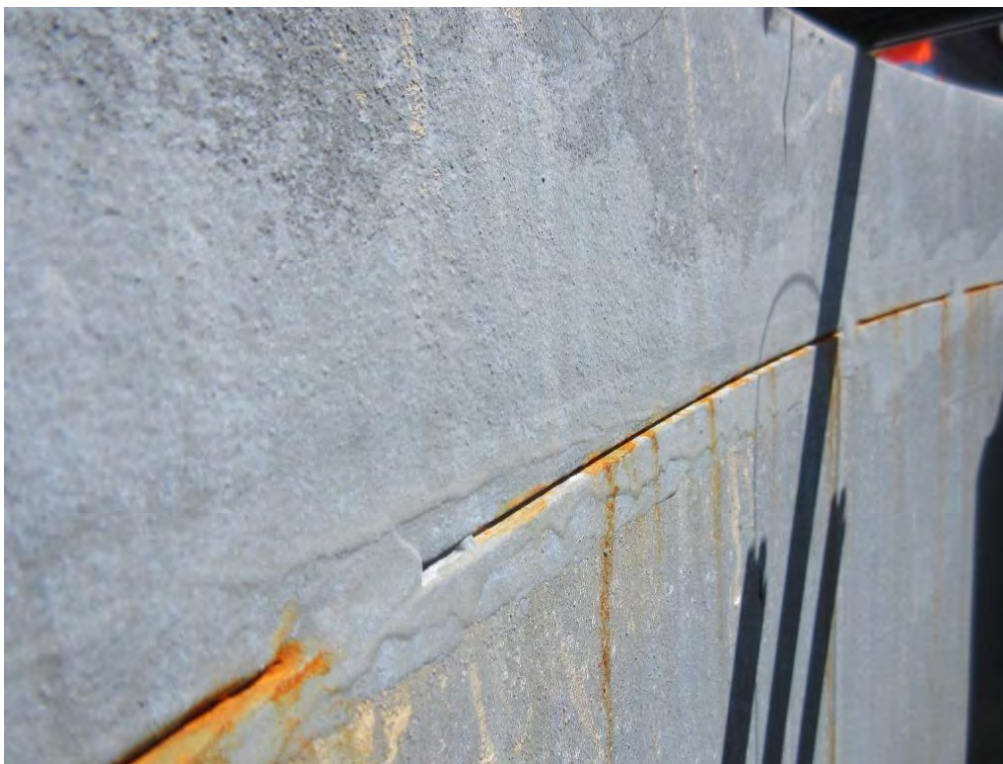
51. Rust staining at vault lid ring to vault liner interface

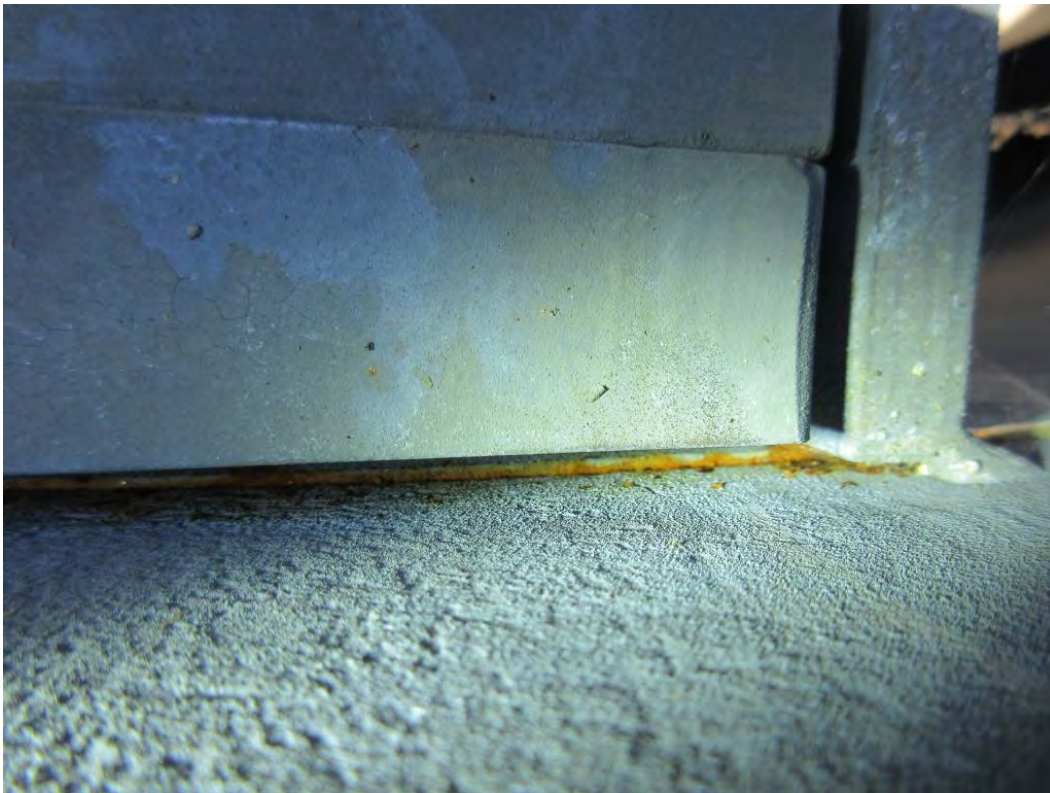
52. Rust staining at vault lid ring to vault liner interface
(view looking down along liner with seismic shim in upper portion of the picture)

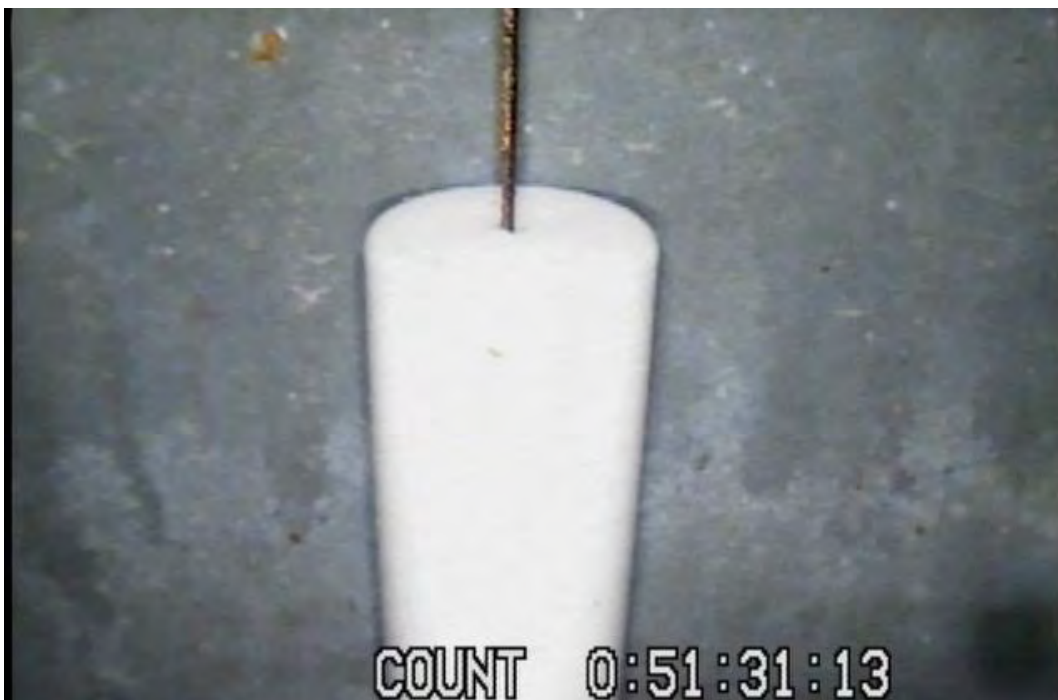
53. Scan 2 rust spot (for size comparison, the wire cable supporting the plumb bob is 1/32" dia.)

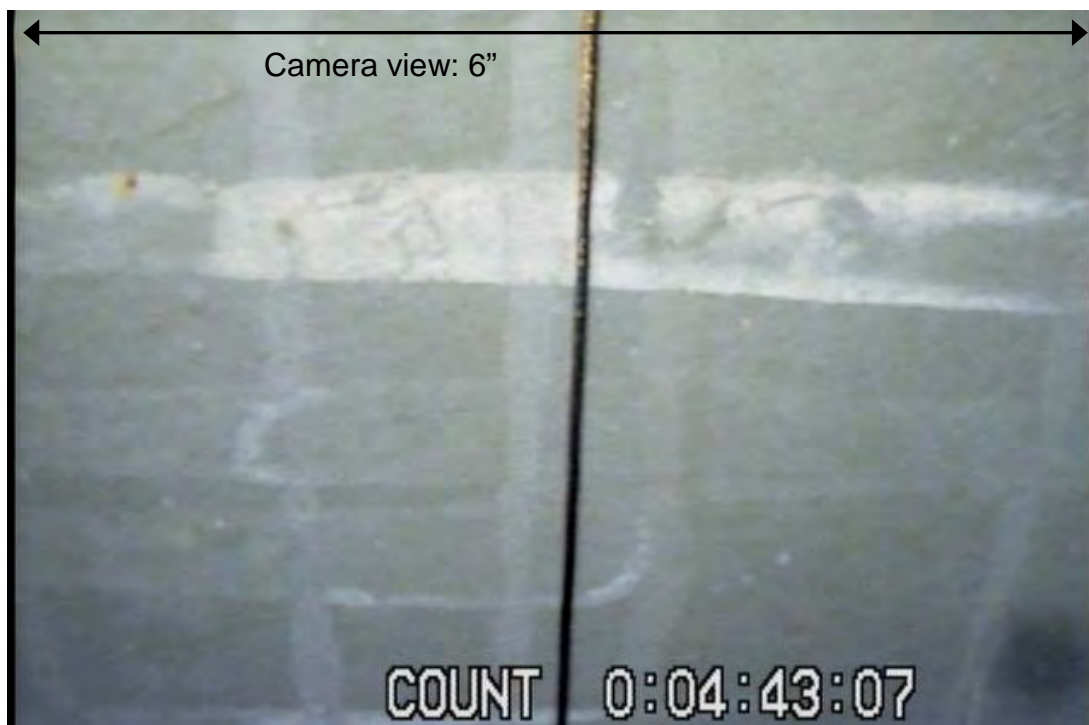
54. Scan 5 rust spot

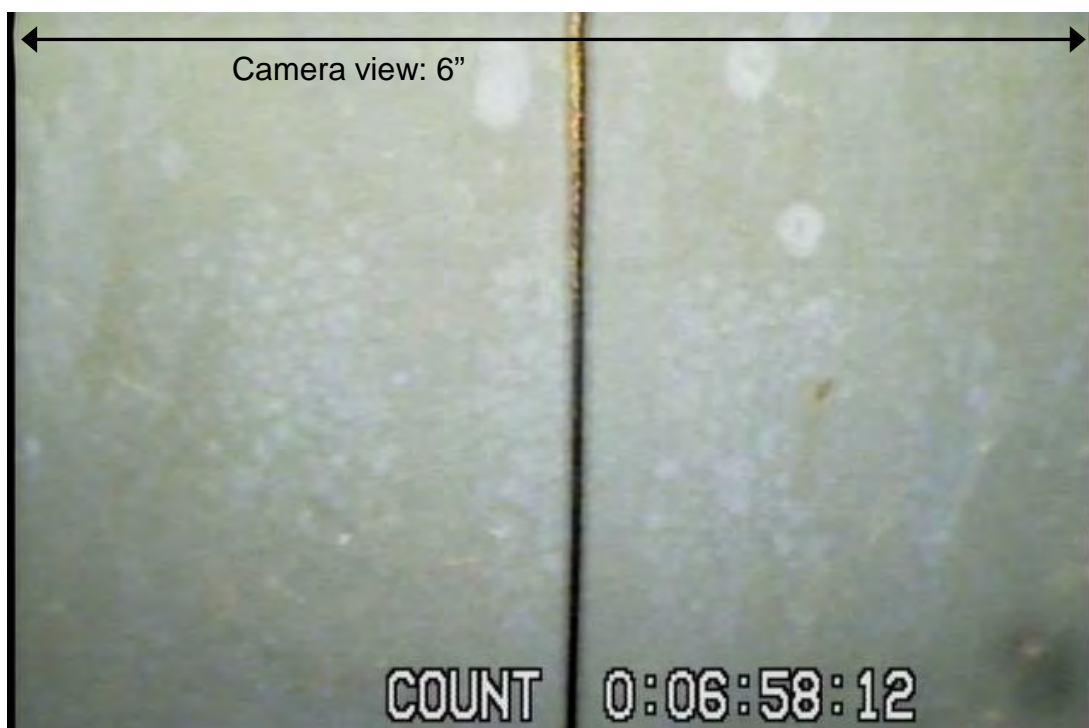
55. Scan 6 rust spot

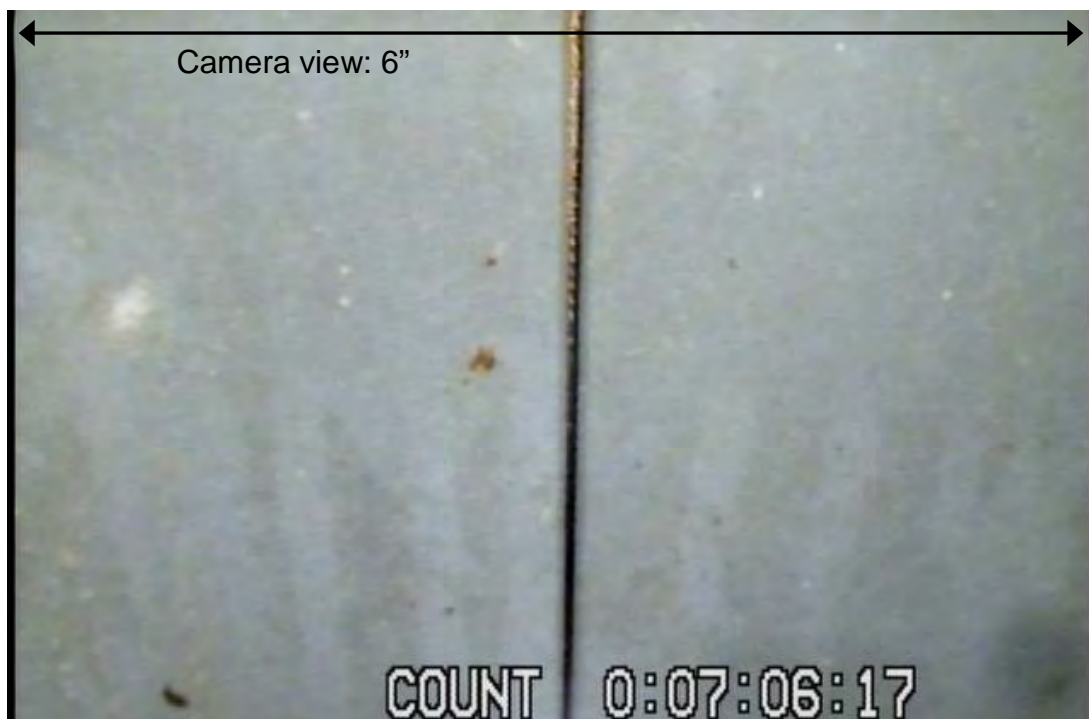
56. Scan 6 rust spots

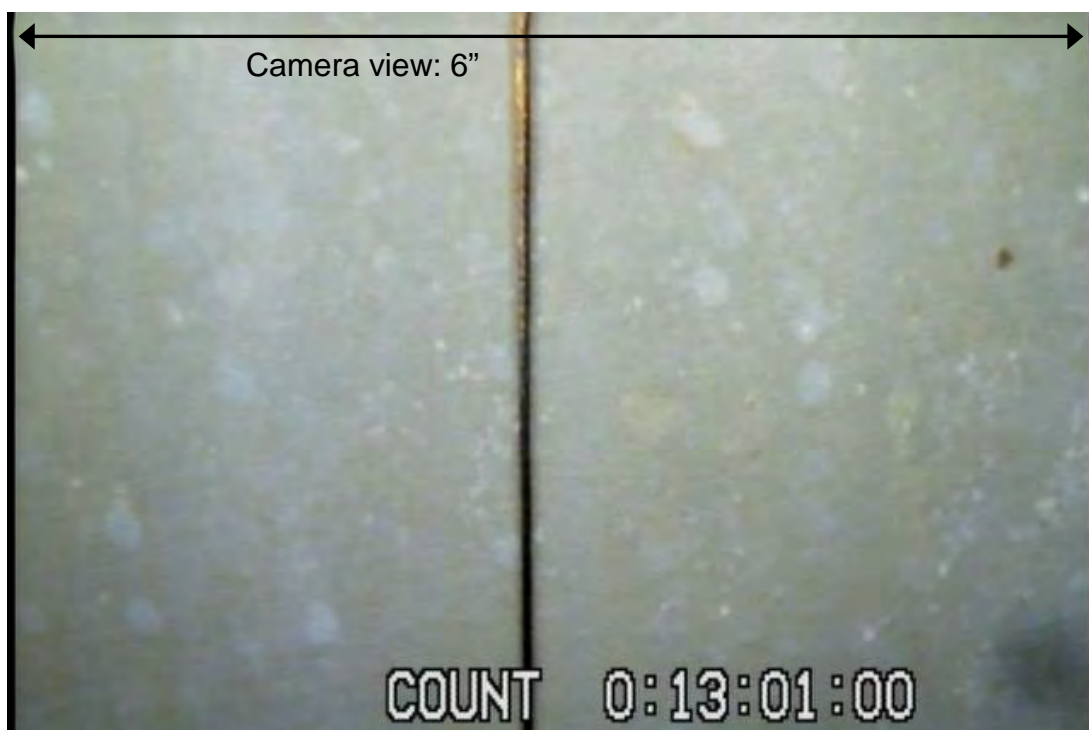
57. Scan 8 rust spot
