Humboldt Bay
Independent Spent Fuel Storage Installation
Site-Specific License Renewal Application

Pacific Gas and Electric Company

Revision 4 November 2019

NRC Docket No. 72-27

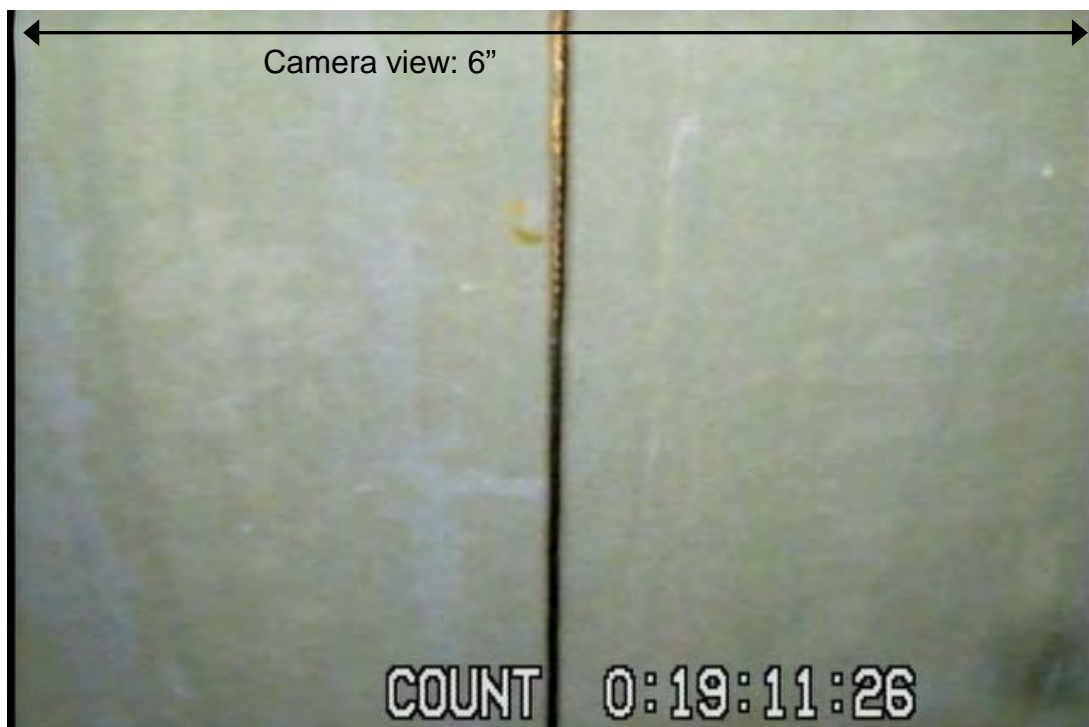
58. Scan 10 rust spot

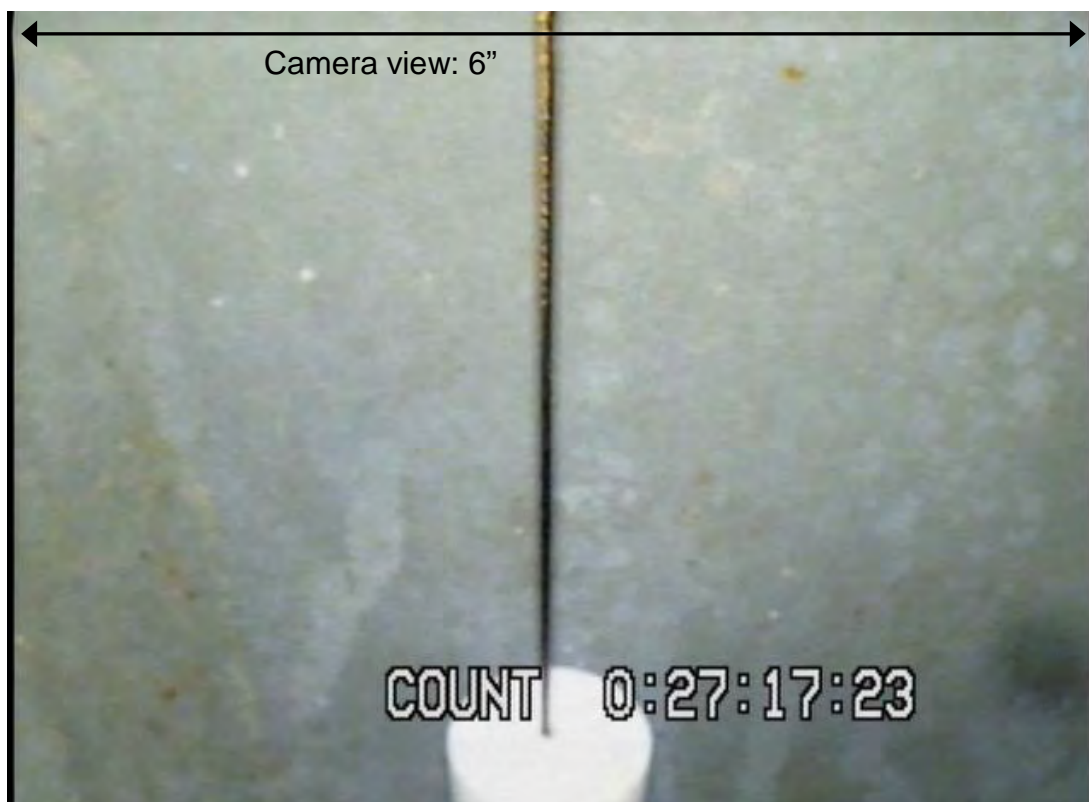
59. Scan 16 rust spot

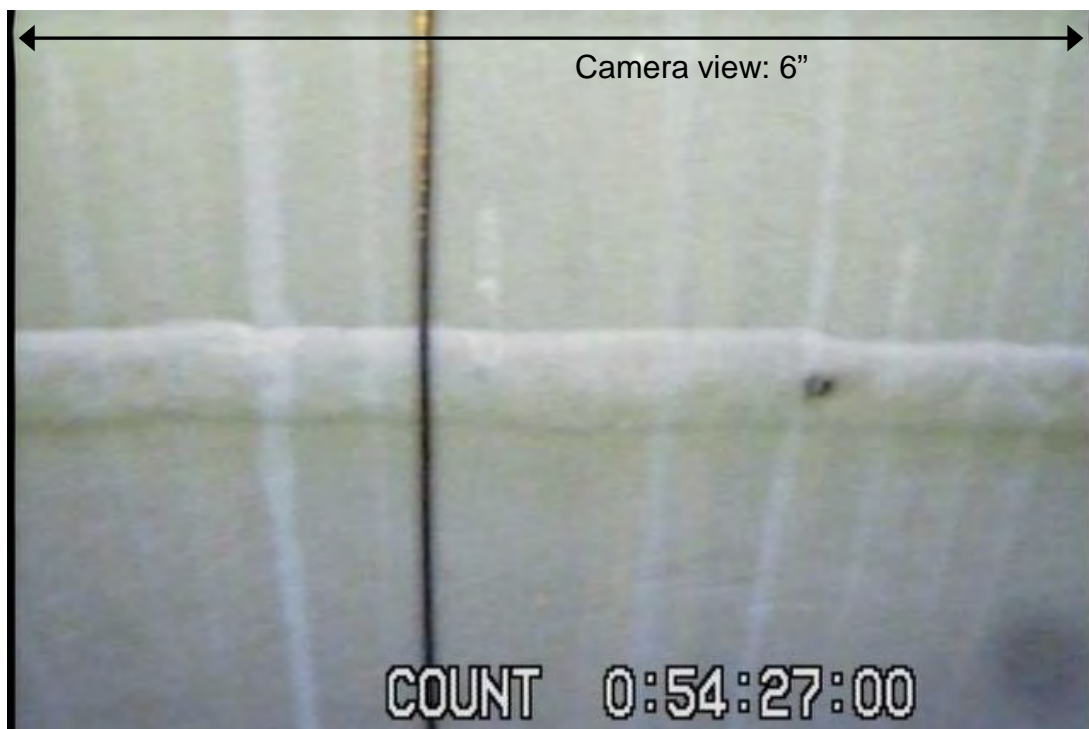
60. Scan 38 Dark spot – possible coating damage – no rust discoloration

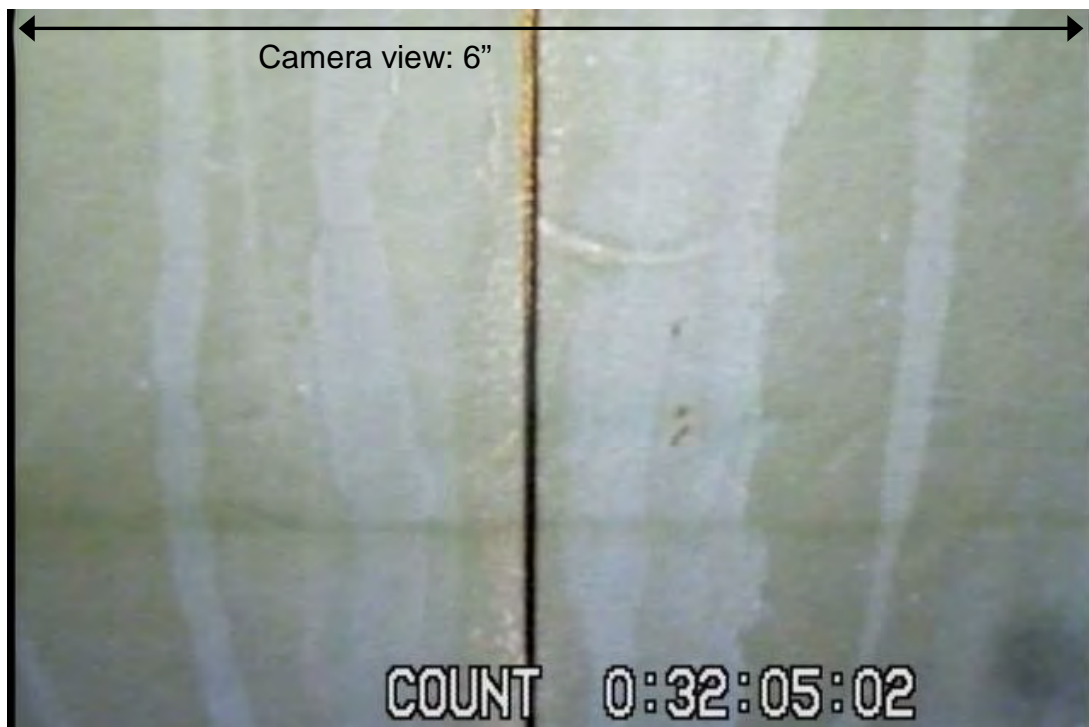
61. Scan 76 rust spots

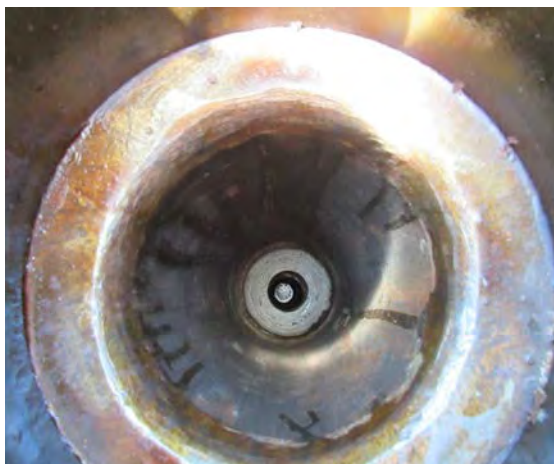
63. Underside of bolting pipe cap showing evidence of condensation

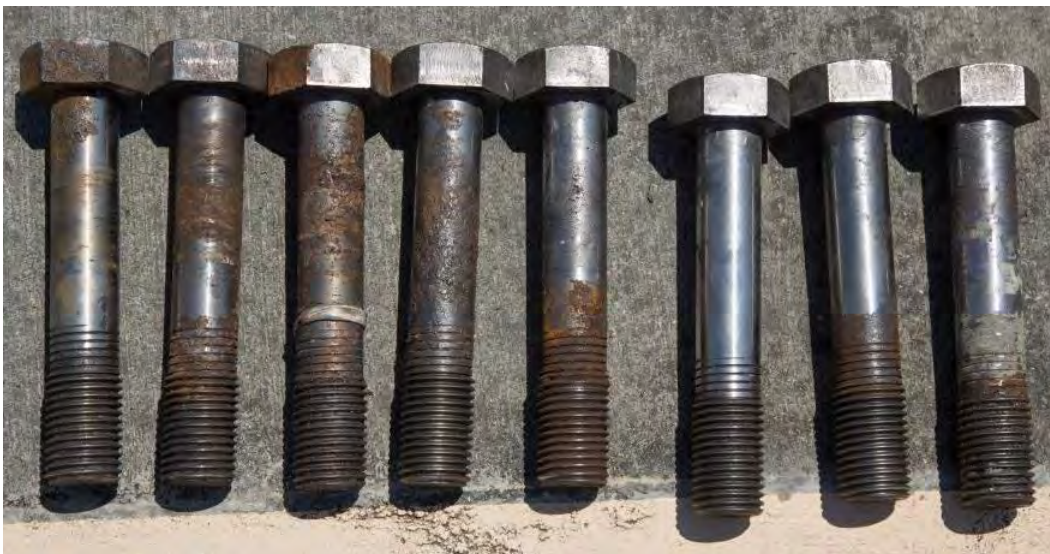
64. Inside lid bolting access hole evidence of moisture intrusion

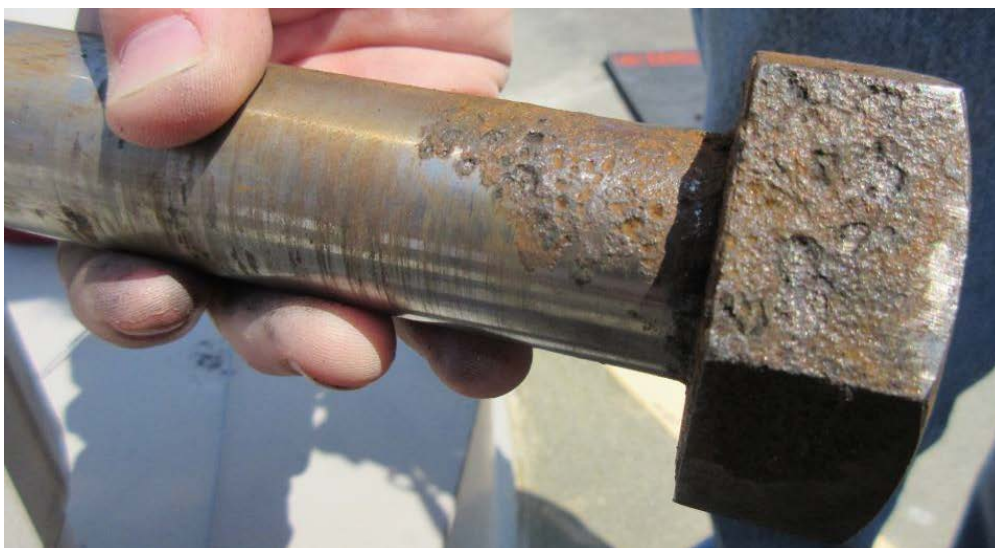
66. Removed bolt following cleaning (pitted bolts replaced)

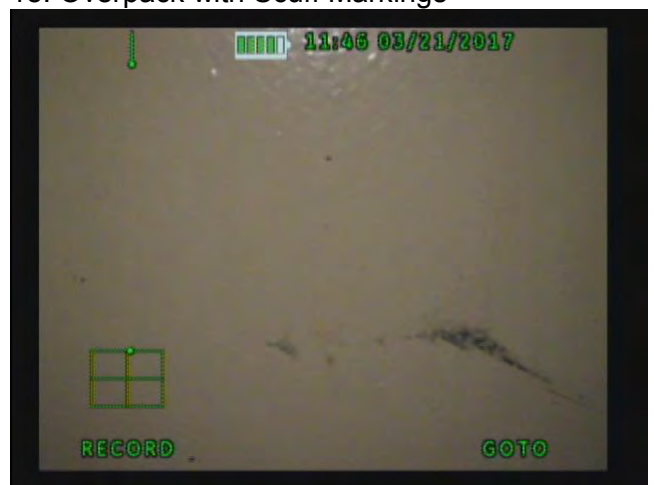
19. Overpack, rust spots

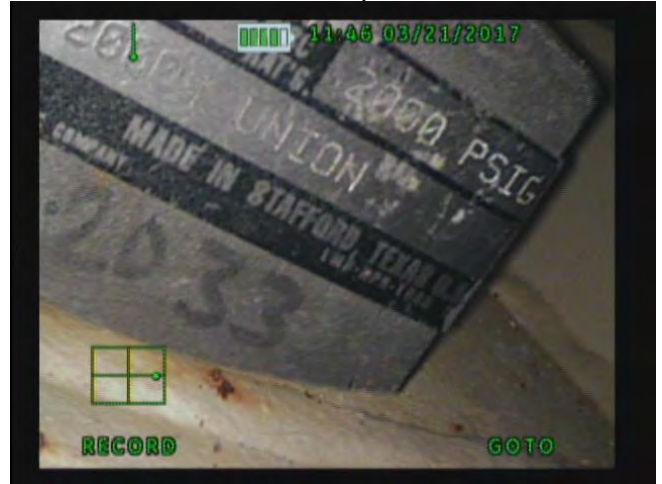
21. Overpack, rust spots
