Subject: 2019 Annual Site Inspection and Monitoring Report for Uranium Mill Tailings  
Radiation Control Act Title II Disposal Sites

Enclosed are six copies of the *2019 Annual Inspection and Monitoring Report for Uranium Mill Tailings Radiation Control Act Title II Disposal Sites*. The report covers the annual inspections of the six Title II disposal sites managed by the U.S. Department of Energy Office of Legacy Management.

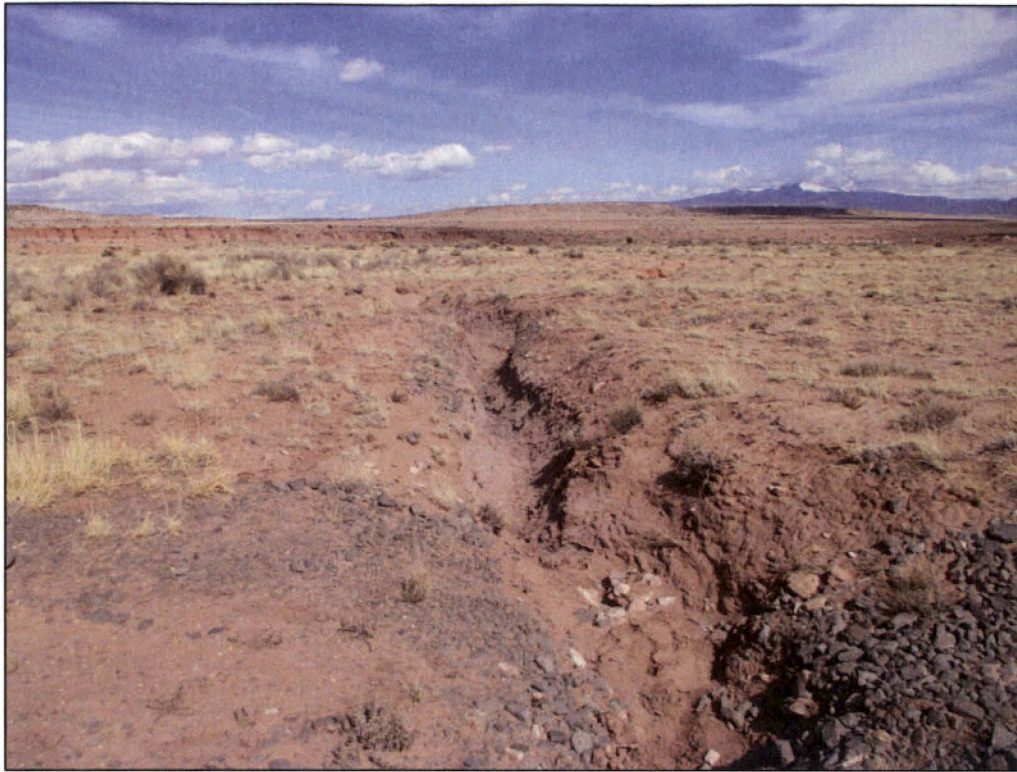
Interior roads used to access LM assets consist of a dirt track covered at places with crushed basalt. The roads are susceptible to erosion and are repaired when they become impassable. Increased erosion continued to be observed on a road northwest of the main tailings disposal cell (PL-1 and PL-2). A gully intersecting the road at this location required maintenance in the past. Riprap previously was added to repair this section of the road; other repair options were evaluated in 2019. LM is proposing to repair the road in 2020 and to construct two armored low-level crossings to protect against future erosion. No other maintenance needs were identified.

*PL-1. Erosion of the Site Perimeter Road (South Area)*

Inspectors also identified the need to repair erosion along the interior road. This work is currently proposed for 2020.

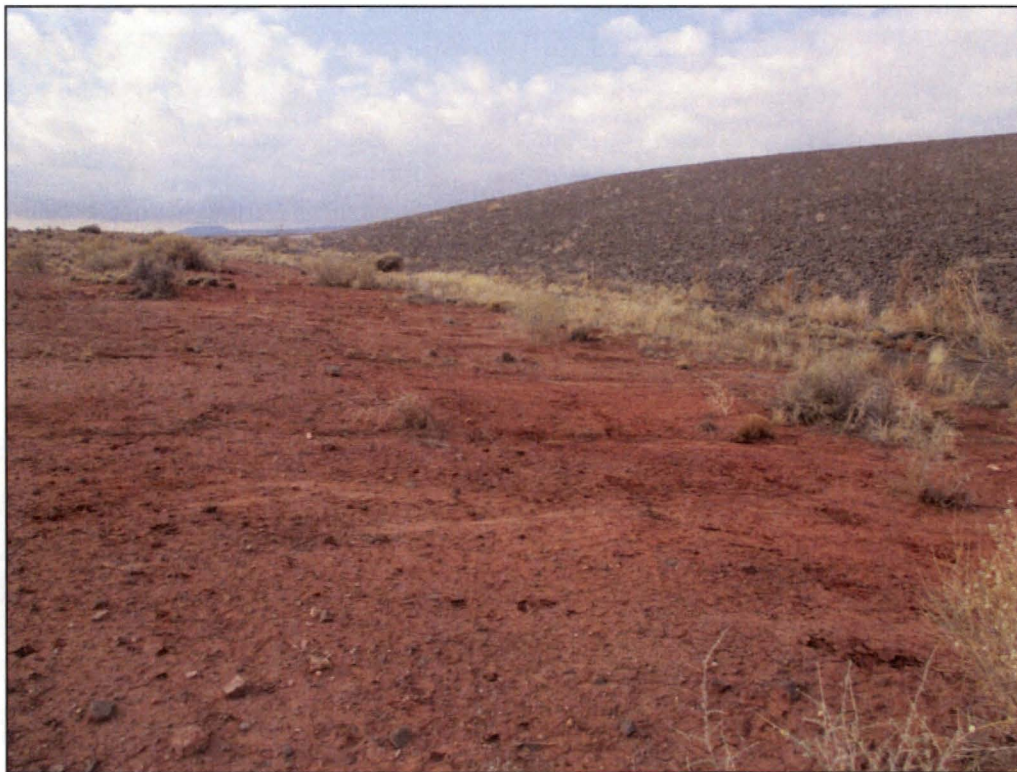
*PL-10. Rills at the Base of the Main Tailings Disposal Cell East Side Slope*

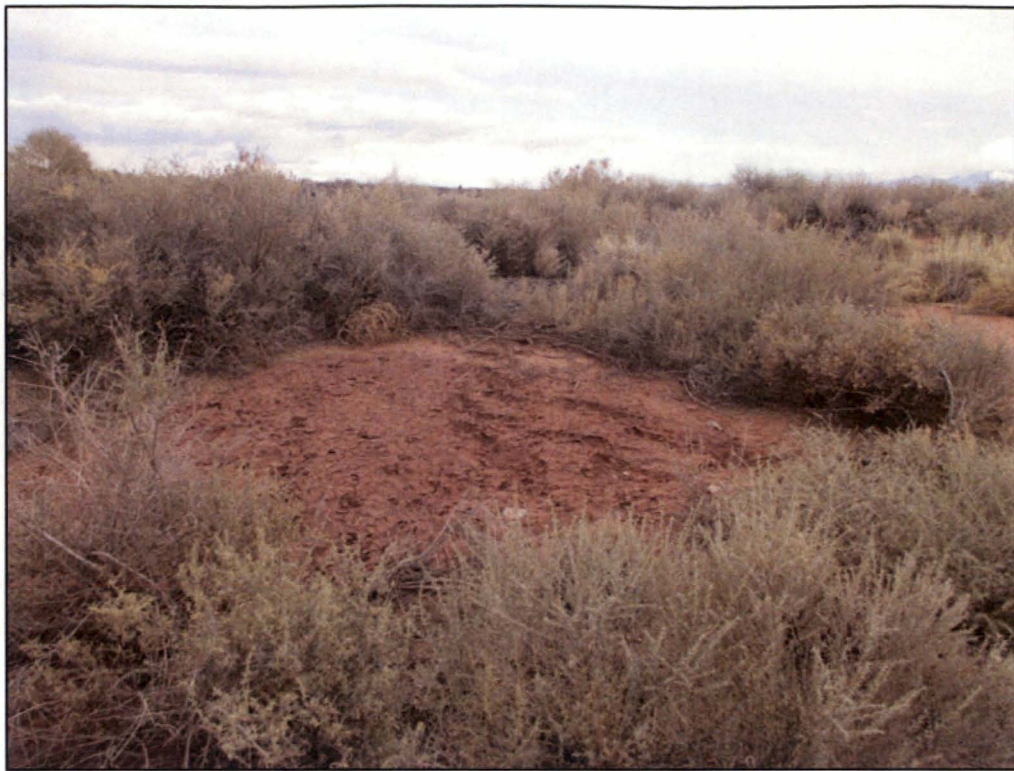
The 2-acre asbestos disposal area is a bowl-like feature just south of the carbonate tailings disposal cell. The north, west, and south side slopes of this feature are covered by limestone riprap; the bottom of the bowl (the asbestos cell cover) is grass-covered. The depressions repaired in May 2018 were observed, and no negative impacts were apparent (PL-13). An additional depression was identified on the north side slope (PL-14). The depression was approximately 6 inches deep and 3 × 6 feet in area. LM will continue to observe the depression and make repairs as necessary. No immediate maintenance needs were identified.

*PL-13. Area of Depression Repaired in the Asbestos Disposal Area*

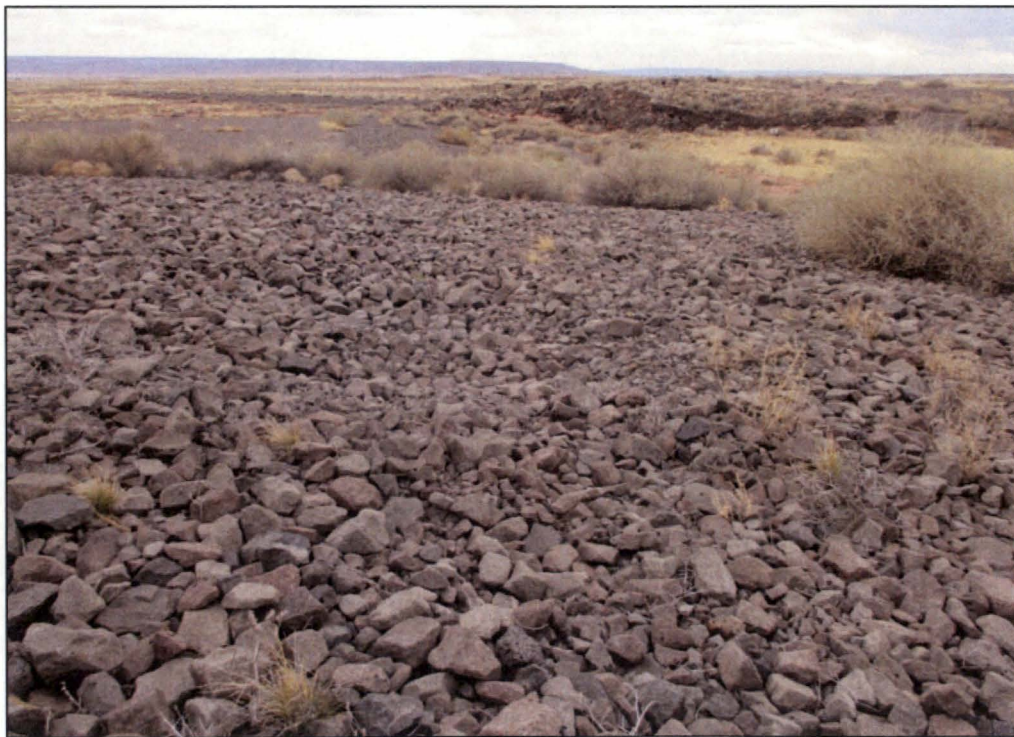
*PL-14. Minor Depression on the Asbestos Disposal Area North Side Slope*

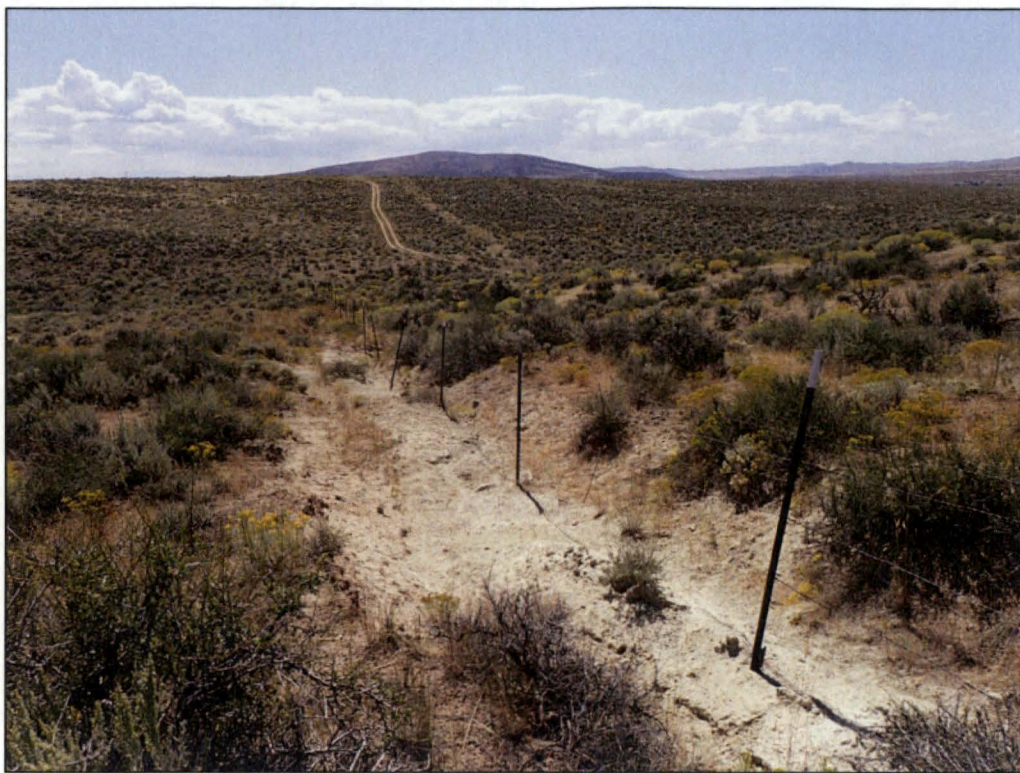
*PL-1. Erosion Along Southwest Perimeter Fence*

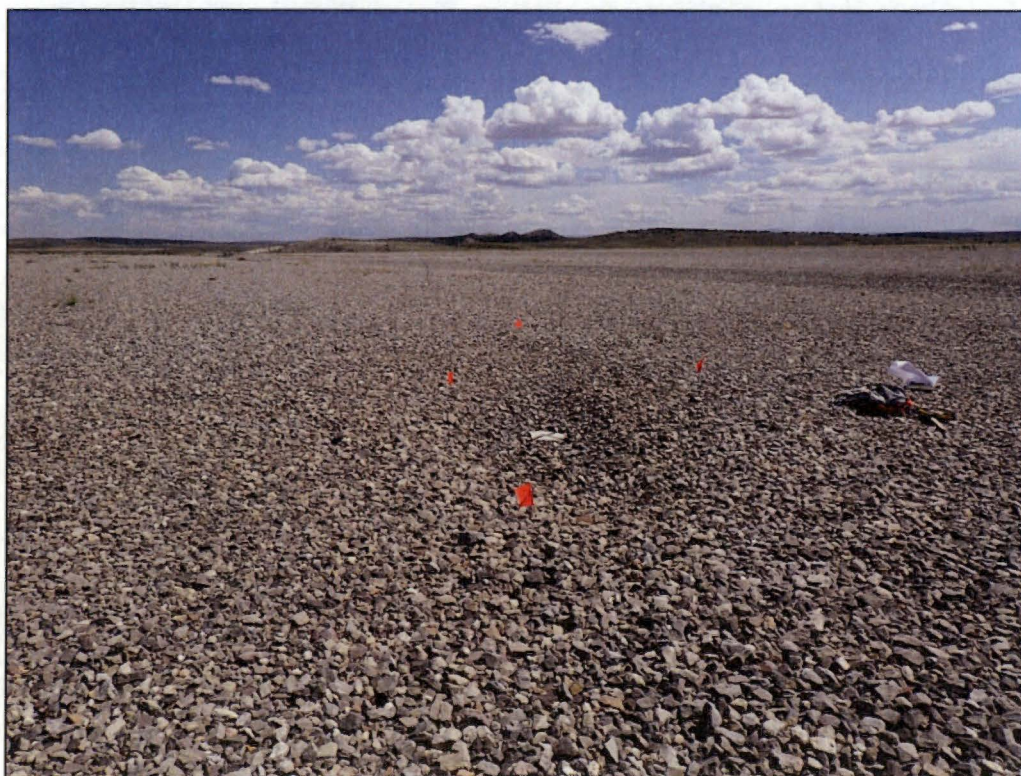
*PL-6. Depression Feature on Top of Disposal Cell*

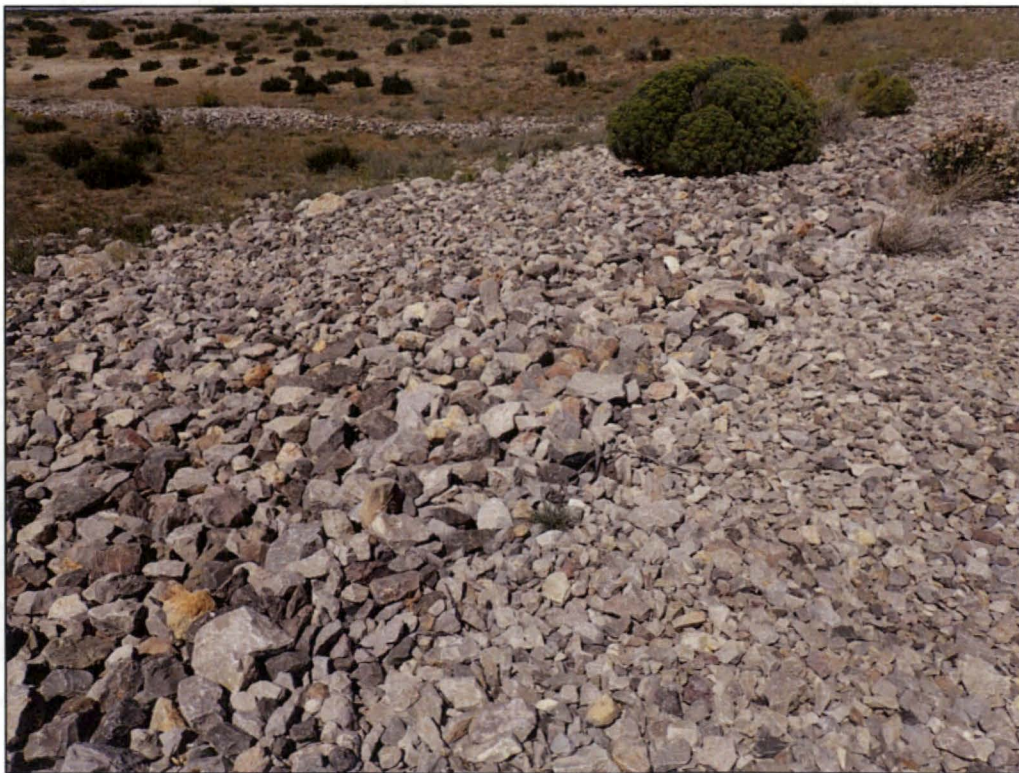
*PL-12. Ancillary Cell West Side Slope with Small Depression on Cell Top Slope in Foreground*

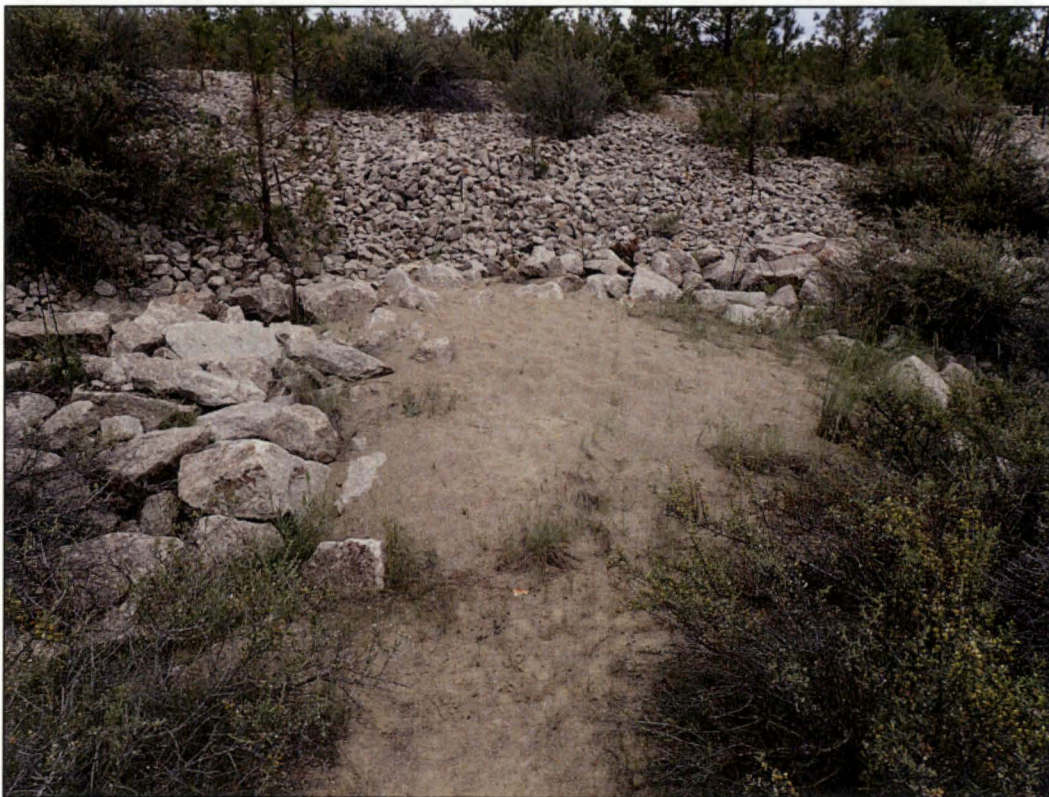
*PL-8. Sand Deposit at Toe of Containment Dam Outslope*

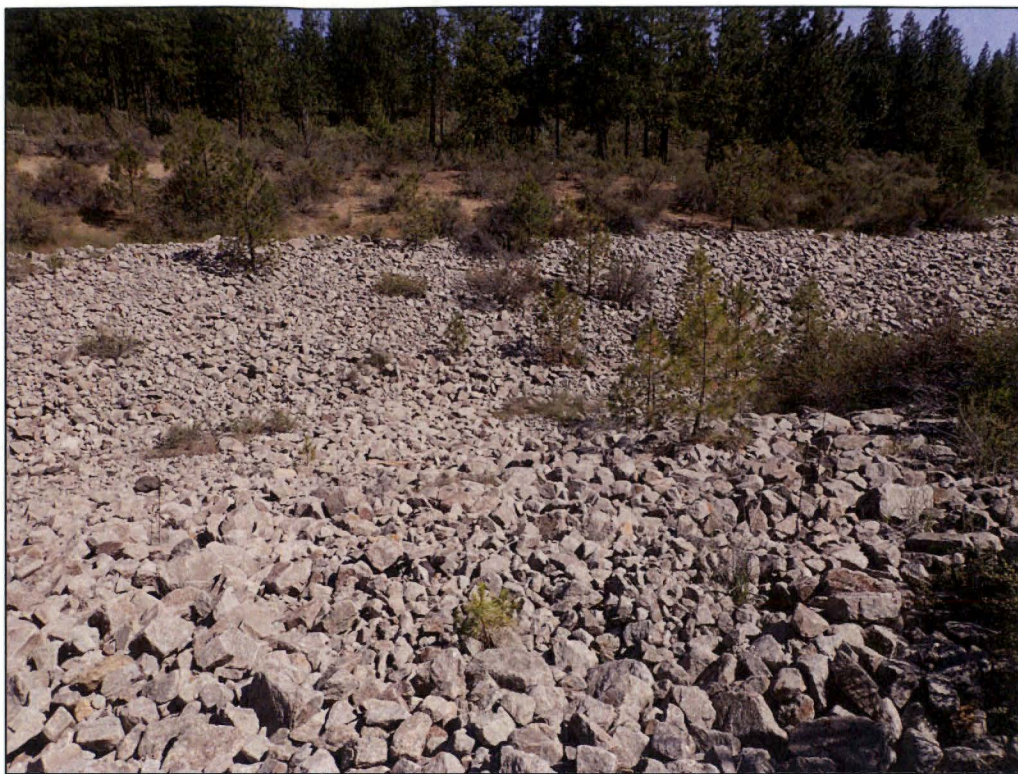
*PL-9. Vegetation in Diversion Channel*

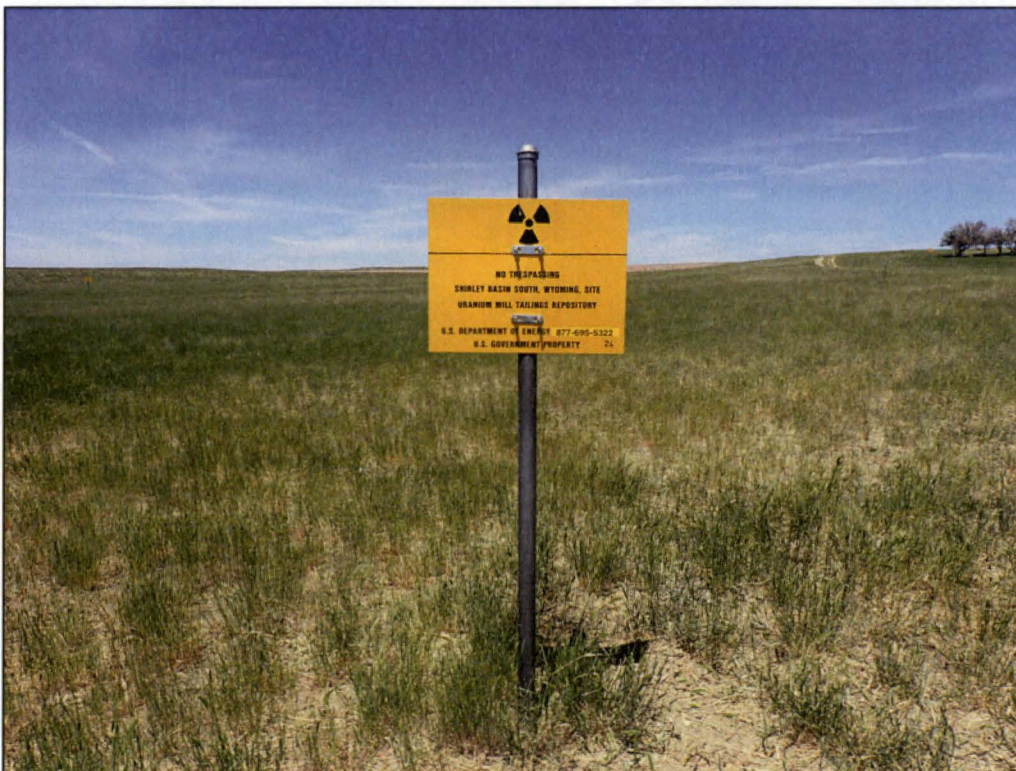
*PL-2. Perimeter Sign P26 (Entrance Sign, Replaced)*

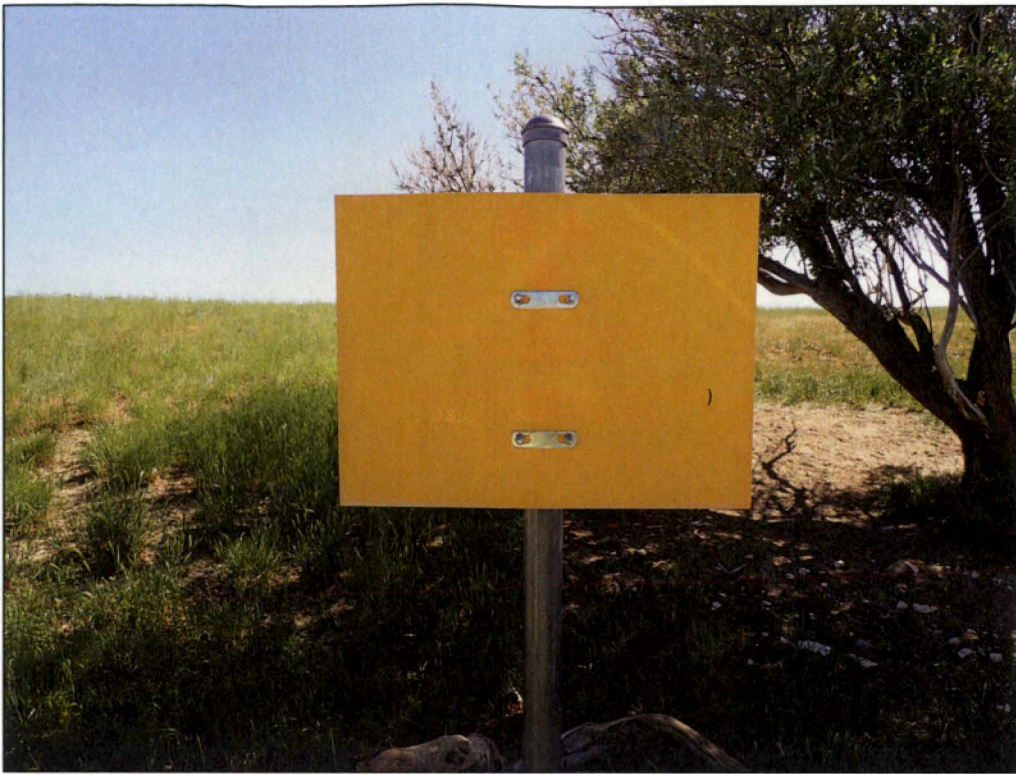
*PL-3. Perimeter Sign P3 (Illegible, Replaced)*
