## RESEARCH REACTOR CENTER

SUBJECT: Written communication as required by University of Missouri Research Reactor  
Technical Specification 6.6.c(3) regarding a deviation from Technical Specifications  
3.2.a and 3.2.f.8.

**Licensee Event Report No. 19-06 – December 10, 2019**  
**University of Missouri Research Reactor**

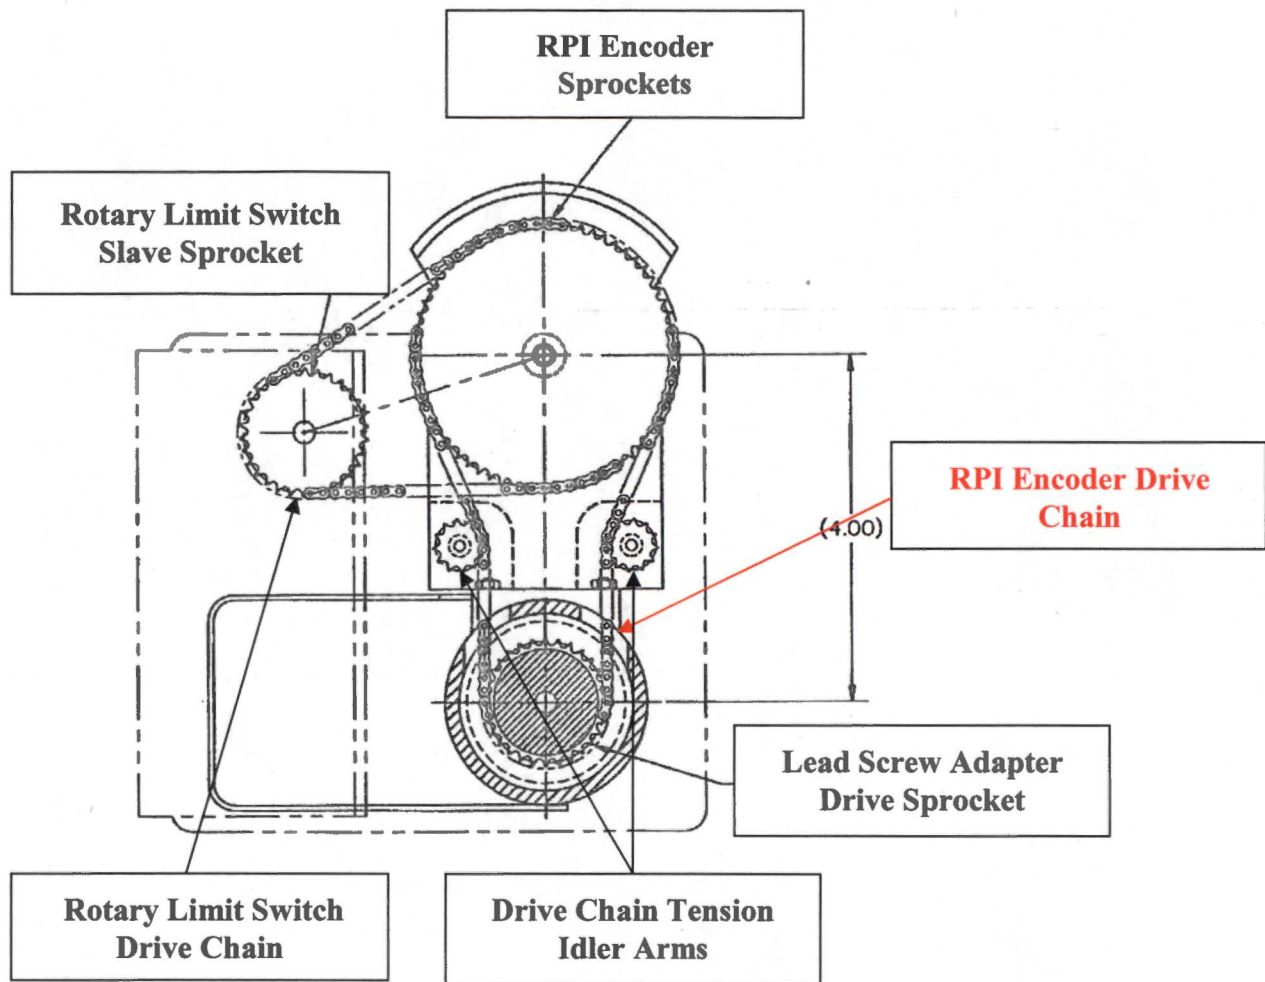
## Regulating Blade Drive Assembly

After the manual scram was initiated, a reactor operator was directed to the reactor bridge to inspect the shim and regulating blade drive mechanisms. It was discovered that the RPI encoder drive chain had fallen off of the regulating blade drive mechanism lead screw adapter drive sprocket. Further investigation revealed that the drive chain had fallen off at a regulating blade height of 13.50 inches while the regulating blade had continued to move in the outward direction in response to the output signal from the NI WRM, since it was discovered that the regulating blade was fully withdrawn at a height of 26.00 inches when the reactor was manually shut down. As described above, the RPI encoder drive chain is not part of the automatic control circuit; therefore, even with the drive chain not connected to the regulating blade drive mechanism lead screw adapter drive sprocket the regulating blade will still reposition in response to the WRM output signal to the servomotor.

After placing the RPI encoder drive chain back on its associated sprockets and idler arms, the drive chain was adjusted for proper alignment and tension.
