RBG-47985

Subject: Licensee Event Report 50-458 / 2019-004, "Potential Loss of Safety Function for all ADS (Automatic Depressurization System) Valves".  
River Bend Station, Unit 1  
NRC Docket No. 50-458  
Renewed License No. NPF-47

<b>4. Title</b> Potential Loss of Safety Function for all ADS (Automatic Depressurization System) Valves.
--

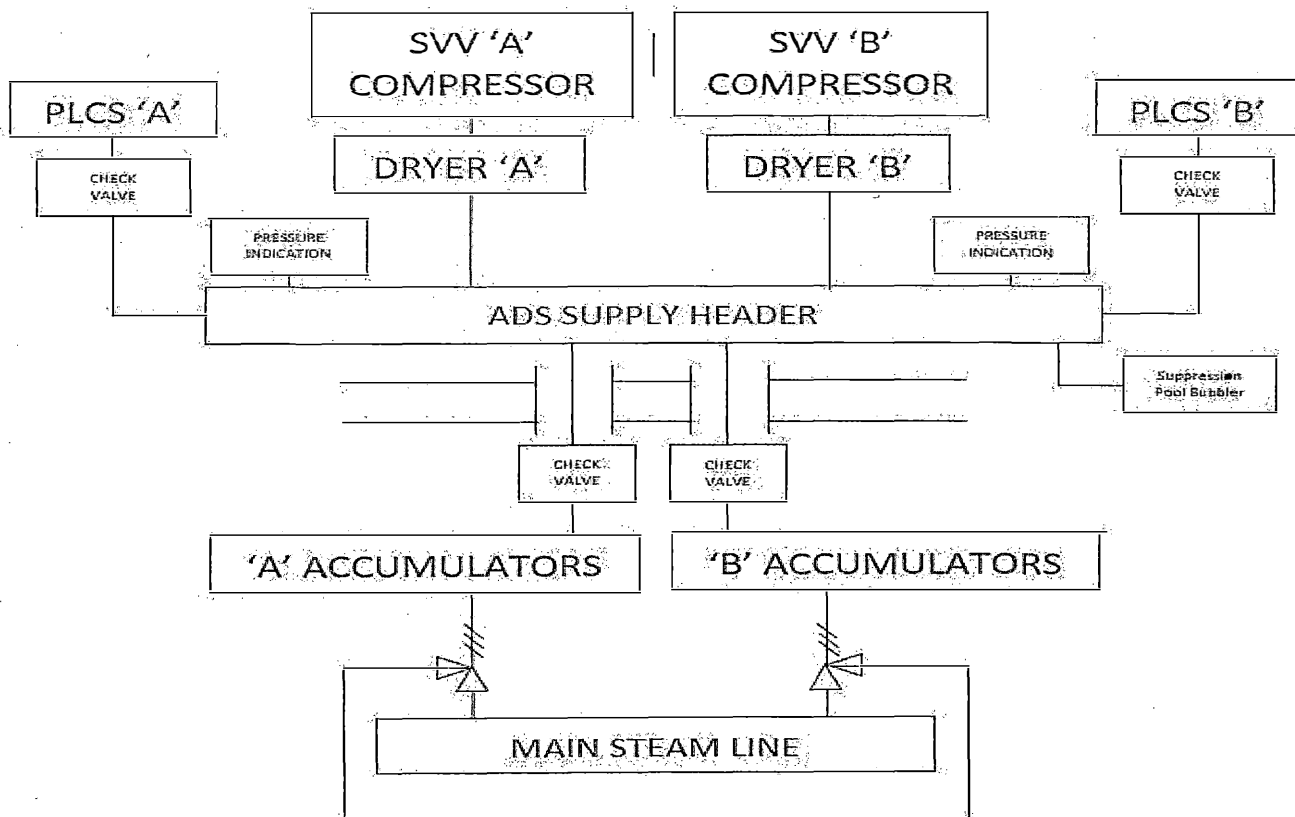
This illustration provided for basic understanding of ADS.

In addition, the portion of the ADS supply header where pressure is sensed is bounded by check valves which isolate the ADS Supply Header and the ADS accumulators. As header pressure began to lower, air pressure was contained within the piping and accumulators bounded by these check valves. ADS Supply Header pressure lowered due to the identified leaks in the 'B' Train ADS and as a result of air supplied to the Suppression Pool Level Transmitter Bubbler as seen in illustration provided.
