UNIVERSITY of MISSOURI

RESEARCH REACTOR CENTER

SUBJECT: Written communication as required by University of Missouri Research Reactor
Technical Specification 6.6.c(3) regarding a deviation from Technical Specifications
3.2.a and 3.2.f.8.

Licensee Event Report No. 19-07 – December 19, 2019
University of Missouri Research Reactor

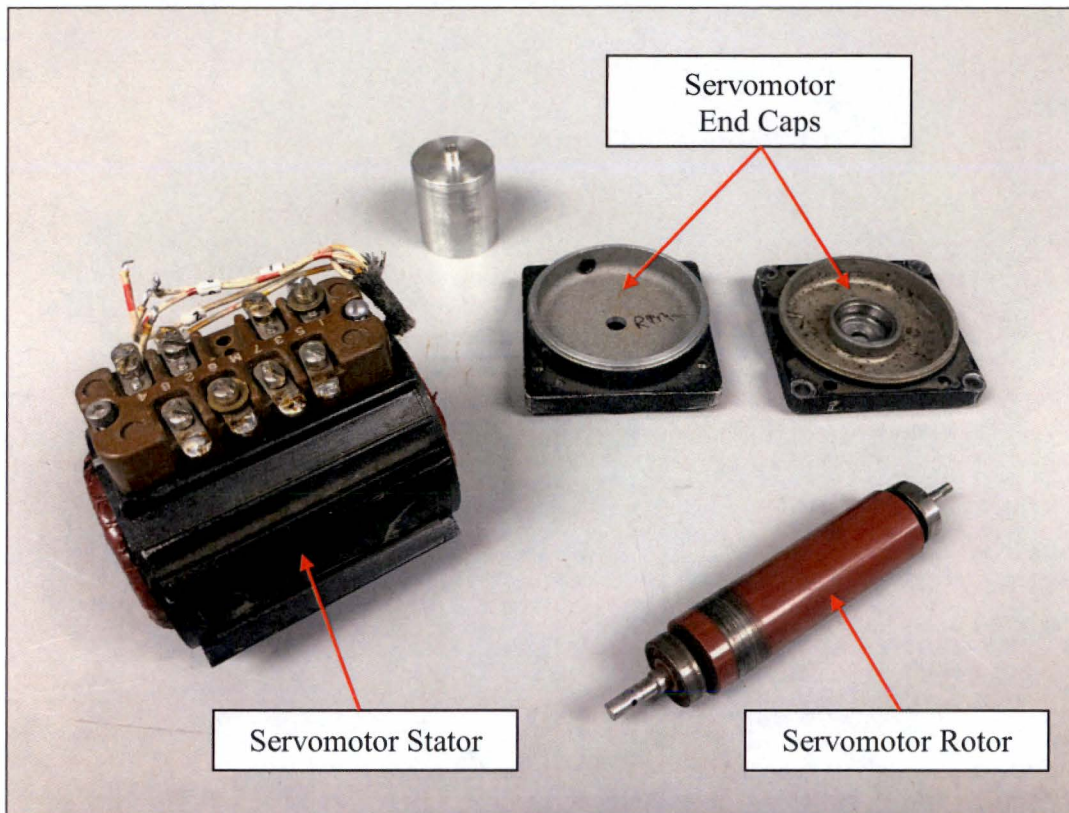
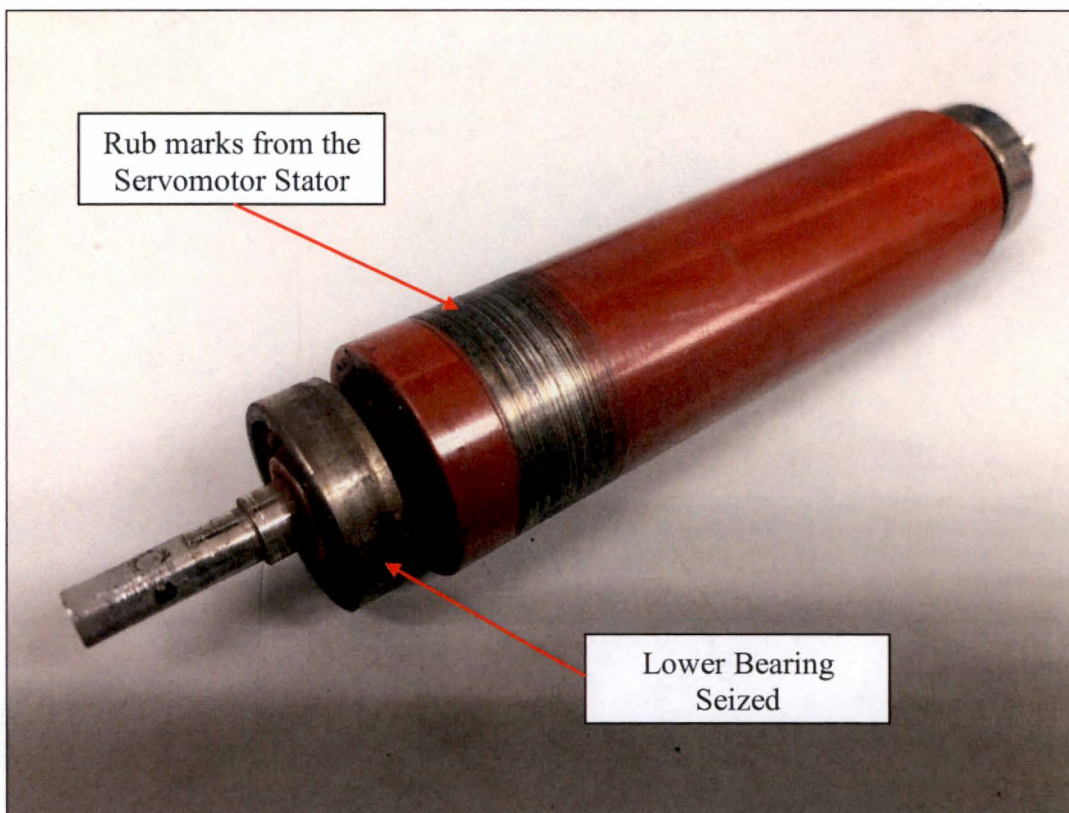
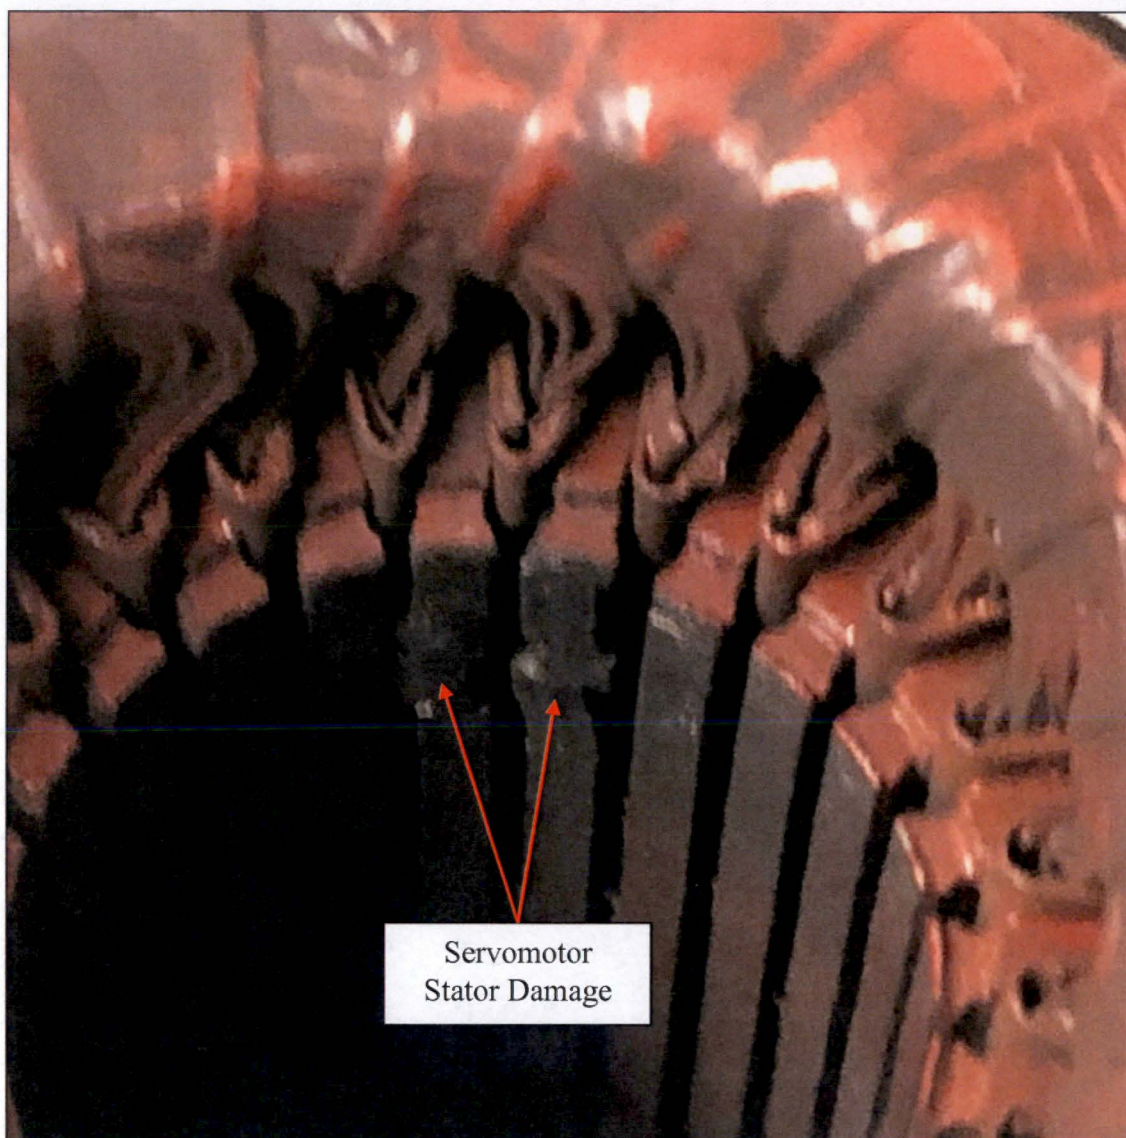
The reactor was shut down by manual scram when it was determined that the regulating blade was inoperable. The regulating blade drive mechanism was removed and transferred to the Instrumentation Support shop for inspection and troubleshooting. It was determined that the regulating blade drive mechanism servomotor had seized – see photos on pages 6 and 7. The lower rotor bearing would not rotate and there were circular rub marks on the lower 1/3rd of the rotor which were caused by the stator as the bearing failed. The last photo shows damage to the servomotor stator from the rotor. The current servomotor is a Diehl Manufacturing Company Model No. F 12004, 115V, 60 Hz, 25 Watts.

Failed Regulating Blade Drive Mechanism Servomotor Disassembled

The servomotor for the regulating blade drive mechanism was replaced with a brand new one and the drive mechanism was cycled across its full range 10 times in a test stand prior to re-installation. The regulating blade drive mechanism was then reinstalled and connected to the regulating blade. The regulating blade was cycled across its full range two (2) times prior to pre-startup checks. No visual or audible abnormalities with the chain, sprockets, shafts, RPI, or rotary switch assembly operation were noted during these cycle tests.
