April 9, 1981  
Fort St. Vrain  
Unit No. 1  
P-81119

REPORTABLE OCCURRENCE 81-022  
ISSUE 0  
Page 1 of 4

FORT ST. VRAIN NUCLEAR GENERATING STATION  
PUBLIC SERVICE COMPANY OF COLORADO  
16805 WELD COUNTY ROAD 19 1/2  
PLATTEVILLE, COLORADO 80651

REPORT NO. 50-267/81-022/03-L-0

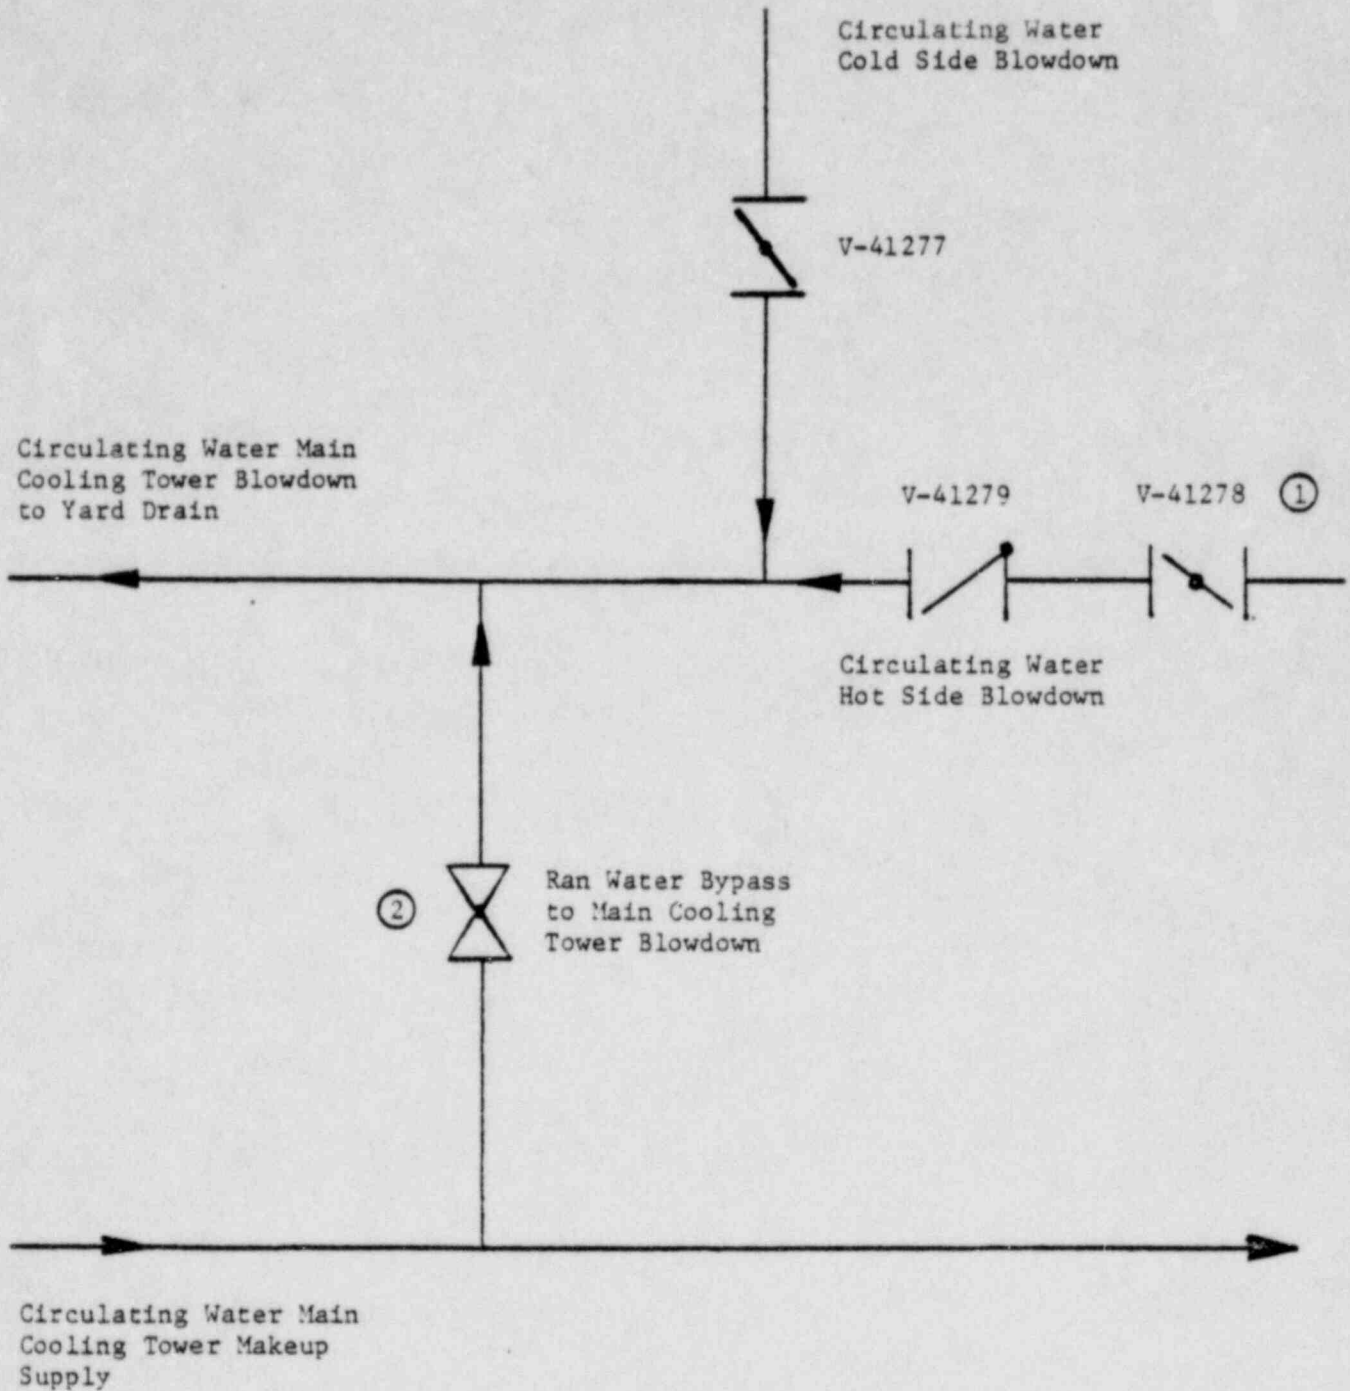
FIGURE 1

On several previous occasions, the non-radioactive liquid effluent has exceeded the LCO NR 1.1 limit for residual chlorine. These events were reported in Reportable Occurrences 79-61, 80-28, and 81-004. Because of the difficulty in obtaining the exact chlorination required by the system, plant operations have been modified to include closing the blowdown discharge valve (1) (see Figure 1) from the circulating water system during chlorination to prevent inadvertent discharge of any high residual chlorine to the Goosequill ditch. To maintain minimum blowdown rate requirements during the chlorination, the raw water bypass valve (2) was opened to make up the lost flow.

On Friday, February 20, 1981, this was done during the regular chlorination of the circulating water system; however, following the chlorination, the blowdown discharge valve (1) was not re-opened. This resulted in the continued concentration of total dissolved solids in the circulating water system due to evaporation. The circulating water system was sampled Tuesday, February 24, 1981, and the total dissolved solids were found to be high. The blowdown valve (1) was fully opened, and the blowdown of the circulating water system continued at this rate for approximately two hours when it was noted that the Goosequill total dissolved solids was 3175 parts per million was in excess of the LCO NR 1.1 limit of 2300 parts per million. The blowdown rate was adjusted to reduce the total dissolved solids being discharged to the plant effluent and the liquid effluent was within required chemical limits by the next shift. The blowdown was continued and has maintained the total dissolved solids within acceptable limits. The water discharged to the Goosequill ditch during this event followed the regular discharge

1. Excessive build-up of total dissolved solids in the circulating water system between February 20 and 24, 1981, due to no system blowdown during this period.
2. The following blowdown of the systems on Tuesday, February 24, 1981, at a rate greater than the dilution capability of the Goosequill ditch flow.

Circulating water system blowdown was adjusted to a lower rate, and the total dissolved solids returned to acceptable values by the time of the next sample.
