# Public Service Company of Colorado

April 9, 1981  
Fort St. Vrain  
Unit No. 1  
P-81117

REPORTABLE OCCURRENCE 79-05

REPORT NO. 50-267/79-05/03-X-1

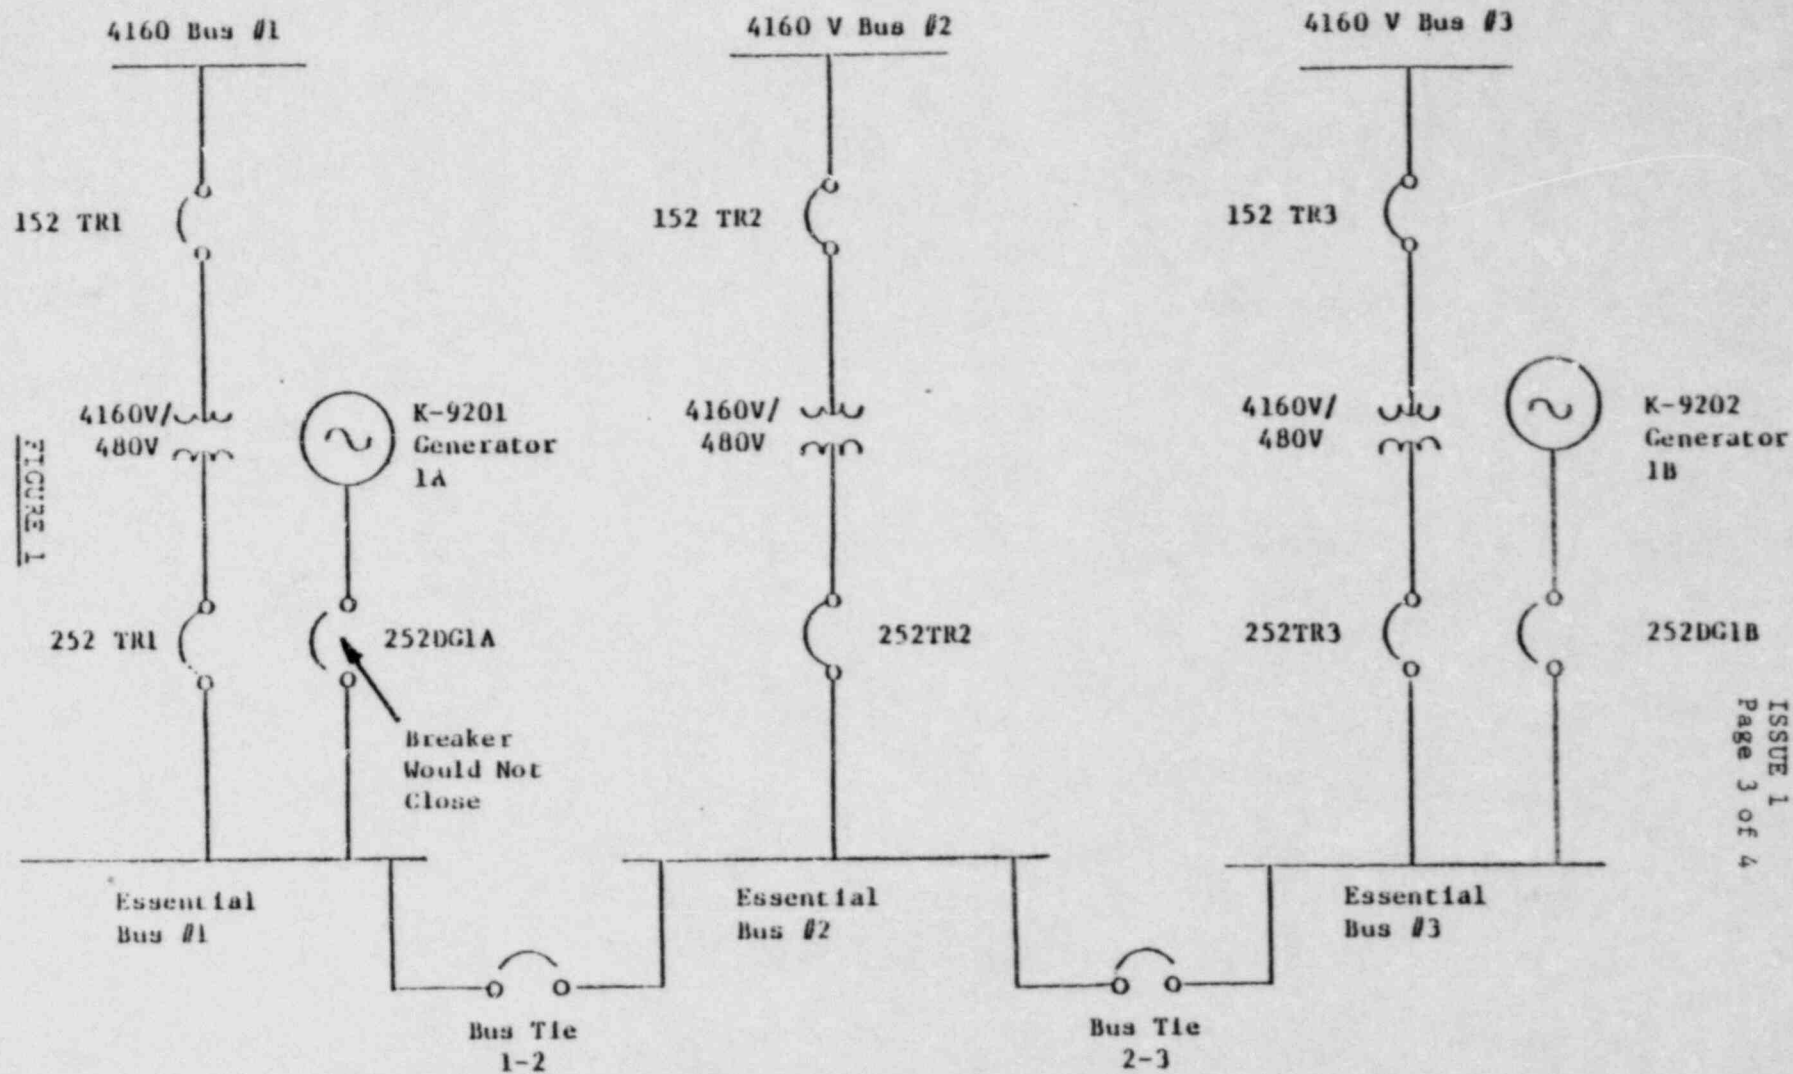
FIGURE 1

While the plant was shutdown, the Surveillance Test was being run, which simulates the loss of outside electrical power and main turbine trip. Upon simulation of loss of outside electrical power and turbine trip, both diesel generators started automatically. However, the diesel generator 1A output breaker (252 DGLA) to the essential 480 volt bus No. 1 did not close (refer to Figure 1). Diesel generator 1B had been interlocked to simulate that it would not be the first generator to reach operating conditions, as required by the procedure. Therefore, diesel generator 1B correctly did not close in on 480 volt bus No. 3, because diesel generator 1A had not closed in to supply 480 volt bus No. 1 first.
