May 27, 1981
Fort St. Vrain
Unit No. 1
P-81155

REPORTABLE OCCURRENCE 81-036
ISSUE 0
Page 1 of 6

FORT ST. VRAIN NUCLEAR GENERATING STATION
PUBLIC SERVICE COMPANY OF COLORADO
16805 WELD COUNTY ROAD 19 1/2
PLATTEVILLE, COLORADO 80651

REPORT NO. 50-267/81-036/01-T-0

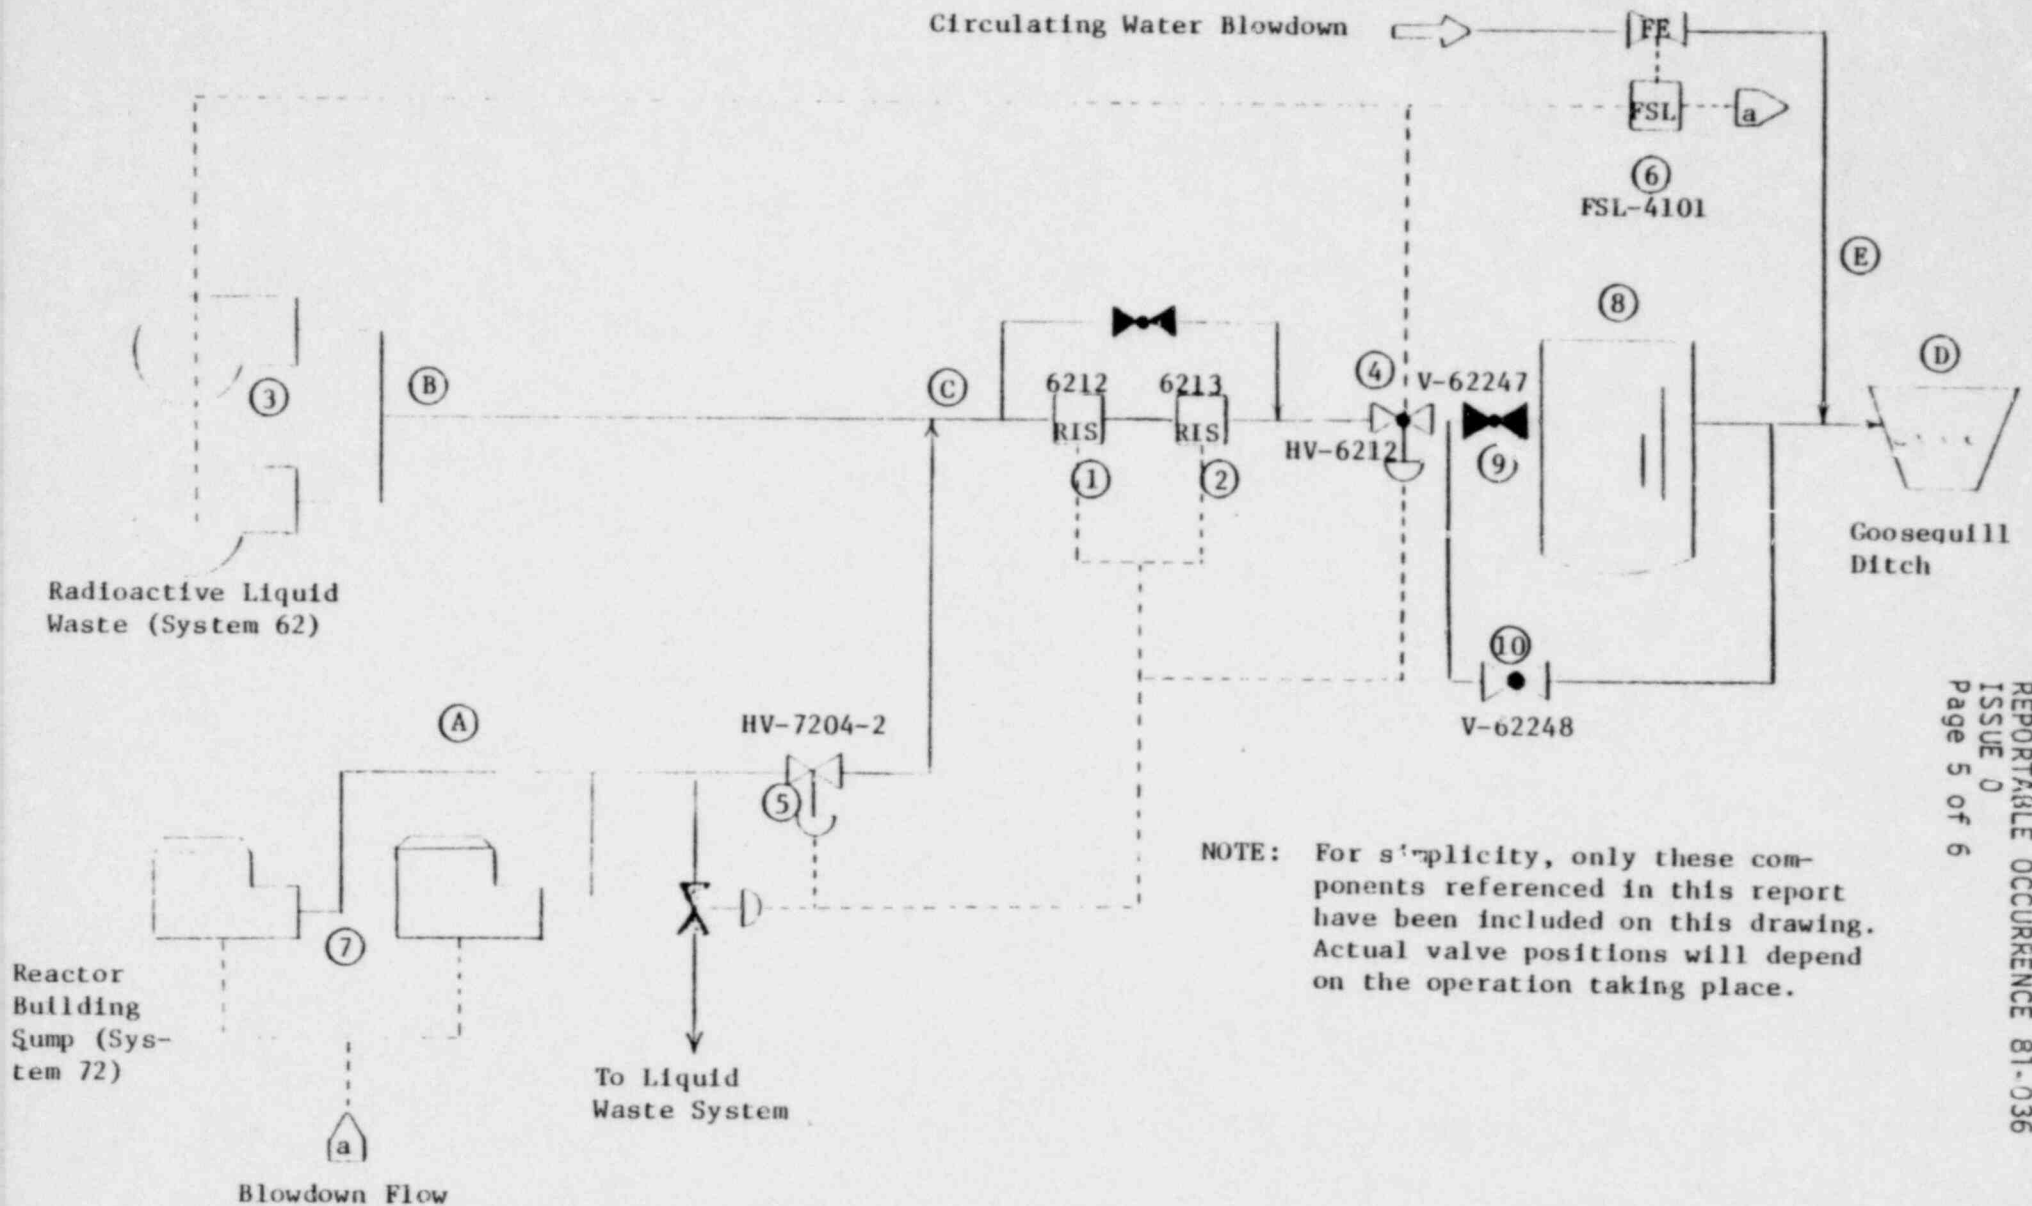
FIGURE 1

Refer to Figure 1. Effluents from the Reactor Building sump (A) and the liquid waste system (B) are discharged to a common line (C) leading to the Goosequill Ditch (D). Circulating water blowdown (E) is admitted for dilution purposes prior to the effluent reaching the Goosequill Ditch. Radiation monitors RIS-6212 and RIS-6213 (1 and 2) in the common discharge line alarm at preset values on high activity in effluent discharged from either the Reactor Building sump or the liquid waste system and provide a signal to trip the liquid waste transfer pumps (3), close HV-6212 (4), and if the release is from the Reactor Building sump, close HV-7204-2 (5), thus terminating the release.

Circulating water blowdown (dilution) flow is monitored by flow switch FSL-4101 (6), which at a preset value of low blowdown flow

provides a signal to close HV-6212 (④) and trip the liquid waste transfer pumps (③) and Reactor Building sump pumps (⑦) (a). In order to avoid a holdup of radioactive liquid waste in the oil separator (⑧) in the discharge line common to the Reactor Building sump and liquid waste system, normally open V-62247 (⑨) is closed and normally closed V-62248 (⑩) is opened prior to initiating a liquid waste release. These two valves are returned to their normal positions upon completion of a liquid waste release.

The design of the Fort St. Vrain liquid waste discharge system is inadequate to preclude problems of this nature from arising.

An analysis of the main cooling tower makeup and blowdown flow recorder (FR 4101) subsequent to the occurrence indicated that blowdown flow was interrupted at approximately 1255 hours on May 12, 1981, for approximately one to two minutes. Similar analysis of the liquid waste blowdown flow recorder (FR 6215) confirmed that the automatic control system responded properly by tripping the liquid waste transfer pump and closing HV-6212. The transfer pump was manually restarted by Operations personnel approximately eight to ten minutes after tripping, and the release was completed without further incident.

Although the automatic control actions worked properly, the approximately 150 to 200 gallons of liquid waste downstream of HV-6212 continued to be released upon loss of circulating water blowdown (dilution). The lack of sufficient dilution flow during this release period resulted in a tritium concentration in an unrestricted area in excess of the limit of LCO 4.8.2(a).

1. Operations personnel are investigating the cause of the circulating water blowdown (dilution) flow interruption.
2. Plant Management is investigating the possibility of installing another automatic valve at the location where the liquid waste discharge line meets the circulating water blowdown line, designed to isolate the dead leg until conditions are acceptable for release to the unrestricted area.
