DUKE POWER COMPANY
OCONEE NUCLEAR STATION

Report Number: RO-269/81-5

Facility: Oconee Unit 1, Seneca, South Carolina

Identification of Occurrence: Leaking LPI Check Valve

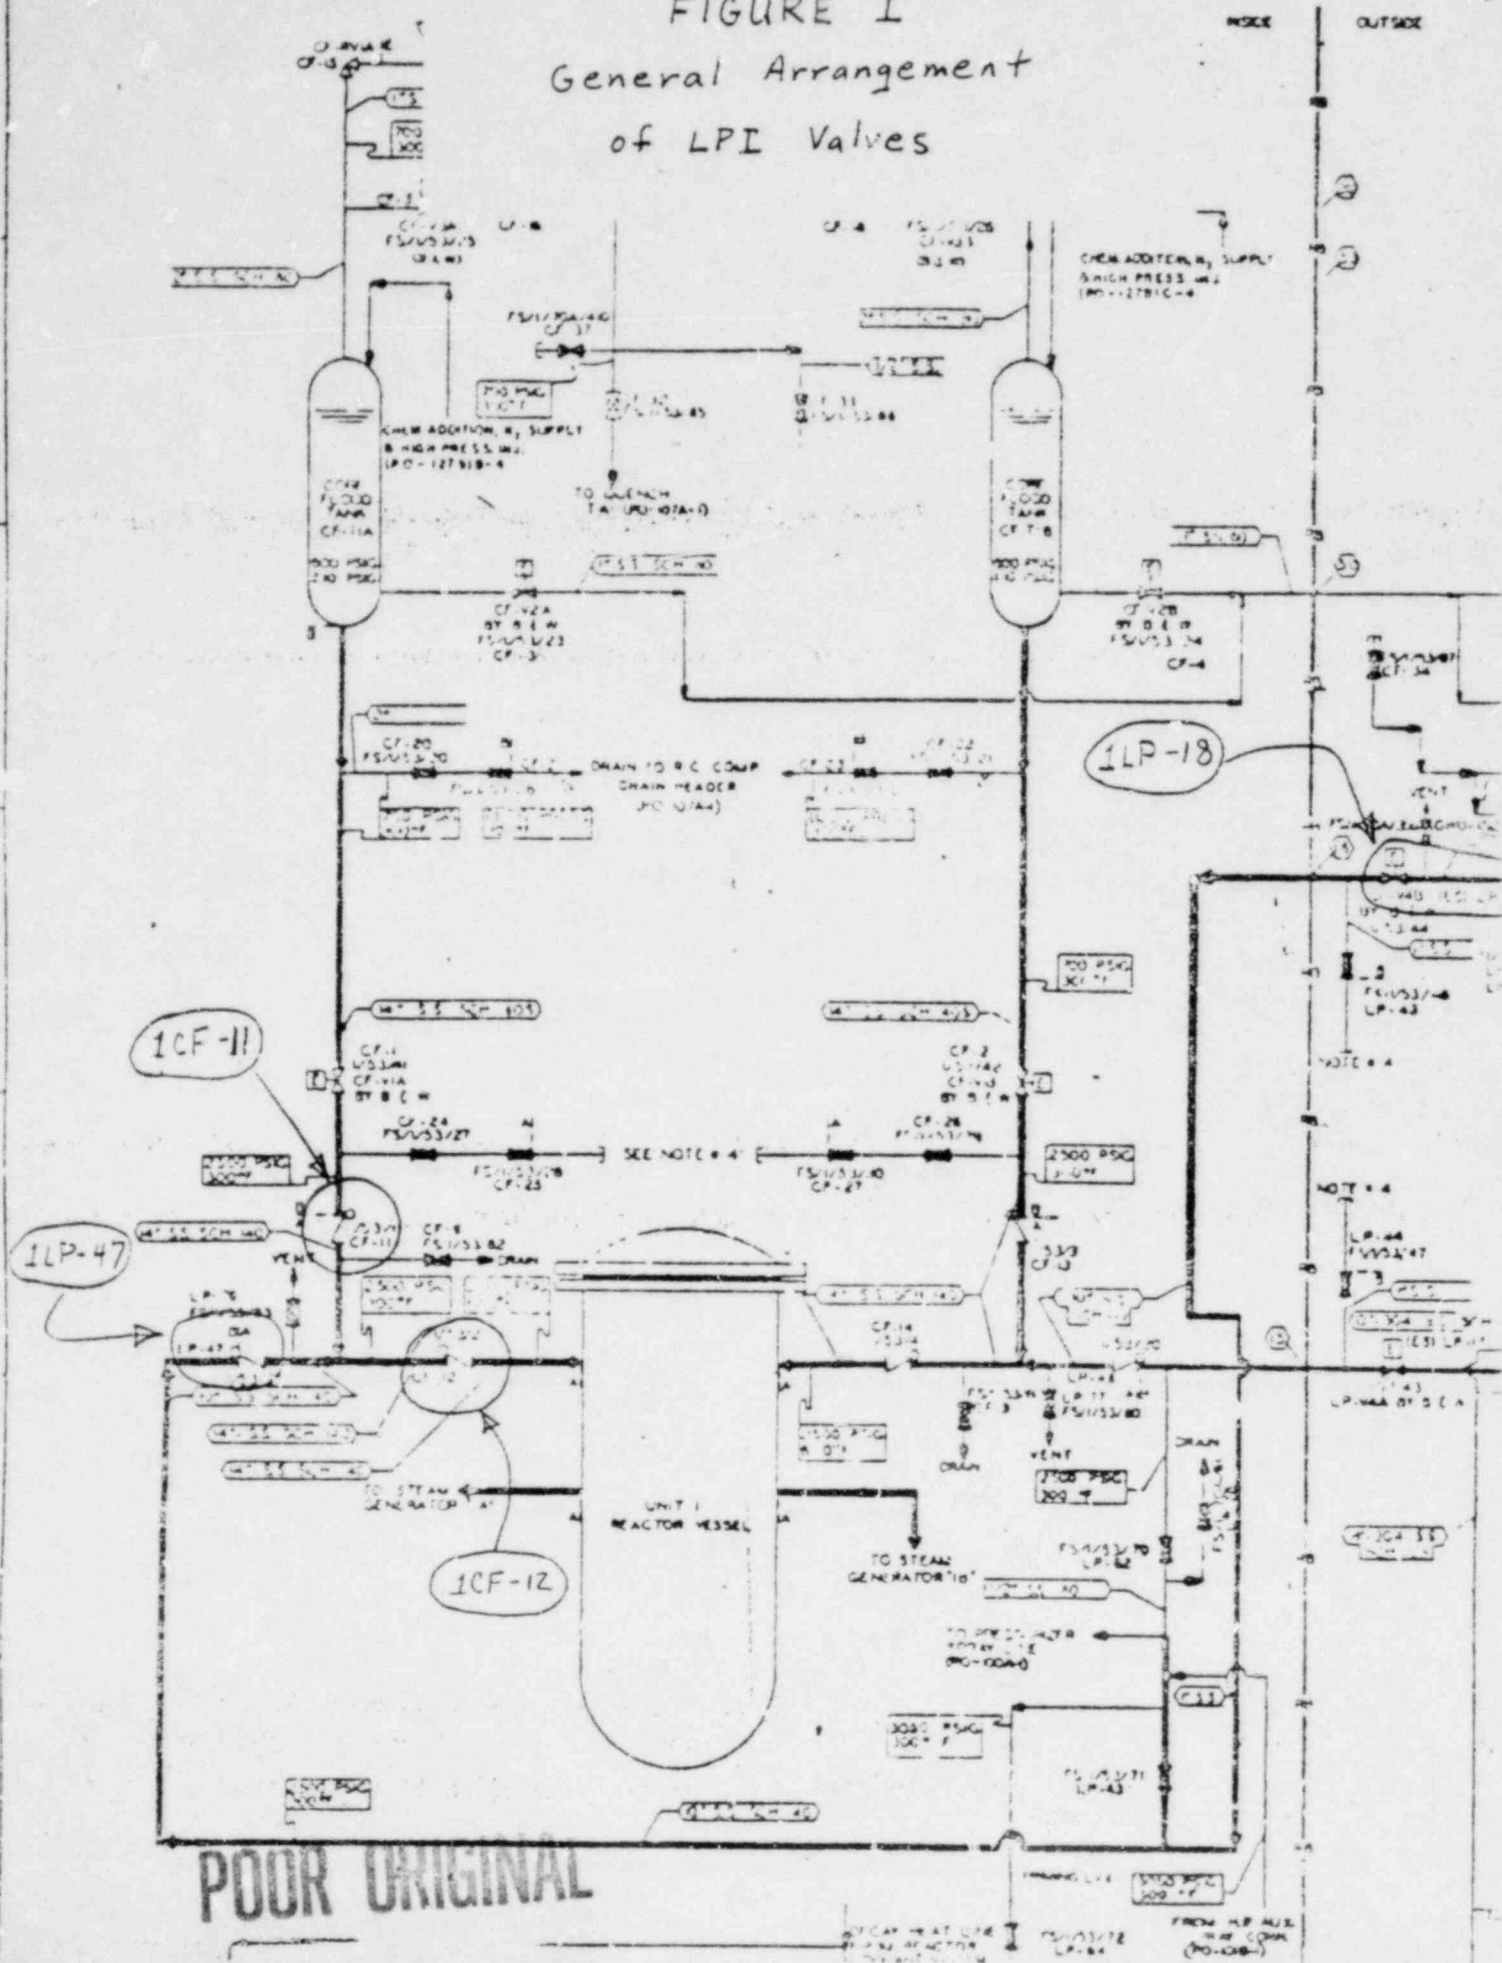
FIGURE 1
General Arrangement
of LPI Valves

Analysis of Occurrence: Prior to the testing of 1 CF-12, backup check valves 1 CF-11 and 1 LP-47 (see Figure 1) had been leak tested and both had shown zero leakage. In addition, the LPI loop "B" motor operated valve 1 LP-18 was in its normal closed position during this period of time. Thus, the prevention of leakage from the RCS to the low pressure section of the LPI system was assured.

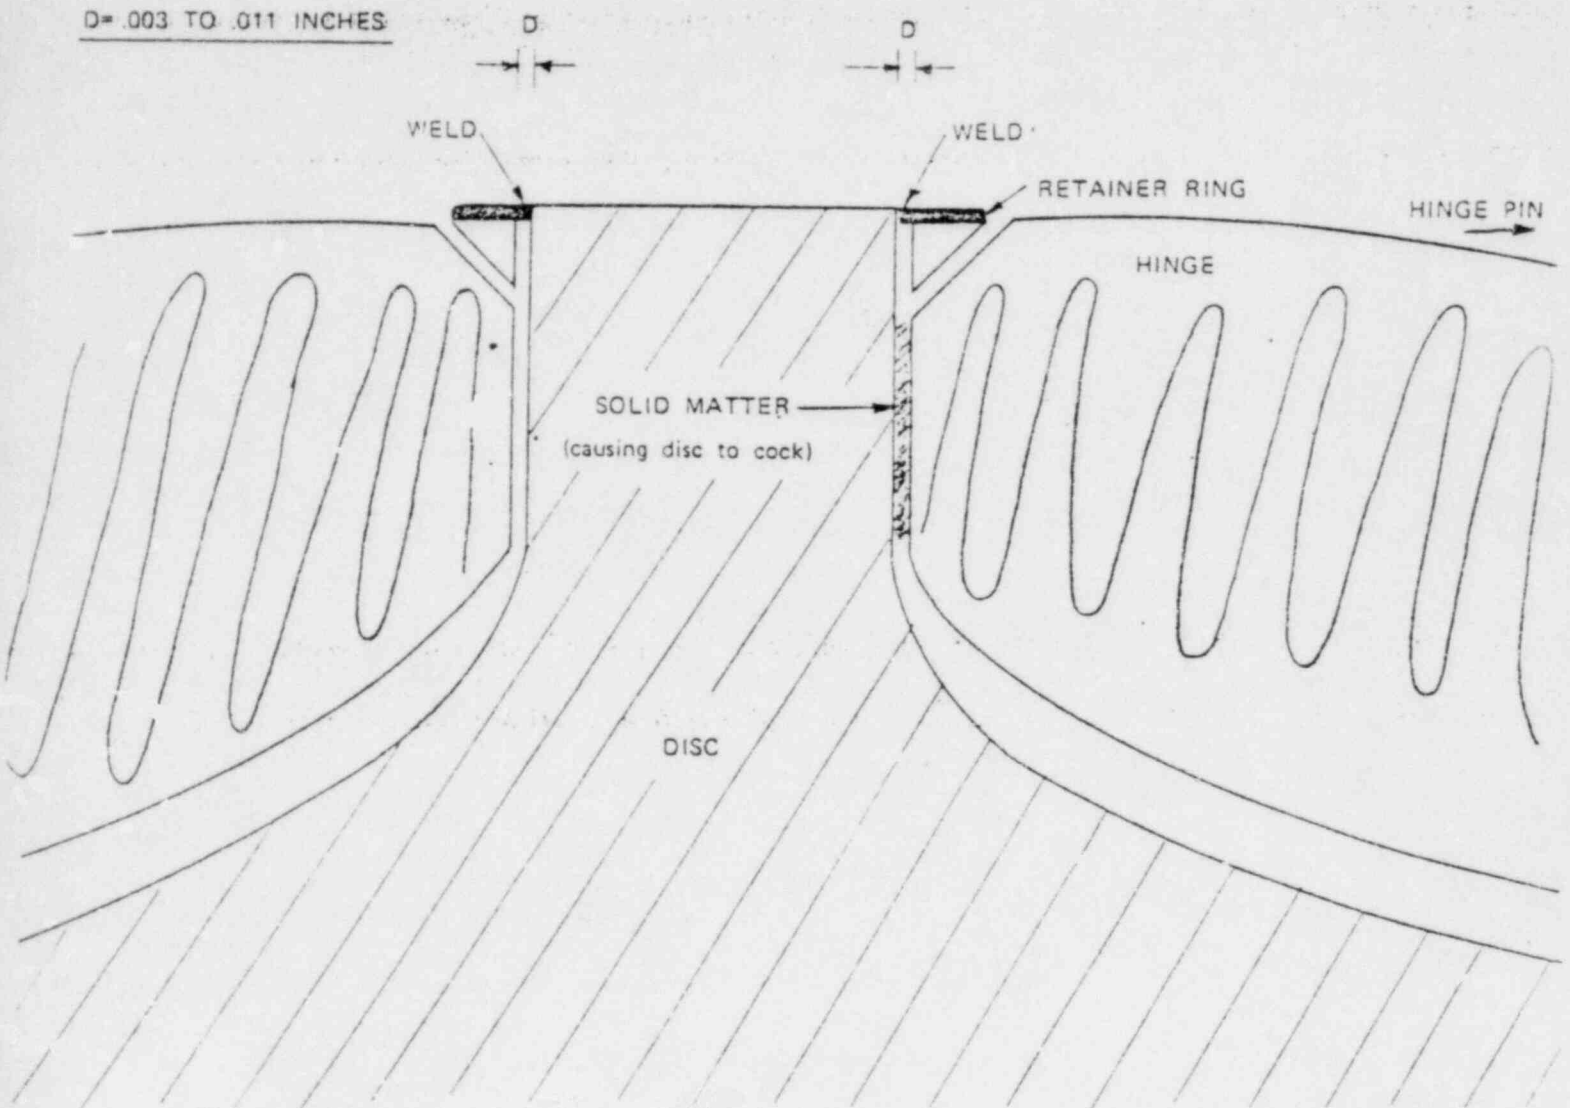
FIGURE 3

Apparent Cause of Occurrence: 1 CF-12 is a 14-inch Crane Co. 1500 PSI Alloy Steel Swing Check Valve (design pressure of 2500 PSIG). Figure 2 provides some details about this type of valve. The disc in this type of valve has a cylindrical "knob" on its back which is inserted through a hole in the hinge arm and then has a retainer ring welded to it to hold the assembly together (see Figure 3). This method of assembly allows the valve disc to pivot to a certain extent on the hinge arm. By pivoting, the disc is allowed to find its seat properly should the mating surfaces become slightly altered. A manufactured tolerance of 3 to 11 mils between the disc "knob" and the hinge at the pivot prevents the disc from swaying too freely.

Examination of the valve disc-hinge assembly in 1 CF-12 has shown that the disc had become frozen at the pivot in a cocked position. Consequently, only about half of the disc was seating. The "freezing" of the disc at the pivot was apparently caused by a buildup of deposits in the gap between the hinge and the disc "knob" on the side of the knob closest to the hinge pin. While there is flow through the valve, the disc is normally in a cocked position, and it is postulated that the flow could carry deposits into the pivot gap area, where they could accumulate. The accumulation of deposits could then cause the disc to remain slightly cocked when the flow was stopped.

During examination of the valve disc, the retaining ring was removed and unsuccessful attempts were made to remove the disc from the hinge. Both the hinge and disc are made of the same type of stainless steel (ASTM Spec. No. A351 GR. CF8M) and under the high temperature of unit operation, some galling could have occurred. At the time of this report, the disc is still connected to the hinge.

D = .003 TO .011 INCHES

Corrective Action: The unit was returned to cold shutdown conditions so that the valve could be repaired. The valve seat of 1 CF-12 was lapped and the internals (disc, hinge, and hinge pin) were replaced with new parts. The valve was retested on March 2, 1981 and revealed zero leakage by the seat.

An analysis will be performed on the substance in the pivot gap of the valve to determine its origin. Extreme contamination of the 1 CF-12 internals, however, has made examination of these parts undesirable at this point with respect to personnel exposure. These parts remain in the Unit 1 reactor building. It is expected that examination of these internals will be feasible during the Unit 1 refueling outage scheduled for this summer. A report on the results of the analysis of the pivot gap substance in 1 CF-12 will be provided to the NRC when this information becomes available.
