**ANALYSIS OF "B"
& "C" 1989
DIESELS FAILURE**

SEA-CW-037

ROOT CAUSE FAILURE ANALYSIS OF "B" AND "C" DIESELS: 1989

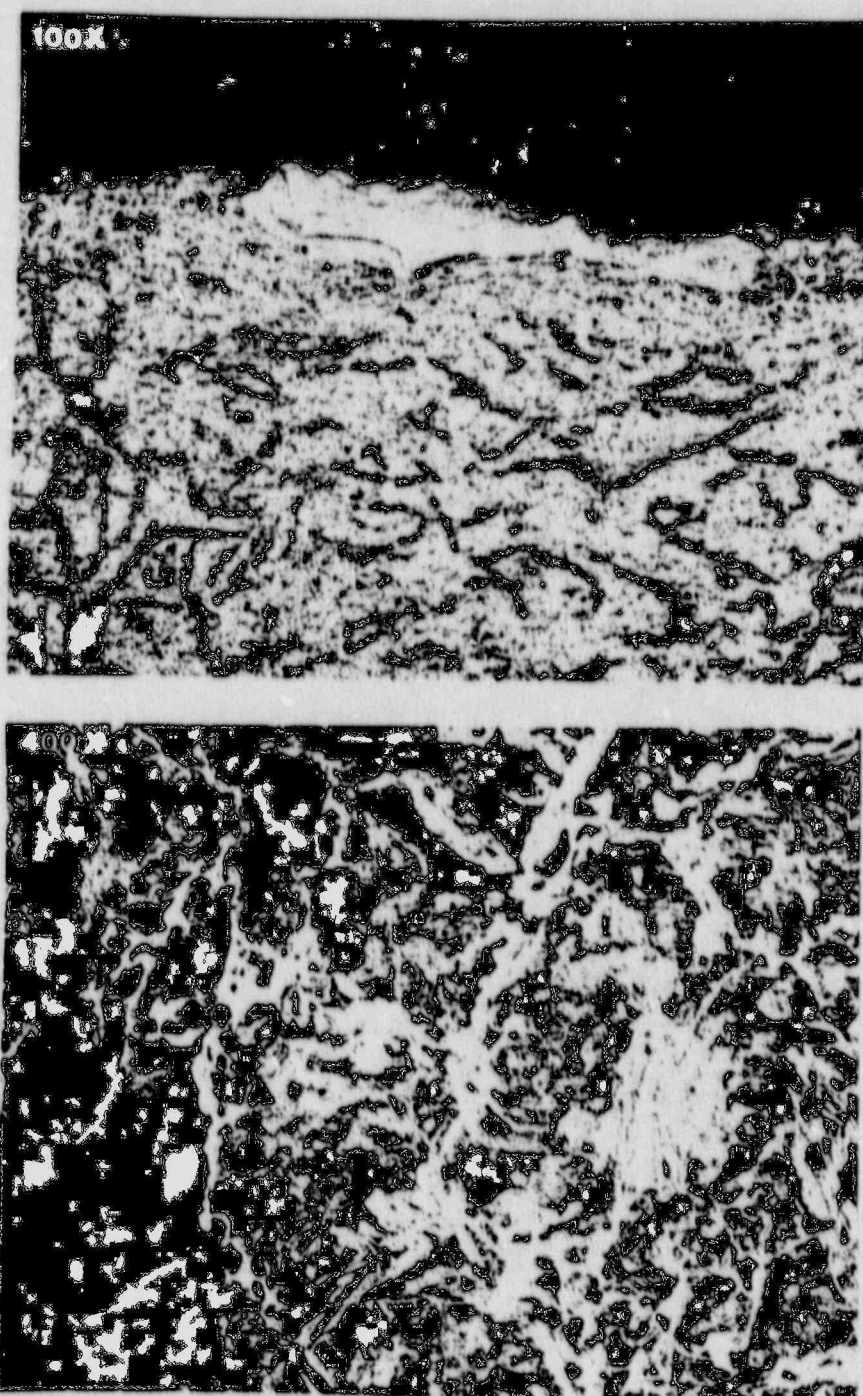
oil ring. A cross-section of a selected area from this region (Figure B-2) shows that the surface is coated with some very heavily deformed metal. Higher magnification pictures in Figure B-2 shows that just below the layer of deformed metal the cast iron has a martensitic microstructure. Since the normal structure is perlitic surrounding graphite flakes, it is evident that temperatures in excess of 1350°F had to be generated locally. Figure B-3 shows a high magnification micrograph of the surface layer revealing that it is layered with different phases.

Figure B-2. Cross-section of the B diesel 7L piston skirt area showing deposited metal in the upper micrograph and martensite formation in the microstructure in the lower micrograph. The latter indicates temperatures in excess of 1350 deg F were experienced by the material locally.

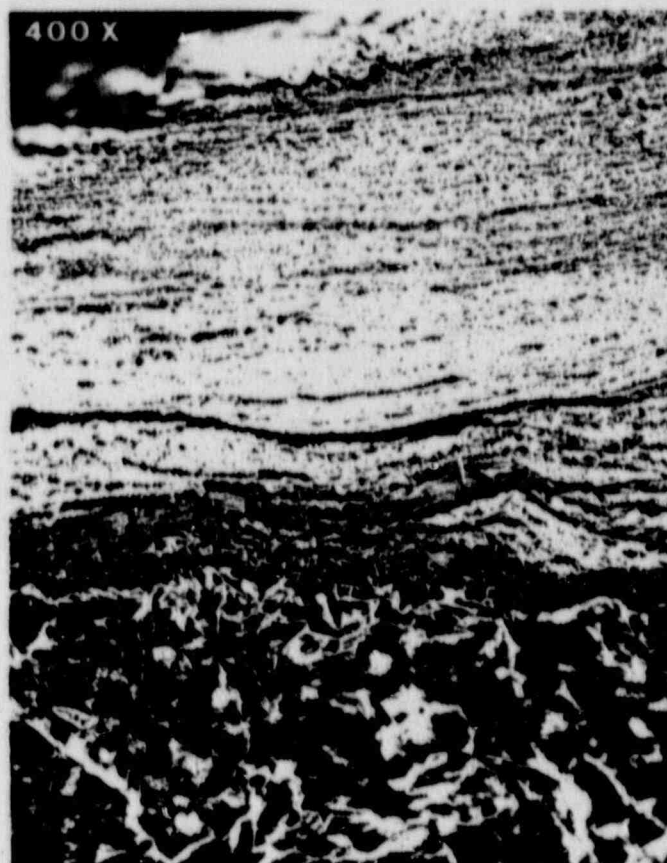
Figure B-3. Enlarged section of the deposits on the skirt of the D diesel 7L cylinder showing the layering evident there.

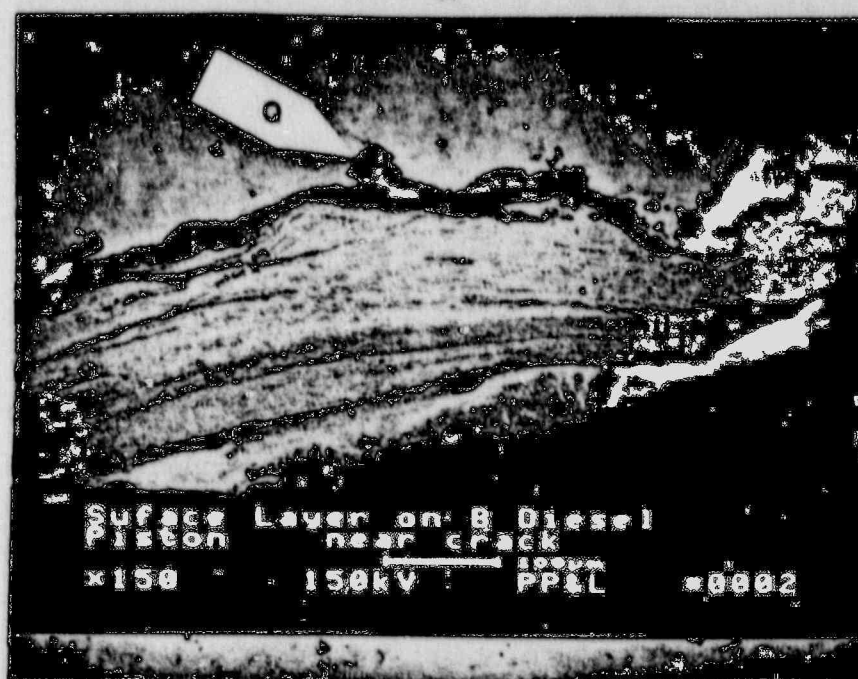
- 2.1.3 Figures B-6 and B-7 show another area of the piston skirt where a crack was found along with the layering phenomena. Figure B-6B is an enlarged portion of the lower left portion of Figure B-6A. Area "Q" was analyzed by the EDS technique to determine the elemental components here. Figure B-8 shows the spectrum obtained, which include high peaks for both iron and chromium and a smaller peak for silicon. Figure B-7 is an enlarged area of the surface of Figure B-6B and area "P" was analyzed as shown in Figure B-8 to contain iron and chromium with a small amount of tin mixed in. Finally both light grey and dark grey areas of Figure B-7 layers were analyzed and were found to contain mostly chromium with only a small amount of iron mixed in. These curves are shown in Figure B-9. Since the only source of chromium is from the cylinder liner plating, some transfer of this element had to occur to the piston skirt from the liner during the failure process.

Figure B-6. Cross-section of a cracked area of the B diesel 7L piston skirt showing metal deposits on the surface.

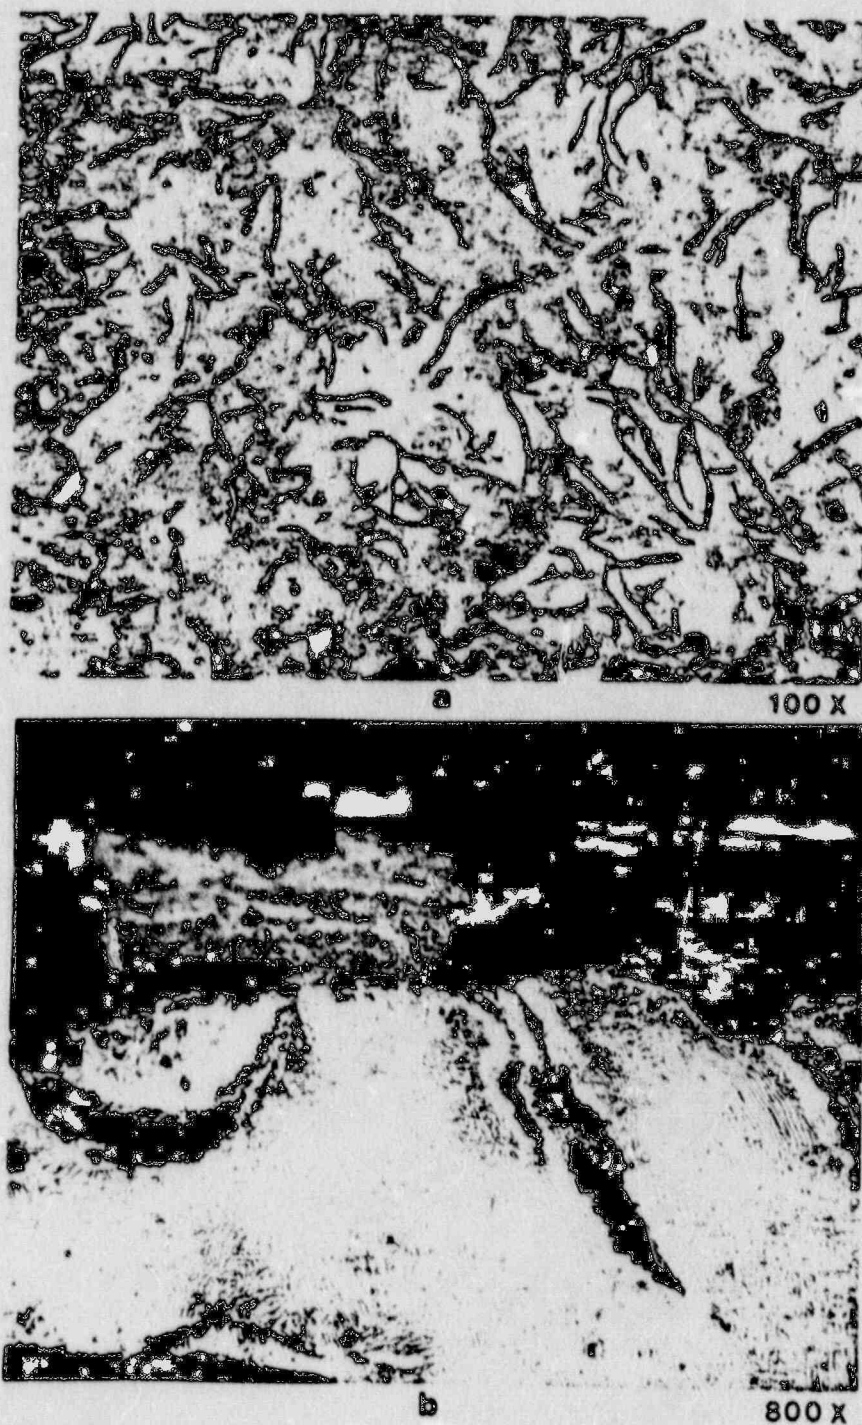
- 2.1.4 A section of the piston head material was removed in the thinnest section near a valve depression to determine if excessive overheating had occurred. Figure B-10a shows the microstructure in a thick section of the piston head, and Figure B-10b shows the structure in the thinnest section of the same piston head. Both microstructures are perlitic and do not show any overheating. It would take temperatures above 1000°F before any significant changes would be detectable visually.

Figure B-10. Microstructure of the head of the B diesel 7L piston showing a normal pearlitic, graphite flake condition
a. Thick section b. Thinnest section

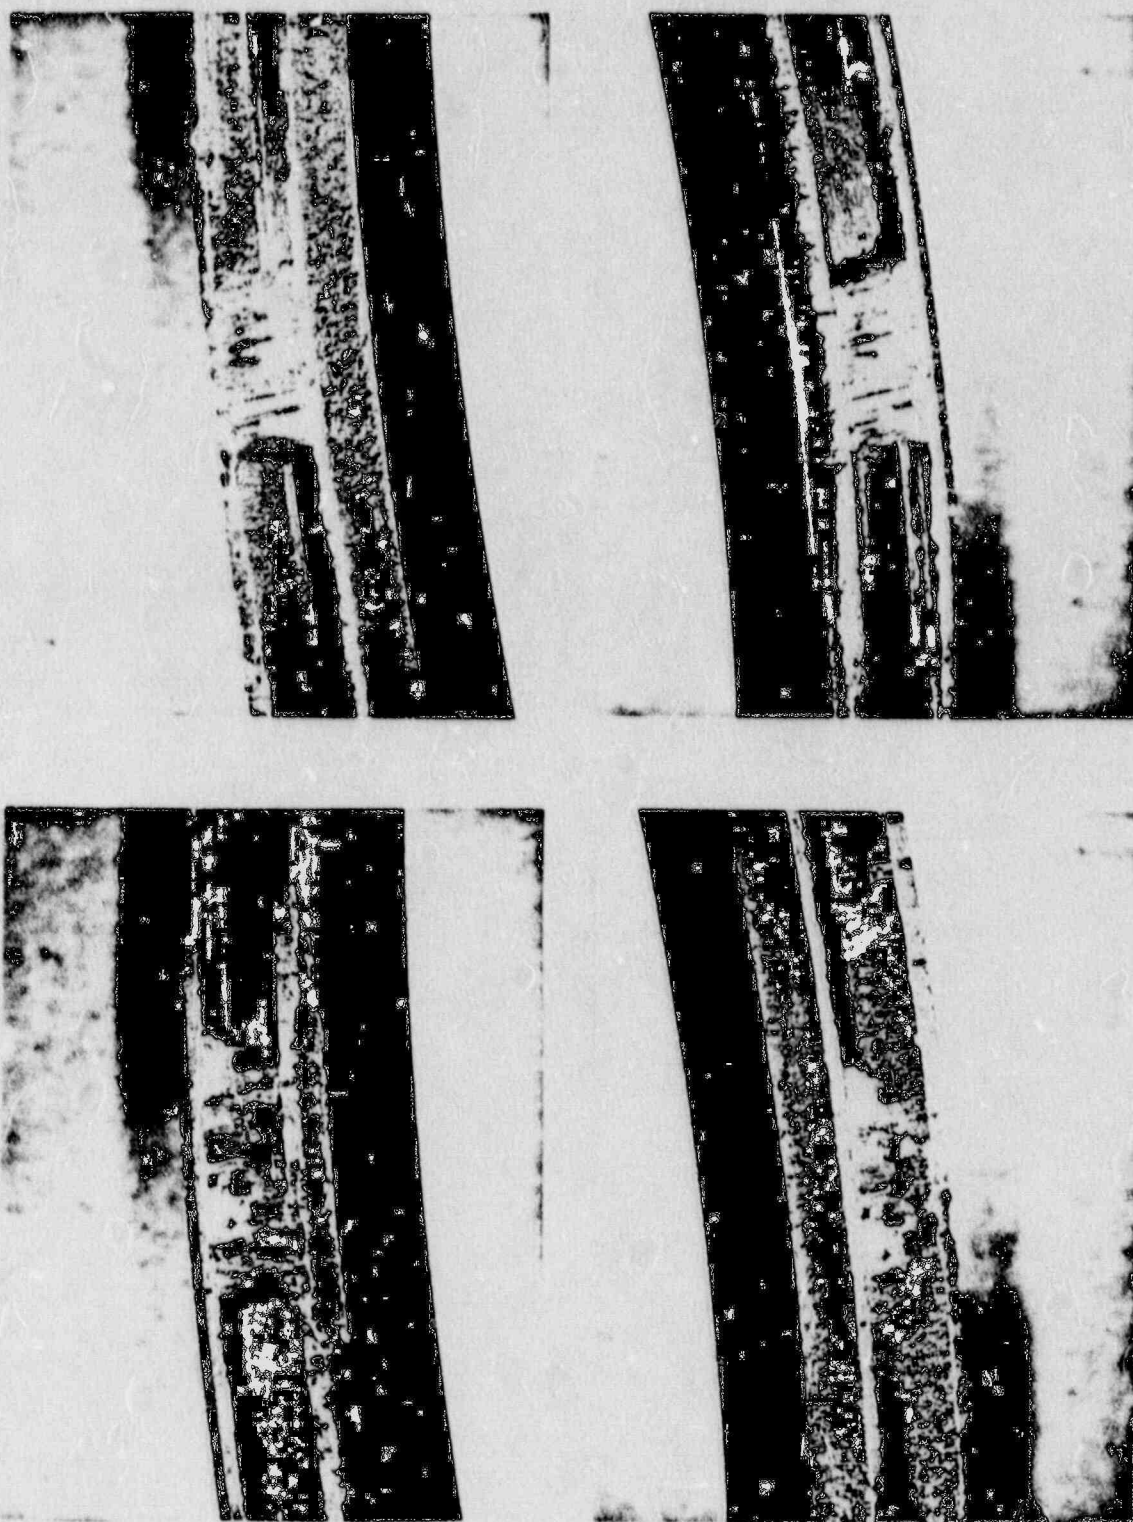
Figure B-11. Portions of the top wiper ring of the B diesel, 7L piston showing the pickup of metal and debris on the surfaces touching the liner.

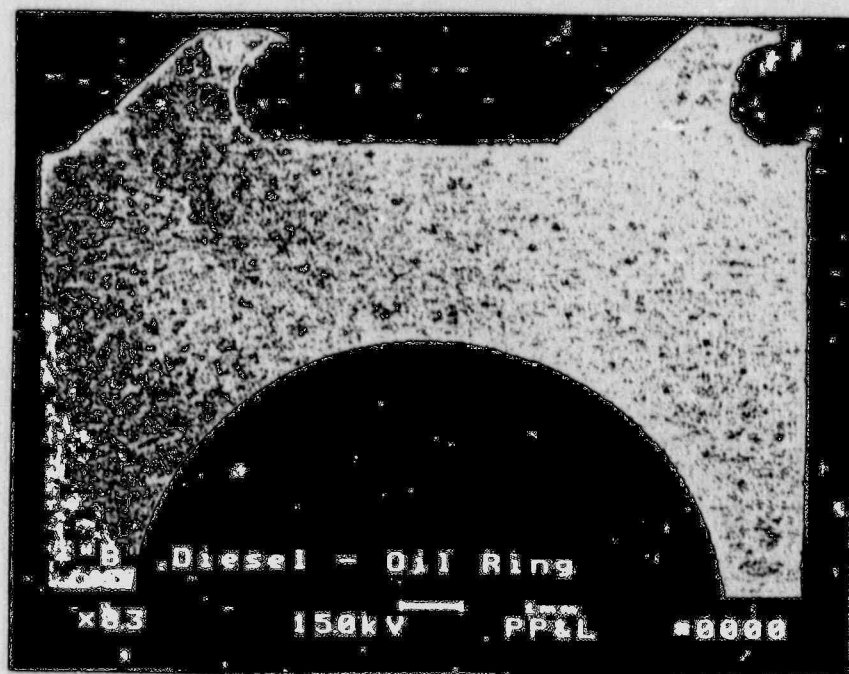
Figure B-12. Cross section of the lower oil ring from the B diesel 7L piston showing the wear and deformation on the two wiper surfaces.

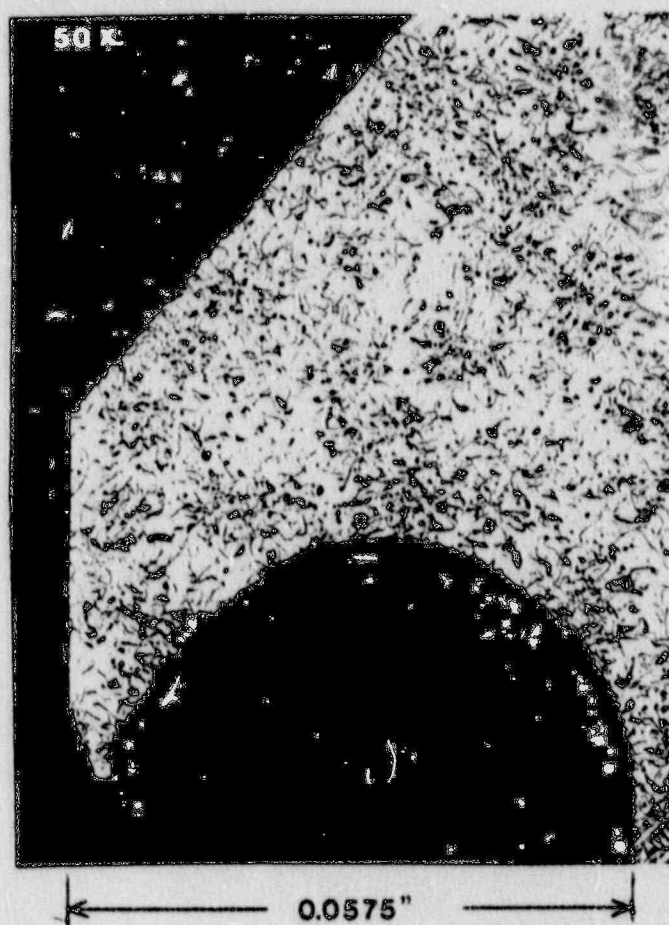
Figure B-13. Picture of oil ring profile at high magnification.
Magnified image of oil ring finger from B diesel,
7L piston lower oil ring showing structure deformation and size of
the finger.

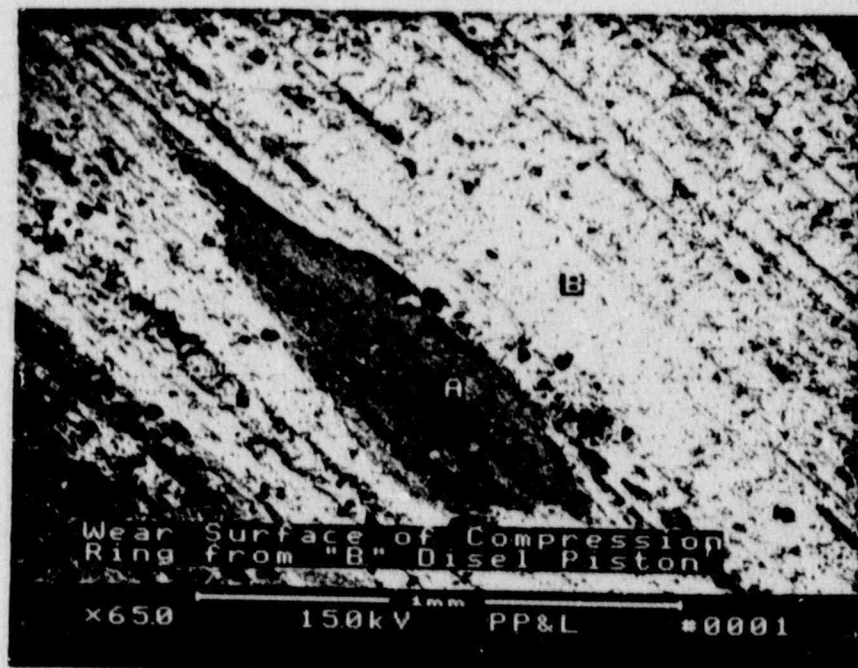
Figure B-15. Smeared metallic deposits found on the #4 compression ring of the B diesel, 7L piston are shown here as the dark gray area labeled 'A'. EDS analysis of area 'A' shows it to contain Cr, Fe, Si(trace) and Sn(trace). Area 'B' shows only Fe with a trace of Cr.

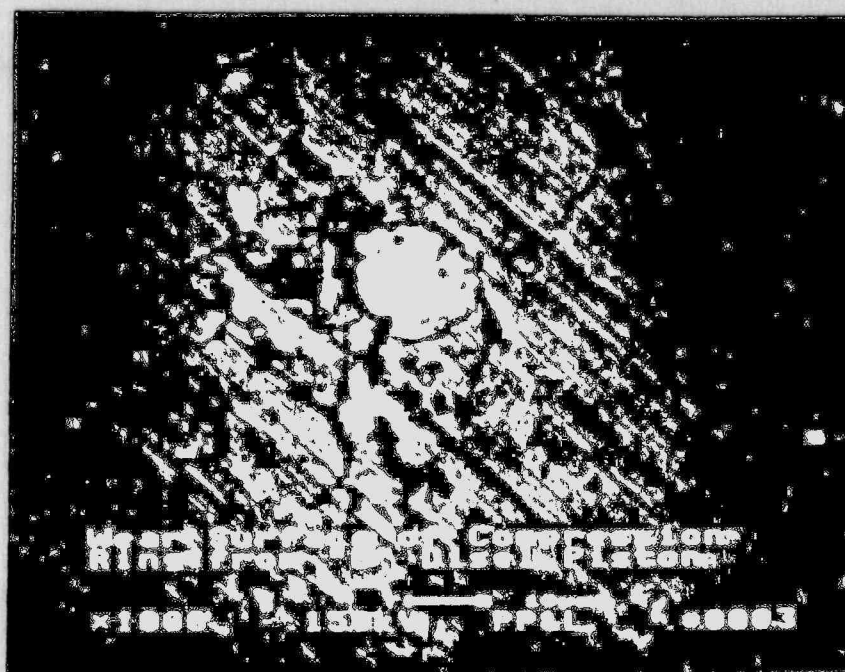
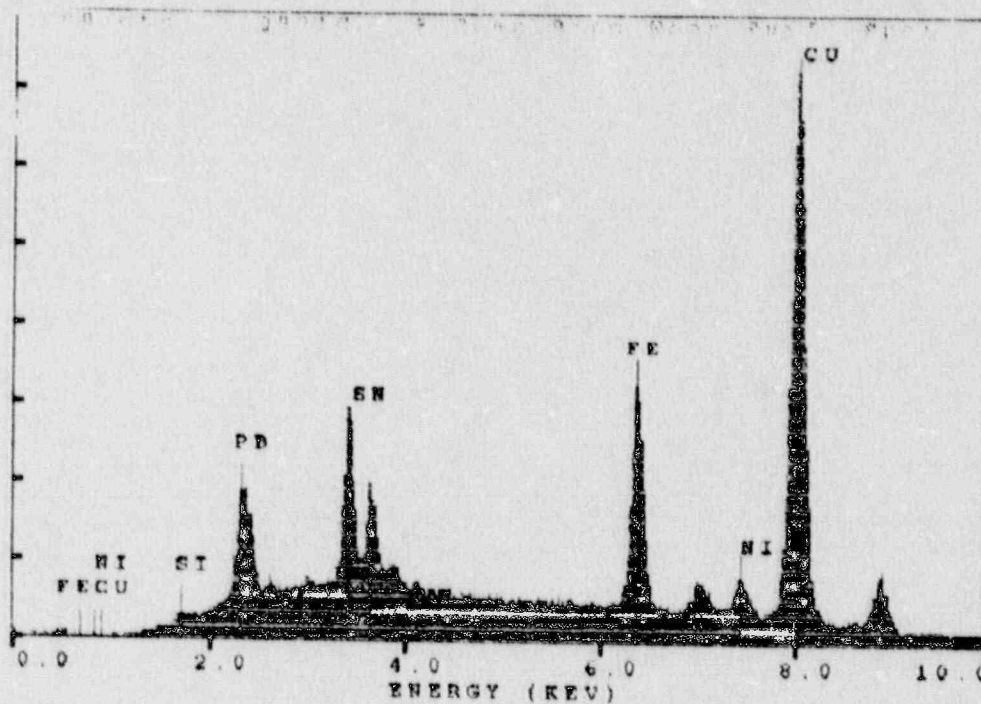
Figure B-17. An unusual spot of foreign material found embedded in the #4 compression ring from the B diesel 7L piston. EDS analysis shows it to contain Cu, Fe, Sn, Pb, and Ni.

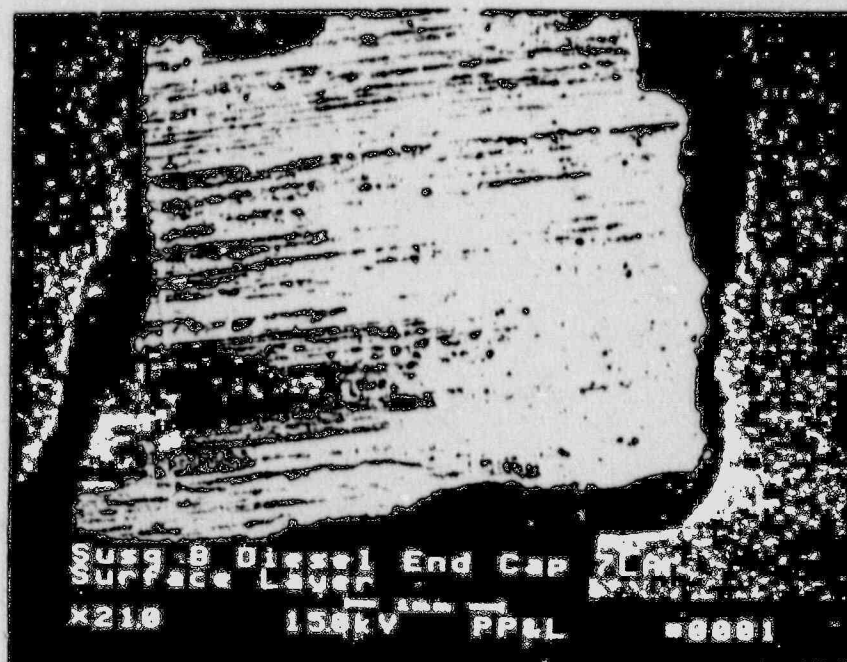
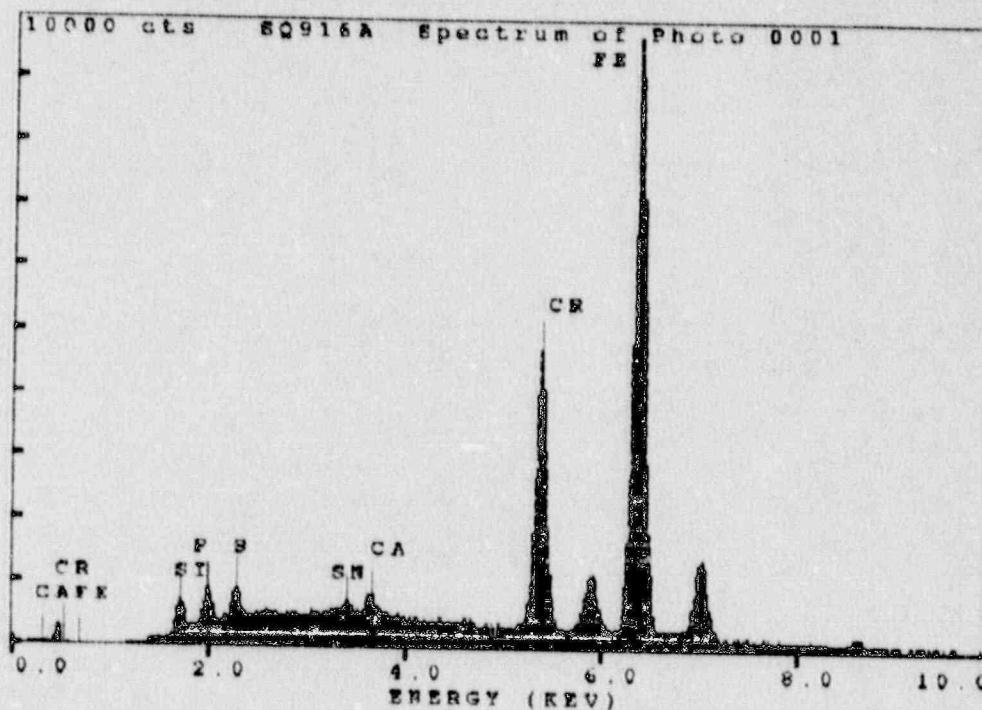
Figure B-19. Picture and EDS analysis of a piece of smeared metal removed from end cap 'A' from the B diesel 7L piston.

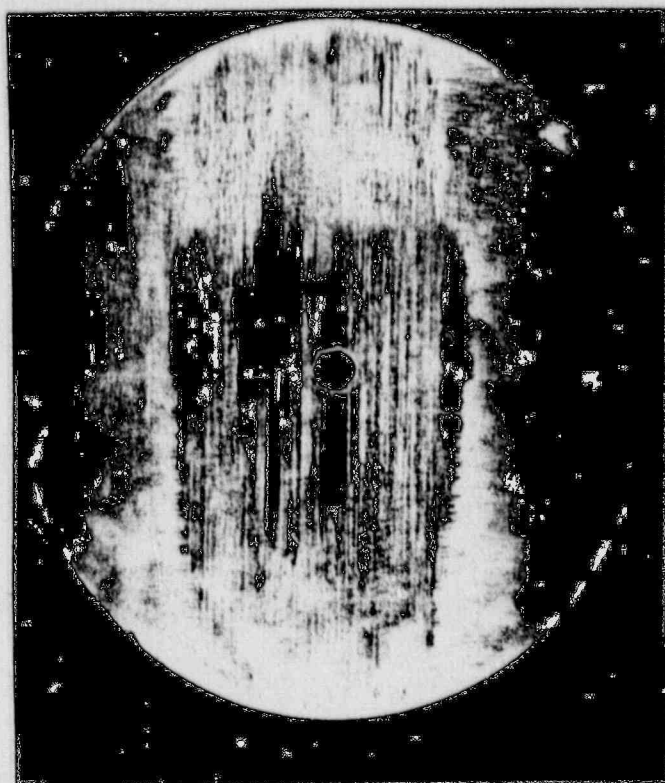
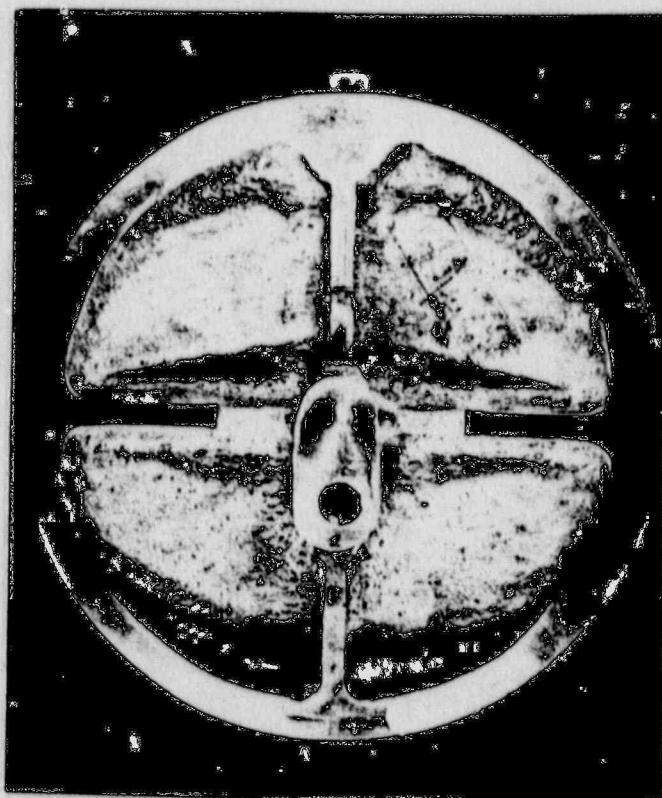
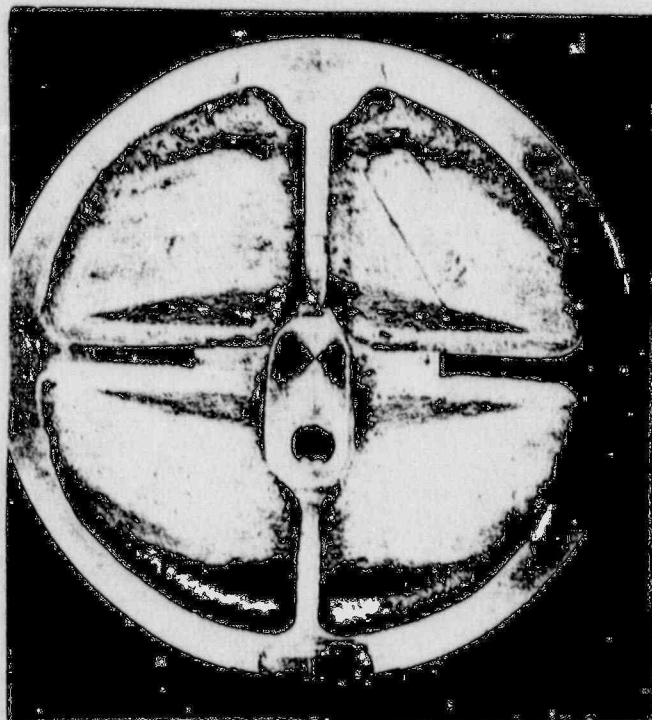
Figure B-21. Abrasion and wear found on the B diesel 7R piston pin end caps.

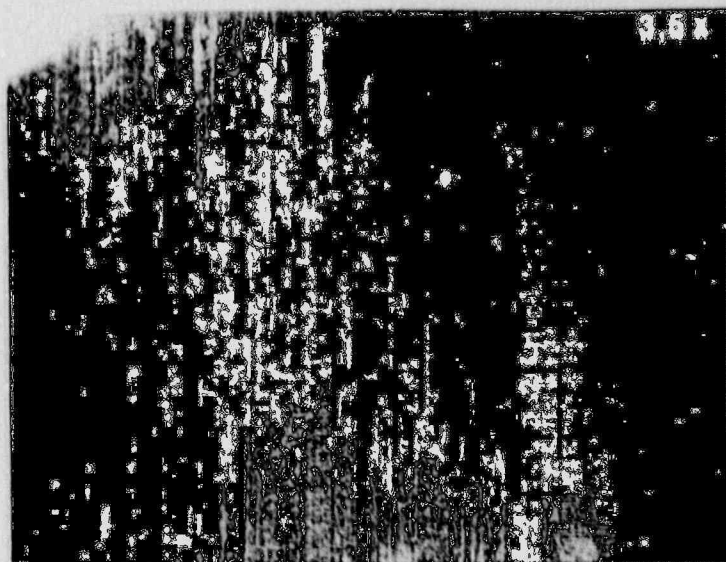
Figure B-22. Photograph of the B diesel 7R piston end cap which showed the worst amount of wear, heating and metal transfer.

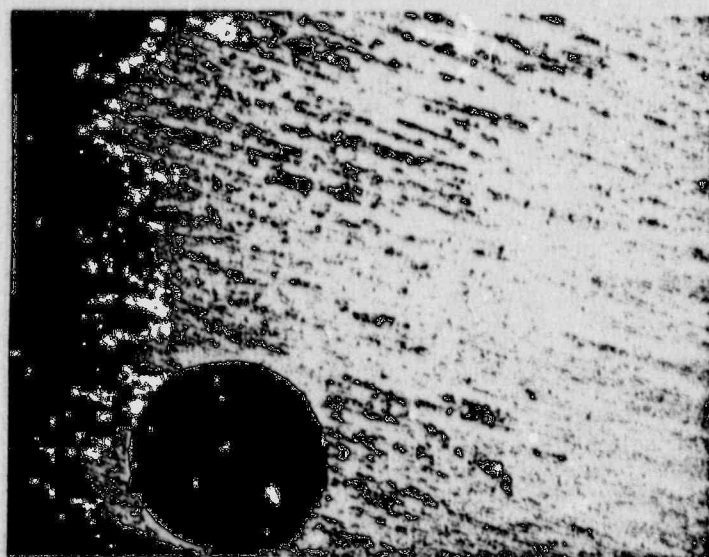
Figure B-23. B diesel 7R end cap showing the least amount of wear, but does show that the cap was touching the surface of the liner as evidenced from the light scratch marks on the surface perpendicular to the machining marks.

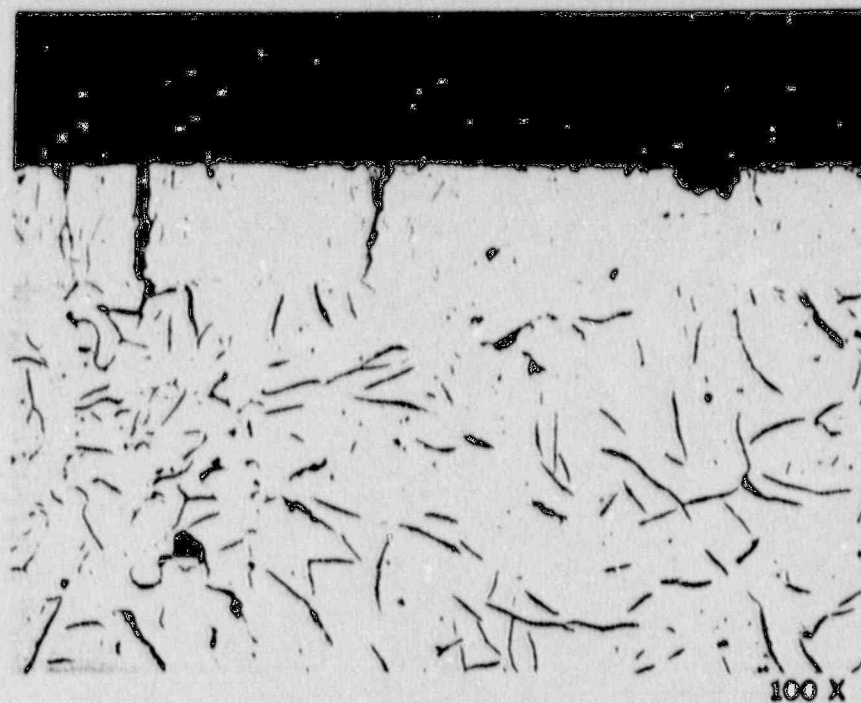
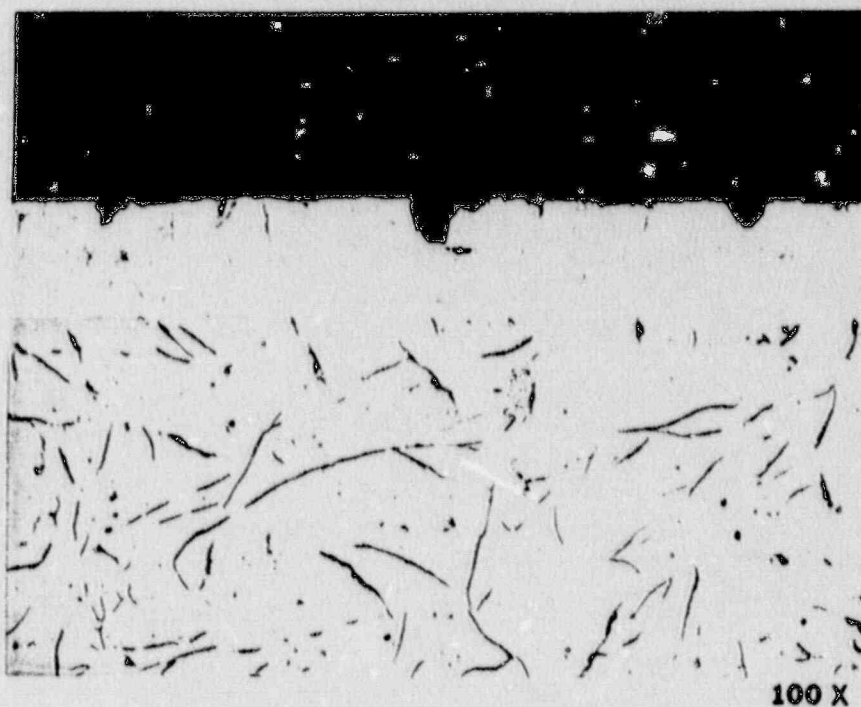
Figure 9-27. Transverse cross-sectional views of the thrust side of the B diesel 7L liner 22 7/8 inches from the bottom (piece 'A'). The chromium plating is cracked and some of the pores are filled with metallic particles.

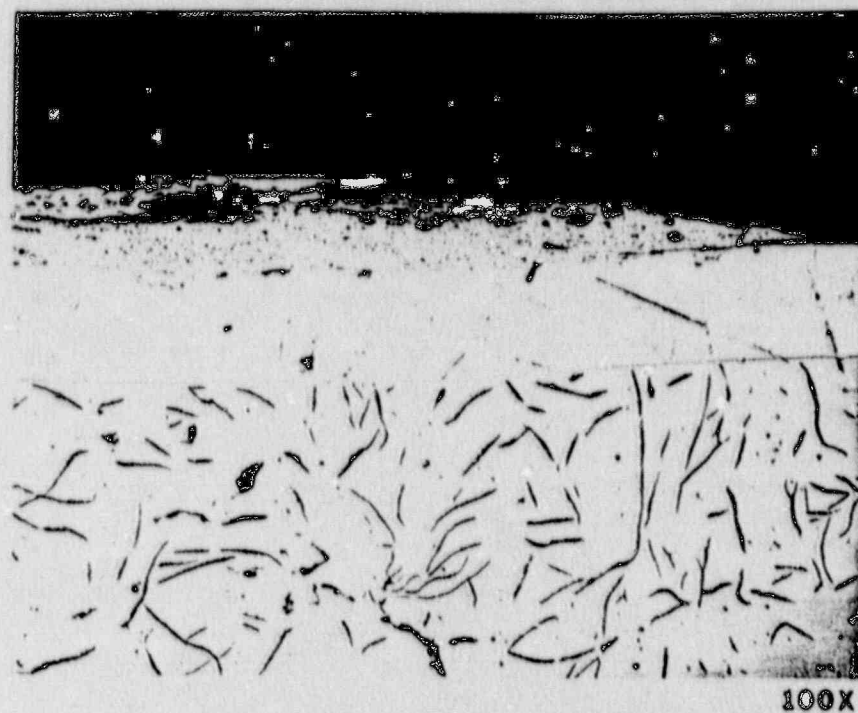
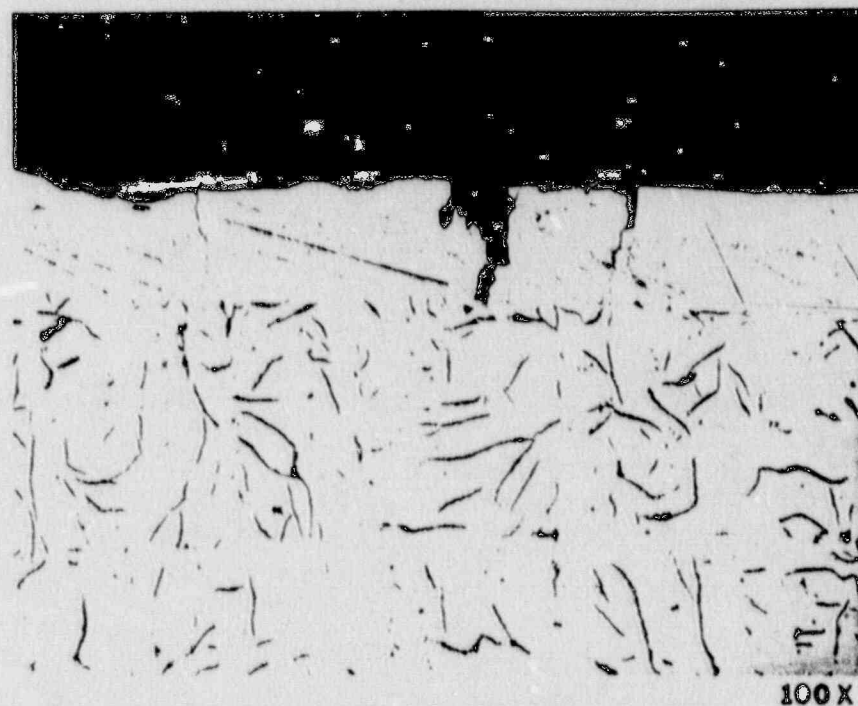
Figure B-28. Longitudinal view of the B diesel 7L liner on the thrust side 11 1/2 inches from the bottom showing metallic deposits, filled pores and cracking in the Cr plating(piece labeled 'B').

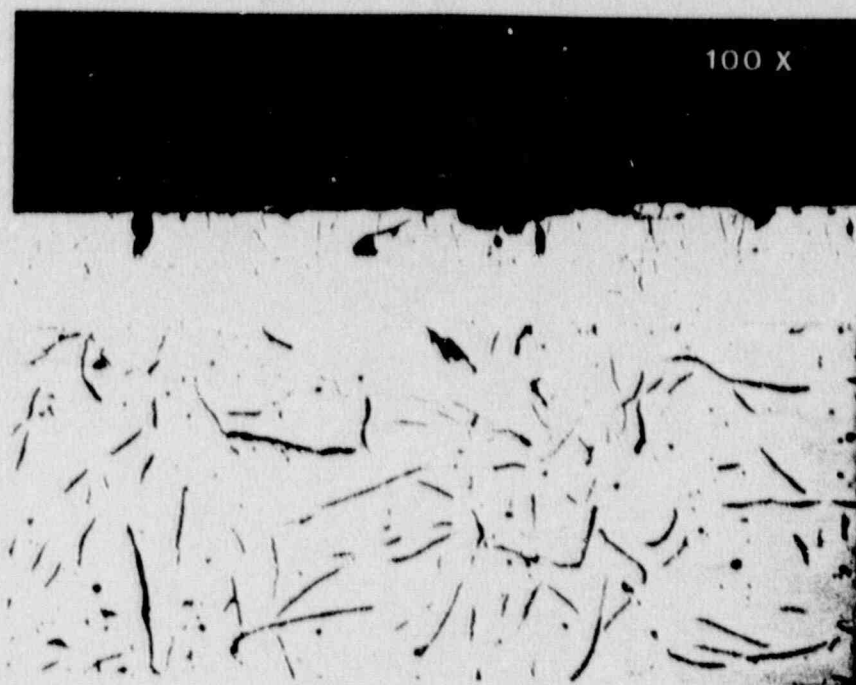
Figure B-29. Longitudinal cross-section (labeled 'C') taken 12 inches from the bottom of the B diesel 7L cylinder liner showing a rough fractured surface with pieces missing and some debris in the pores of the chromium plating layer.

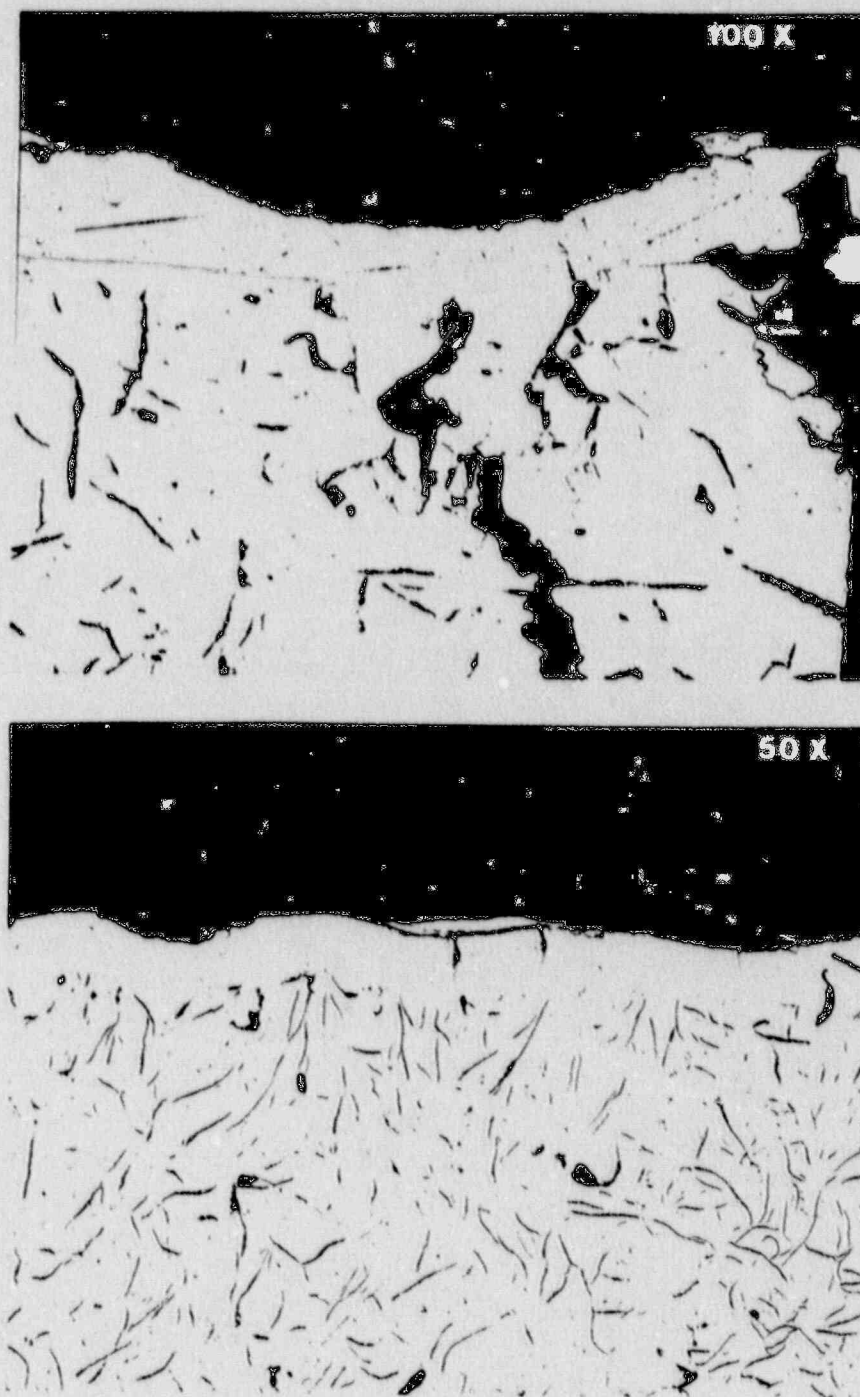
Figure B-30. Transverse cross-section(labeled area 'D') taken 7 1/2 inches from the bottom of the B diesel 7L liner showing depressions in the Cr plating surface, cracking of the base metal casting and deposited metal.

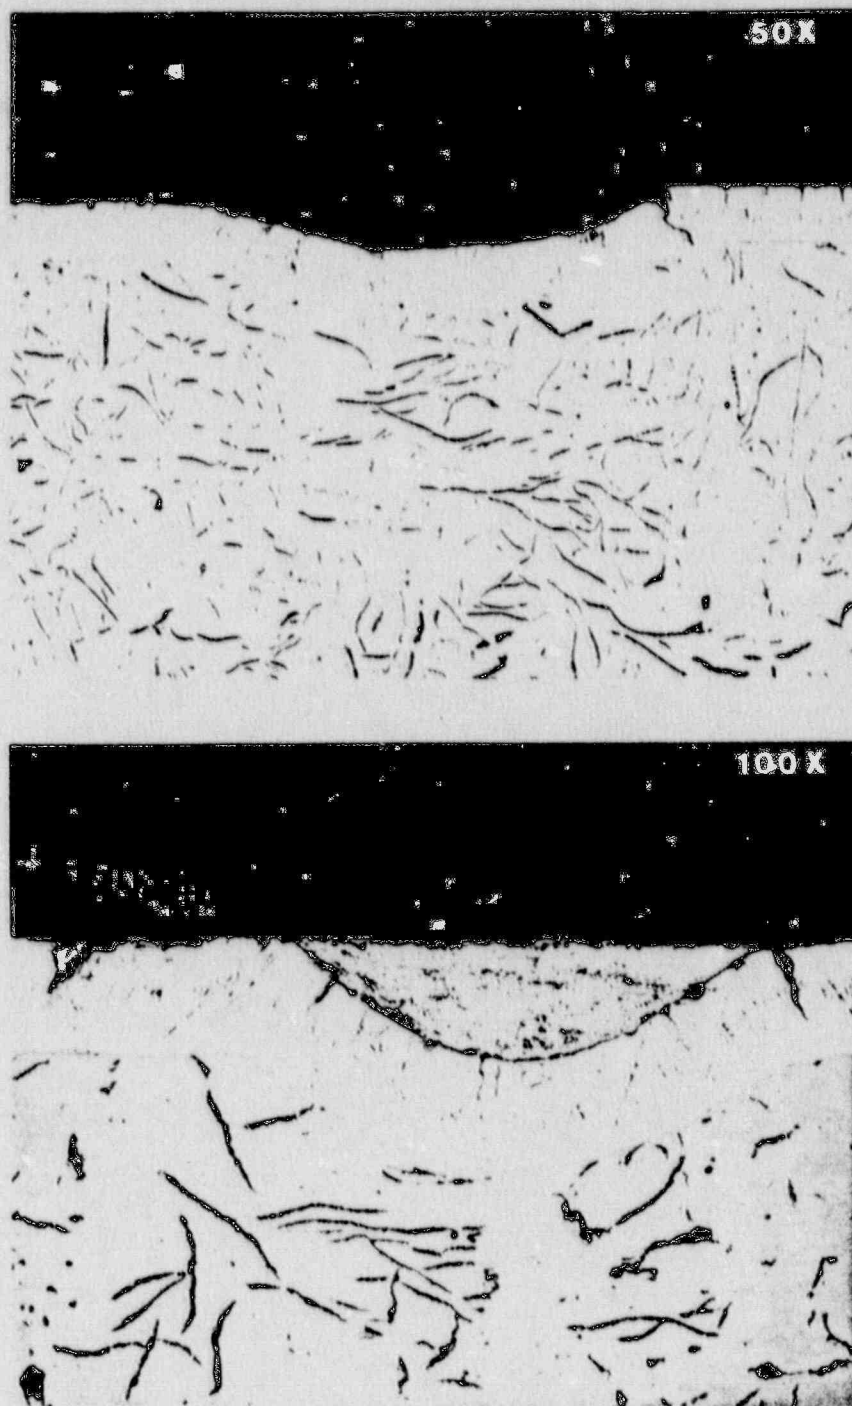
Figure B-31. Transverse cross-section (Labeled area 'E') of the thrust side of the B diesel 7L liner taken 7 1/2 inches from the bottom showing depressions in the Cr plating and deposited metal.

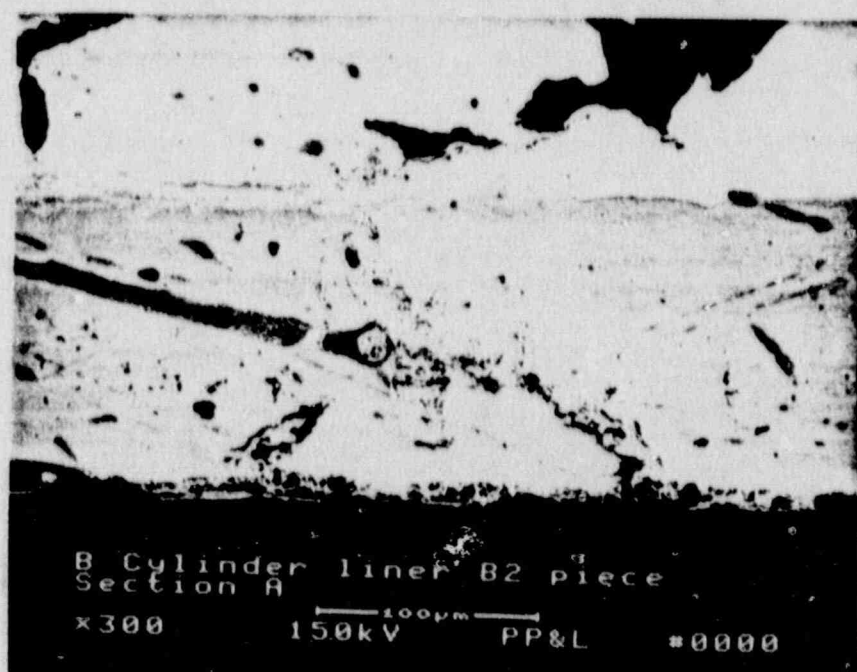
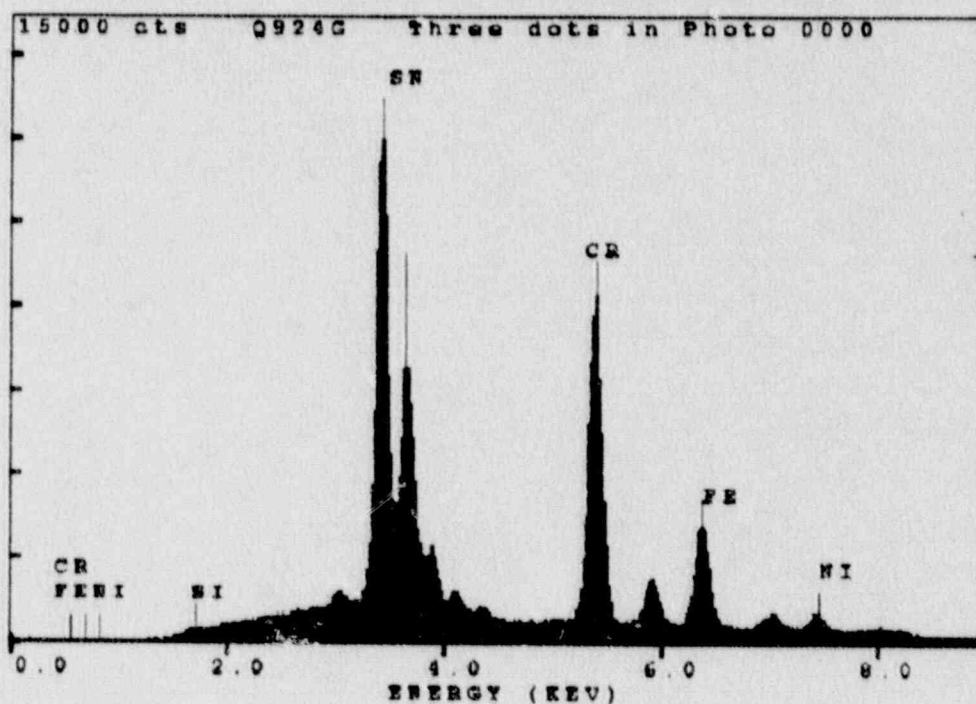
Figure B-34. Longitudinal section of B diesel 7L liner (labeled 'A' of part B-2) showing cracking in the Cr plating surface and the presence of Sn at the Cr-Fe base metal interface.

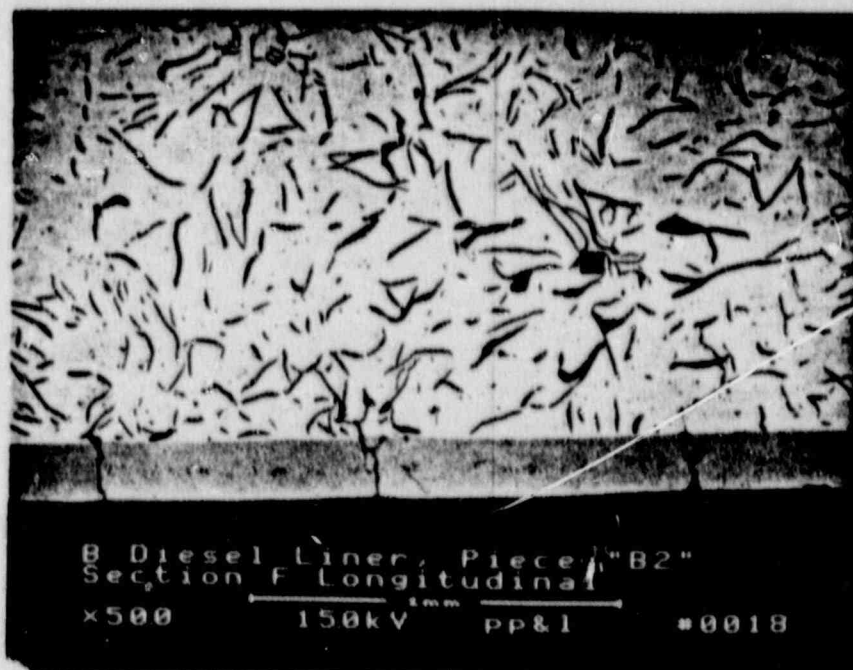
Figure B-38. Longitudinal section 'F' from B diesel liner 7L piece B-2 taken 24 5/8 inches above the bottom. This section does not show any pores filled or otherwise, but does show several cracks through the thickness of the Cr plate.

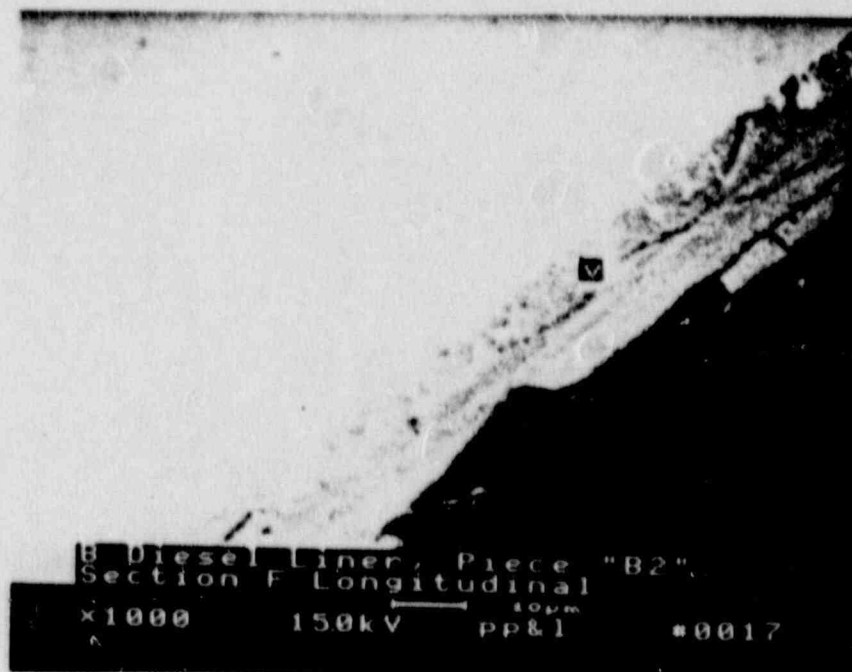
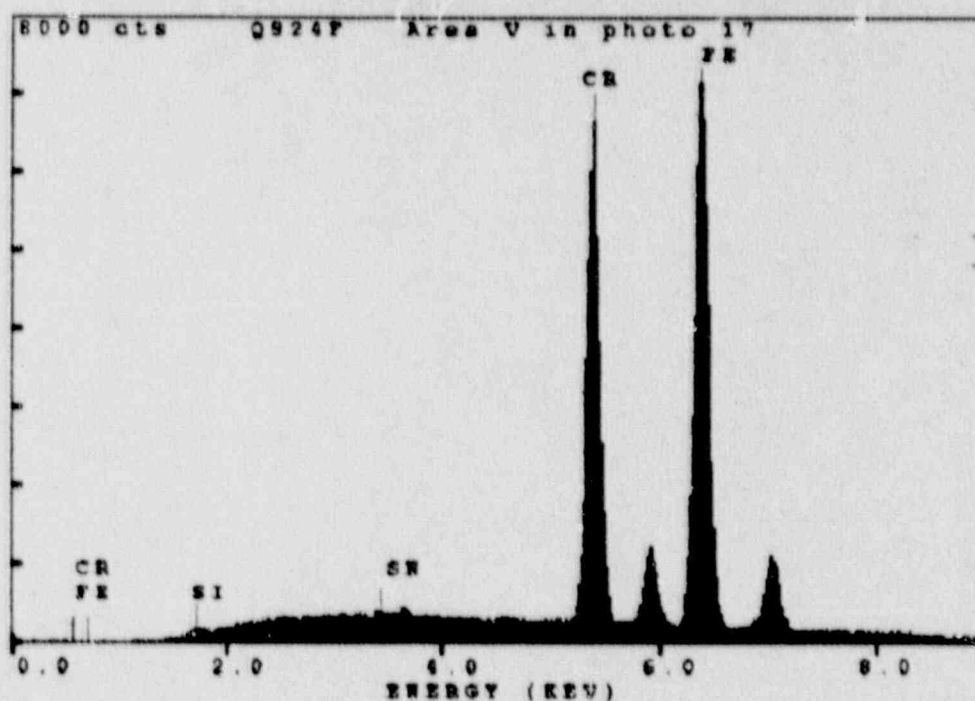
Figure B-39. Longitudinal section of B diesel 7L liner taken from the end cap side 24.625 inches from the bottom showing the layer of deposited metal and the EDS analysis of the lighter grey area.
