**ANALYSIS OF "B"
& "C" 1989
DIESELS FAILURE**

SEA-CW-037

ROOT CAUSE FAILURE ANALYSIS OF "B" AND "C" DIESELS: 1989

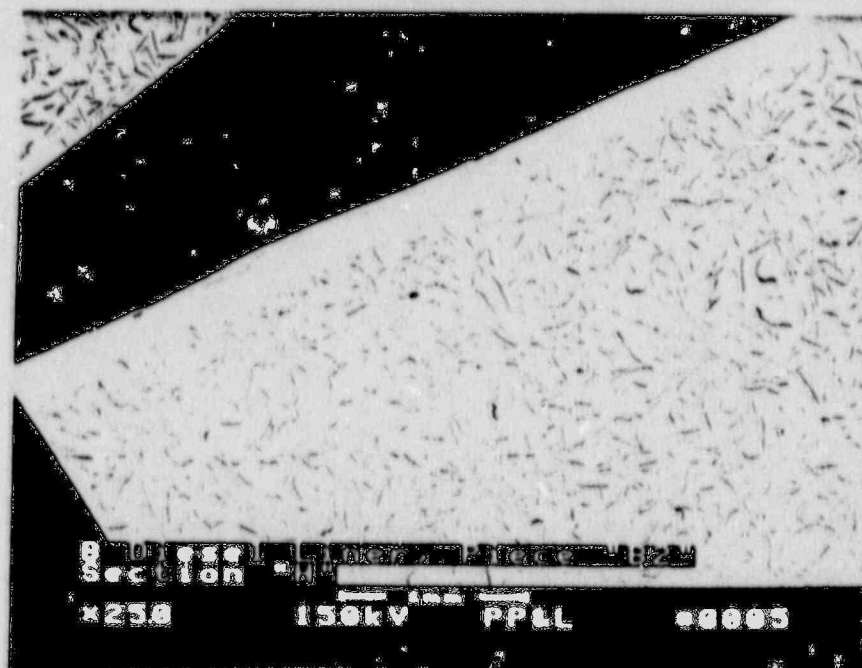
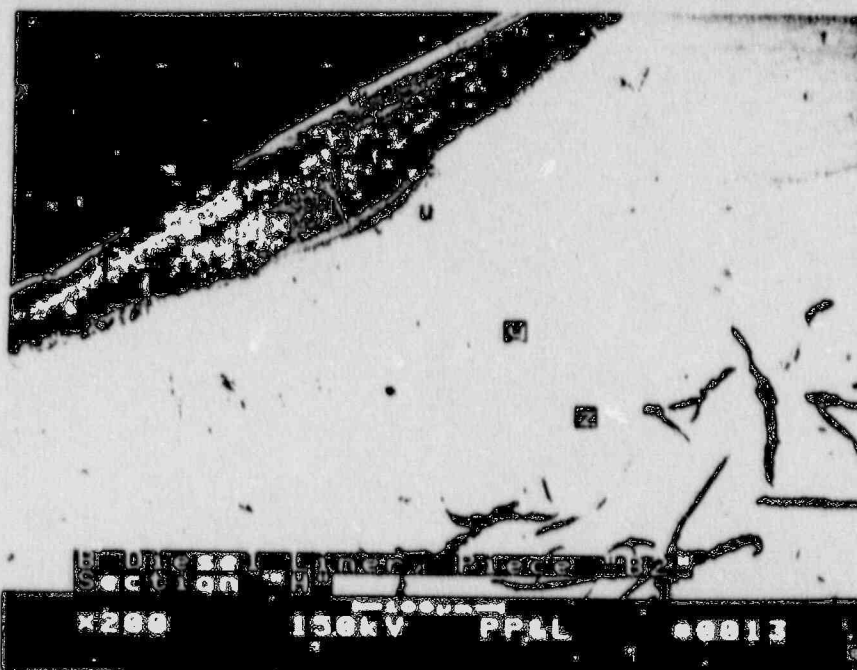
Figure B-40. End cap side of the B diesel 7L liner taken from transverse section H showing damage to the chromium liner and deposited metal. EDS analysis of the various layers are shown in figures B-41 and B-42.

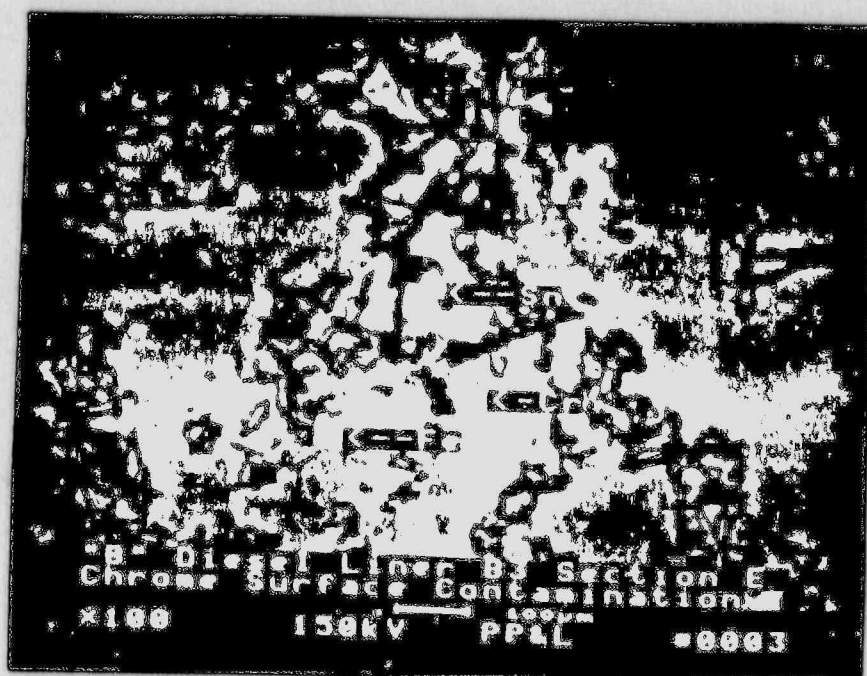
Figure B-44. Magnified image of the surface condition of the non-thrust side of the B diesel 7L liner near the upper position of the top compression ring. Both iron and tin are seen embedded in the chromium liner pores.

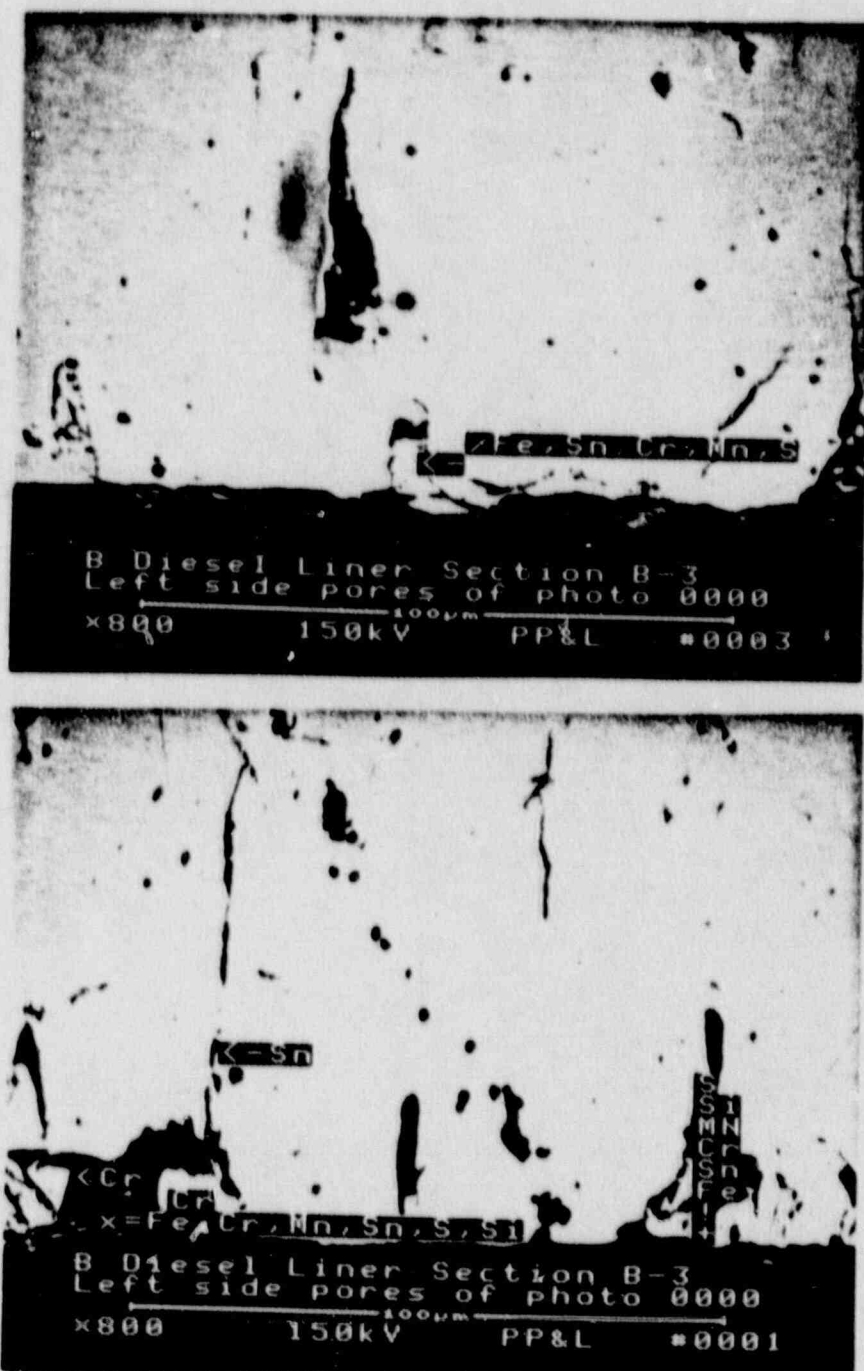
Figure B-55. Another area of pore deposits and elements found present in longitudinal cross-section 'C' part B-3 of the B diesel liner 16.5 inches from the bottom.

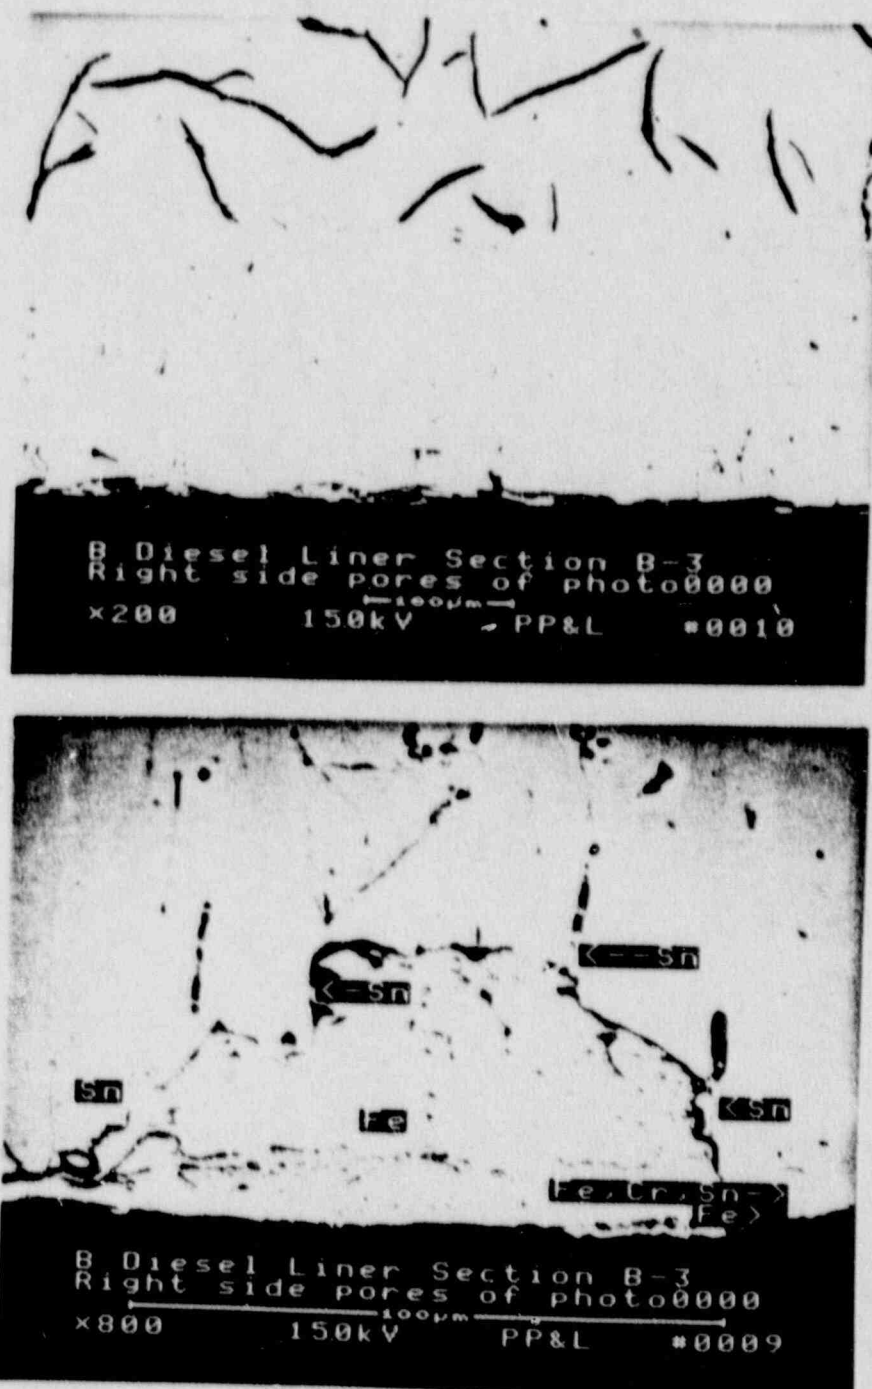
Figure B-56. Various elements and their location found in a pore from the B diesel liner 7L, part B-3, area 'C'.

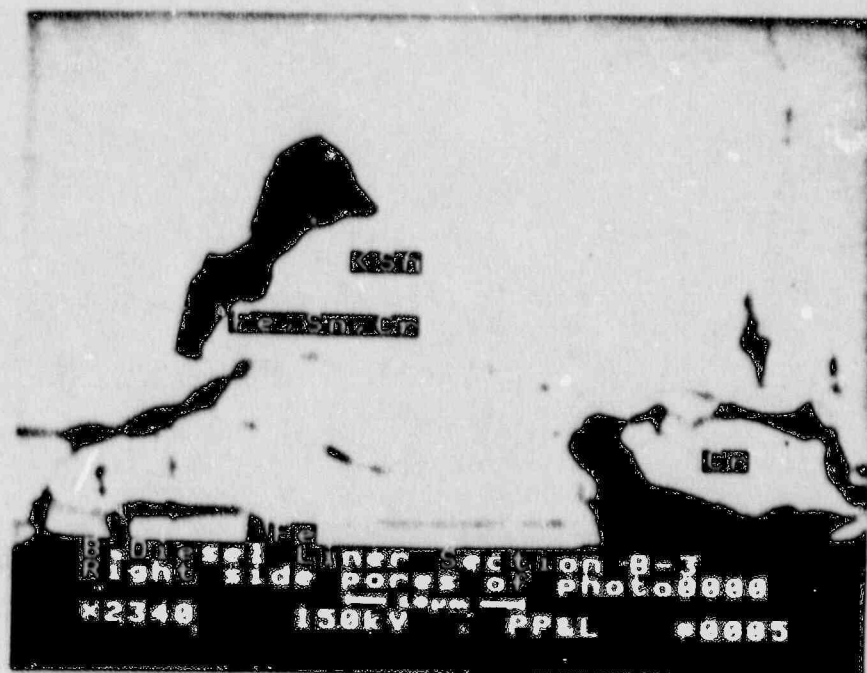
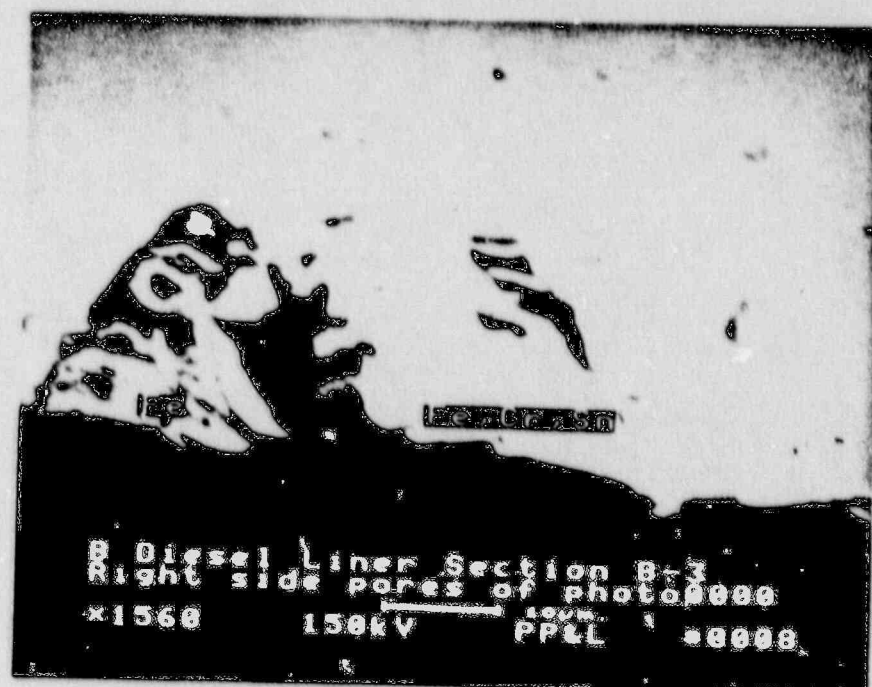
Figure B-57. Elemental contents of two pores filled with metal in the B diesel 7L liner 16.5 inches from the bottom of part B-3, area 'C'.

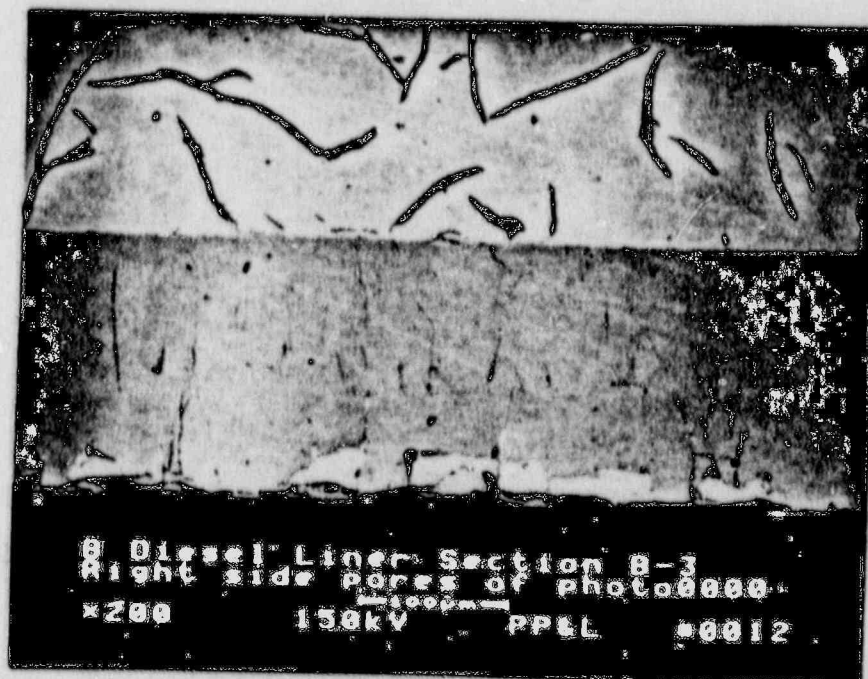
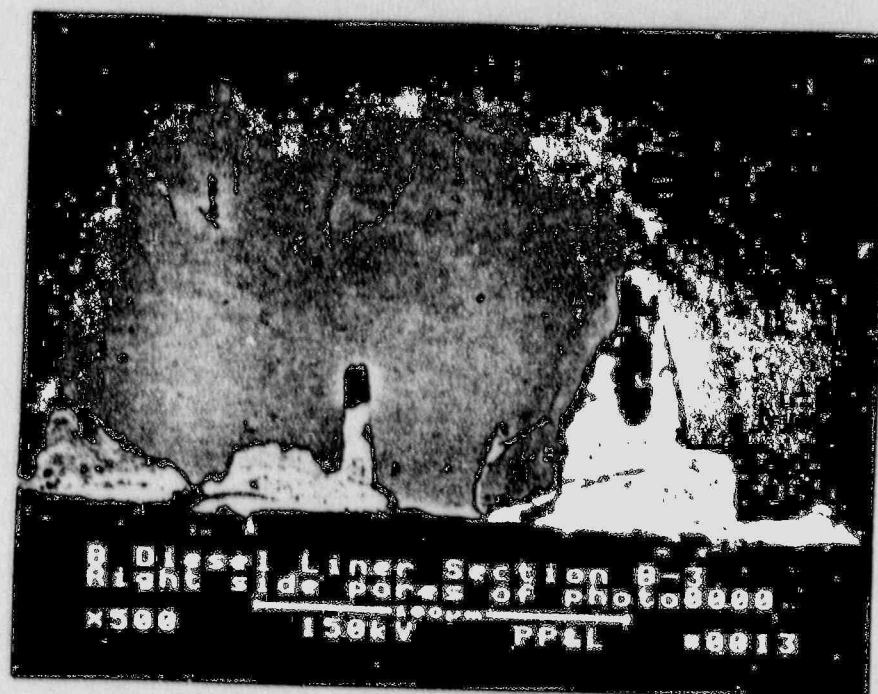
Figure B-58. Additional areas of filled pores found in area 'C' of part B-3 of the B diesel 7L cylinder.

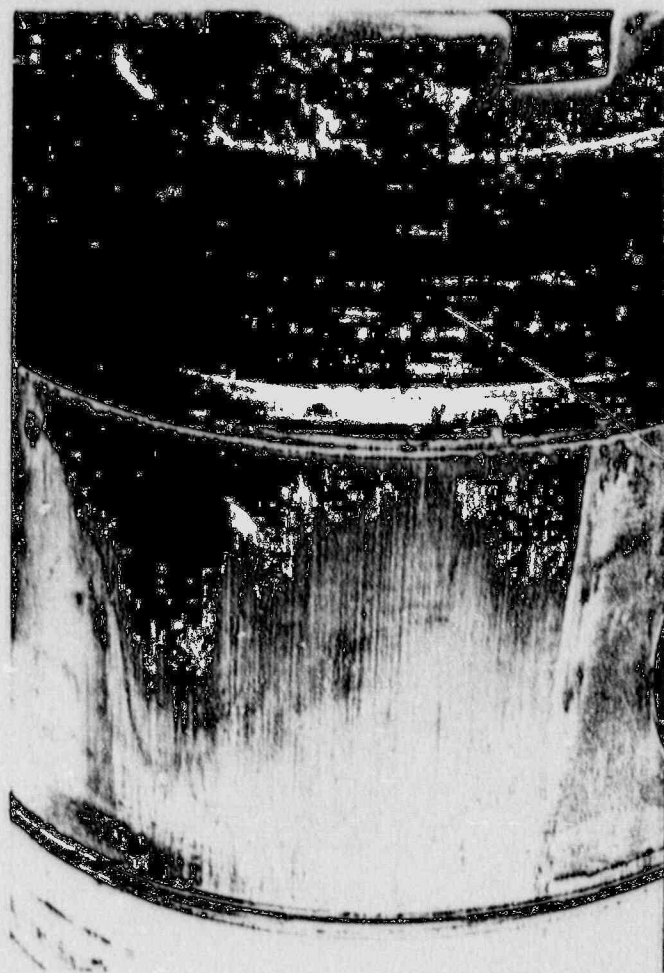
Figure C-1. Photograph of the 6L piston from the C diesel showing the area of detining and the alignment of the compression rings.

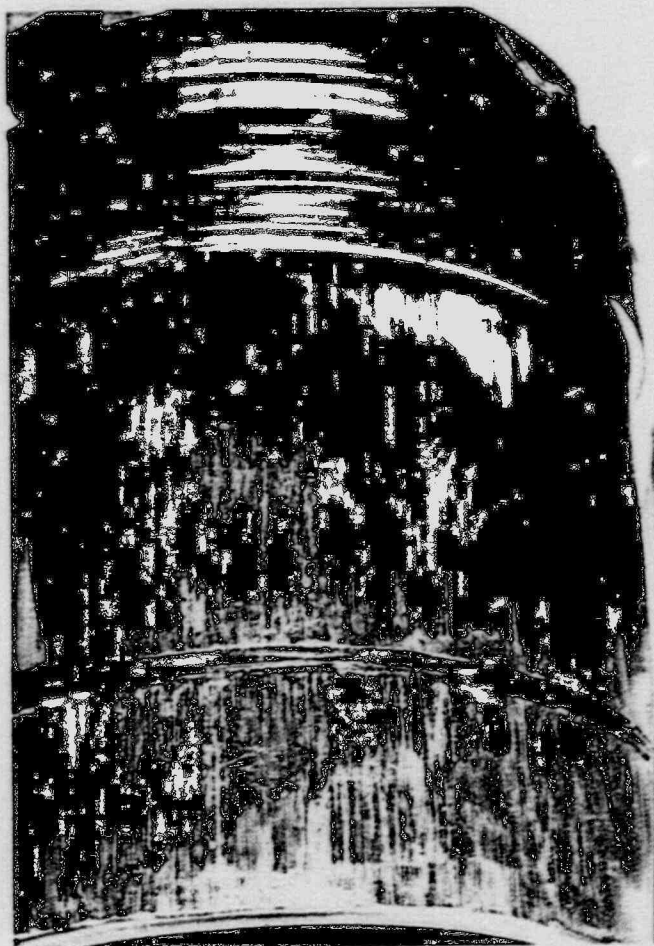
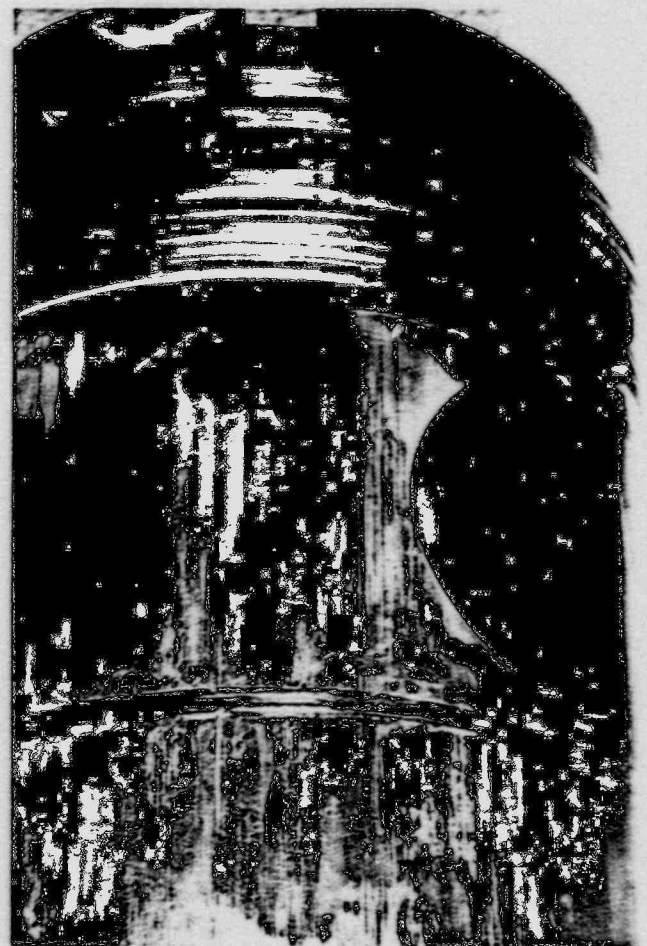
Figure C-6. Photographs of the damage on the thrust side (center of engine) of the 5R piston, C diesel.

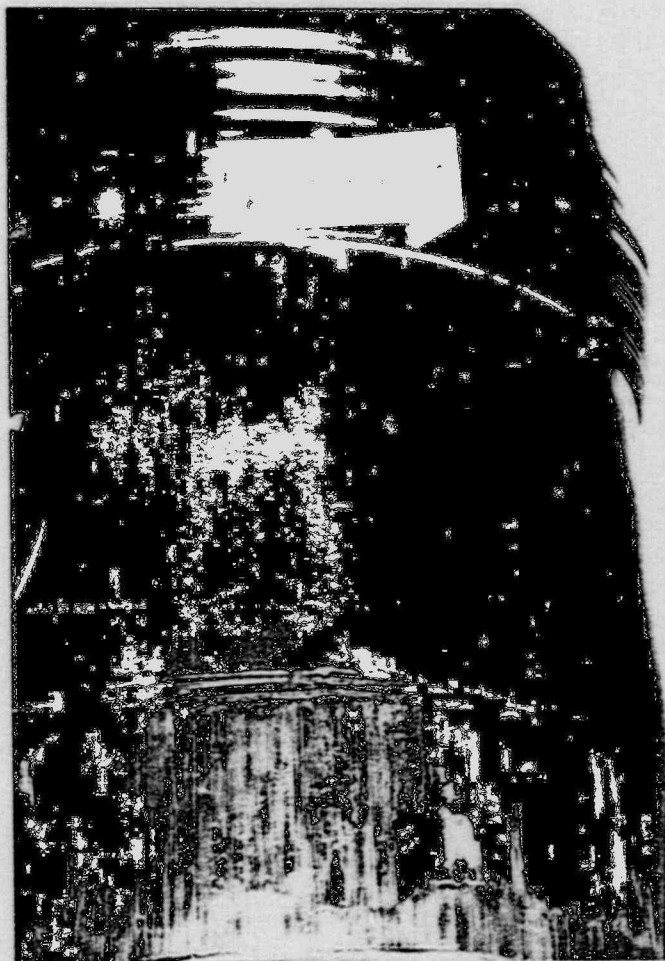
Figure C-8. Photographs of the damage on the non-thrust side of the 5R piston, C diesel; Note the two holes in the skirt at the bottom center of the photo on the right.

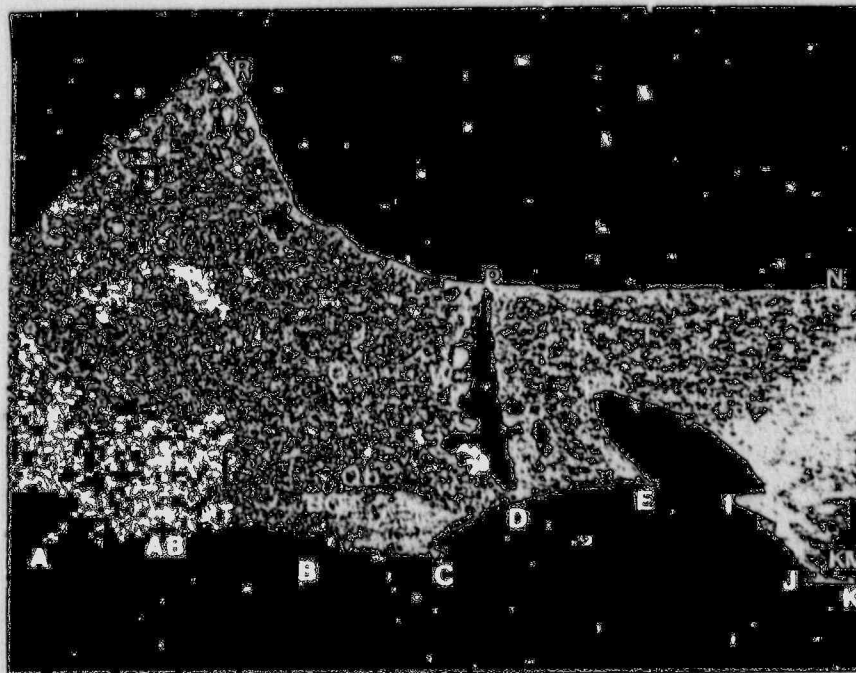
Figure C-10. A microphotograph of the cross section of the 5R piston skirt Hole 'A'; in Figure C-9. The letters designate the areas evaluated metallurgically.

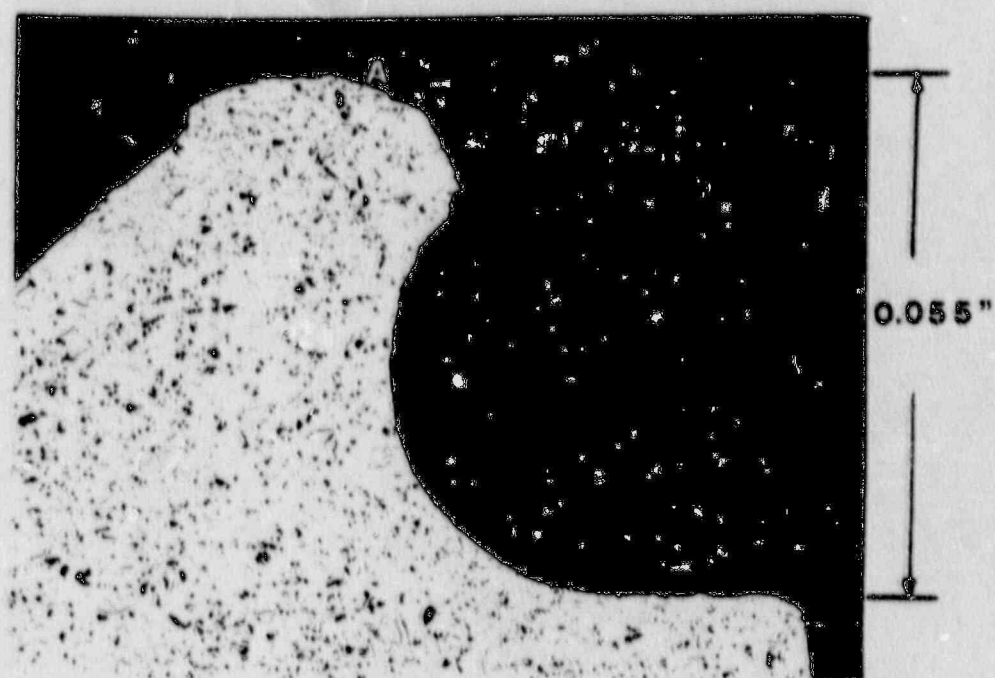
Figure C-21. Microphotograph at 50X of cross section of the lower oil ring from the 5K piston, C diesel. The deformed structure where the oil ring was worn can be seen at area 'A'.

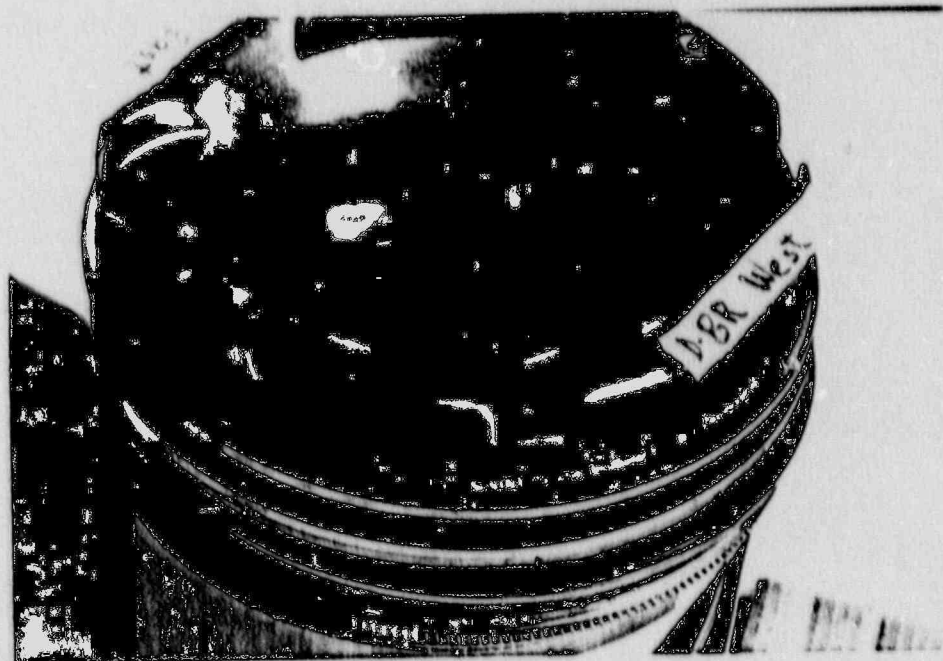
b

Figure D-1. (a) Non-thrust side of 8R piston showing wear between No. 1 and No. 2 compression rings. (b) Head view of 8R piston.

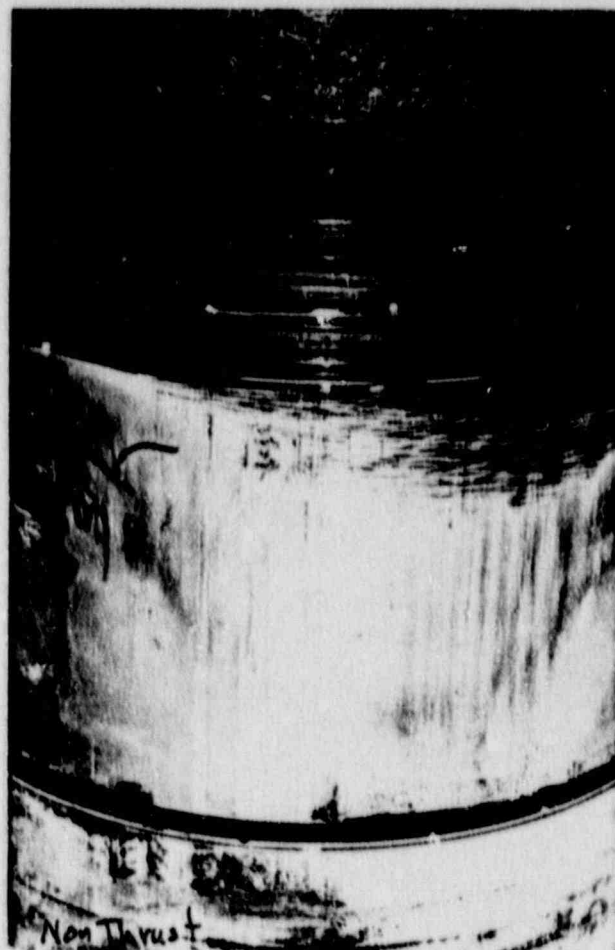
Figure A-2. Photo of the longitudinal scratches on the non-thrust side of the 3R piston - probably caused by the piece broken off the middle oil ring.

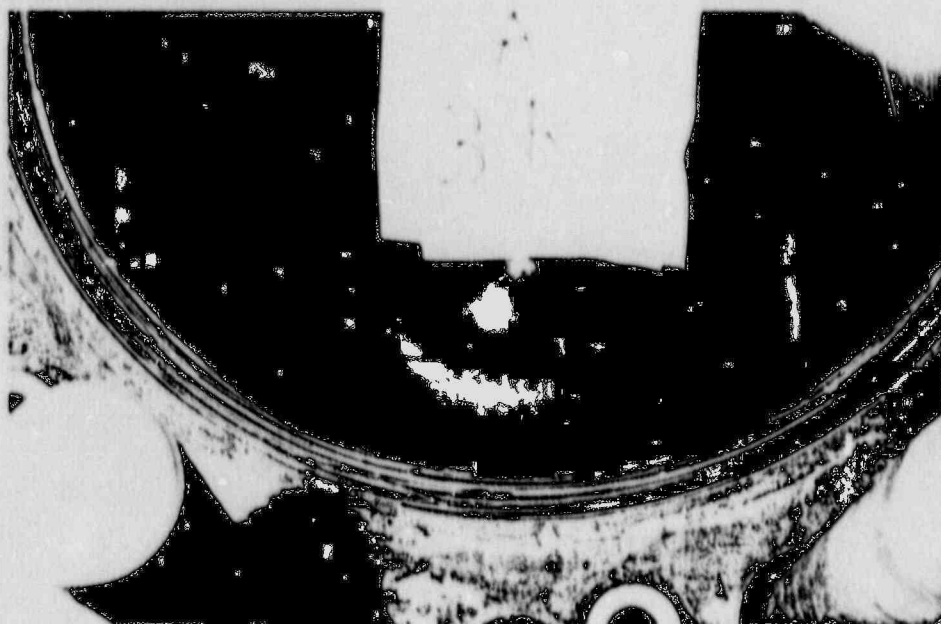
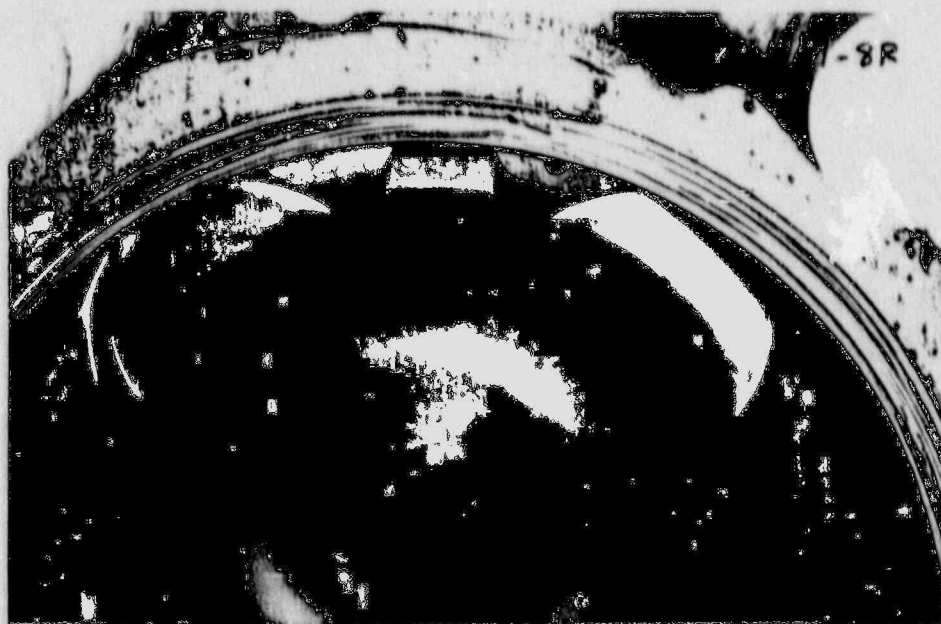
When Maintenance removed the heads from the 8R and 3R cylinders, they discovered damaged gaskets. The gaskets, shown in photos on Figures 5a and b, had disintegrated to a point where just the metal portion of the gasket remained; no binder was left. Cooper has substituted new gaskets that no longer deteriorate.

Figure A-5. Photos of deteriorated head gaskets found after removing head on cylinder 3R. All the binder in the gasket had disintegrated leaving the metal windings.
