PRAIRIE ISLAND NUCLEAR GENERATING PLANT  
Docket Nos. 50-282 License Nos. DPR-42  
50-306 DPR-60

Response to Generic Letter 89-13  
Service Water System Problems  
Affecting Safety-Related Equipment

SERVICE WATER SYSTEM PROBLEMS  
AFFECTING SAFETY-RELATED EQUIPMENT

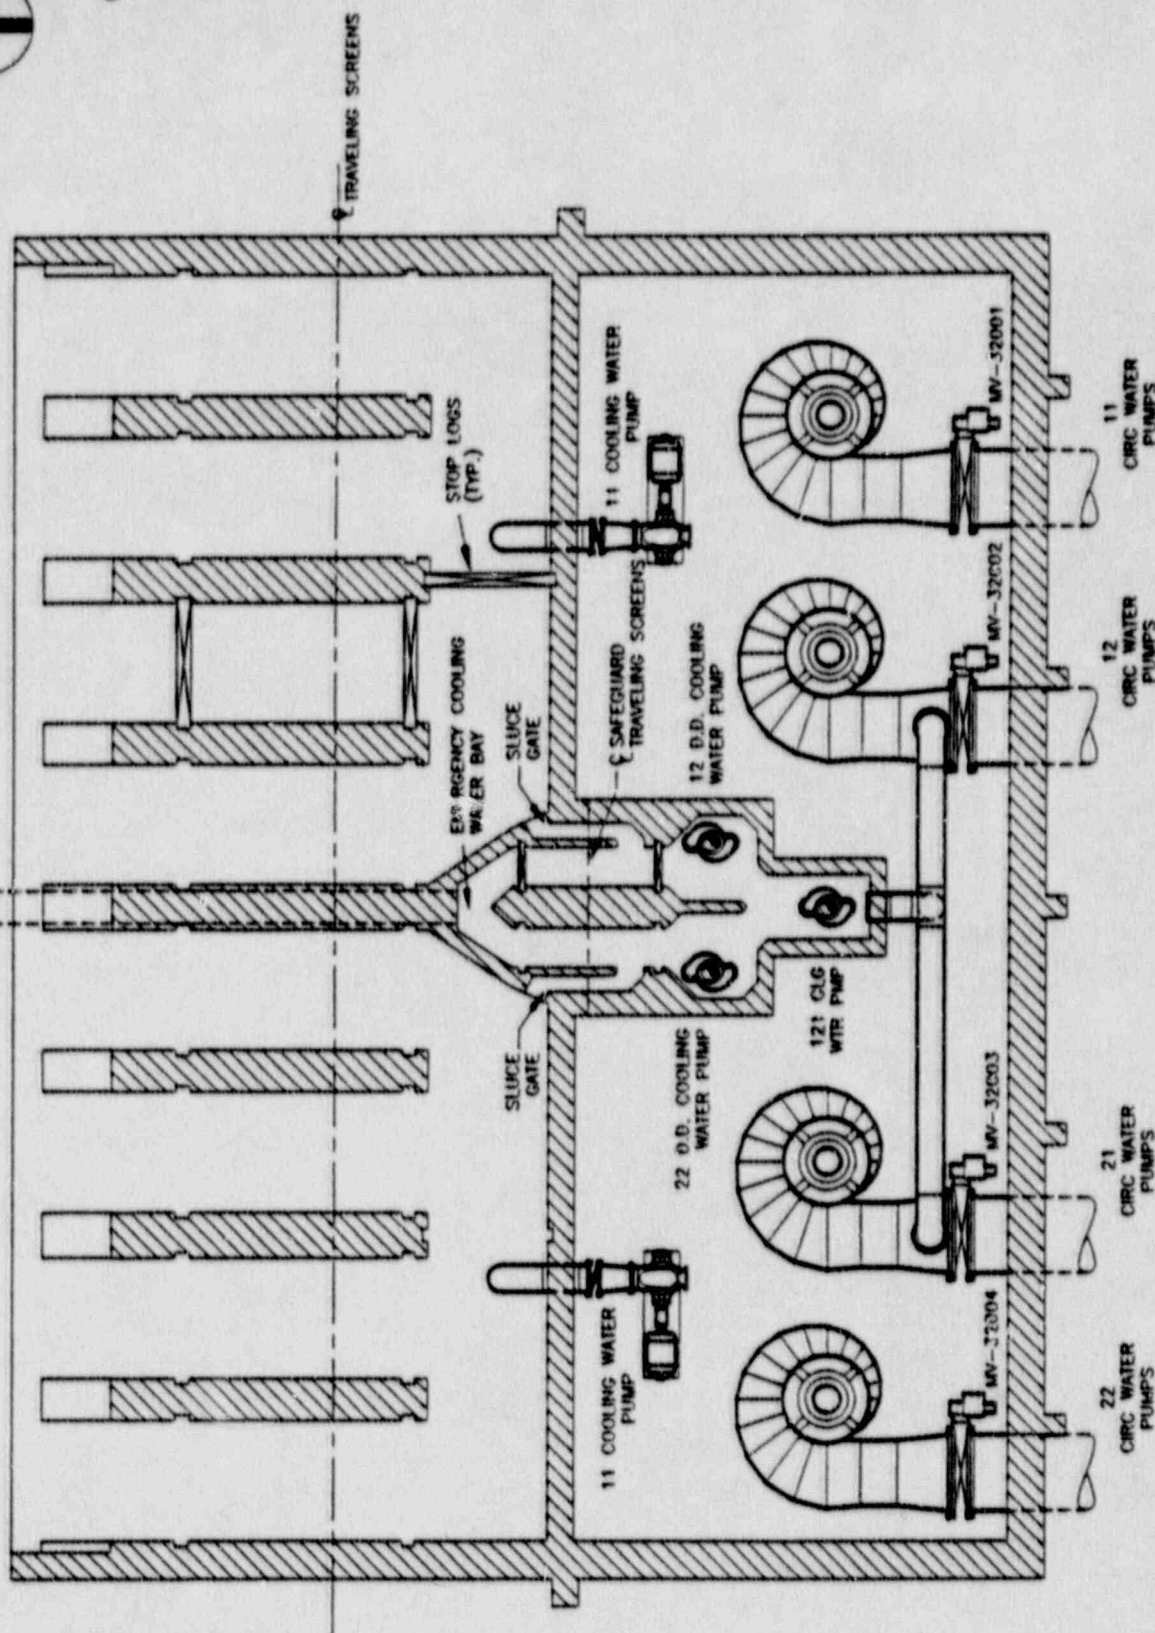
FIGURE 1

Prairie Island has two different intake locations for the emergency cooling water pumps. The normal supply to the emergency pump bay is from the circulating water pump bay. Water is also supplied to the emergency bay via a 36" emergency intake pipe. This pipe, buried in the approach canal and intake canal bottom, directs water from the deepest part of the river to the emergency bay (See Figure 1).

The emergency intake bay and intake pipe are flushed on a monthly basis via a standing surveillance procedure. A recent inspection by a scuba diver has proven this method to be very effective in lieu of dewatering and cleaning. Because the emergency intake bay and intake pipe are shared by both units it is not possible to dewater the complete emergency cooling water bay due to safety concerns and Technical Specification limitations.

A procedure will be developed to periodically inspect the emergency intake crib located in the river. The initial inspection was performed in the Fall of 1989. Since this inspection demonstrated that the monthly backwash has been effective, the frequency of these inspections will be set at 5 years.
