LIMERICK GENERATING STATION

SUBJECT: Licensee Event Report  
Limerick Generating Station - Units 1 and 2

Reference:	Docket No. 50-353
Report Number:	2-90-002
Revision Number:	00
Event Date:	January 8, 1990
Report Date:	February 7, 1990
Facility:	Limerick Generating Station P.O. Box A, Sanatoga, PA 19464

FACILITY NAME (1)  
Limerick Generating Station, Unit 2DOCKET NUMBER (2)  
0 5 0 0 0 3 5 3 1 OF 0 6TITLE (4)  
Hydrogen/Oxygen Analyzer Inoperability due to Installation Error

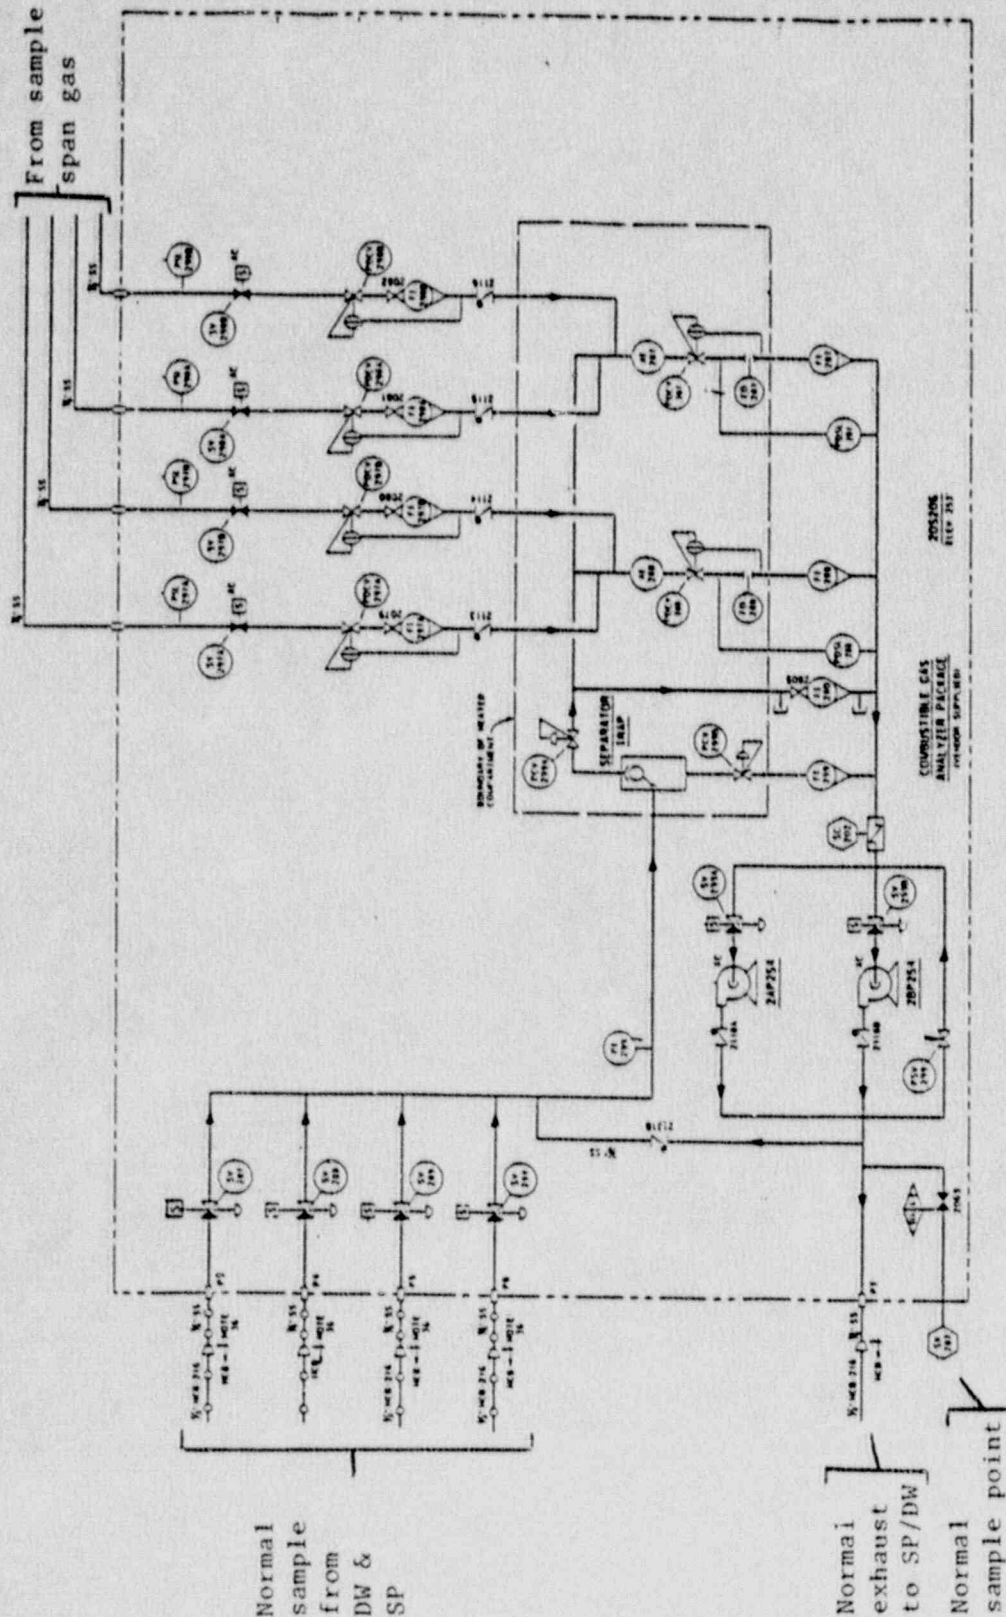
(See LCS Piping and Instrument Diagram M-57 sh 6 of 6 for detail)

During troubleshooting of the analyzer a Health Physics (HP) technician requested an Instrumentation and Controls (I&C) technician to remove the return gas sample point line cap to enable him to obtain a direct sample of the SP atmosphere (see attached sketch). At this time, approximately 1845 hours on January 5, 1990, the I&C technician determined that the ports on the sample skid for the sample line and exhaust to the containment were incorrectly tubed. This resulted in a recirculation path back through the analyzer rather than an exhaust path to the SP as designed. A sample of the SP atmosphere was obtained to verify that the nitrogen inerting was progressing as planned. A Maintenance Request Form (MRF) was generated to correct the reversed tubing and the designed sample line isolation valve 57-2063 was blocked open with a supervisory blocking tag attached. The open valve resulted in an exhaust path to the SP as designed and the analyzer was recalibrated and restored to operable status at 0001 hours, January 6, 1990, approximately 23 hours after discovery of the inoperable condition.

The cause of this event was an error in the labeling of the connection ports on a vendor supplied analyzer. The H2/O2 analyzers are supplied by Comsip-Delphi (model-K). Installation of the analyzer was accomplished by connecting the labeled outlet/inlet ports to the desired locations/lines in the plant. In this instance (see attached sketch) the port on the panel for connection to the sample line was labeled as the port for connection to the exhaust to containment and vice-versa. As a result of the reversed installation, the normally closed sample point isolation valve, 57-2063, was in the line exhausting to containment while the sample point line had only a cap. This resulted in an indeterminate percentage of sample recirculation through the analyzer rather than normal exhaust to the SP or DW.

During the pre-operational test phase analyzer calibration was considered to have been achieved because, during calibration, PCV-57-299A (see attached sketch) acts as a stop valve forcing the exhaust gases back to the SP through the sample line. This configuration, although not a designed exhaust path to the SP, would allow sufficient exhaust flows to achieve calibration of the analyzer. The problem was not suspected because flow through the analyzer was observed. During normal operation PCV-57-299A would allow recirculation due to the closed exhaust path preventing accurate indication of the SP H2/O2 concentration.

The return gas sample point valve 57-2063 was opened and then a supervisory block was applied. The analyzer was calibrated by I&C technicians and declared operable at 0001 on January 6, 1990. A MRF was initiated to correct the reversed tubing to agree with approved design. The physical work was completed January 17, 1990, the supervisory block on 57-2063 was removed, and the sample valve was restored to its normally closed position.
