Public Service Company of Colorado

March 19, 1981
Fort St. Vrain
Unit No. 1
P-81099

REPORTABLE OCCURRENCE 81-019

REPORT NO. 50-267/81-019/03-L-0

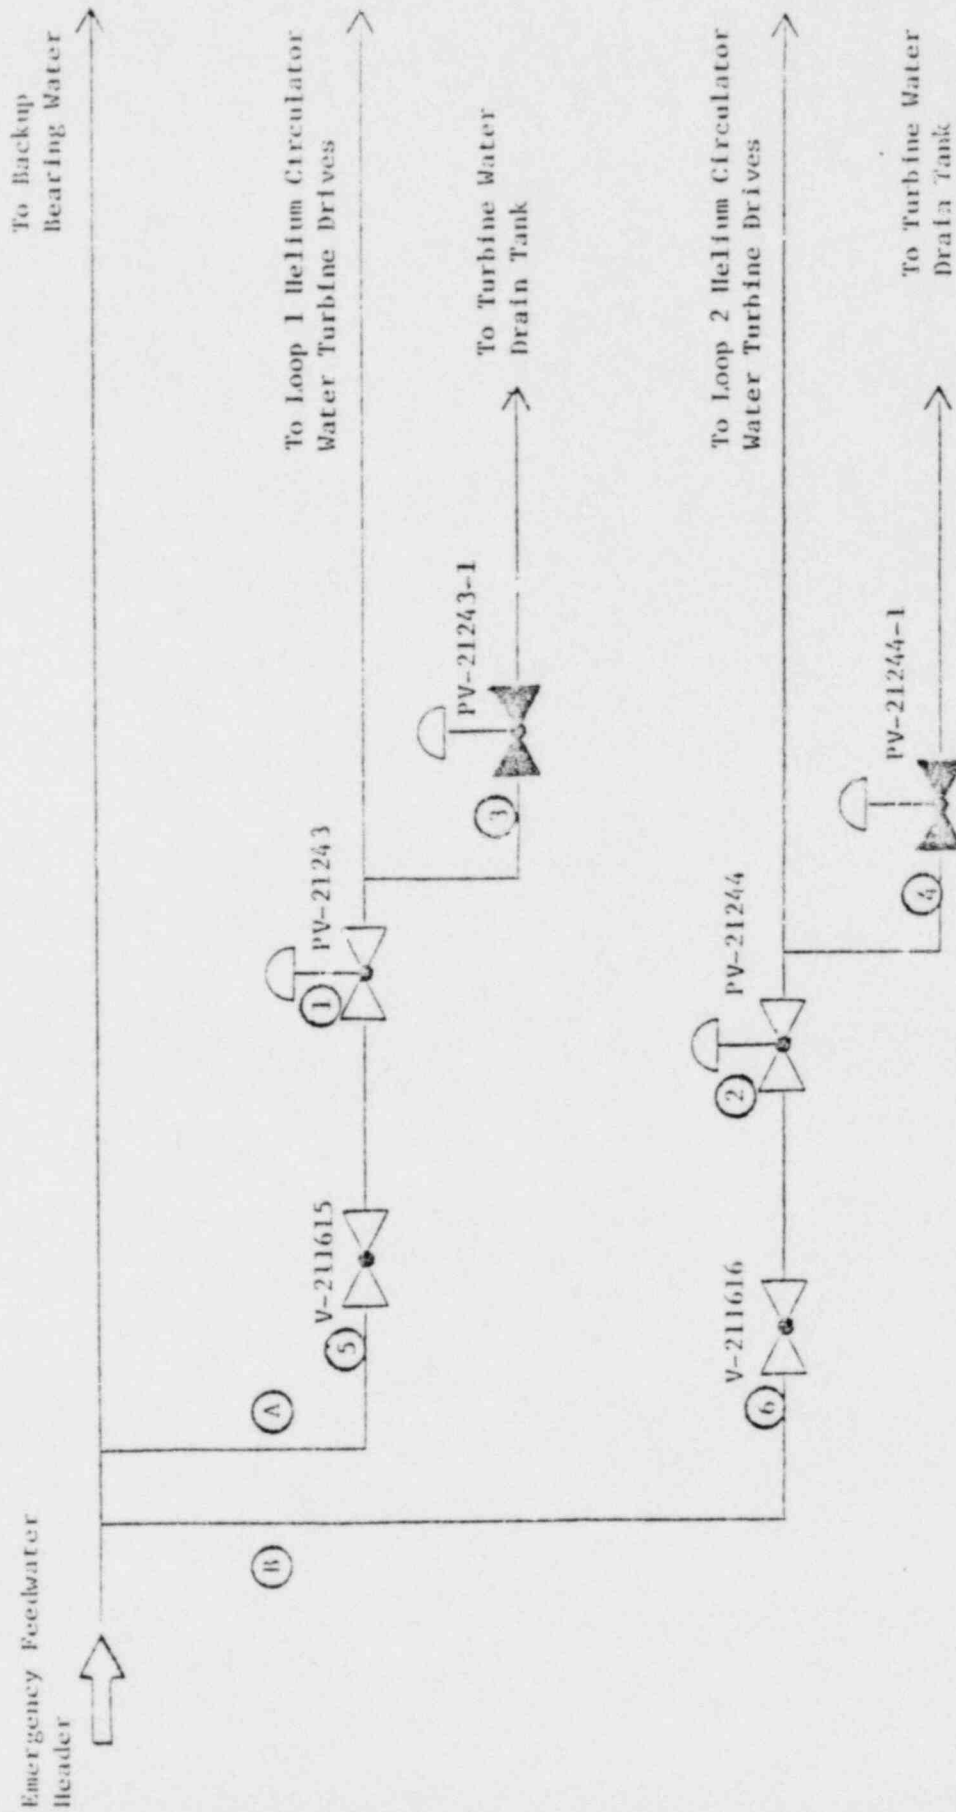
FIGURE 1

Refer to Figure 1 for simplified diagram of this system. A pressure control system is provided to control emergency feedwater flow to each of the circulator pelton wheel supply headers (A) and (B) under flow and no-flow conditions. Under flow conditions, PV-21243 (1) controls supply header pressure. Under no-flow conditions, PV-21243-1 (3) is provided to relieve excess header pressure to the turbine water drain tank in the event PV-21243 leaks through. In both of these events, PV-21243-1 was allowing too much pressure to be bled off the header, thereby, causing PV-21243 to cycle erratically. This would not, in itself, render the emergency feedwater to Loop 1 circulators inoperable.

In both events, excess flow through PV-21243-1 caused erratic cycling of PV-21243, necessitating manual isolation of emergency feedwater to Loop 1 circulators to effect repairs.

Emergency Feedwater Pressure Control

PV-21243-1 valve stroke was lengthened and the system returned to service.

PV-21243-1 was removed for repair. The valve seat and stem were replaced, the valve re-installed, and the system returned to service.
