LICENSEE EVENT REPORT

1. Reportable Occurrence Report No. 50-313/80-015/01X-2
2. Report Date: April 13, 1981
3. Occurrence Date: 5/10/80
4. Facility: Arkansas Nuclear One - Unit One
Russellville, Arkansas
5. Identification of Occurrence:

Abnormal degradation discovered in Reactor Coolant System pressure boundary, due to a total reactor coolant leakage rate exceeding 10 GPM, defined by T.S. 3.1.6.1. Reportable per T.S. 6.12.3.1.C.

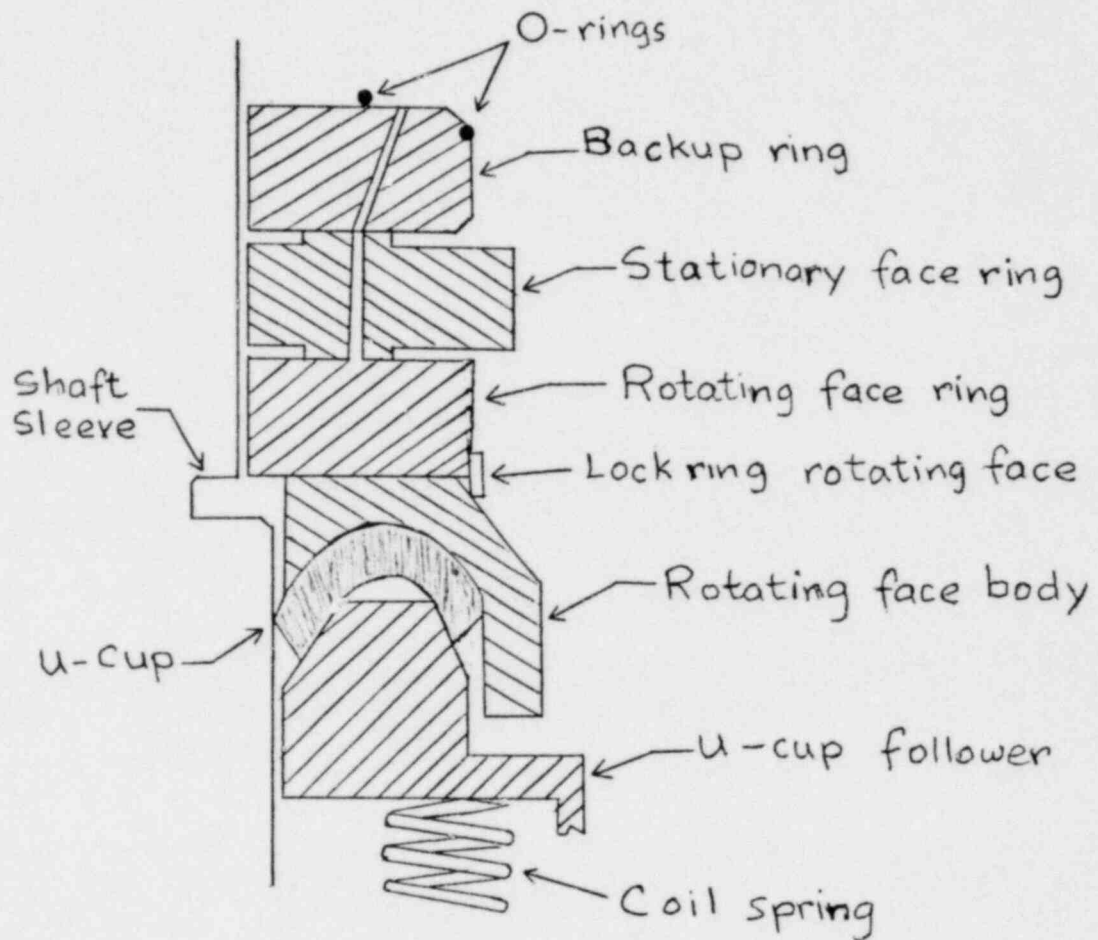
Figure 1

Byron Jackson Pump
Seal Arrangement
