June 3, 1981
Fort St. Vrain
Unit No. 1
P-81158

REPORTABLE OCCURRENCE 1-034

FORT ST. VRAIN NUCLEAR GENERATING STATION
PUBLIC SERVICE COMPANY OF COLORADO
16805 WELD COUNTY ROAD 19 1/2
PLATTEVILLE, COLORADO 80651

REPORT NO. 50-267/81-034/03-L-0

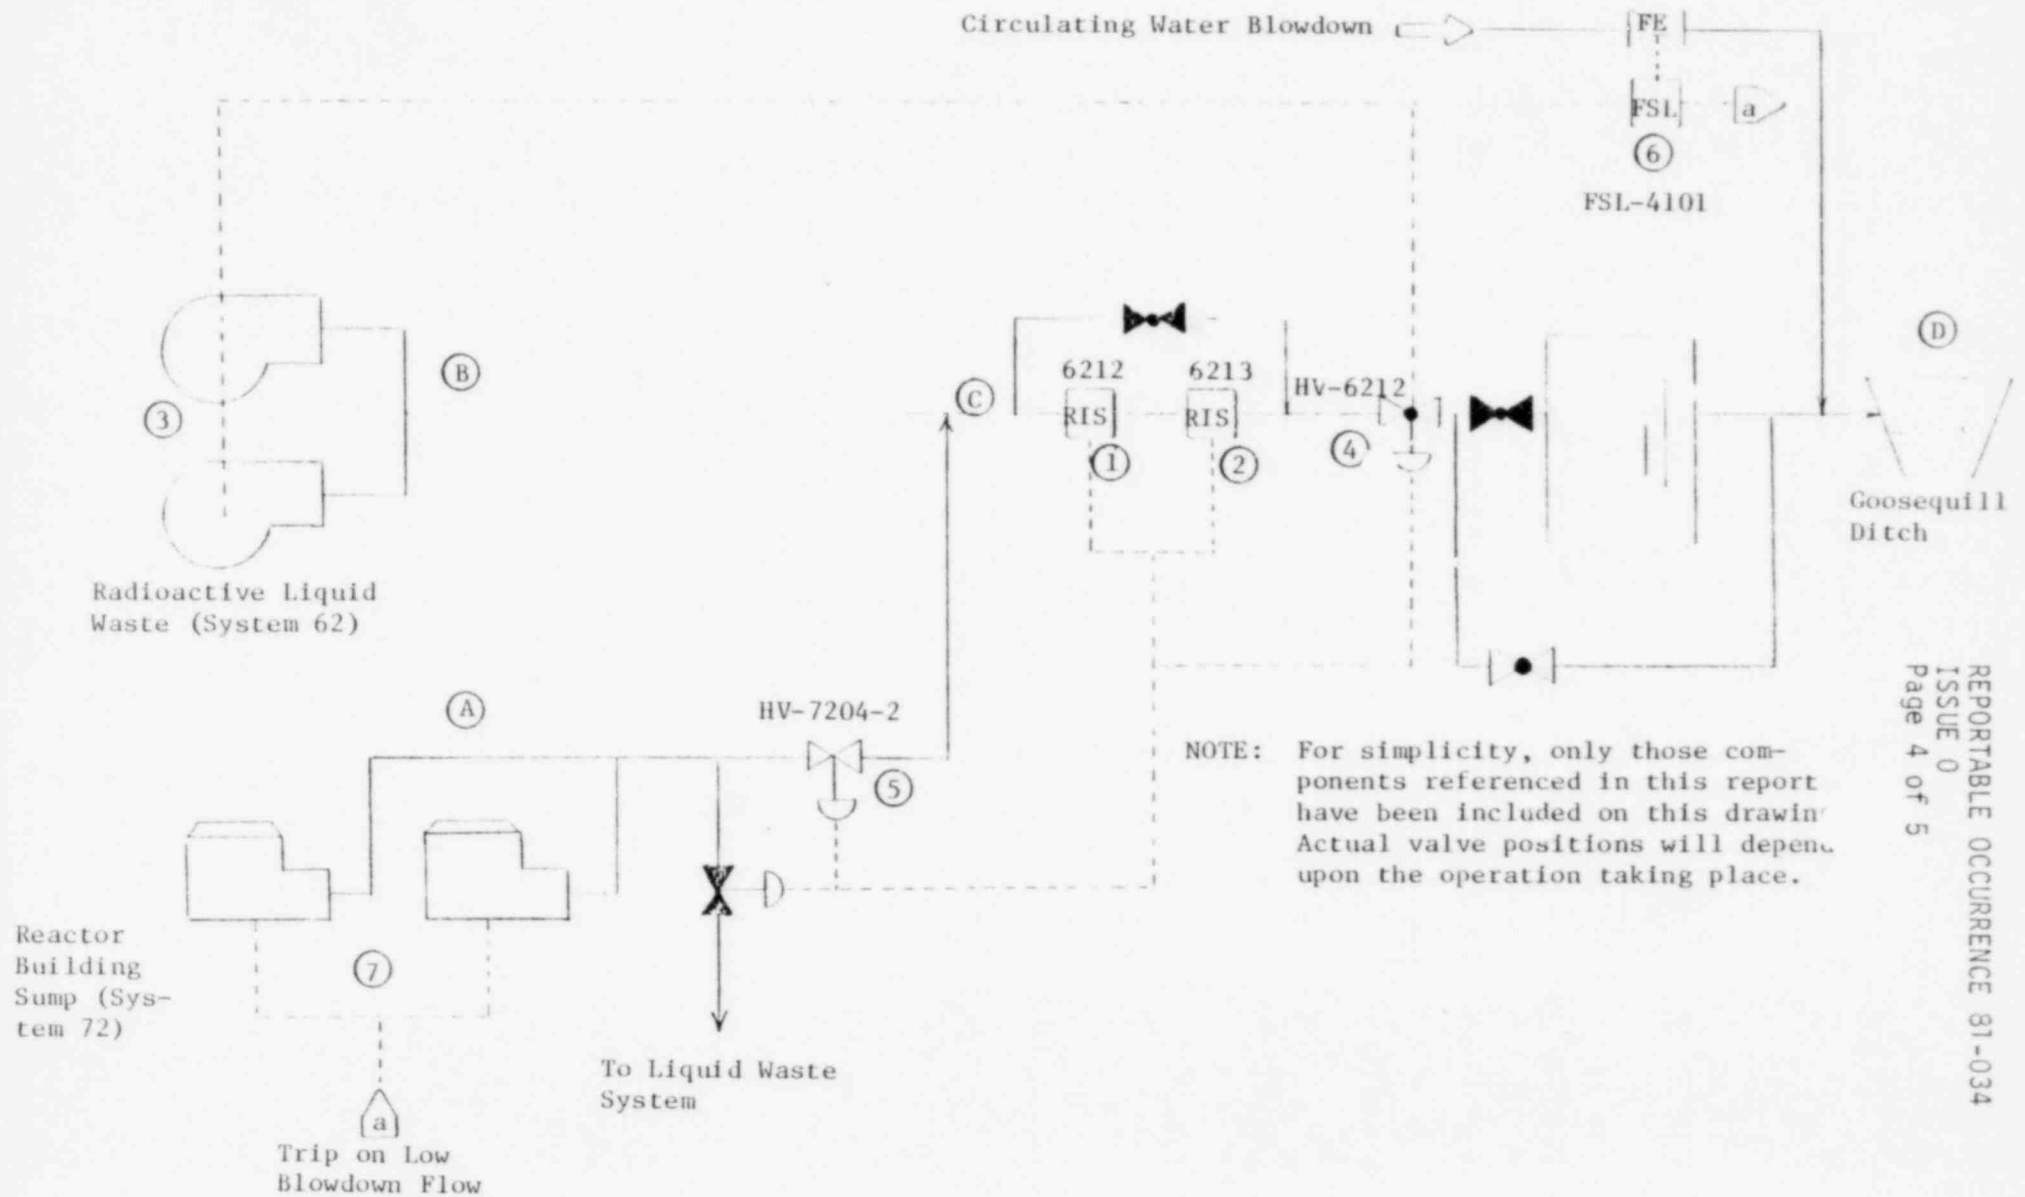
FIGURE 1

Refer to Figure 1. Effluents from the Reactor Building sump (A) and the liquid waste system (B) are discharged to a common line (C) leading to the Goosequill Ditch (D). Circulating water blowdown (E) is admitted for dilution purposes prior to the effluent reaching the Goosequill Ditch. Radiation monitors RIS-6212 and RIS-6213 (1 and 2) in the common discharge line alarm at preset values on high activity in effluent discharged from either the Reactor Building sump or the liquid waste system and provide a signal to trip the liquid waste transfer pumps (3), close HV-6212 (4), and if the release is from the Reactor Building sump, close HV-7204-2 (5), thus terminating the release.

Circulating water blowdown (dilution) flow is monitored by flow switch FSL-4101 (6) and at a preset value of low blowdown (dilution) flow provides a signal to close HV-6212 (4) and trip the liquid waste transfer pumps (3) and Reactor Building sump pumps (7a).

Examination of flow transmitter FT-4101 indicated that both sense lines on the associated flow element were partially plugged. This resulted in the erratic readings on flow recorder FR-4101 and flow integrator FI-4101.

Plant Trouble Report 4-385 was issued on April 29, 1981, indicating the faulty operation on flow controller FC-4101. Plant personnel discovered the partially plugged sense lines and blew out the lines on April 30, 1981. Subsequent testing indicated proper operation of the flow element and auxiliary equipment.
