## DUKE POWER COMPANY

Re: Oconee Nuclear Station  
Docket No. 50-269

Report Number: RO-269/81-11

Identification of Occurrence: Core Barrel Assembly Thermal Shield Bolts  
Broken

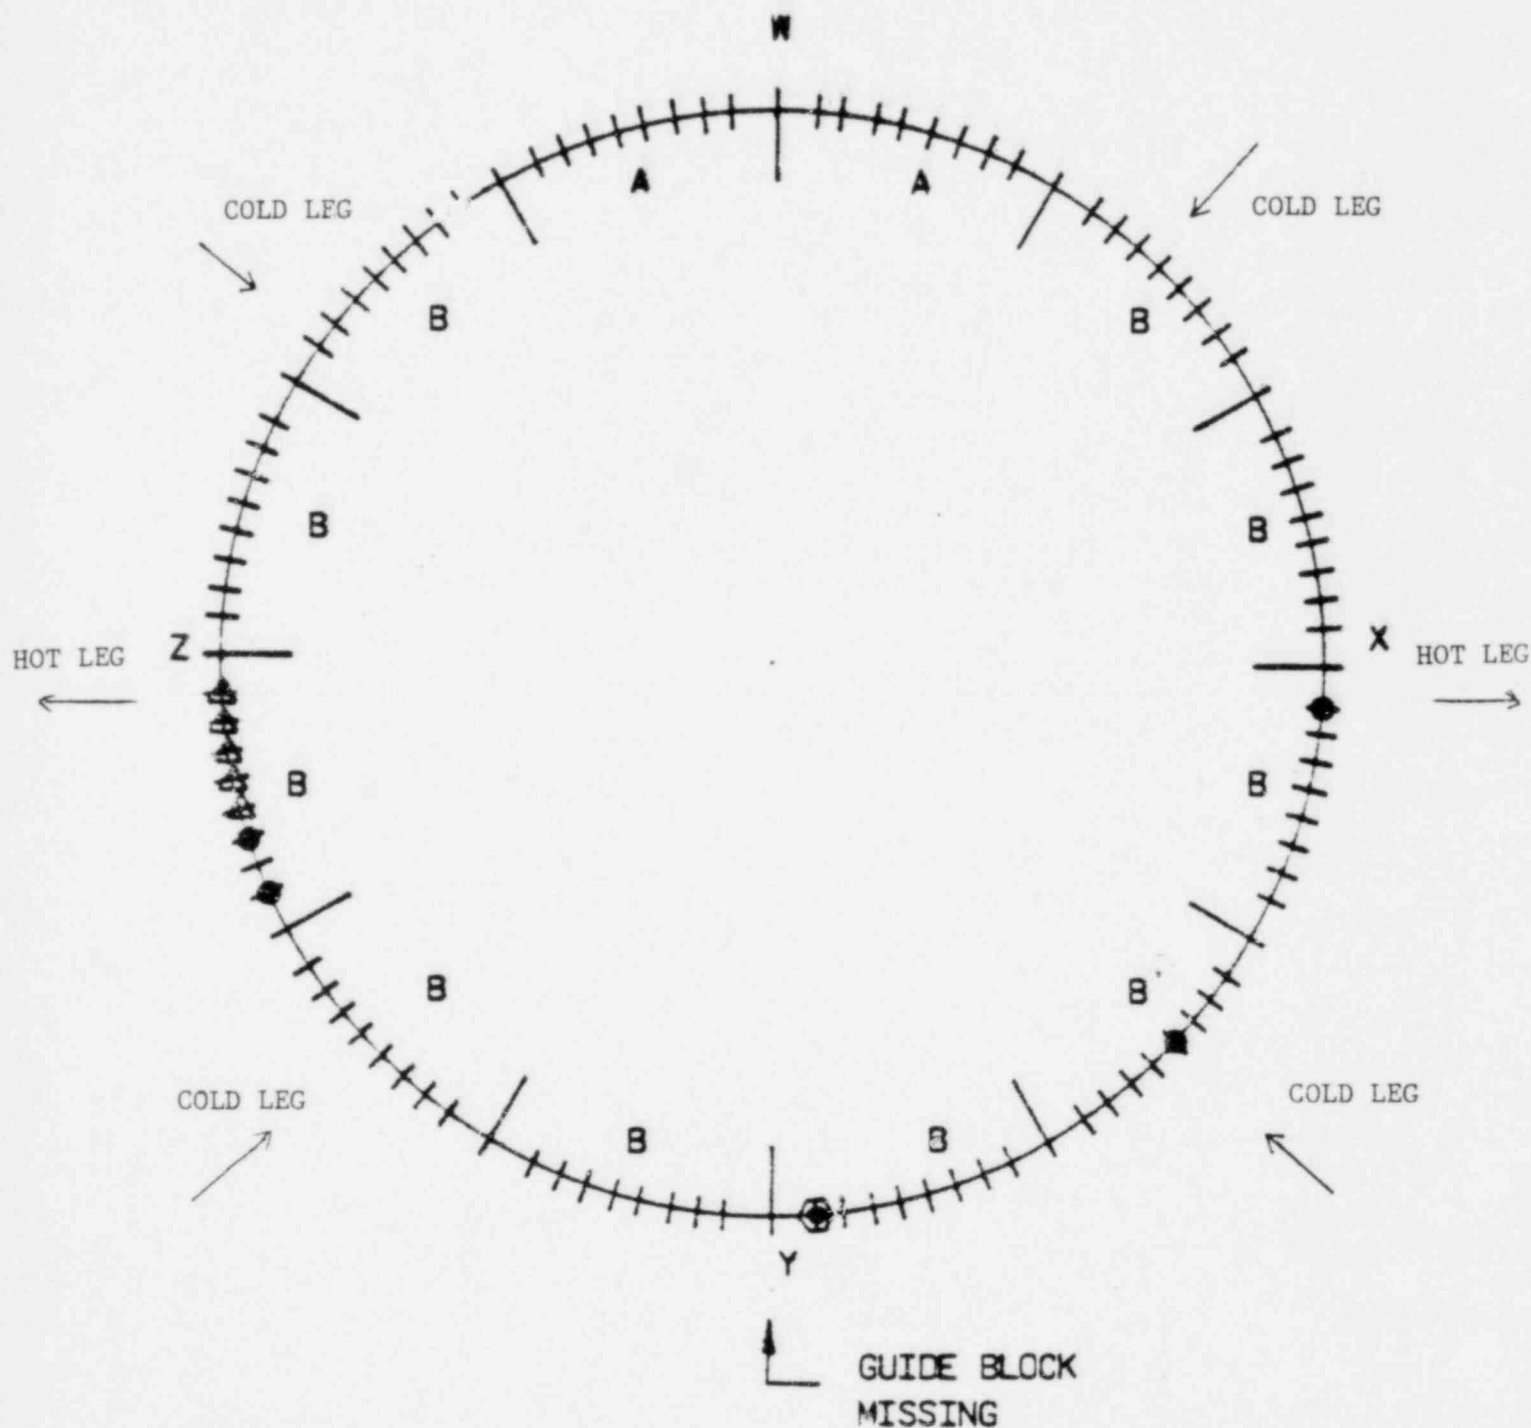
# LOWER THERMAL SHIELD

1. Four of 96 bolts connecting the thermal shield to the lower grid flow distributor flange were missing.
2. Approximately 80 per cent of the remaining thermal shield bolts were backed out from 0.1 to 0.5 inches.
3. Three bolt locking cups were missing.
4. One locking cup partially attached.
5. One guide block on the Y-axis was missing.

in Attachment 4. The ID of the thermal shield is machined to clear the bottom flange of the core barrel and to engage the lower grid with a diametral interference fit. Ninety-six 1-inch-diameter, high-strength bolts secure the bottom end of the thermal shield to the lower grid plate. (The four missing bolts were from this location.)

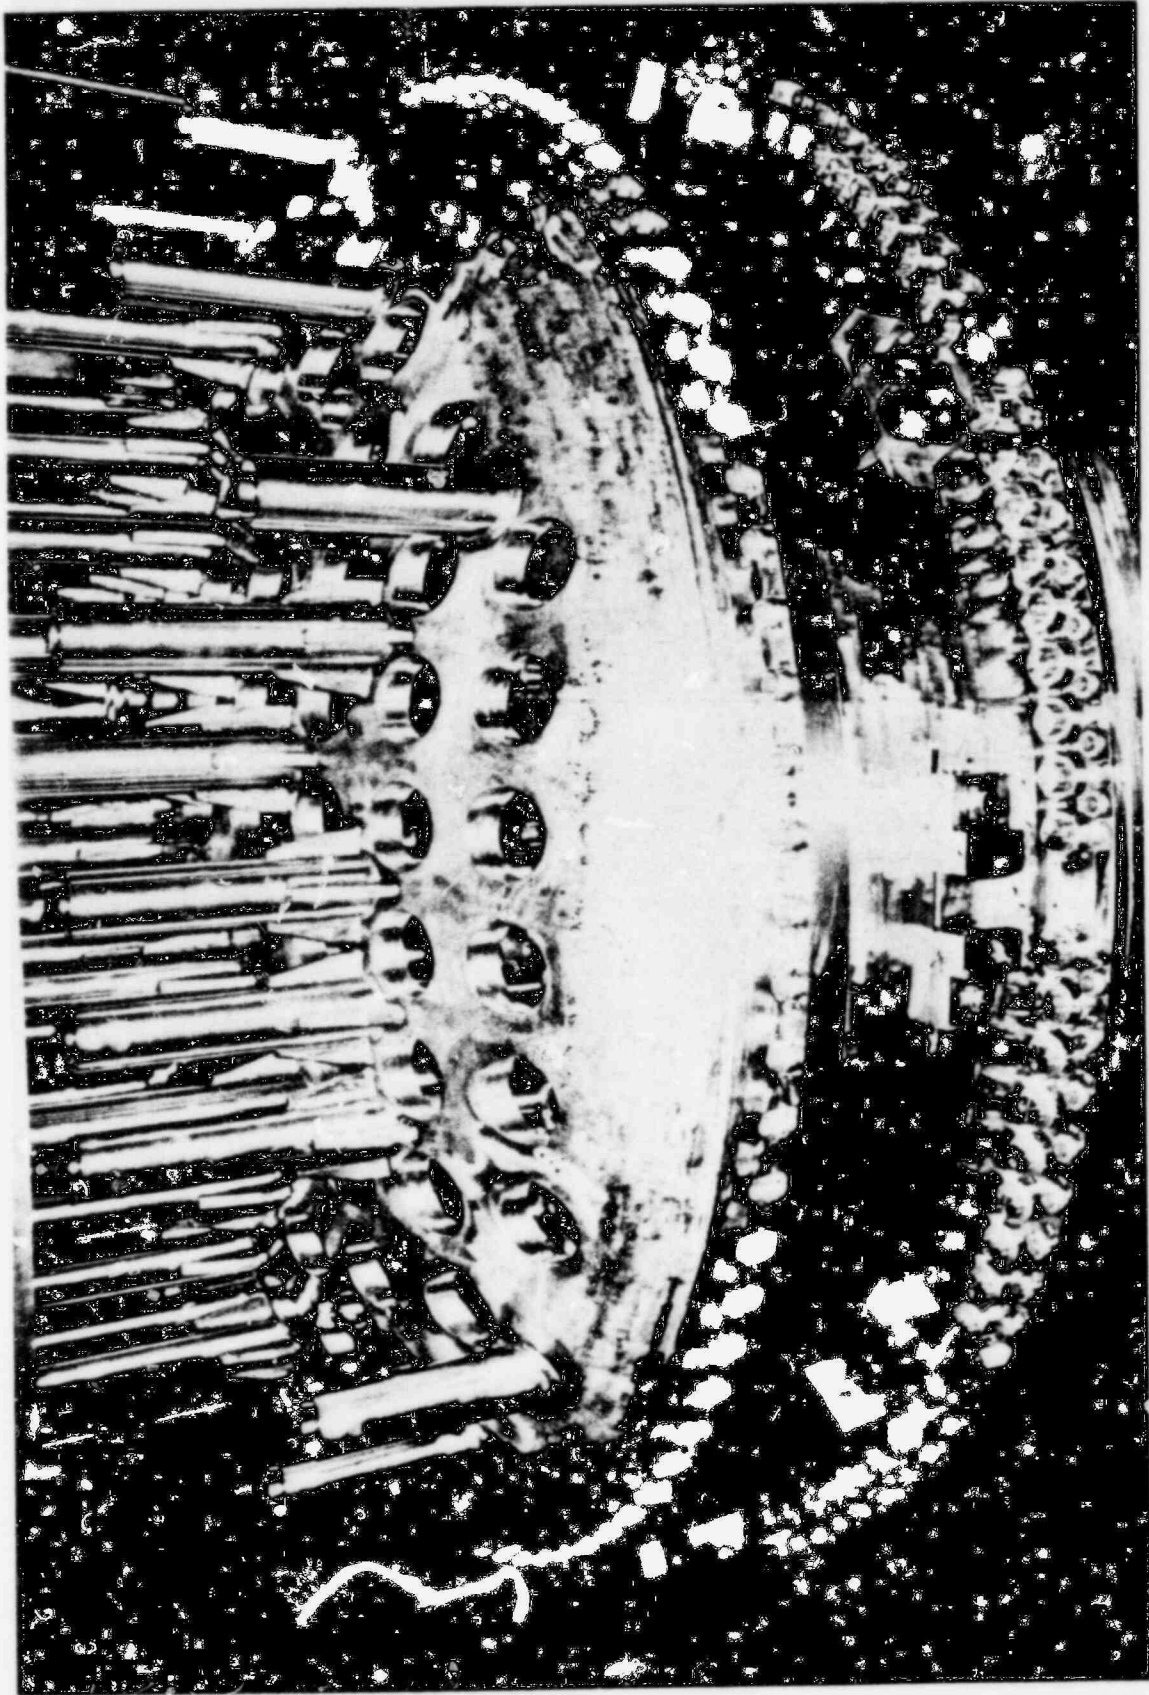
The above results are shown on Attachment 1. Attachment 2 is a photograph view of the lower portion of the internals.

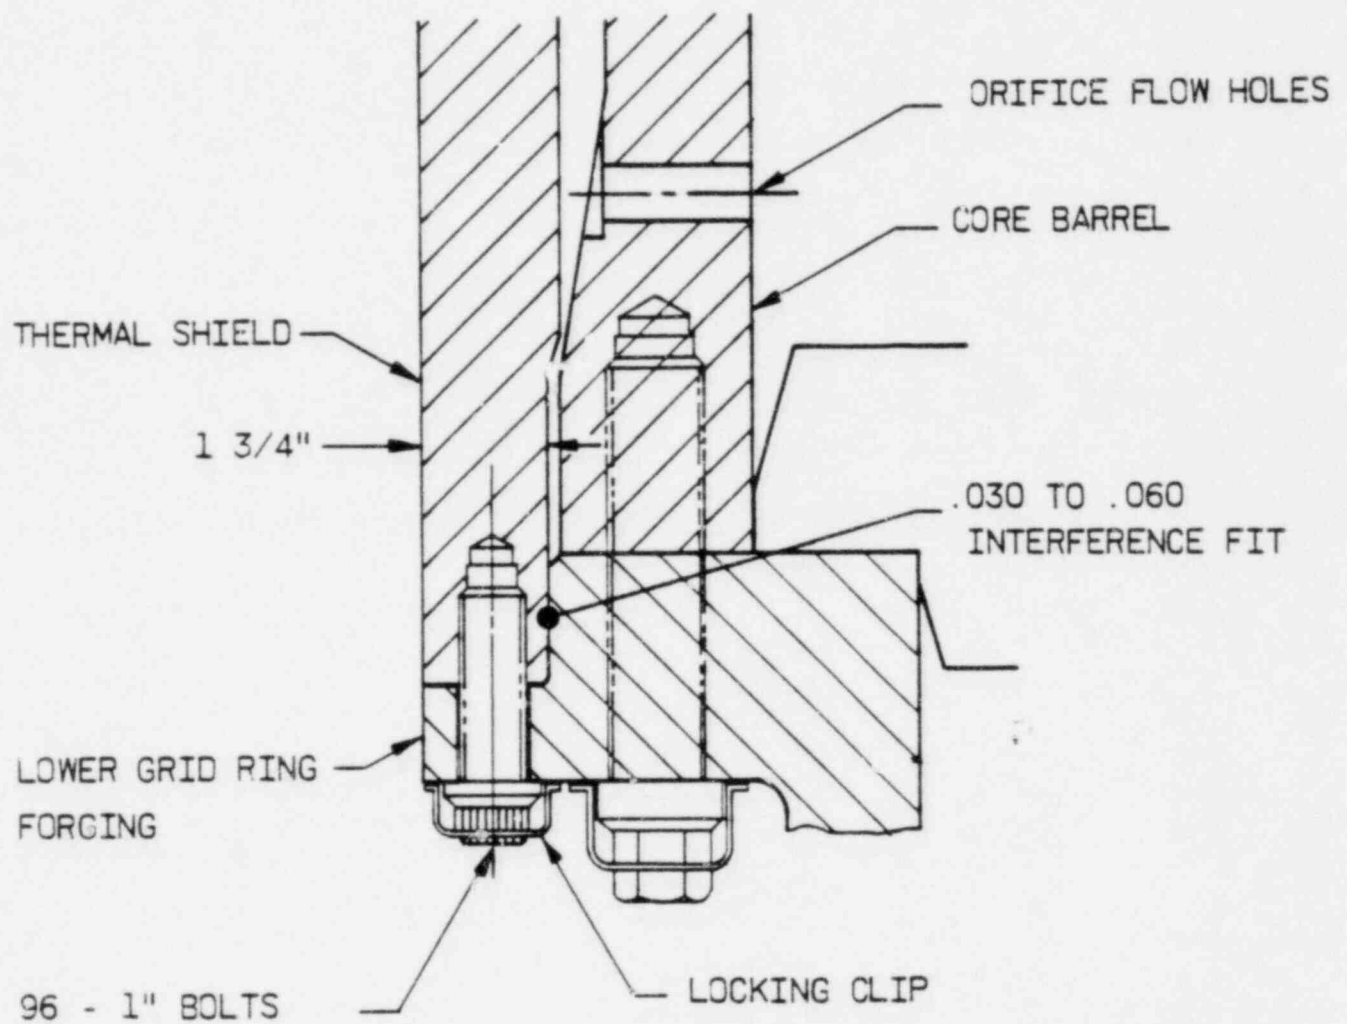
## THERMAL SHIELD LOWER SUPPORT

The thermal shield is a 2-inch-thick cylinder surrounding the core barrel; it extends the length of the core region. Its function is to provide additional shielding against gamma and neutron flux effects on the reactor vessel wall in the core region to reduce gamma heating in the reactor vessel wall and radiation effects on the vessel materials. The bottom support is shown

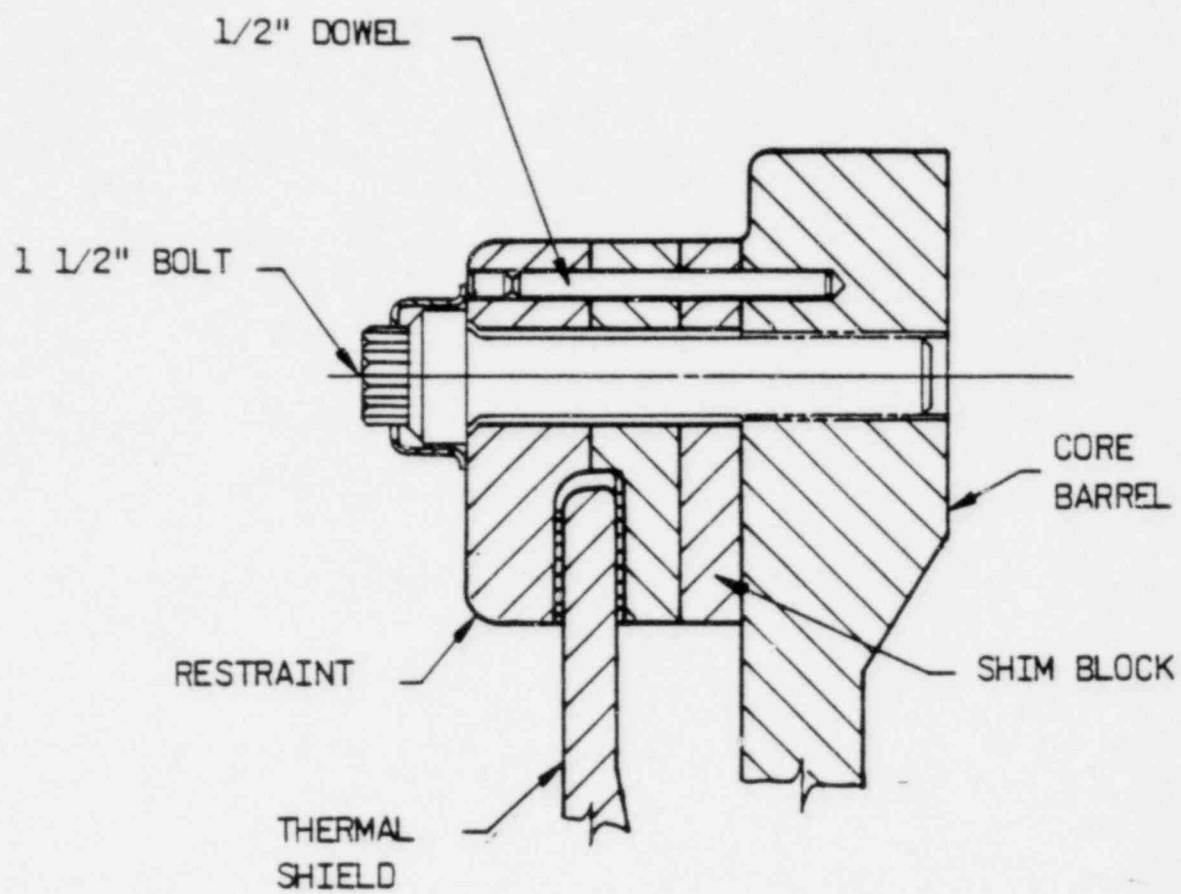
# UPPER THERMAL SHIELD RESTRAINT

The thermal shield's upper support (shown in Attachment 5) consists of a Stellite clamp and shim pad that are contoured to the thermal shield and core barrel curvature. Twenty of these assemblies are placed equal intervals around the top end of the thermal shield and secured to the core barrel by high-strength bolts (three in each assembly). The design restrains the thermal shield radially both inward and outward, and allows axial motion to accommodate longitudinal differential thermal growth between the core barrel and the thermal shield.
