LICENSEE EVENT REPORT

ST. LUCIE UNIT 1

LER - 335-81-32

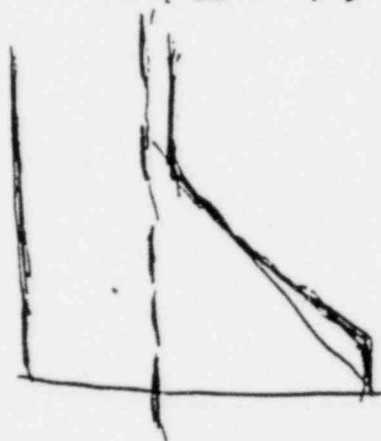
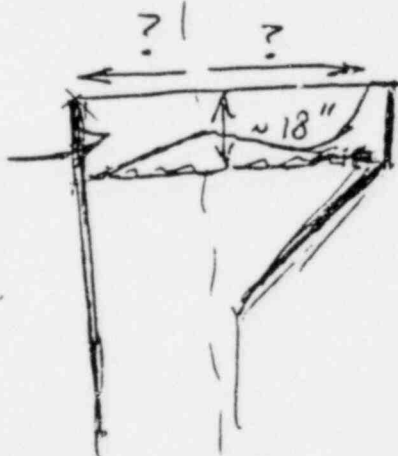
- ② Hatch barrel - 2 section -
inner section 1" thick plate wrapped compressible material
outer section 1 1/2" thick plate - no compressible material

plus shear lug
however was wrapped
& no concrete against
shear lug

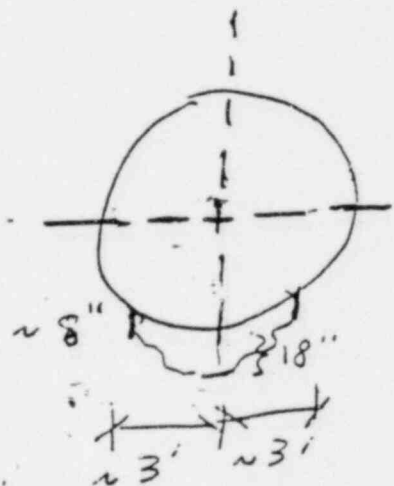
- ③ Bechtel investigation how accounted
for in containment safety evaluation
