SUBJECT: Grand Gulf Nuclear Station
Units 1 and 2
Docket Nos. 50-416 and 50-417
File 0260/0272/L-344.0
Human Factors Engineering Review
AECM-81/267

HUMAN FACTORS ENGINEERING
CONTROL ROOM DESIGN REVIEW FINAL REPORT
GRAND GULF NUCLEAR STATION
MISSISSIPPI POWER AND LIGHT COMPANY

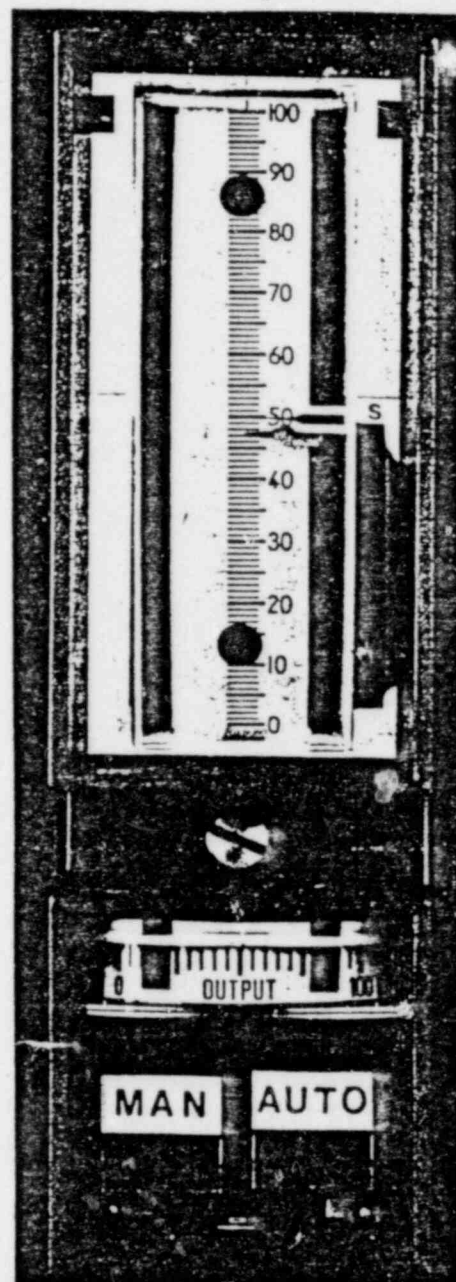
FIGURE 1 FOXBORO
NUCLEAR 250 STATION
(FULL SCALE)

The top row of meters on each of the Remote Shutdown panels is located higher than the recommended maximum height of 70" for reading by a 5th percentile operator. The high location also causes parallax error when reading the upper portions of the vertical meter scales.

A major modification is being made to the upper section of the remote shutdown panels. In order to have proper environmental qualification for the devices on the remote shutdown panels, the GE 180 meters and Bailey controller are being removed and replaced with Foxboro Spec 200 instruments. This modification is part of the long term equipment qualification and will be implemented on a schedule consistent with these requirements. The new panel layout will have no top row of meters, and all meters will be located at the same height as the present second row of meters. As an interim step, stools will be provided at each remote shutdown panel for operator use. The interim step will be completed prior to loading fuel. Figure 1 shows the type of Foxboro instruments to be used.

As part of the remote shutdown panel modification discussed under Finding 1.14, the Bailey controller will be replaced with a Foxboro model N-250HM controller shown in Figure 1. The scales on the Foxboro controller will be modified, as necessary to add appropriate units.
