# MISSISSIPPI POWER & LIGHT COMPANY

SUBJECT: Grand Gulf Nuclear Station  
Units 1 and 2  
Docket Nos. 50-416 and 50-417  
File 0260/0272/L-344.0  
Human Factors Engineering Review  
AECM-81/291

HUMAN FACTORS ENGINEERING  
CONTROL ROOM DESIGN REVIEW FINAL REPORT  
GRAND GULF NUCLEAR STATION  
MISSISSIPPI POWER AND LIGHT COMPANY

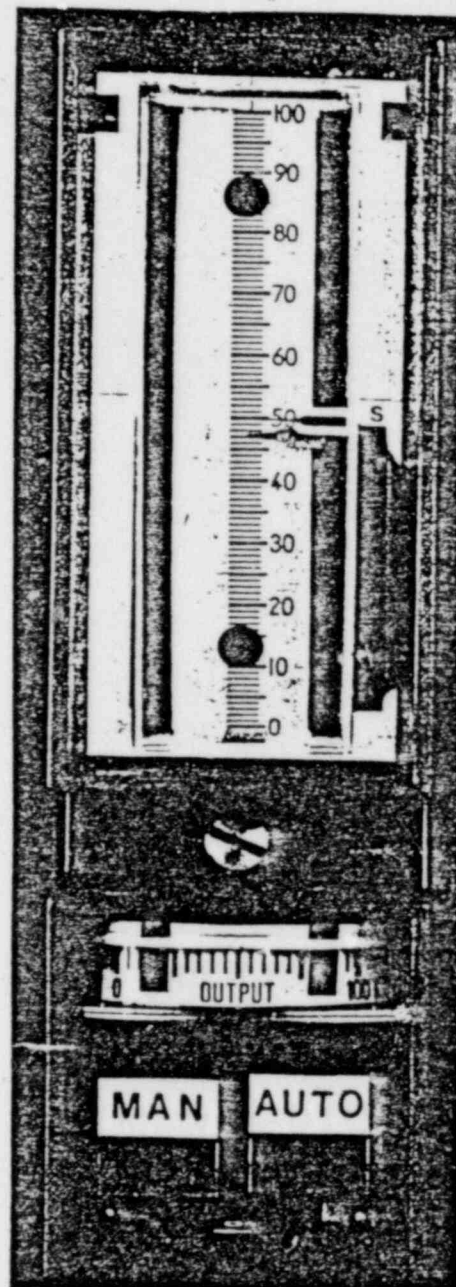
FIGURE 1 FOXBORO  
NUCLEAR 250 STATION  
(FULL SCALE)

The top row of meters on each of the Remote Shutdown panels is located higher than the recommended maximum height of 70" for reading by a 5th percentile operator. The high location also causes parallax error when reading the upper portions of the vertical meter scales.

A major modification is being made to the upper section of the remote shutdown panels. In order to have proper environmental qualification for the devices on the remote shutdown panels, the GE 180 meters and Bailey controller are being removed and replaced with Foxboro Spec 200 instruments. This modification is part of the long term equipment qualification and will be implemented on a schedule consistent with these requirements. The new panel layout will have no top row of meters, and all meters will be located at the same height as the present second row of meters. As an interim step, stools will be provided at each remote shutdown panel for operator use. The interim step will be completed prior to loading fuel. Figure 1 shows the type of Foxboro instruments to be used.

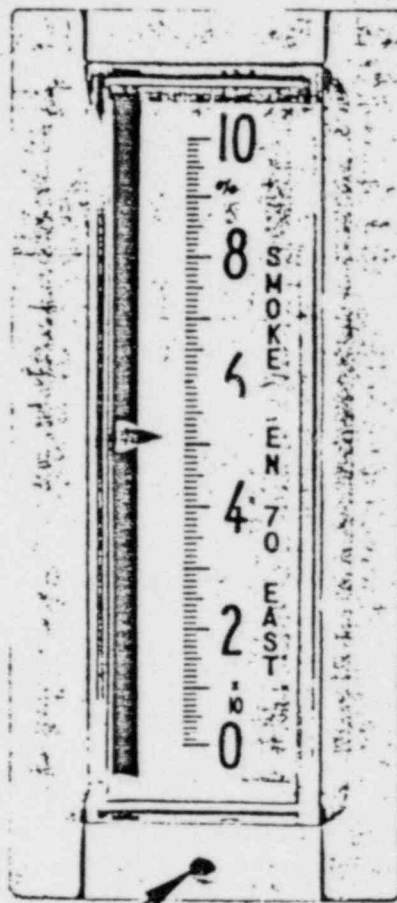
**FIGURE 3 BAILEY  
EDGEWISE INDICATOR  
TYPE ES  
(FULL SCALE)**

<u>ITEM</u>	<u>PRIORITY</u>	<u>FINDING</u>	
91	31	5.15	The display for a Bailey meter on the Remote Shutdown panel for % OPEN does not have the percent symbol included on the scale.
		<u>RESPONSE</u>	As part of the remote shutdown panel modification discussed under Finding 1.14, the Bailey controller will be replaced with a Foxboro model N-250HM controller shown in Figure 1. The scales on the Foxboro controller will be modified, as necessary to add appropriate units.
92	2	5.16	Many of the meters on Panel 680 are too small to be read from a distance (e.g., RX WATER LEVEL, RX PRESSURE, FEEDWATER FLOW, and STEAM FLOW).
		<u>RESPONSE</u>	A survey was made of the small GE 185 meters in the control room to determine which ones require reading from a distance. The survey included: (1) other control room indication present (e.g., annunciators, etc.), (2) criticality to plant safety, (3) does the meter have to be read from a distance, and (4) the use of tolerance zones. The survey determined that only the RX WATER LEVEL, RX PRESSURE, FEEDWATER FLOW, and STEAM FLOW meters were critical. Based on the above, these meters will be replaced with larger Bailey Signaflex meters similiar to the one shown in Figure 3 prior to loading fuel. This figure is provided only for reference and does not reflect true conditions. The parameter legends will be placed on labels similiar to that used elsewhere in the control room and will not be displayed on the meter scales. Table 6 list the meters to be replaced along with corresponding scales.
