Examination and Test of Crystal River Unit No. 3 Power-Operated Relief and Safety Valves PWR Safety and Relief Valve Test Program

EPRI NP-80-13-LD
Project V102-31
Interim Report
December 1980
Limited Distribution
Copy Number *223*

Prepared by
MPR Associates, Inc.
Washington, D.C.

In February 1980, an abnormal transient occurred at the Crystal River Unit No. 3 (CR-3) Nuclear Generating Station. The cause of this transient was an electrical system malfunction which opened the power operated relief valve (PORV) on the pressurizer and held it open electrically for approximately 5 to 7 minutes until the PORV was isolated by closing the upstream block valve. A reactor trip, system blowdown to about 1350 psig, and automatic initiation of high pressure injection into the reactor coolant system occurred within the first few minutes of the transient. The addition of high pressure injection flow filled the pressurizer, increased reactor coolant system pressure, and eventually resulted in actuation of one of the two spring-loaded safety valves installed on the pressurizer. This safety valve subsequently cycled open and closed over a period of up to 2 hours. During the course of the transien

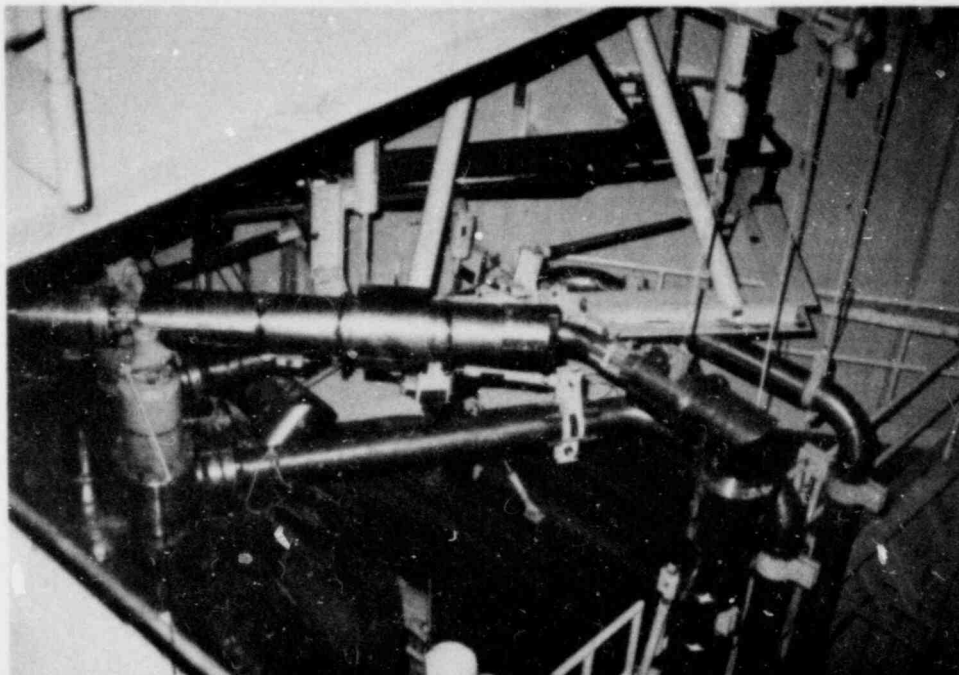
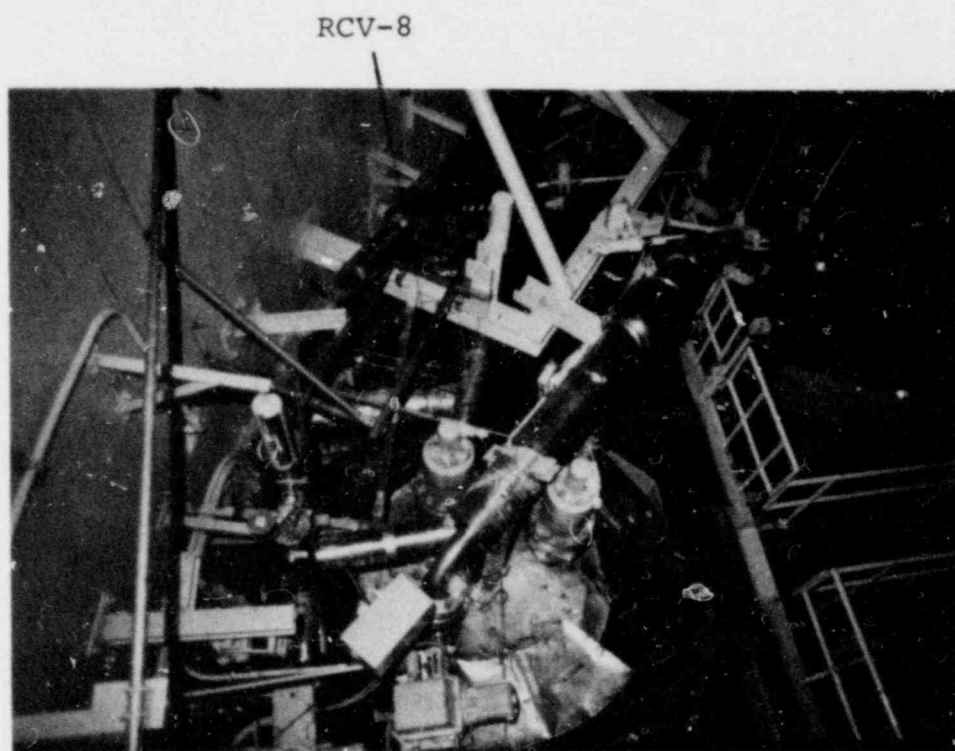
Figure 1. SAFETY VALVE AND PORV INSTALLATION
ON PRESSURIZER

- Visual examination of the discharge piping for the PORV and adjacent spring-loaded safety valves RCV-8 and RCV-9 revealed no damage or deformation in the piping or piping supports.

1. Visual examination of the PORV and its operator, including the solenoid linkages, showed no abnormal conditions or evidence of damage. The operator linkages were in the normal, closed position.
2. Electrical actuation tests were made which confirmed that the solenoid and linkage to the PORV pilot operated properly when energized and de-energized repeatedly from the control room.
3. Visual examinations of the discharge piping for the PORV and the adjacent spring-loaded safety valves (RCV-8 and -9) indicated no damage or deformation to the piping or supports. A portion of this piping and supports is shown in Figure 1.

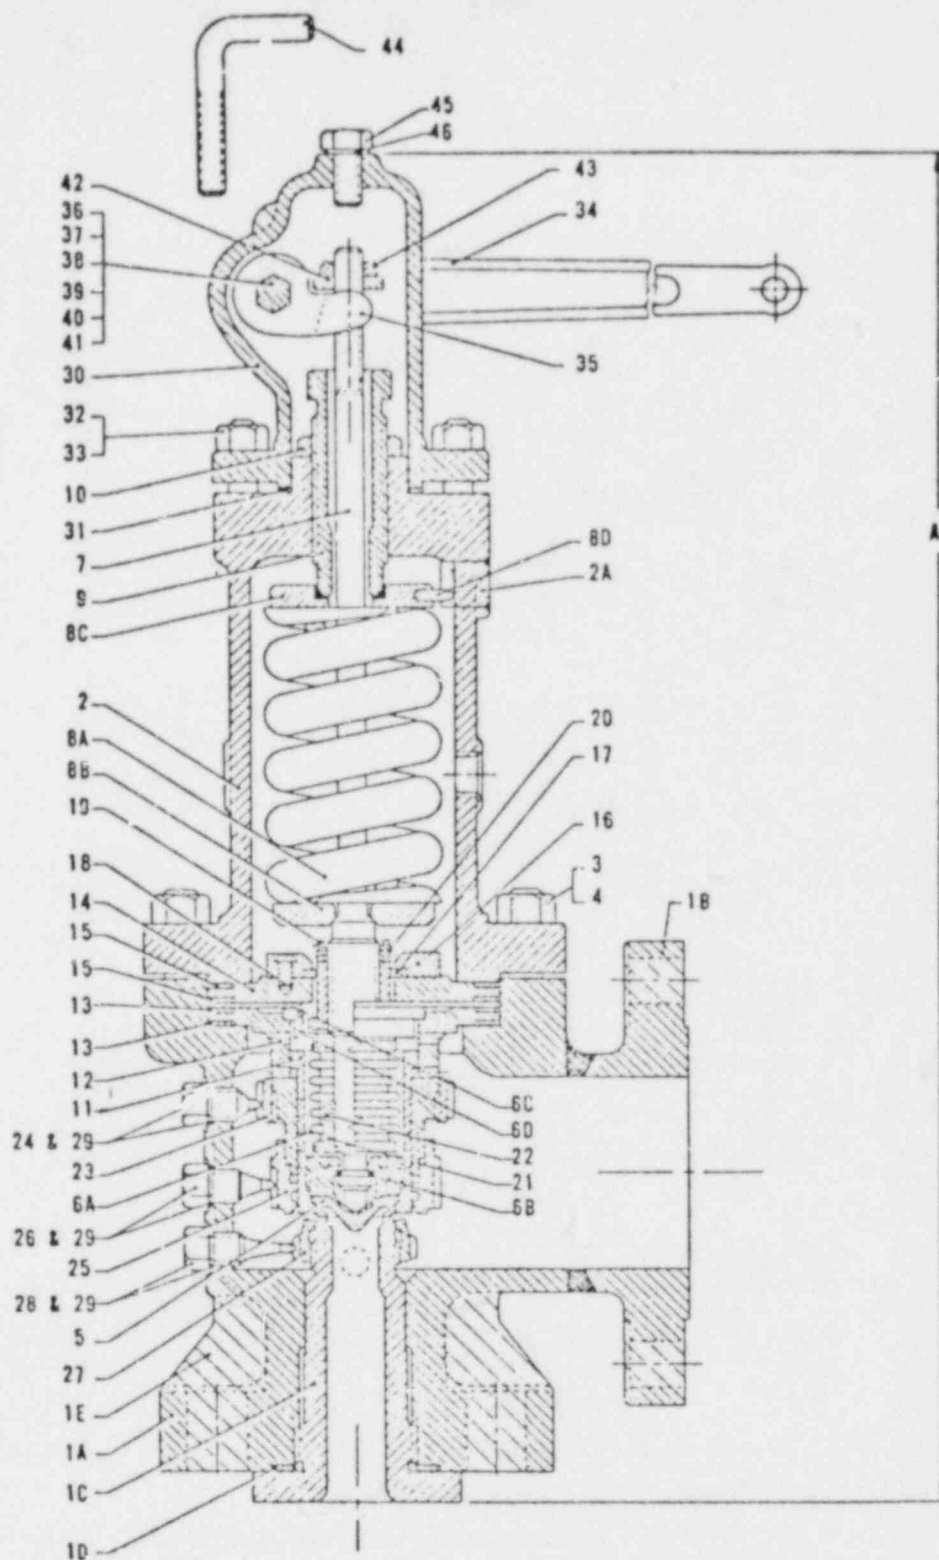
Figure 3. DRESSER SAFETY VALVE

• Two abnormal conditions were found. First, the anti-rotation pin (identified as Part 8d in Figure 3) was found dislodged inside the bonnet cavity. This pin was bent and had become disengaged from the upper spring washer and fallen into the valve bonnet cavity. This anti-rotation pin serves no functional purpose in the valve. Rather, its purpose is to prevent rotation of the upper spring washer (Part 8c) during adjustment of the set pressure compression screw (Part 9). Since the upper spring washer does not move during valve operation, the deformation of the pin had to have occurred due to improper alignment of the pin and the mating slot in the bonnet during the initial assembly and compression of the main spring. According to the Dresser representative (Mr. Bolger), this problem has occurred in a number of applications and this feature of the valve design has been changed in later valves. Binding of this anti-rotation pin on the bonnet during set pressure adjustment could lead to misalignment of parts and thereby promote leakage (which obviously did occur), but it would not appear that this pin would have any effect on valve operation (subsequent tests of the valve without the pin confirmed this). Second, the clearances between the disc holder (Part 11), disc (Part 5) and disc nut (Part 6B) were incorrect. Figure 14 shows the bellows assembly and indicates the clearances that are specified between the disc, disc holder and disc nut to permit slight movement or rocking of the disc on top of the disc nut in order that the disc can self-align with the seat. Inspection of this assembly showed that insufficient clearance was available to permit any rocking or self-aligning of the disc. The inspection showed that assembly of the disc holder on the disc nut firmly retained the disc in the assembly. As a result, the disc was not able to self-align readily on the seat. The differences between the specified and actual clearances could be due to initial assembly errors or deformation of the parts in service. This dimensional discrepancy could explain the observed valve leakage history, but would have no effect on the operation of the valve or its response to steam or water flow.

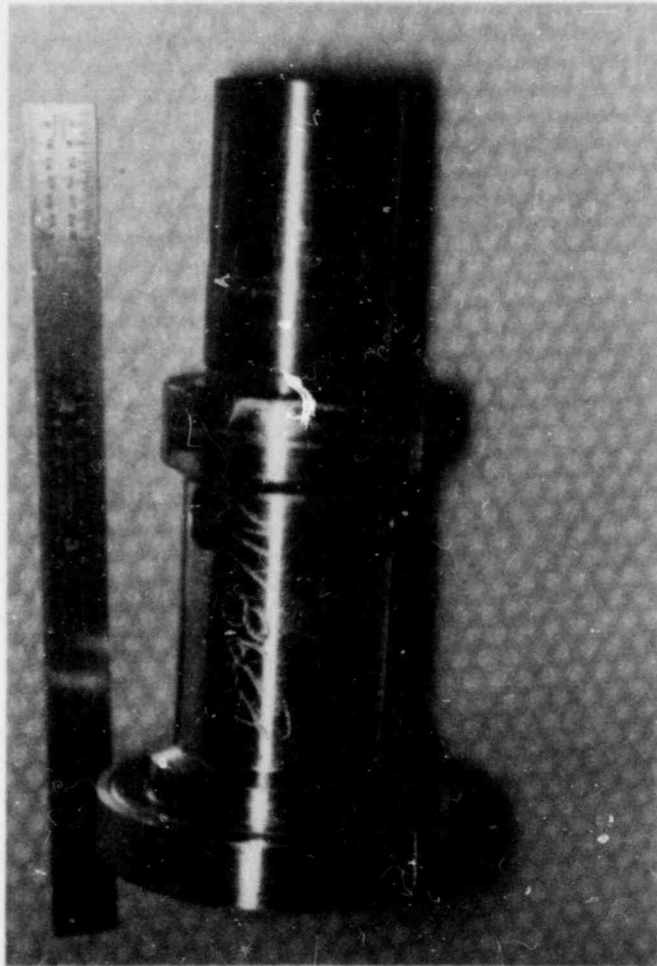
Figure 6. VALVE PILOT GUIDE (Part 12)

1. The valve pilot guide (Part 12) was discolored on its OD, but showed no signs of damage. The ID of the pilot disc guide had slight circumferential wear marks at the top of the guide. These marks were visible, but could not be identified by feel, and are considered normal wear marks. The mating surfaces of the pilot disc showed no wear of any kind.
2. The pilot valve bellows (Part 14A) were intact and appeared undamaged.
3. The pilot disc (Part 10) had a 1/8-inch long discoloration on its seating surface. The discolored area could not be felt by hand, but could be the result of slight pilot leakage at some time in the past.
4. The main disc retaining plate and locking devices were in place and undamaged. It was noted that the central

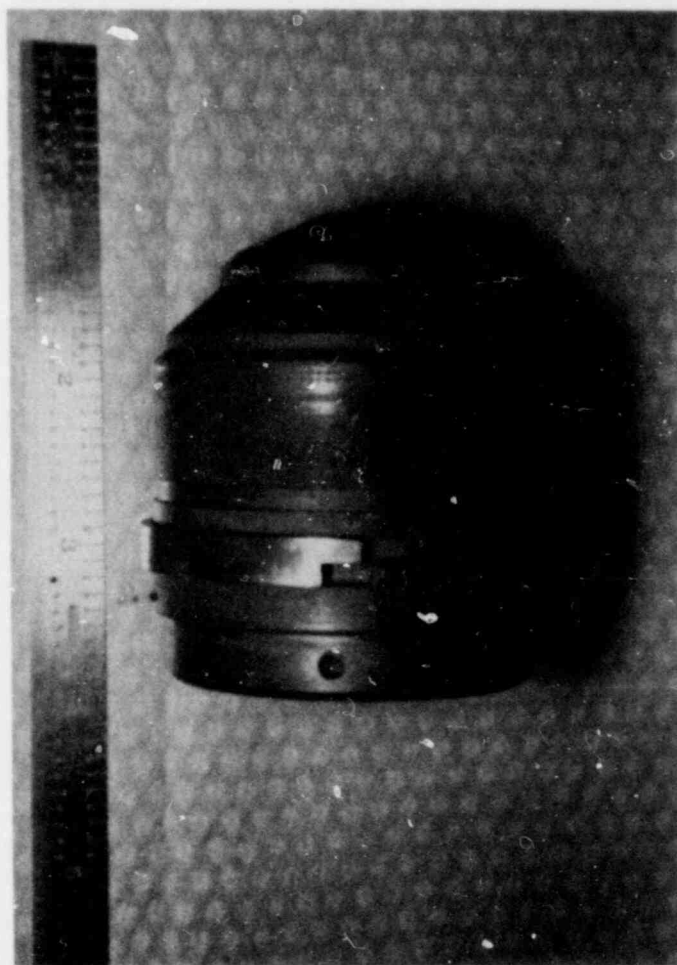
Figure 9. MAIN DISC (Part 3)

5. The main disc (Part 3) and seat showed no evidence of leakage.
6. There was no metal upsetting on the disc, the seat or the disc stop, indicating the valve had not chattered or been subjected to excessive opening or closing loads.
7. The main disc guide (Part 5) showed no significant scoring or wear.

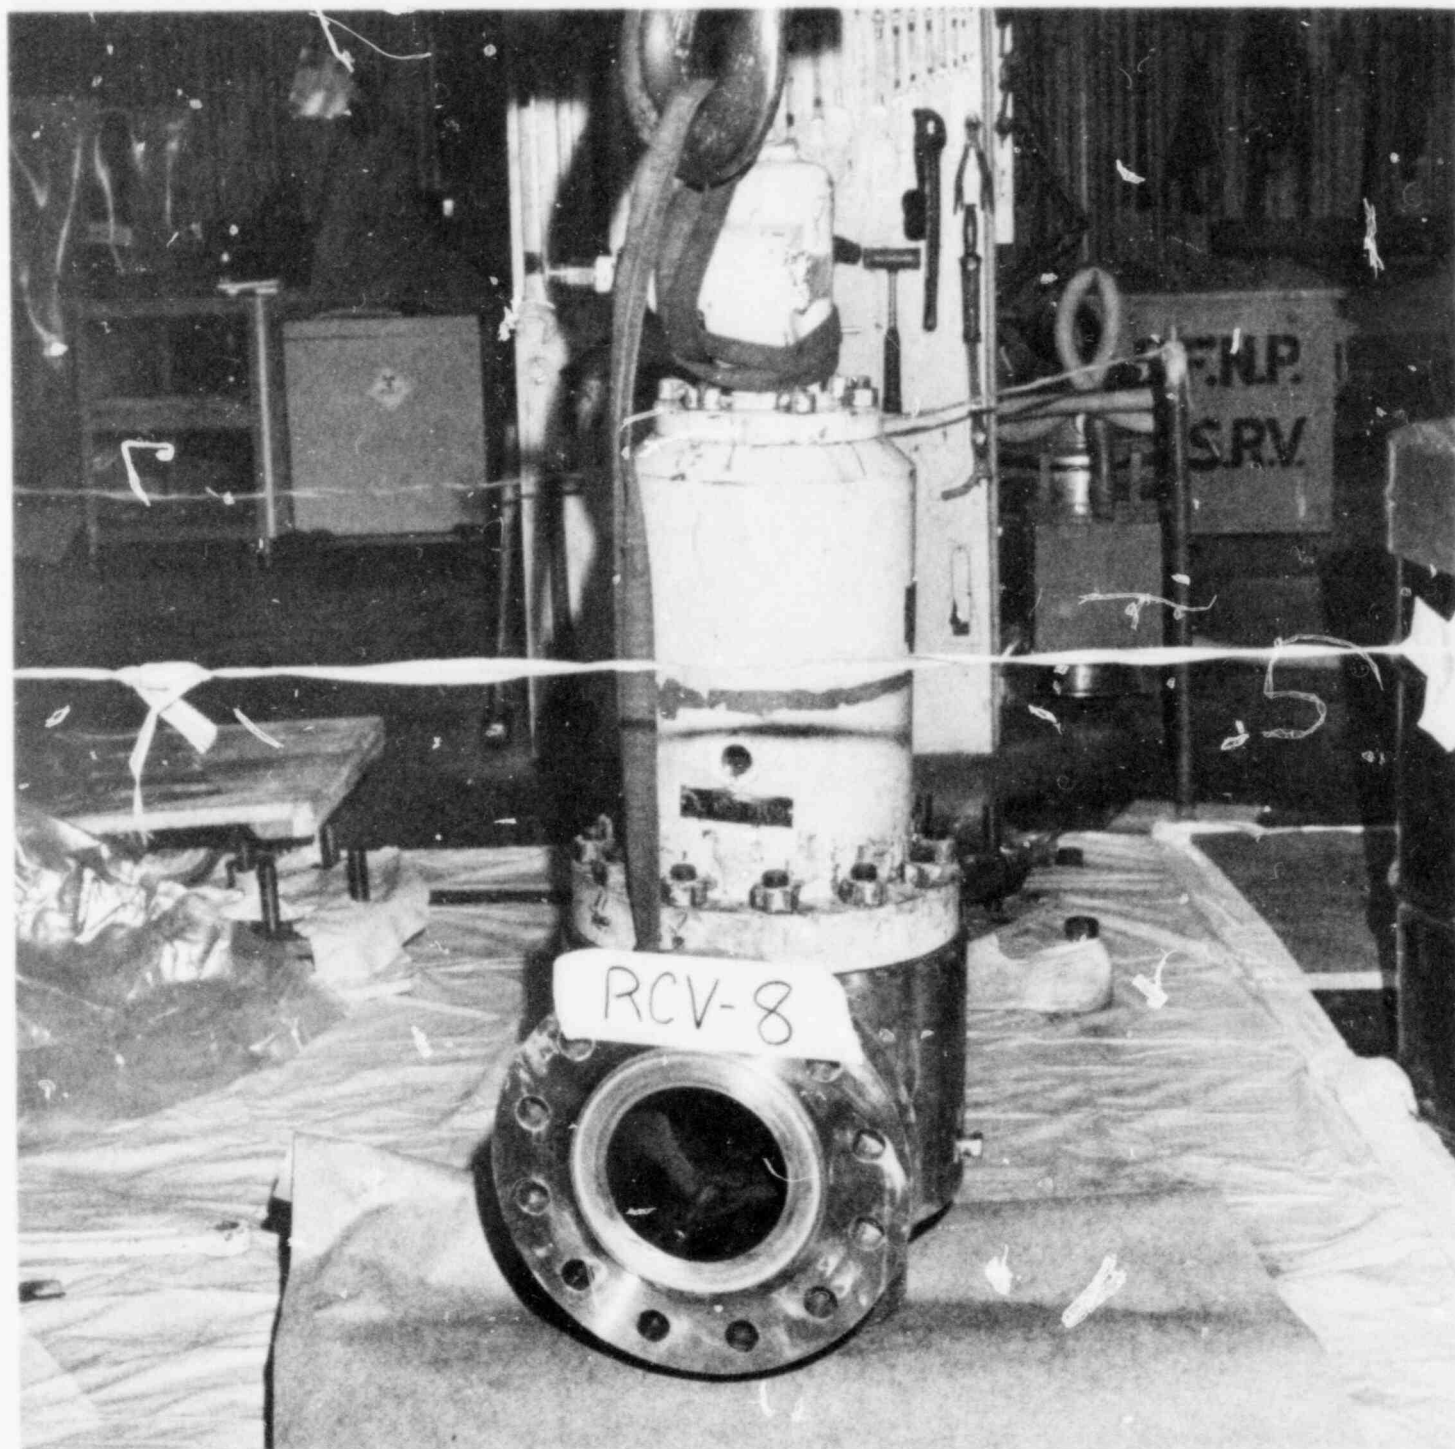
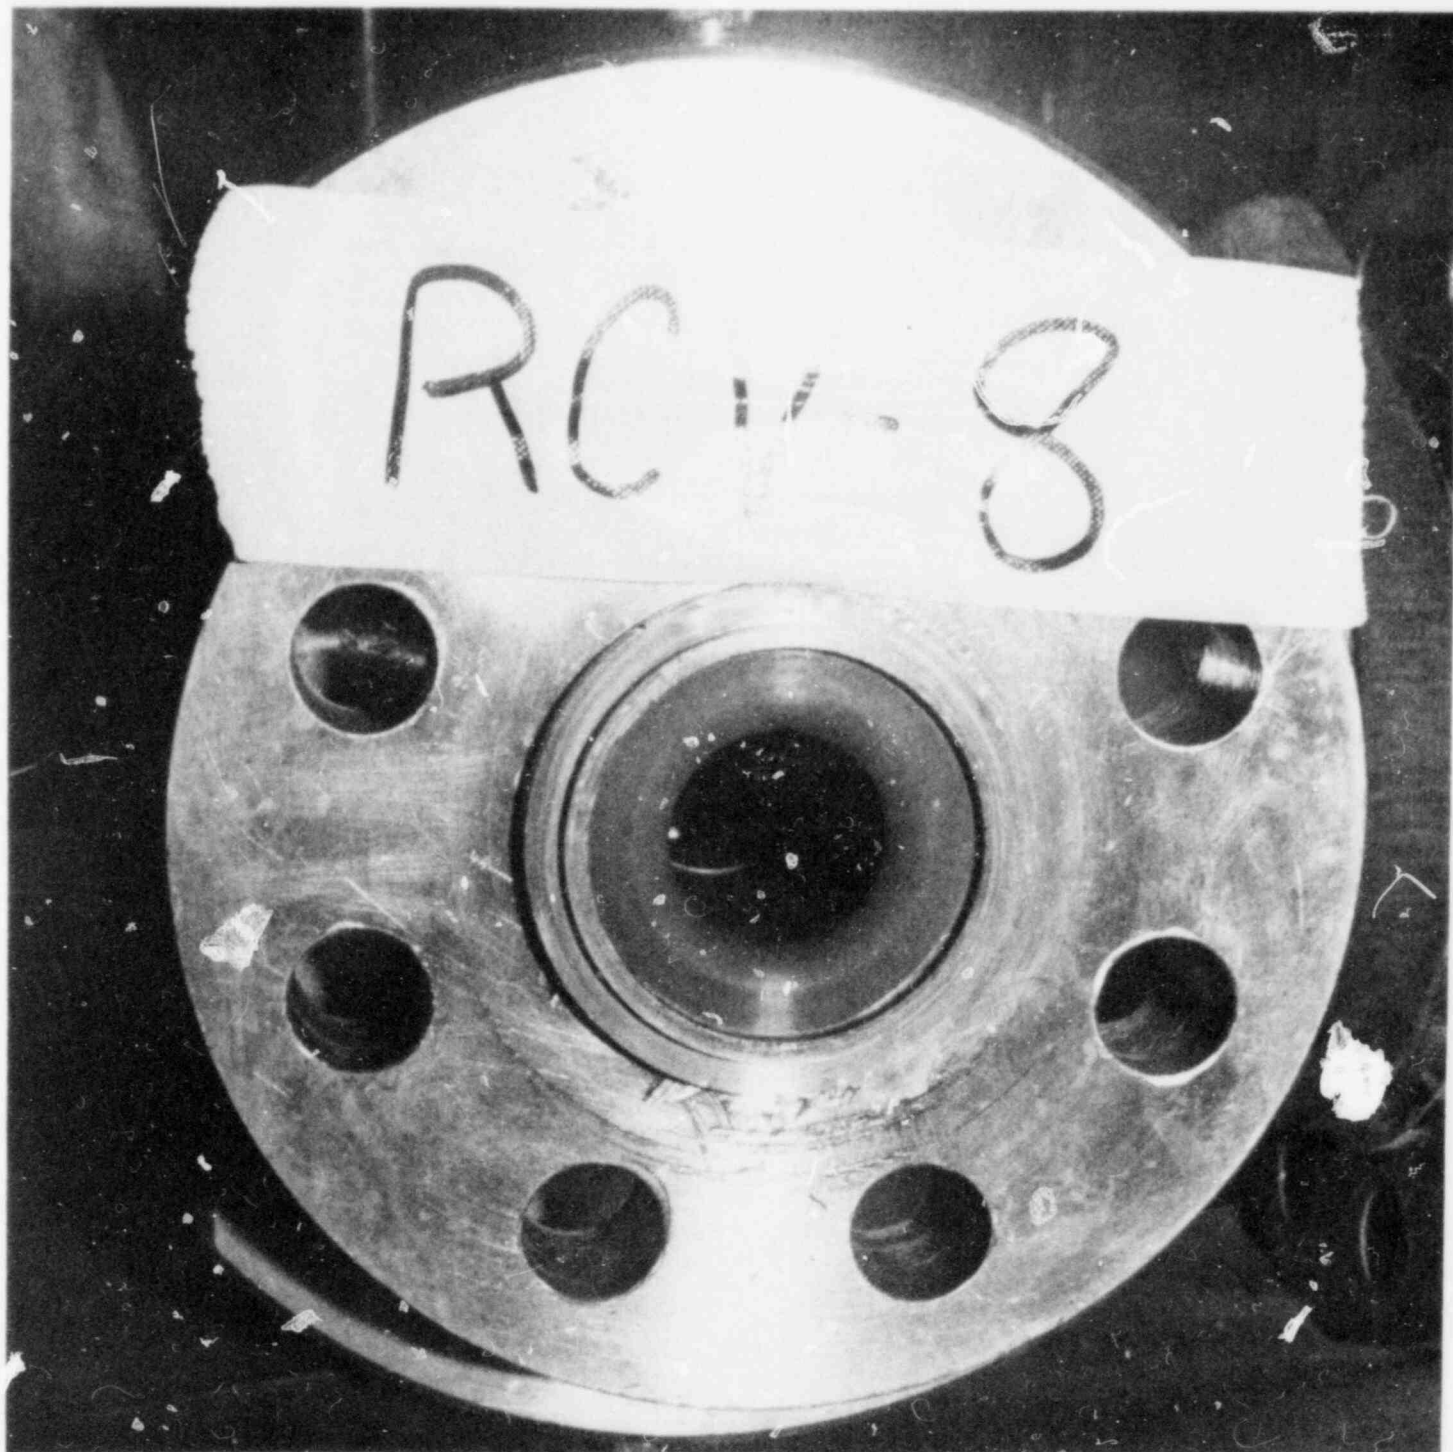
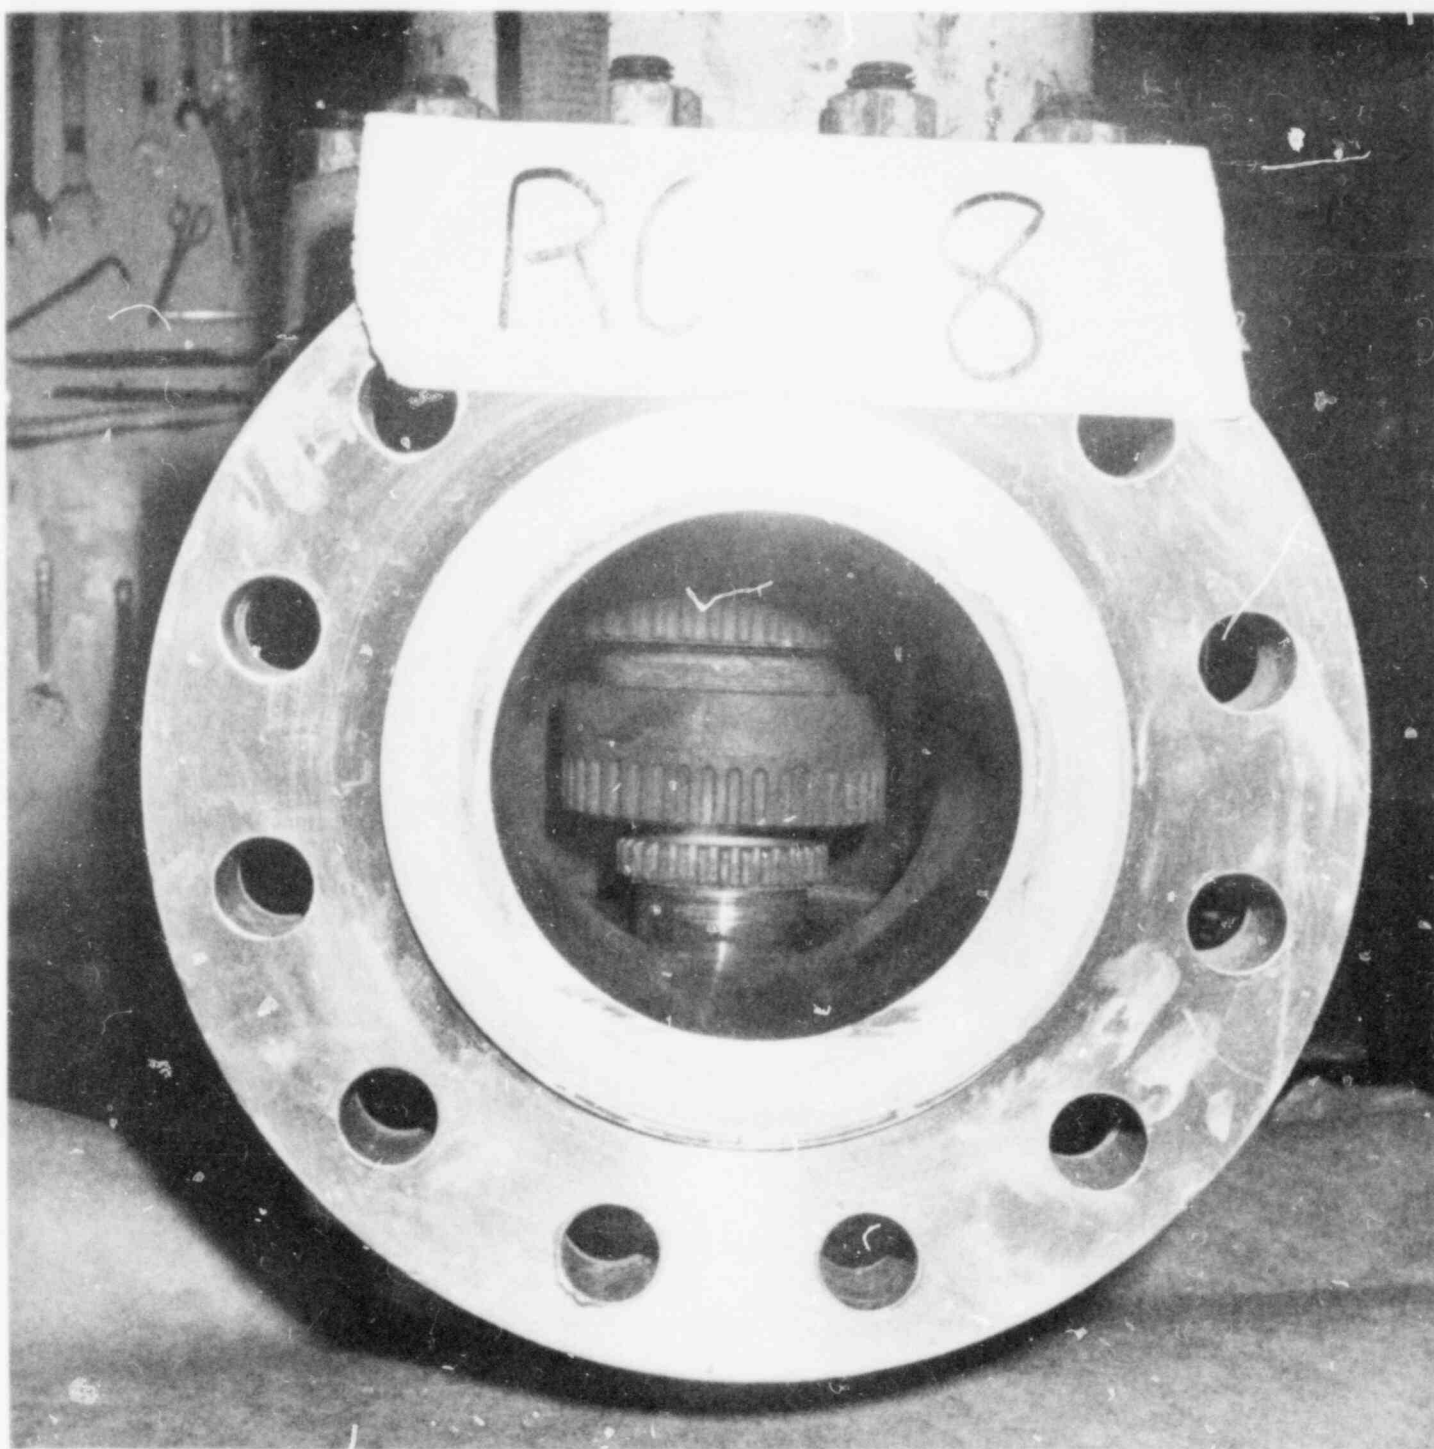
- The internal surfaces of the valve showed evidence of leakage. A black deposit, believed to be magnetite, was apparent over the majority of the internal surfaces of the valve. Photographs of RCV-8 prior to disassembly are presented in Figures 11 through 13.

- The valve seat and disc mating surfaces were extensively steam cut. Steam cutting resulted in several hundred radial marks across the seating faces with depths of several mils. The lower surface of the disc holder (Part 11) adjacent to the disc also showed erosion damage. Liquid penetrant examination of the seating surfaces of the seat and disc and the lower surface of the disc holder showed fine radial cracks 30-60 mils deep, scattered around the lower surface of the disc holder. These cracks were not visible to the unaided eye. The seat and disc were steam cut, but not cracked.

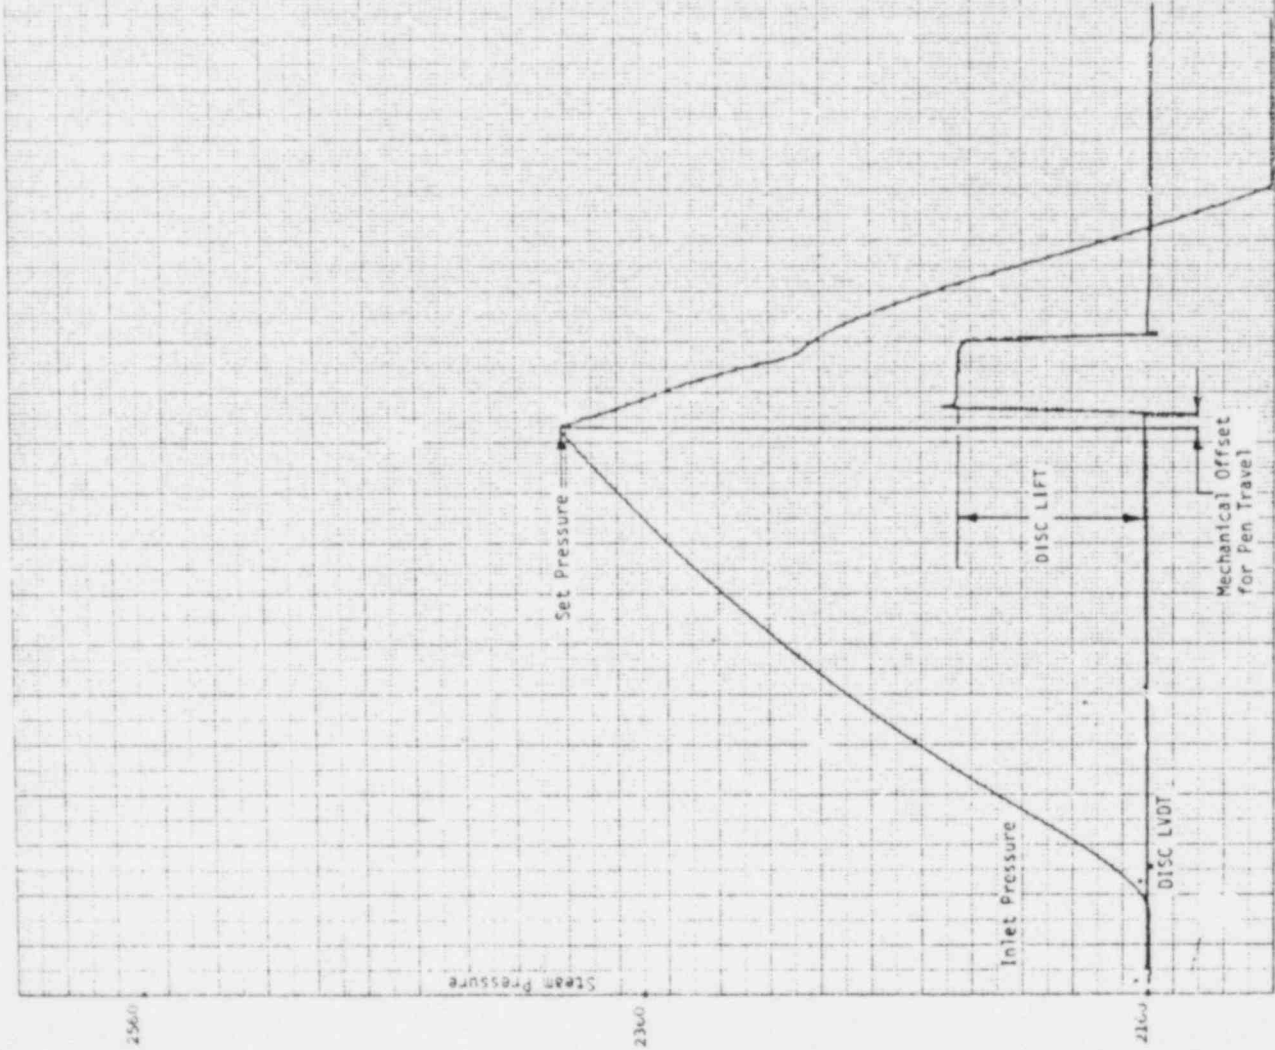
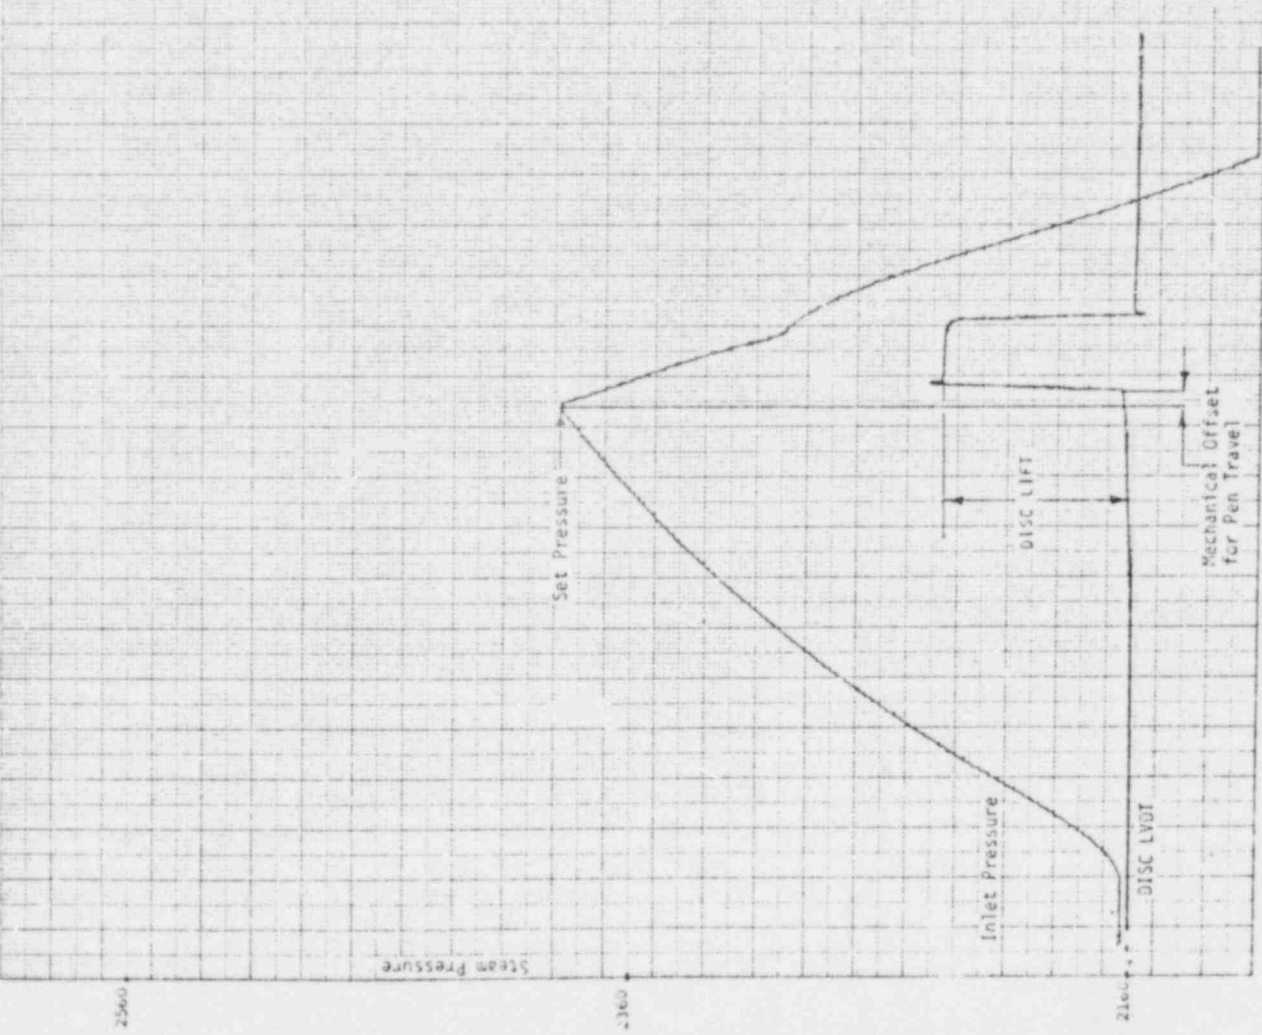
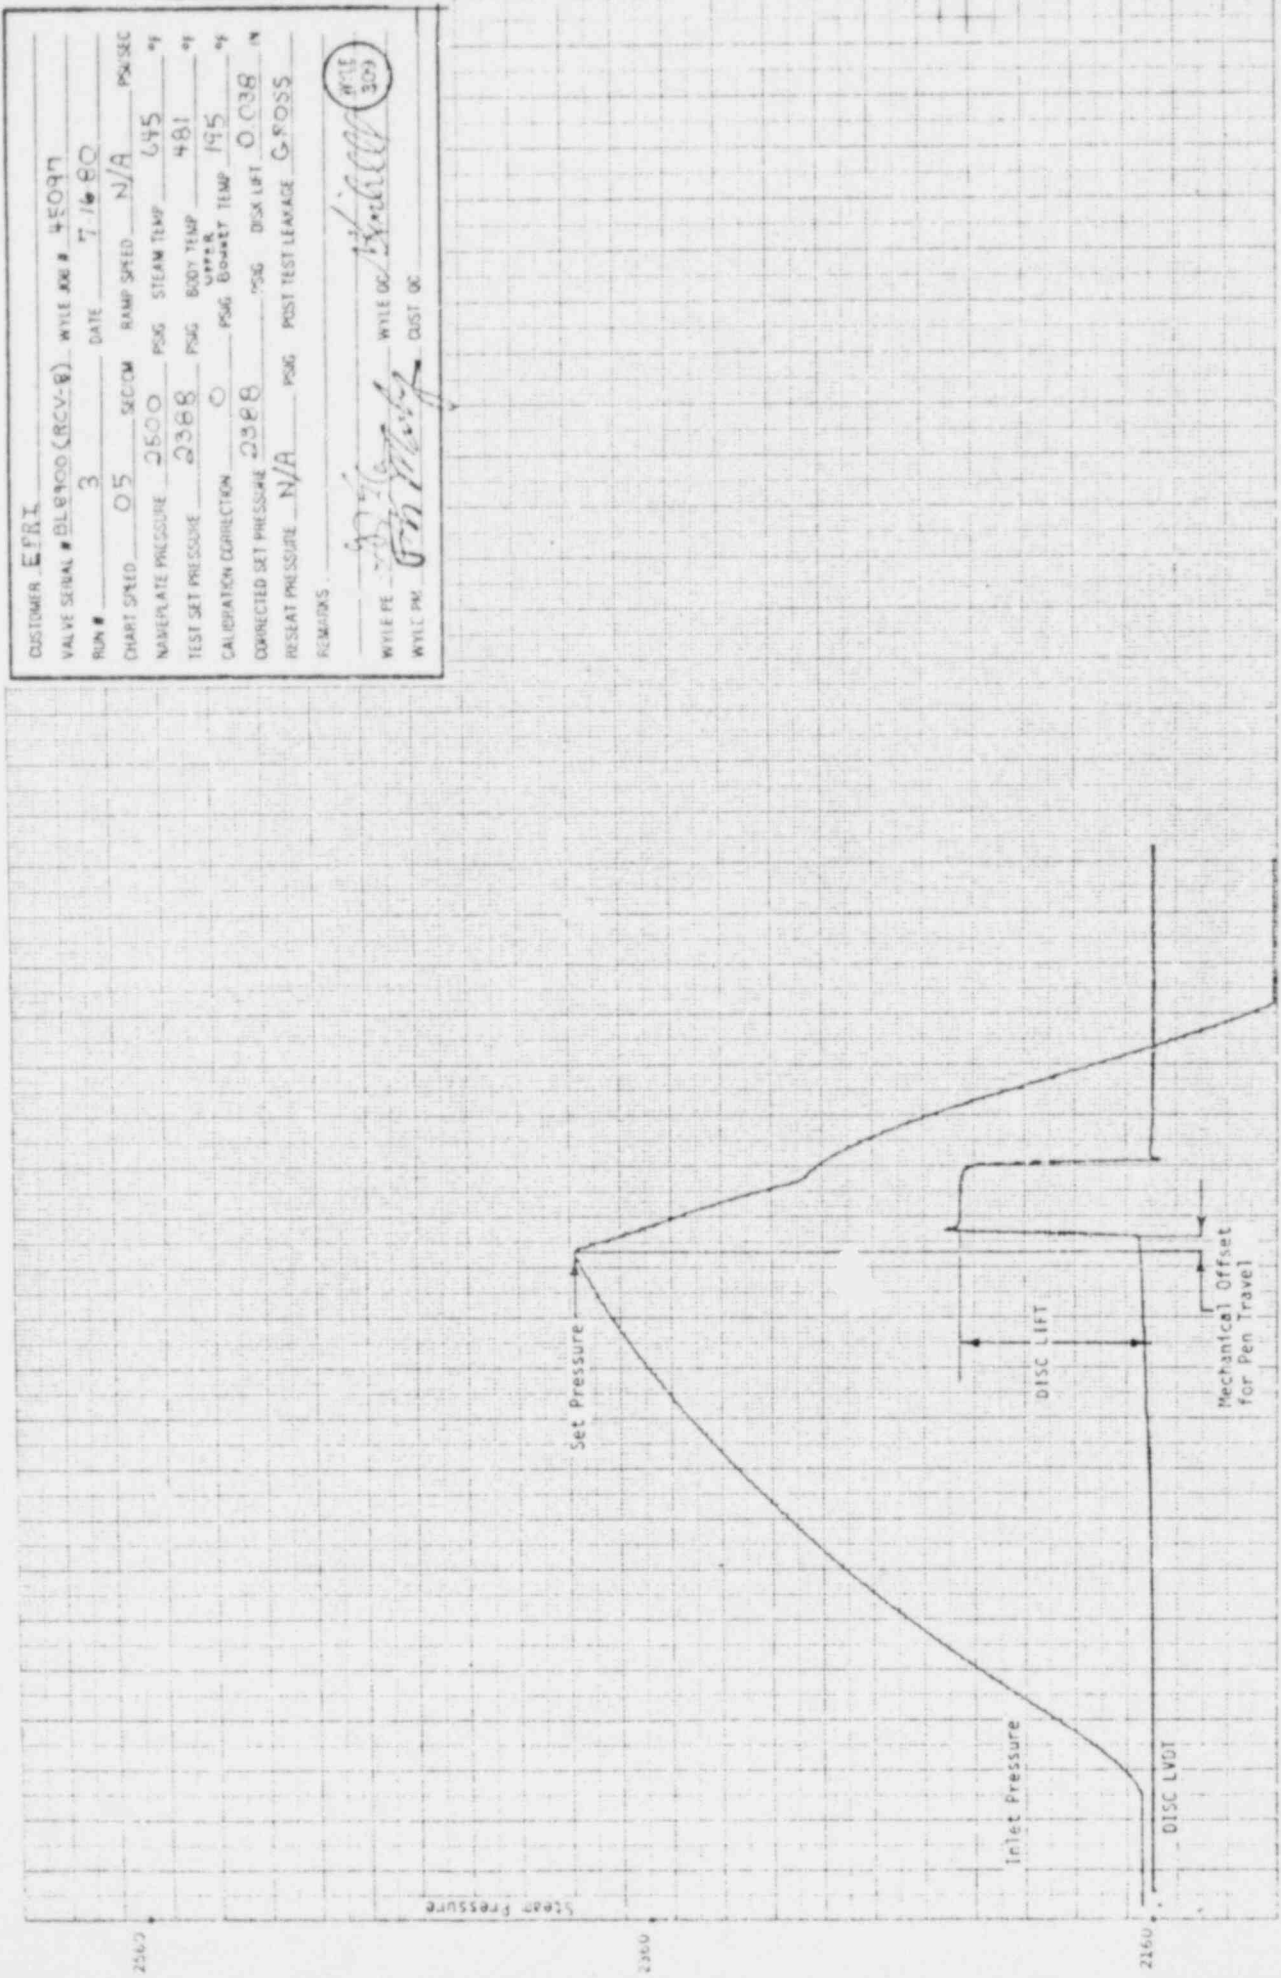
valve was normal during these tests with the exception that simmering of the valves occurred 1-2 seconds before each lift, due to the leakage from the valve. Measured valve lift and pressure traces are shown in Figures 19, 20, and 21. The leakage rate over the 4-hour period that the valve was installed on the test loop at approximately 2200 psi was between 1 and 1-1/2 gpm. The name plate set pressure for this valve is 2500 psig. It was noted that the lift pressure of about 2390 psig is approximately the same pressure at which this valve lifted during the transient at CR-3 in February 1980. The reason for the depressed lift pressure could not be determined as a result of these inspections, however, the most likely explanations are:

- a. The valve lifted prematurely because of the effect of the leakage of steam through the valve, or
- b. The valve was not adjusted properly initially.

- b. Safety valve RCV-9 had a lift pressure approximately within tolerance as received by Wyle. Valve RCV-8 exhibited a lift pressure approximately 100 psi low in the same manner that it operated during the February 1980 transient at CR-3. While the reason for the low set pressure was not specifically identified, it does not appear that it was in any way related to the circumstances of the February 1980 transient. Instead, it is likely that the valve operated at a low lift pressure as a result of either improper adjustment of the set pressure initially, the effect of the leakage through the valve, or both.
