Examination and Test of Crystal River Unit No. 3 Power-Operated Relief and Safety Valves PWR Safety and Relief Valve Test Program

EPRI NP-80-13-LD
Project V102-31
Interim Report
December 1980
Limited Distribution
Copy Number *223*

Prepared by
MPR Associates, Inc.
Washington, D.C.

In February 1980, an abnormal transient occurred at the Crystal River Unit No. 3 (CR-3) Nuclear Generating Station. The cause of this transient was an electrical system malfunction which opened the power operated relief valve (PORV) on the pressurizer and held it open electrically for approximately 5 to 7 minutes until the PORV was isolated by closing the upstream block valve. A reactor trip, system blowdown to about 1350 psig, and automatic initiation of high pressure injection into the reactor coolant system occurred within the first few minutes of the transient. The addition of high pressure injection flow filled the pressurizer, increased reactor coolant system pressure, and eventually resulted in actuation of one of the two spring-loaded safety valves installed on the pressurizer. This safety valve subsequently cycled open and closed over a period of up to 2 hours. During the course of the transien

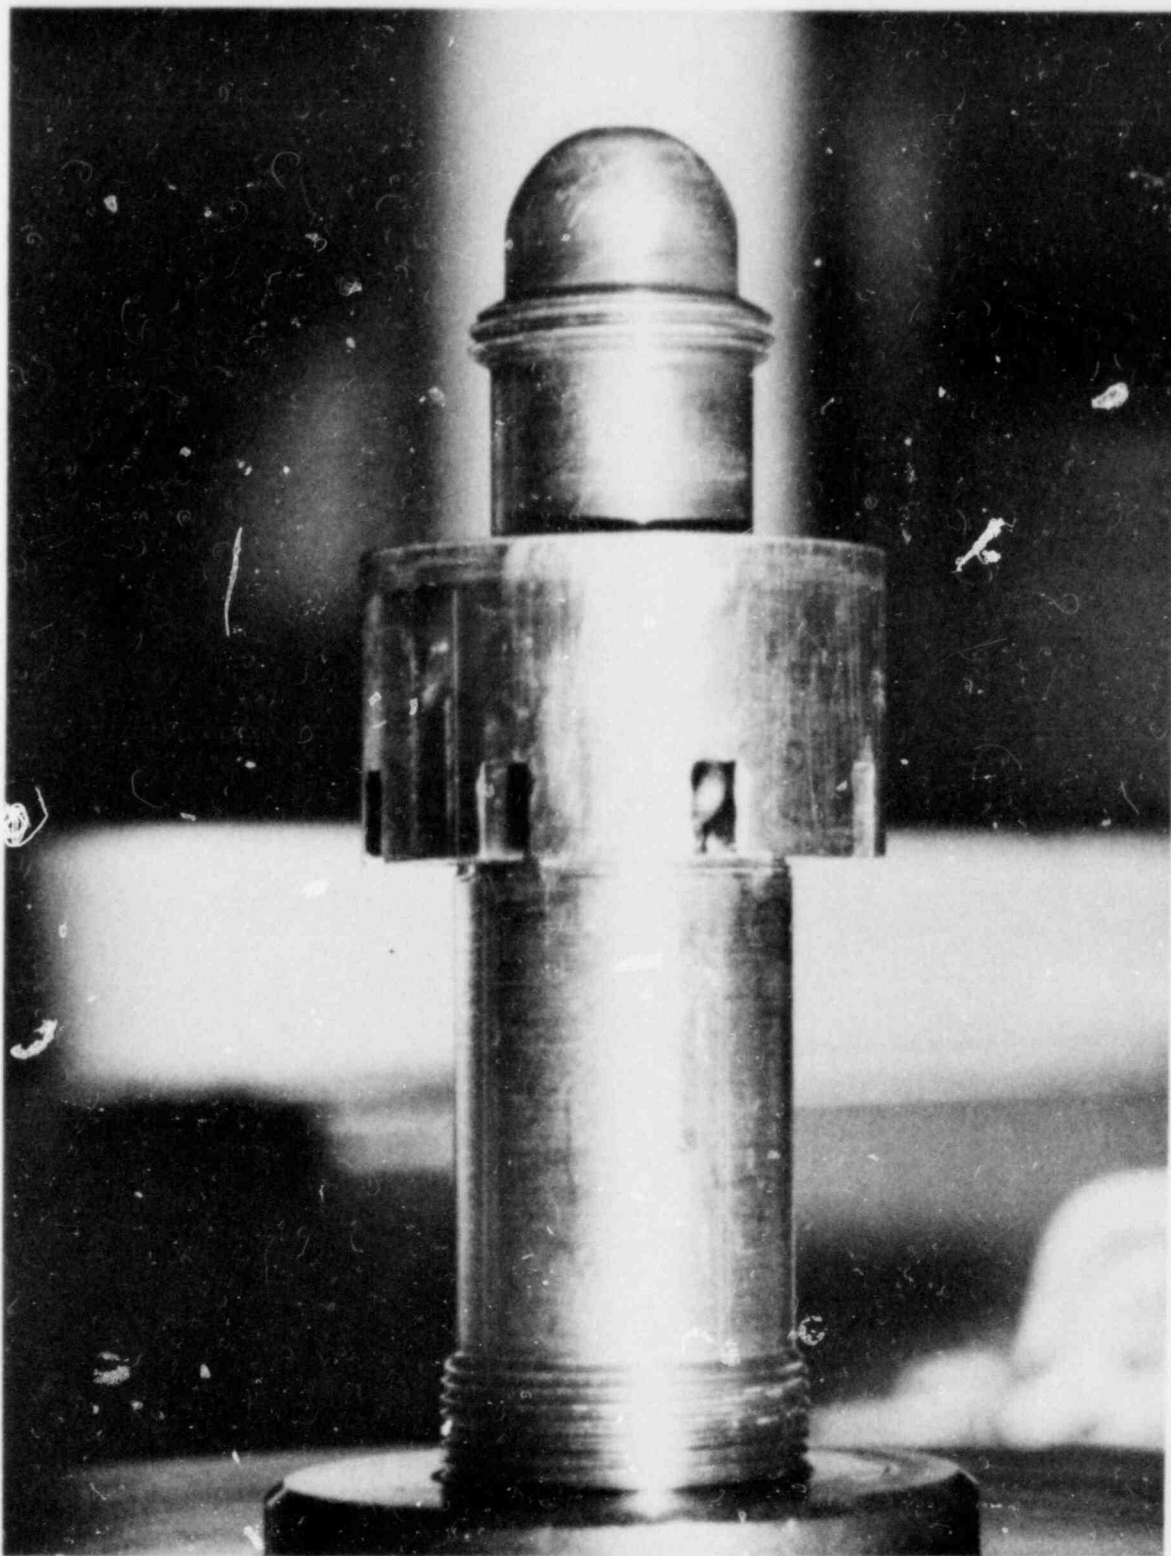
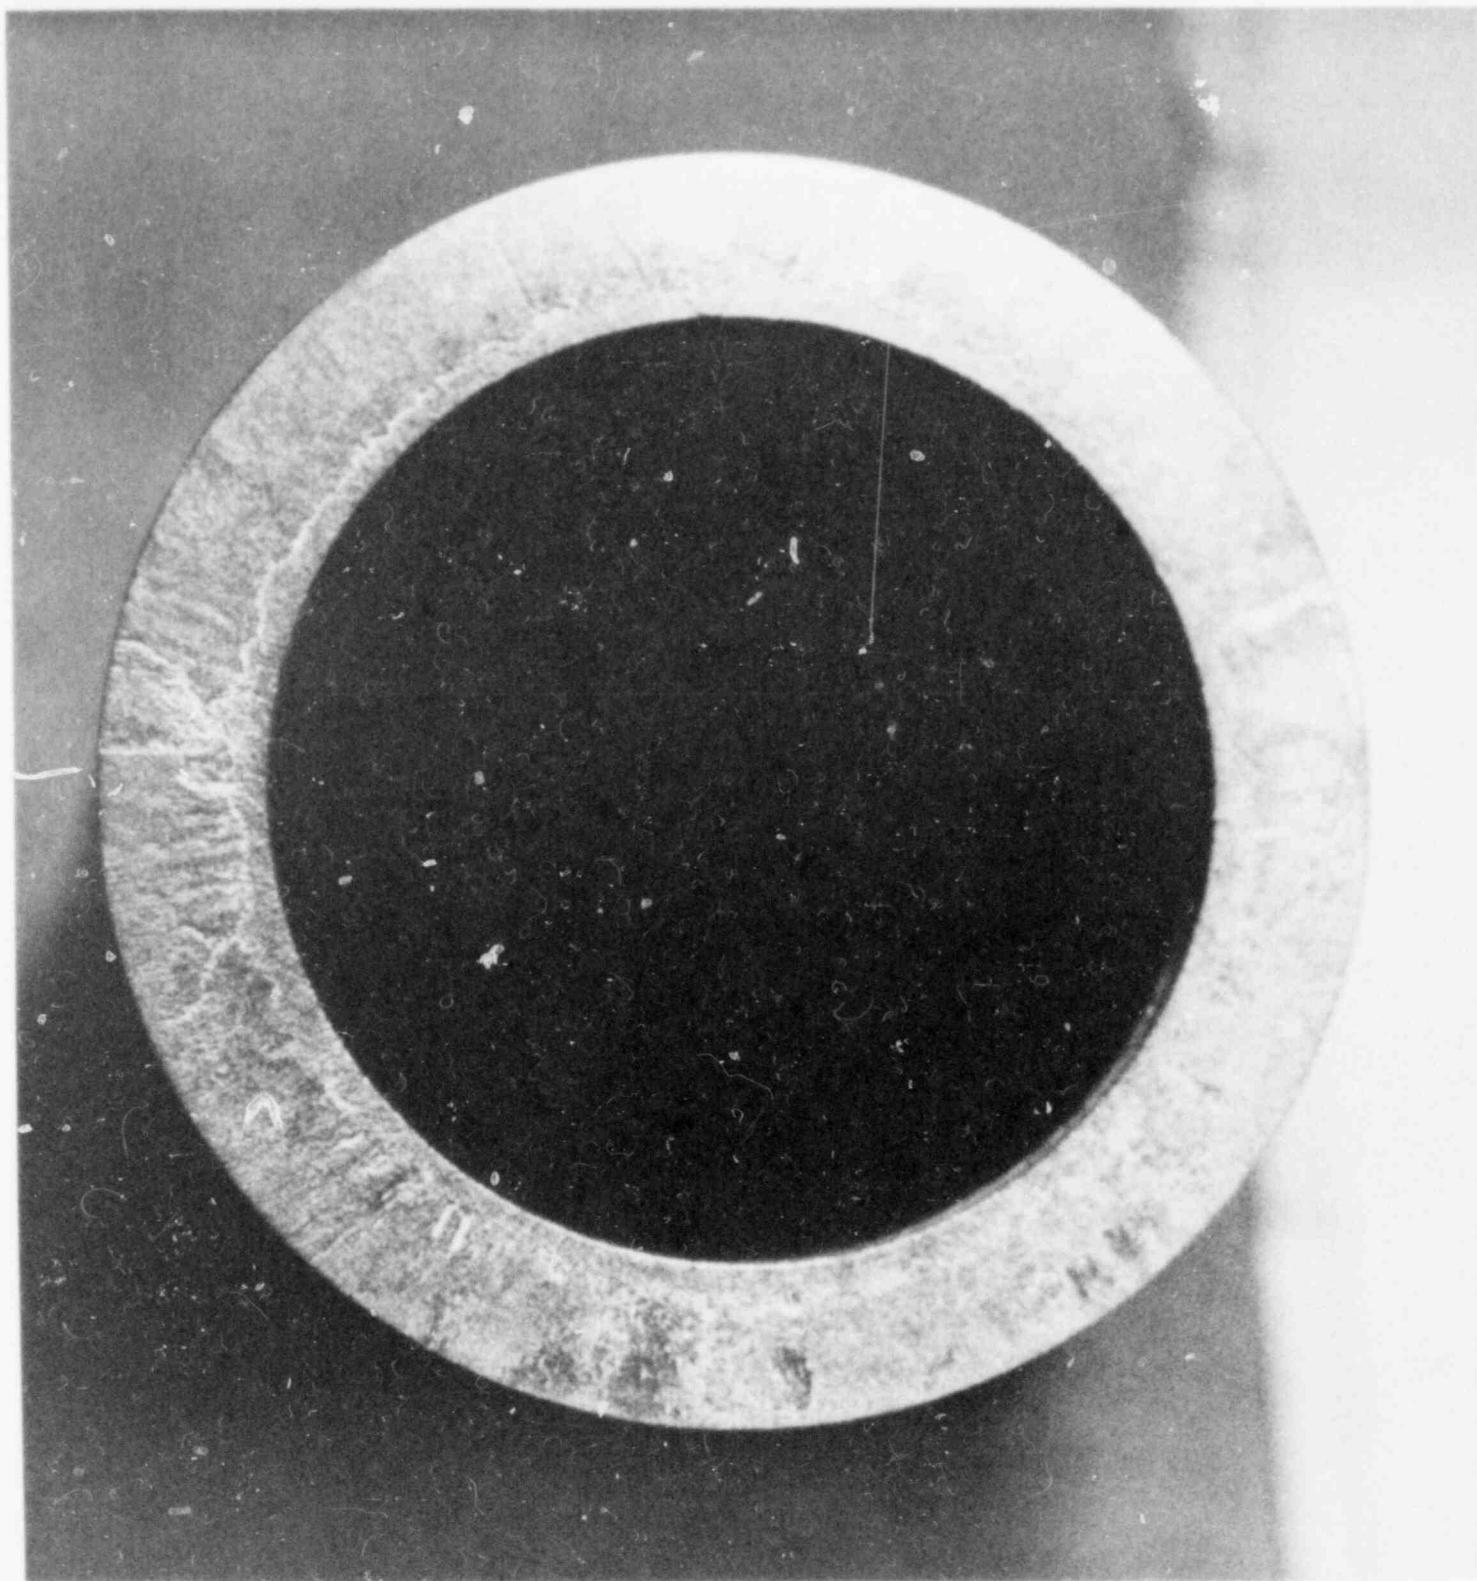
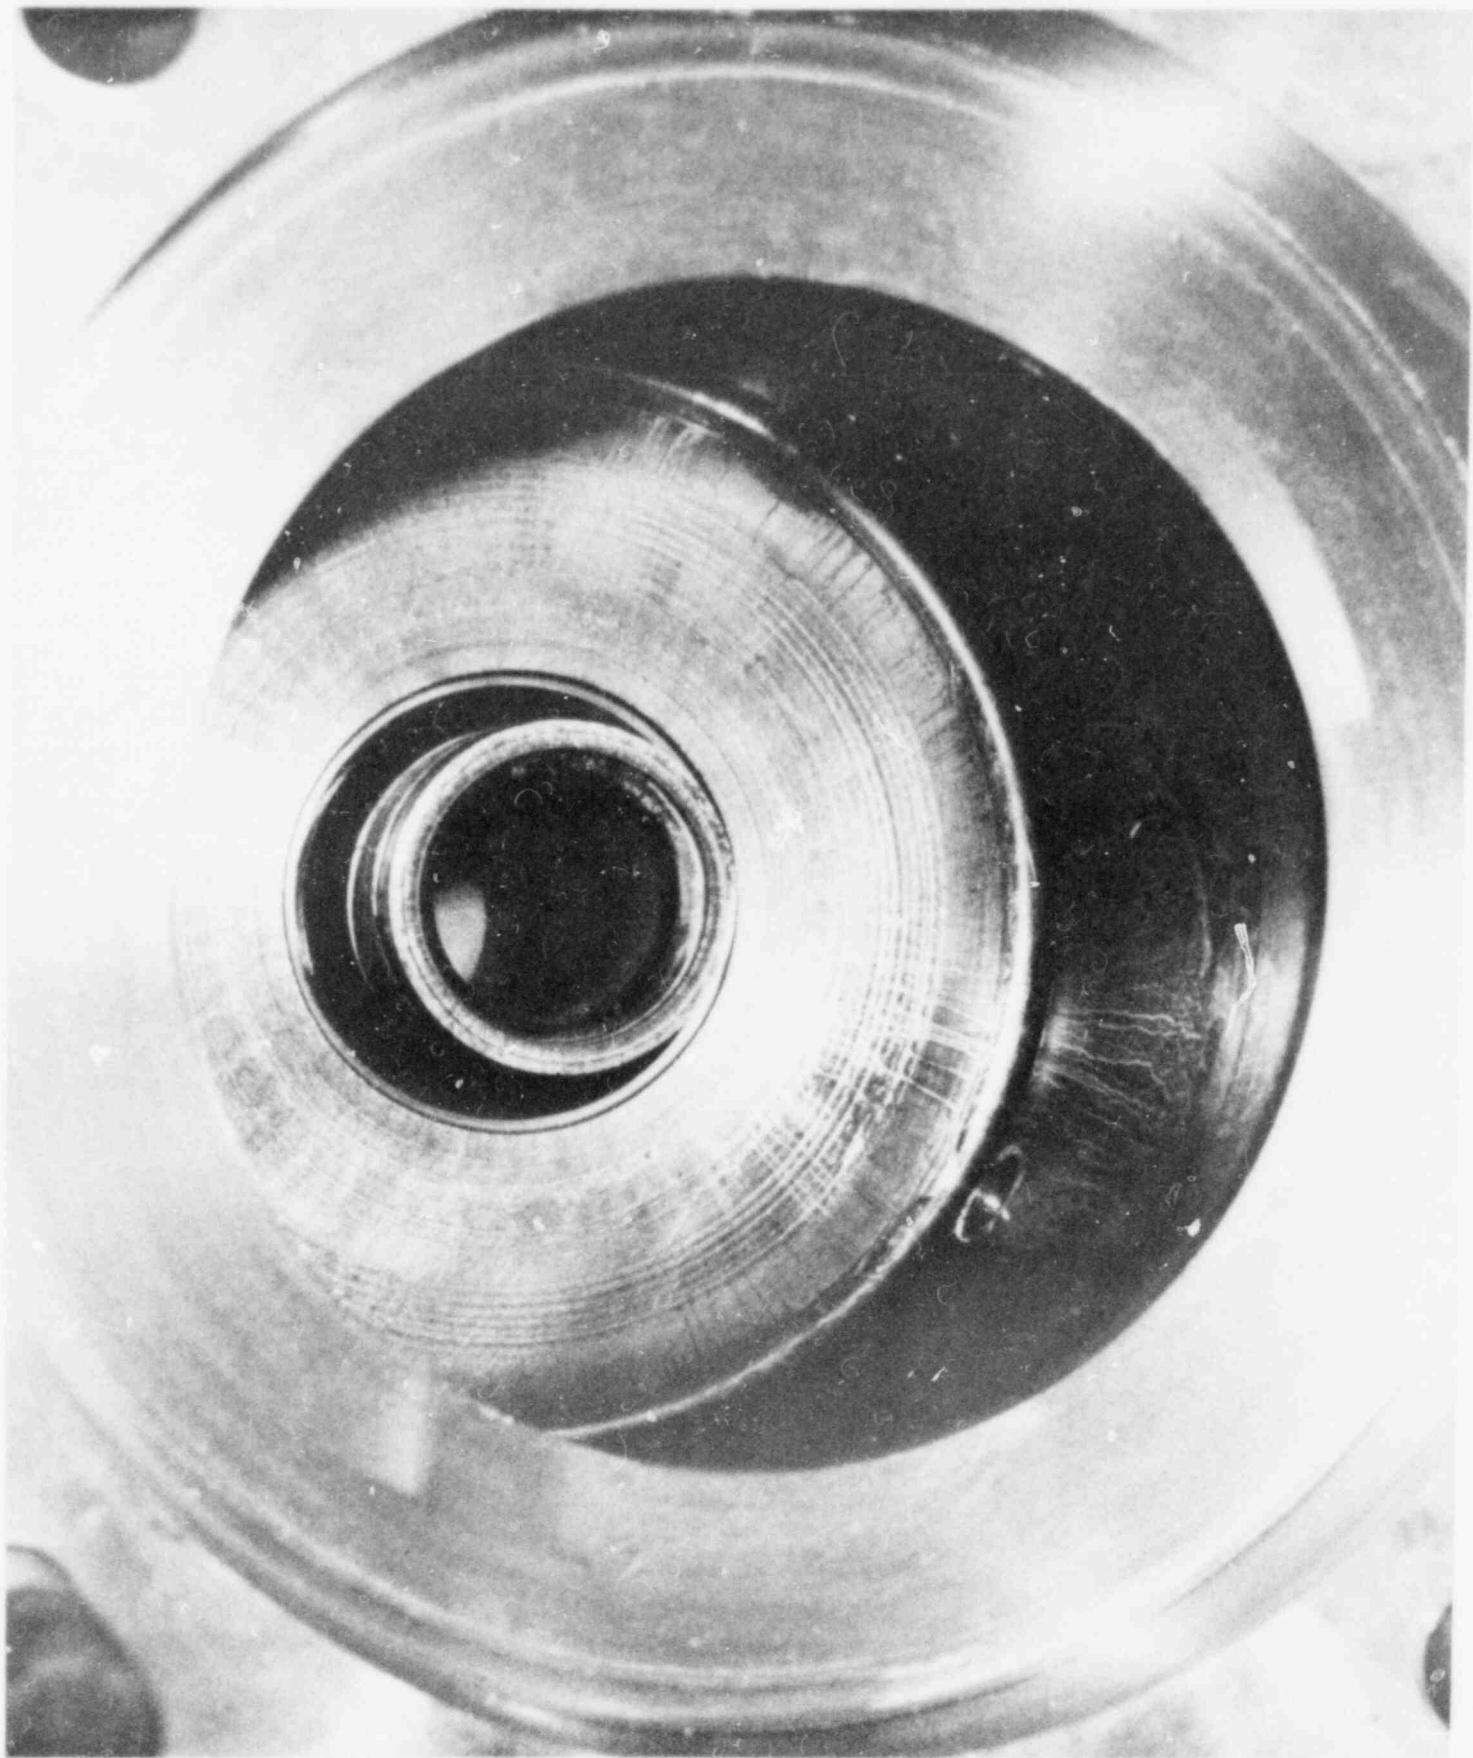
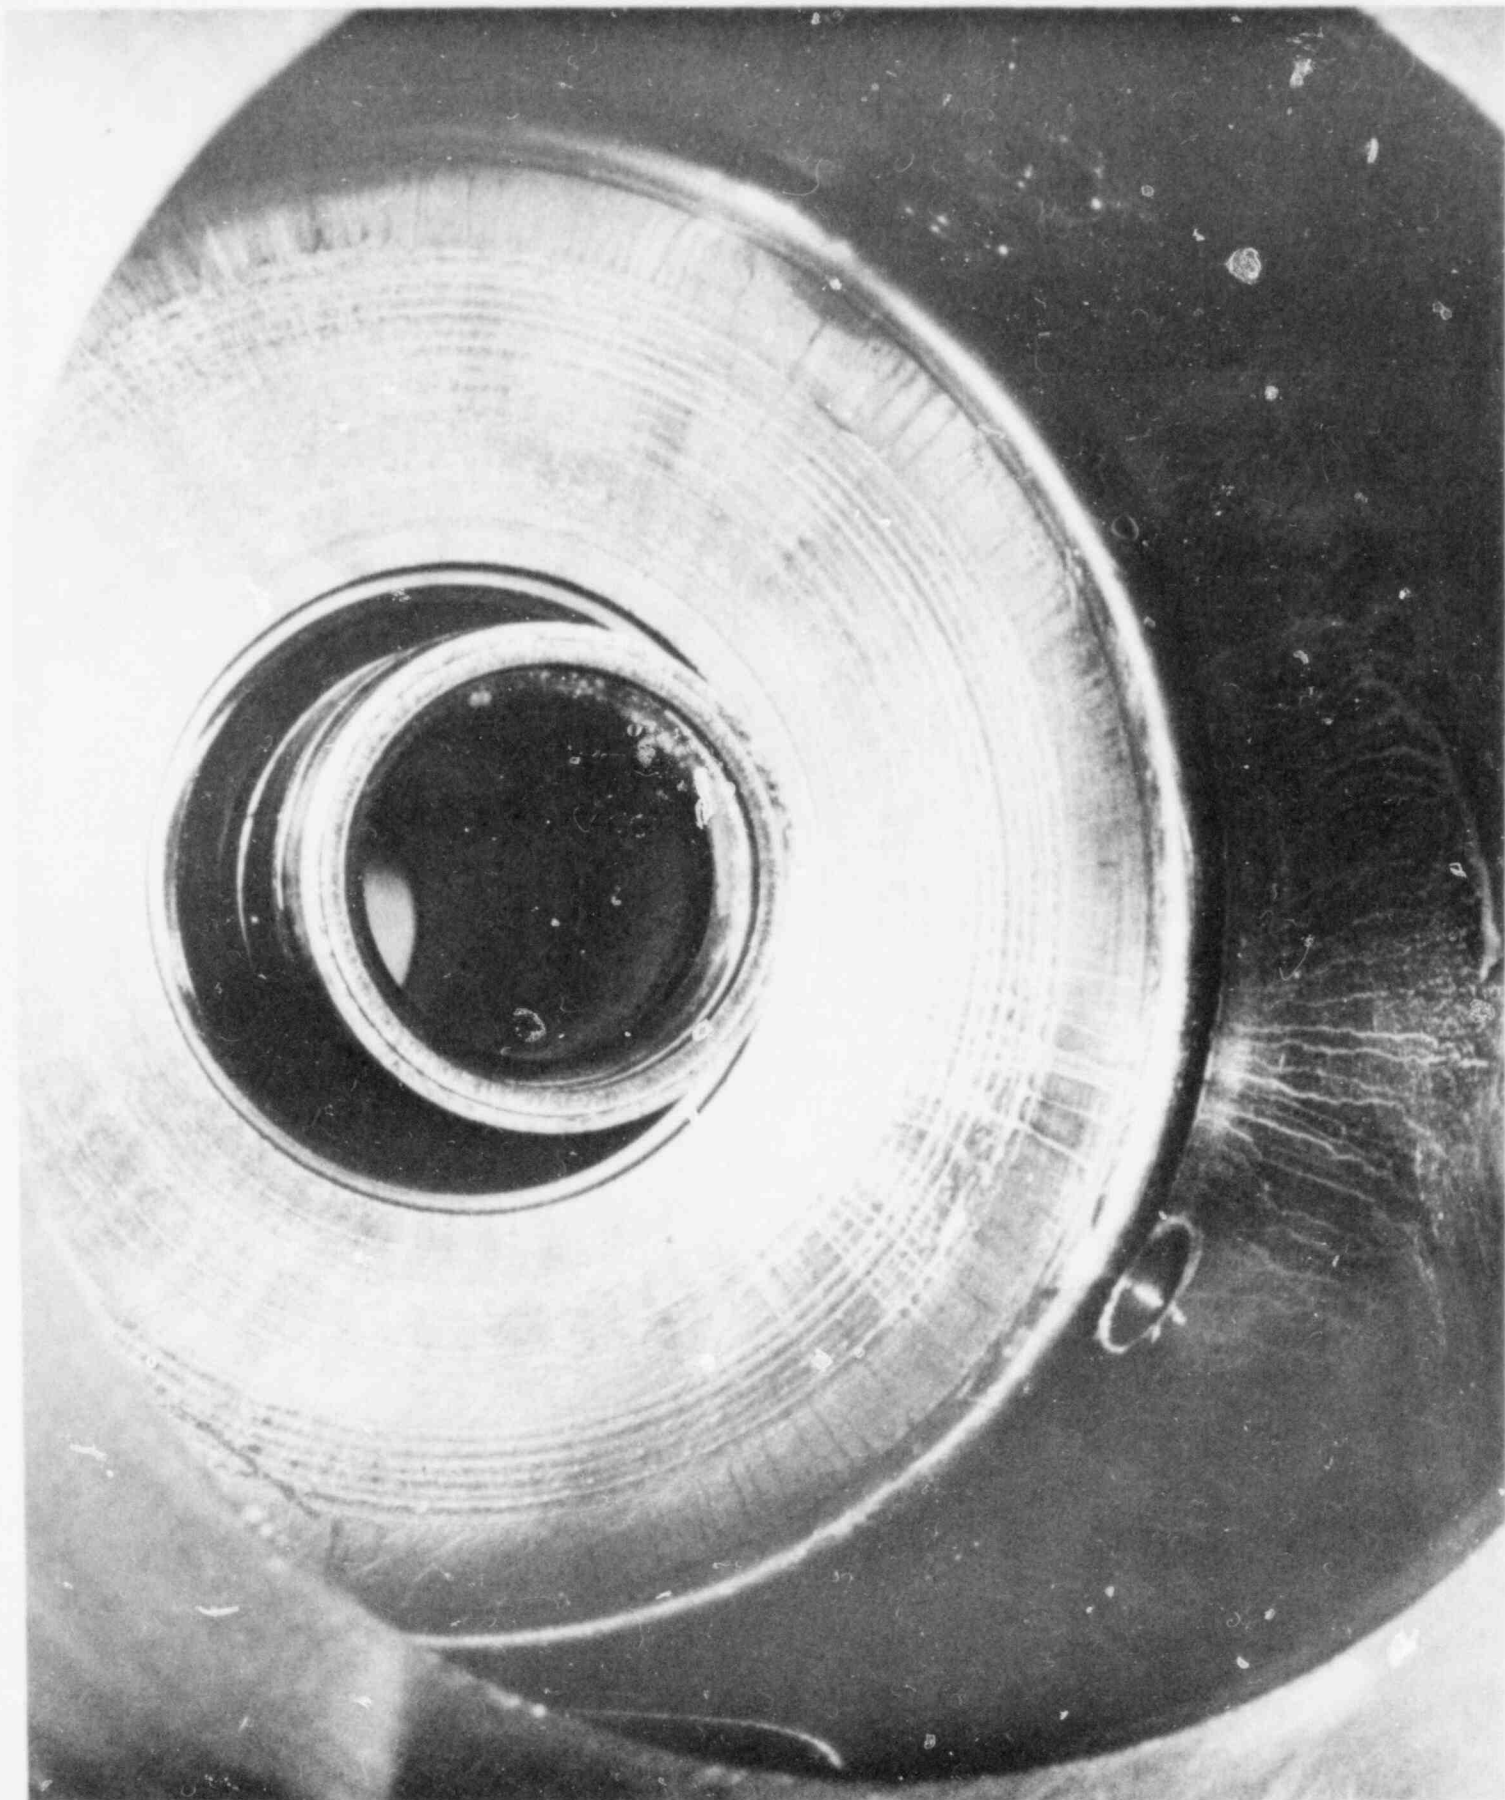
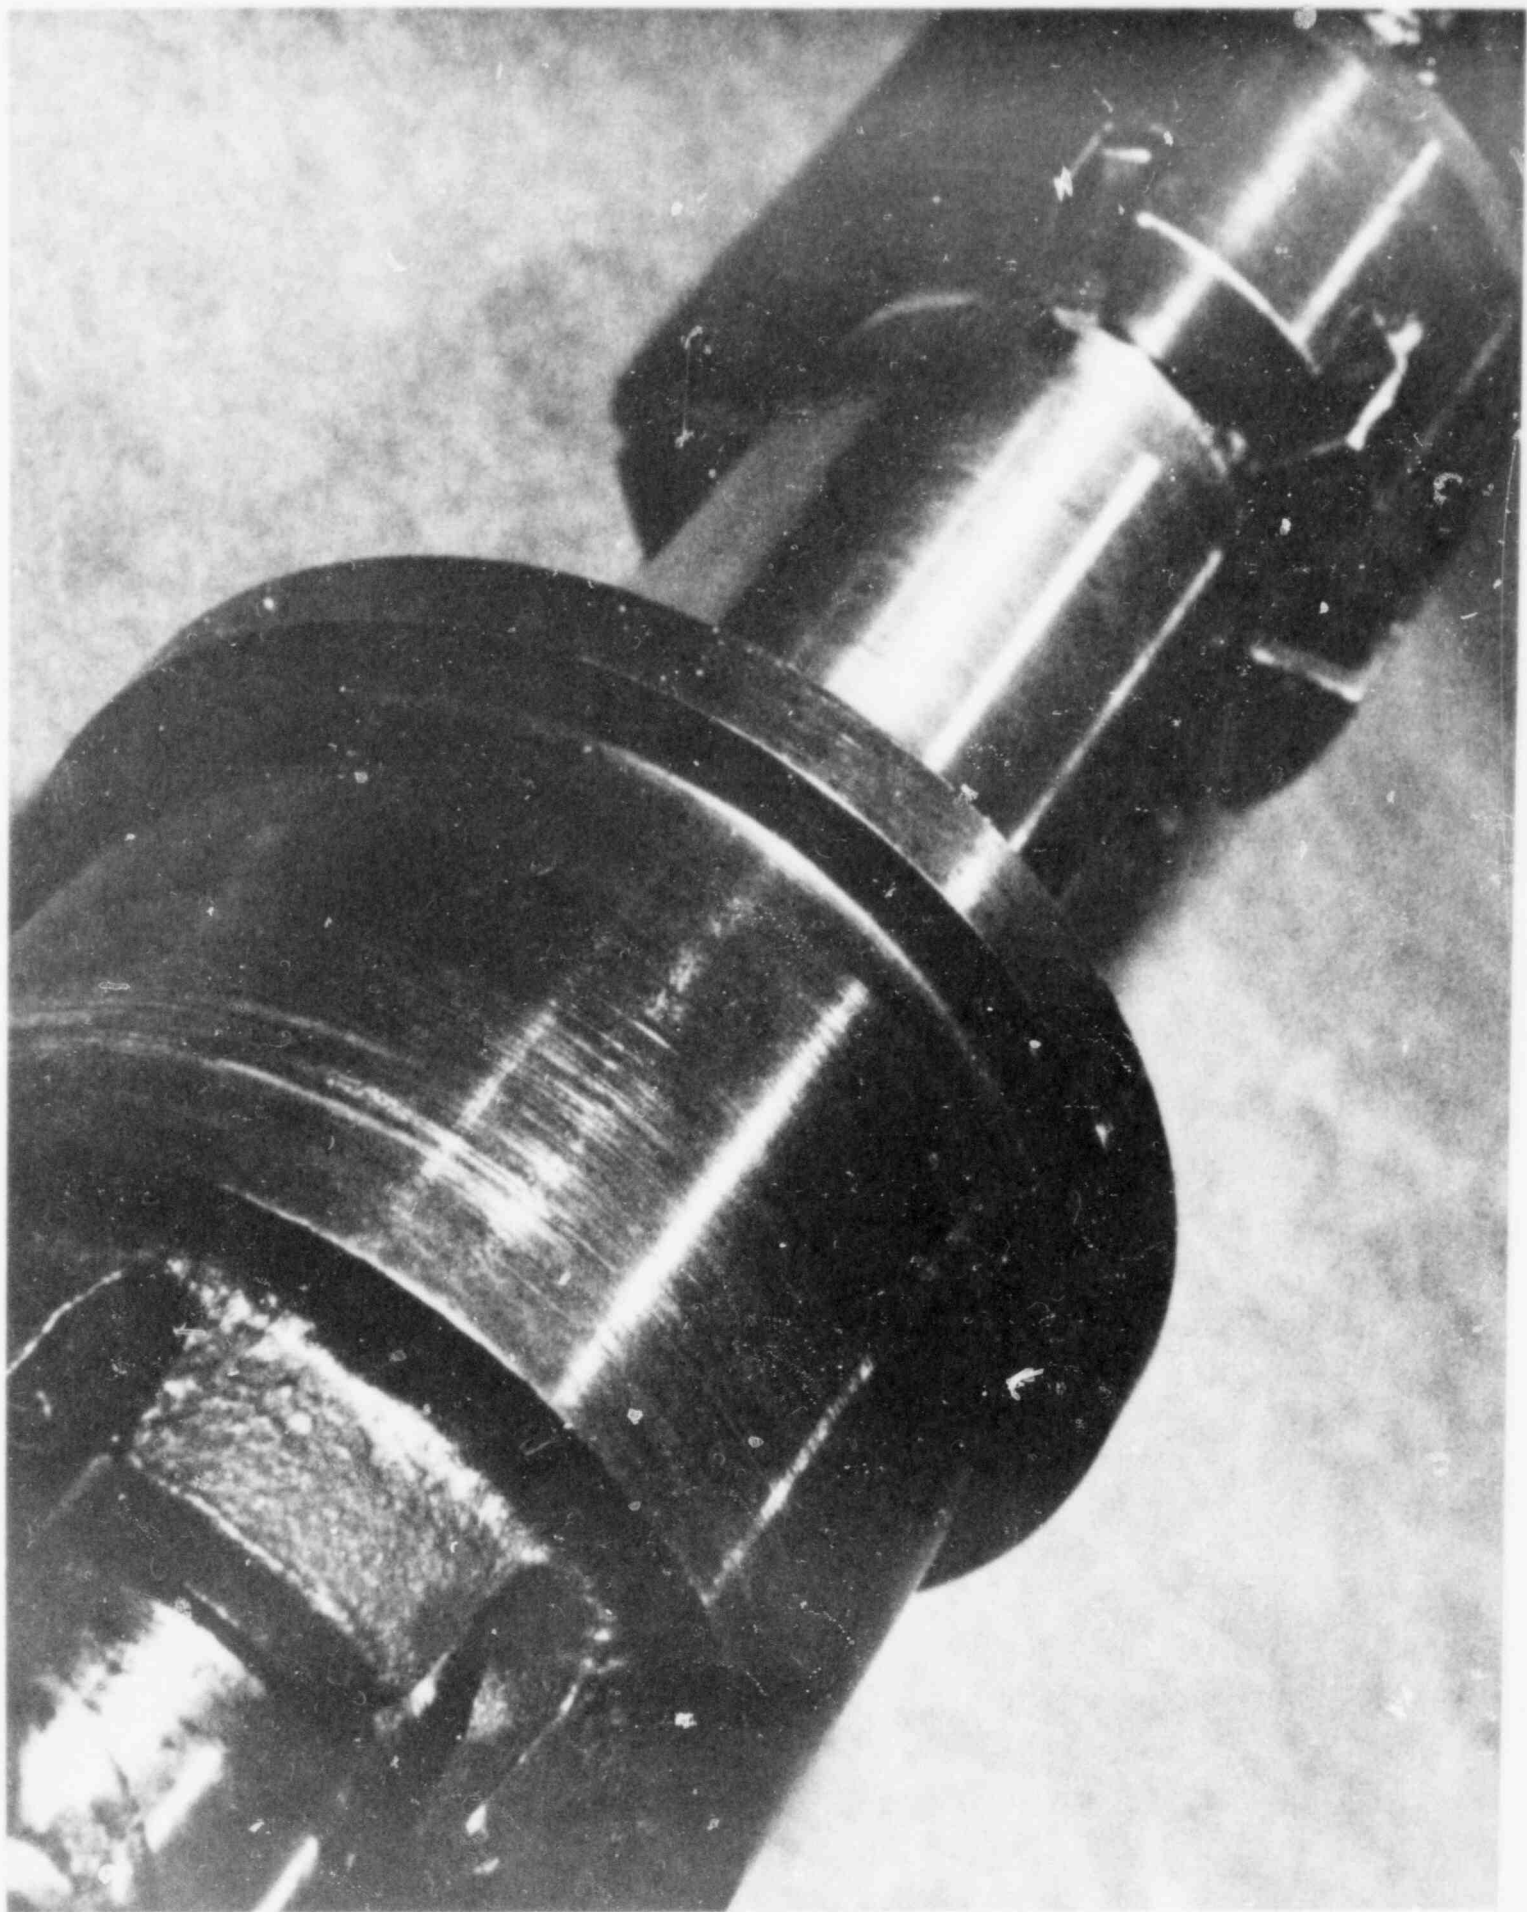
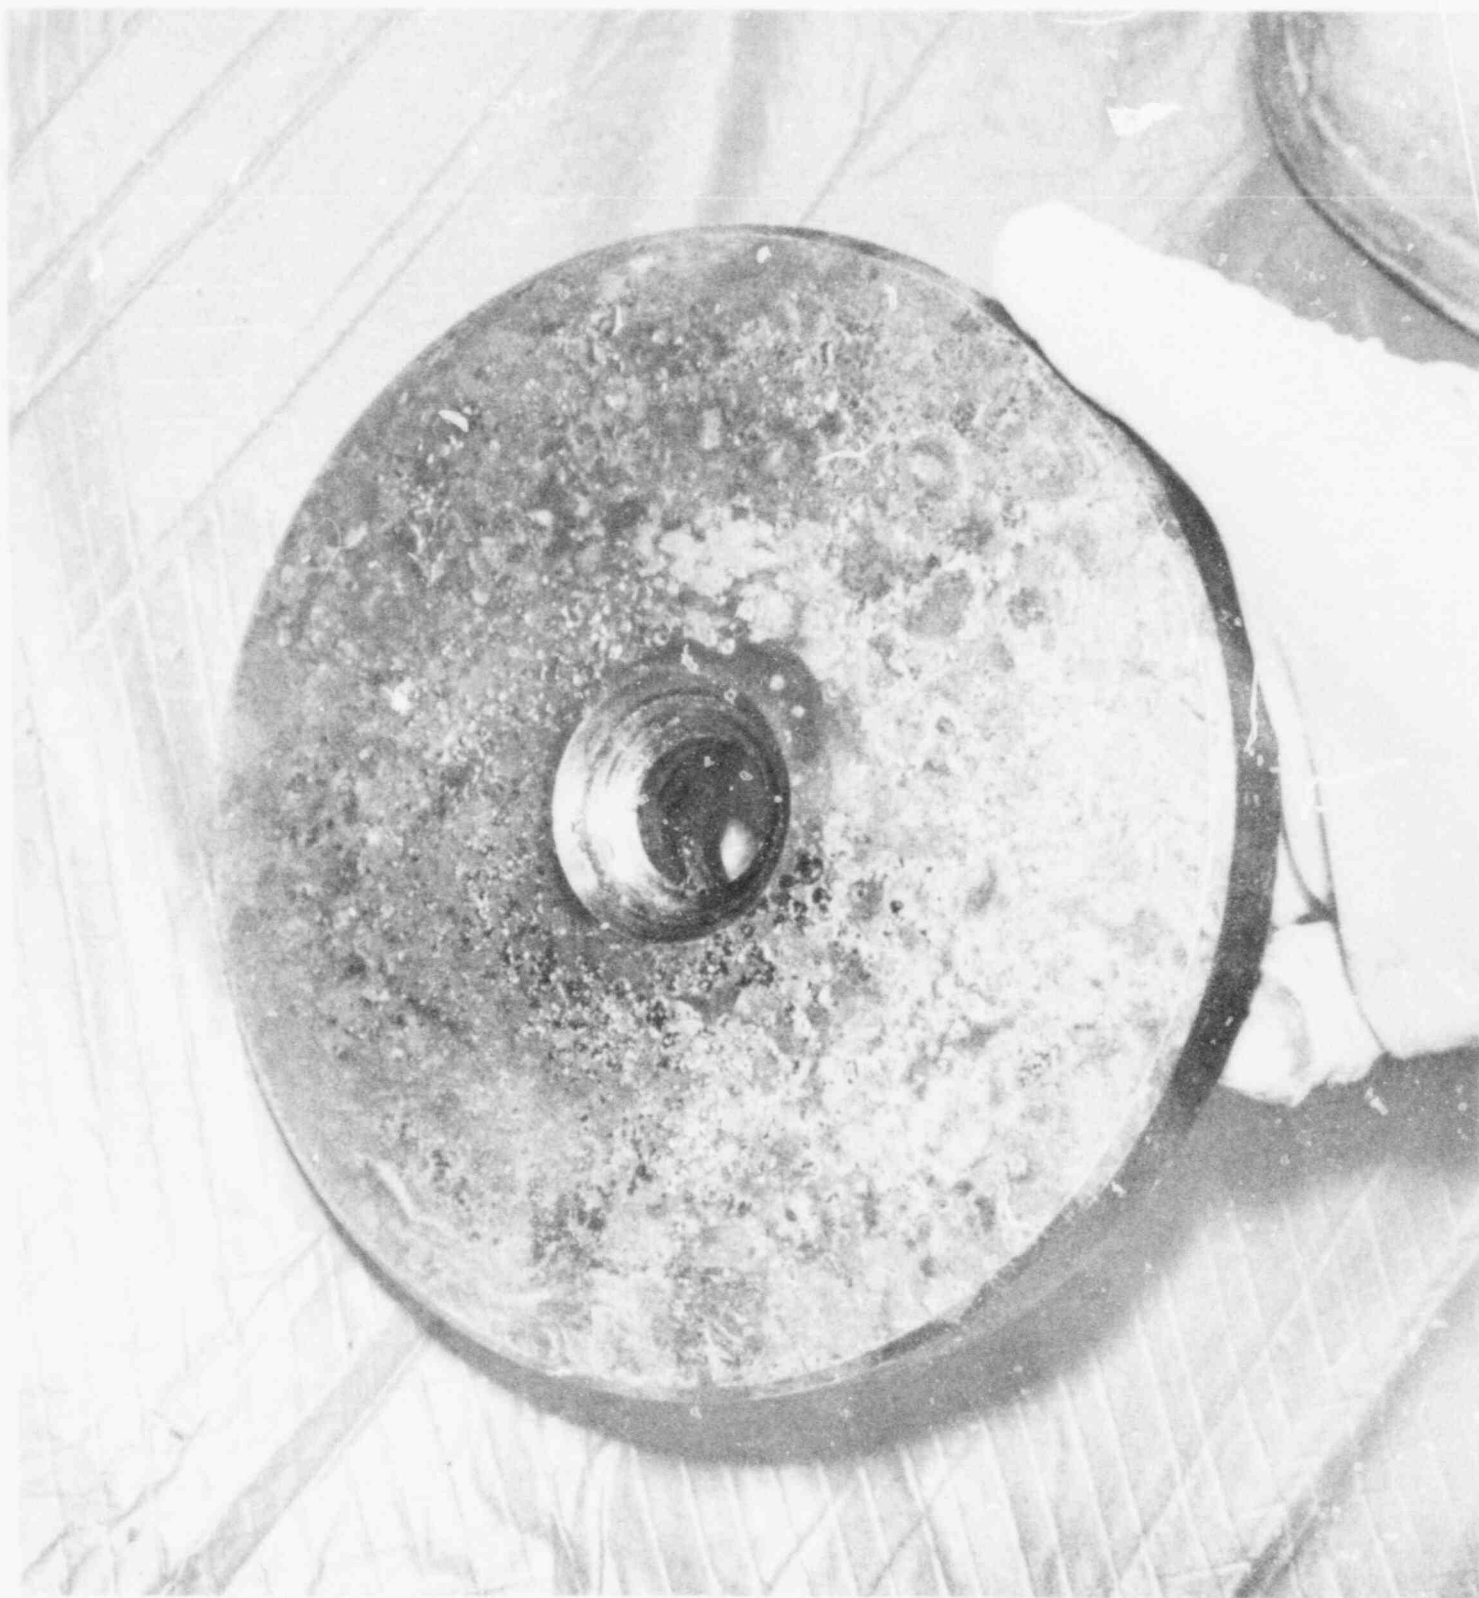
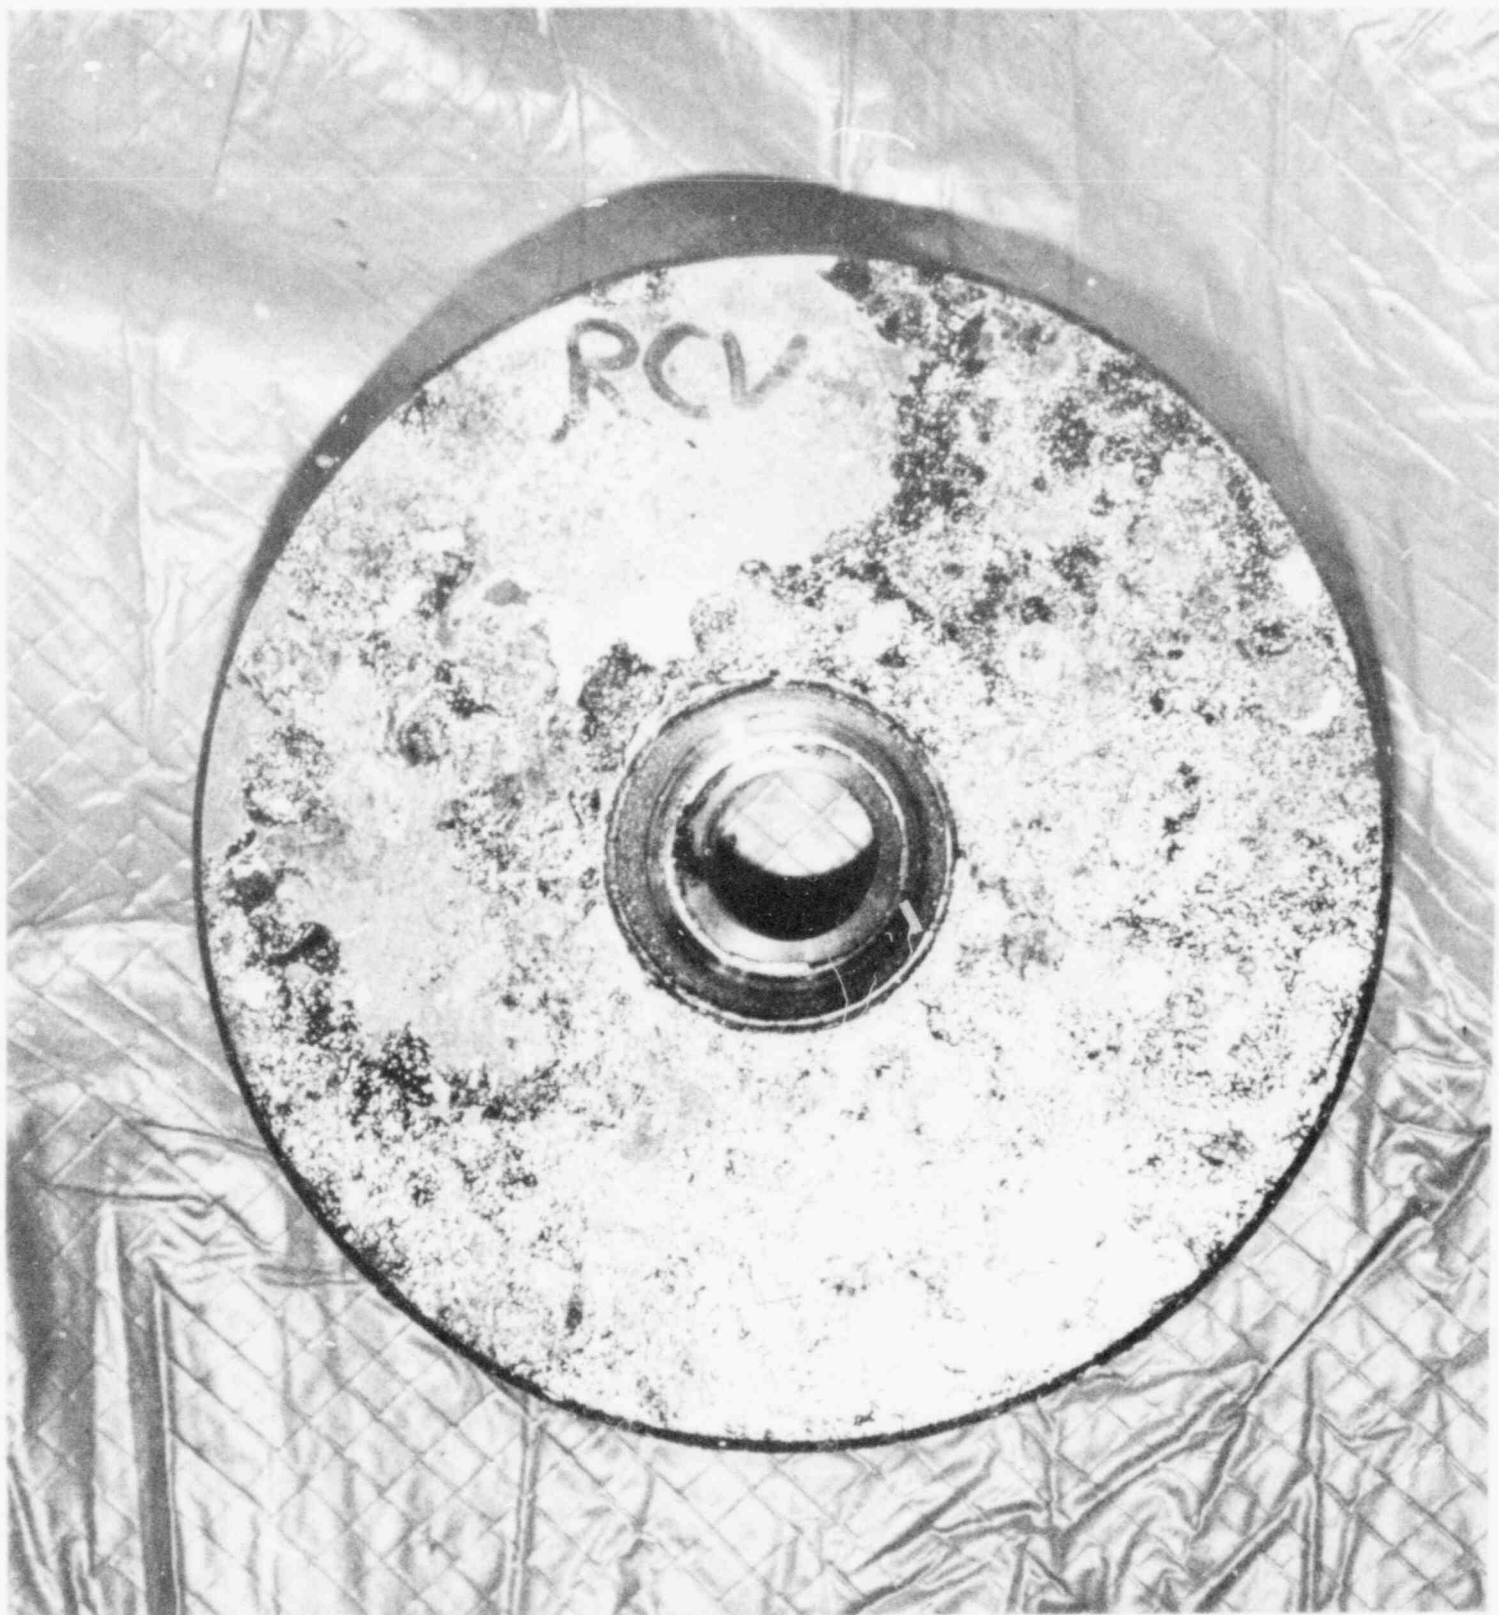
parts as compared to their condition prior to test. Photographs of RCV-8 parts following steam testing are presented in Figures 22 through 30.

In summary, there was no evidence of any damage due to the test or previous operation in the plant, except for the steam cutting and erosion of the seat, disc and adjacent surfaces due to the 1 to 1-1/2 gpm leak rate.
