Examination and Test of Crystal River Unit No. 3 Power-Operated Relief and Safety Valves PWR Safety and Relief Valve Test Program

EPRI NP-80-13-LD
Project V102-31
Interim Report
December 1980
Limited Distribution
Copy Number *223*

Prepared by
MPR Associates, Inc.
Washington, D.C.

In February 1980, an abnormal transient occurred at the Crystal River Unit No. 3 (CR-3) Nuclear Generating Station. The cause of this transient was an electrical system malfunction which opened the power operated relief valve (PORV) on the pressurizer and held it open electrically for approximately 5 to 7 minutes until the PORV was isolated by closing the upstream block valve. A reactor trip, system blowdown to about 1350 psig, and automatic initiation of high pressure injection into the reactor coolant system occurred within the first few minutes of the transient. The addition of high pressure injection flow filled the pressurizer, increased reactor coolant system pressure, and eventually resulted in actuation of one of the two spring-loaded safety valves installed on the pressurizer. This safety valve subsequently cycled open and closed over a period of up to 2 hours. During the course of the transien

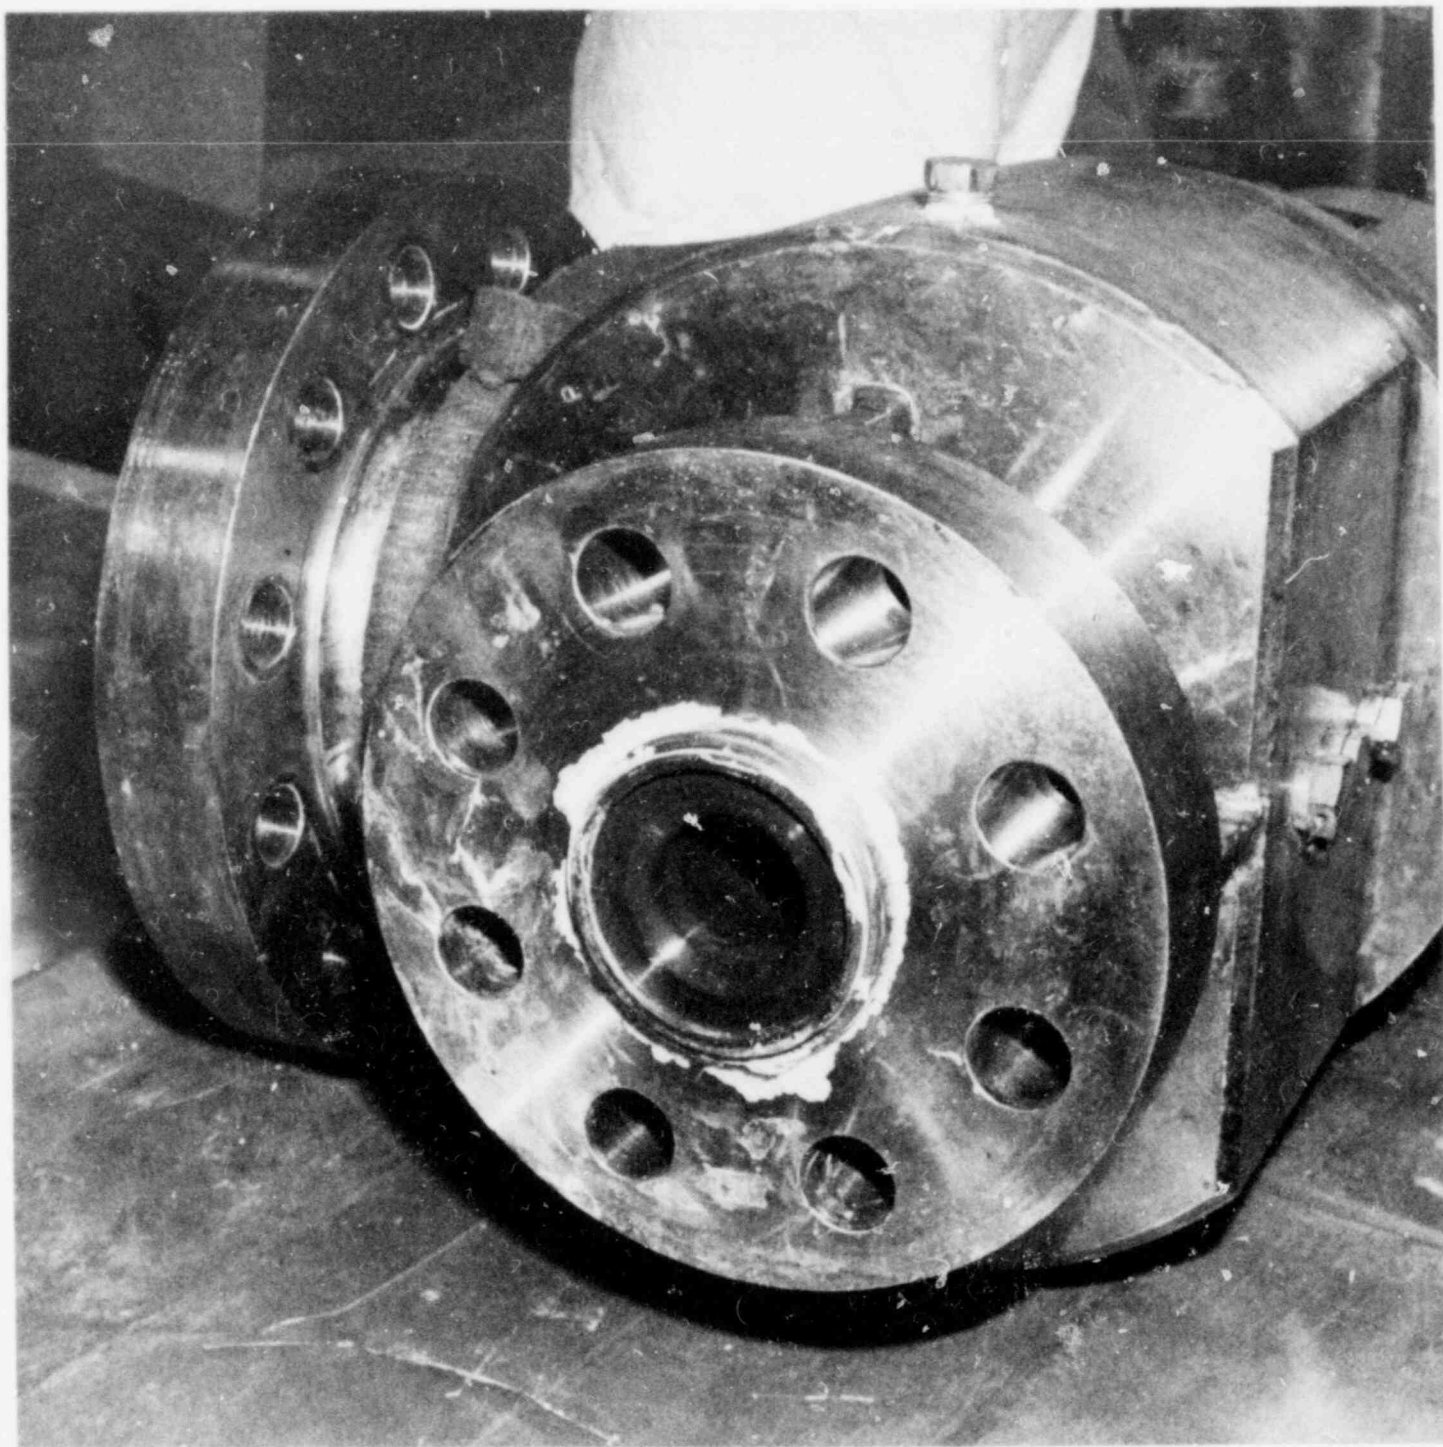
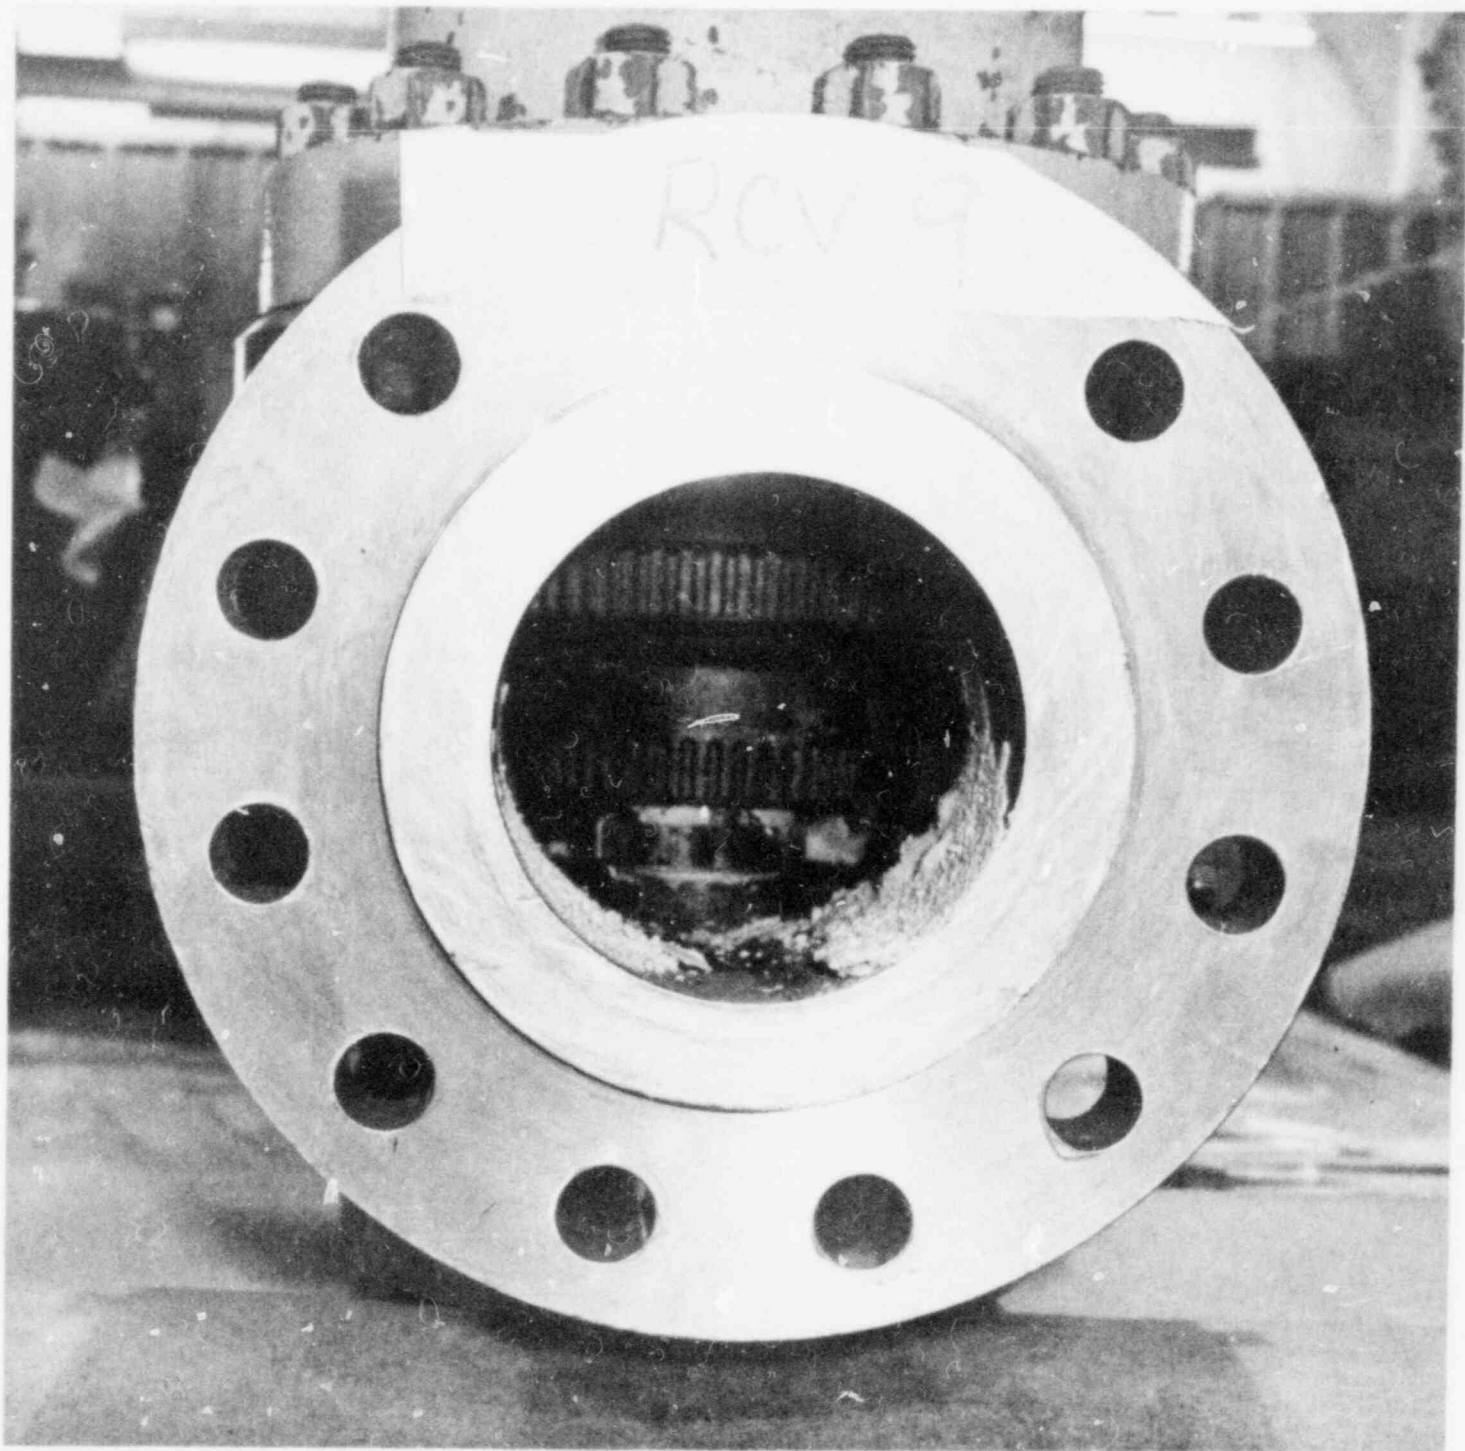
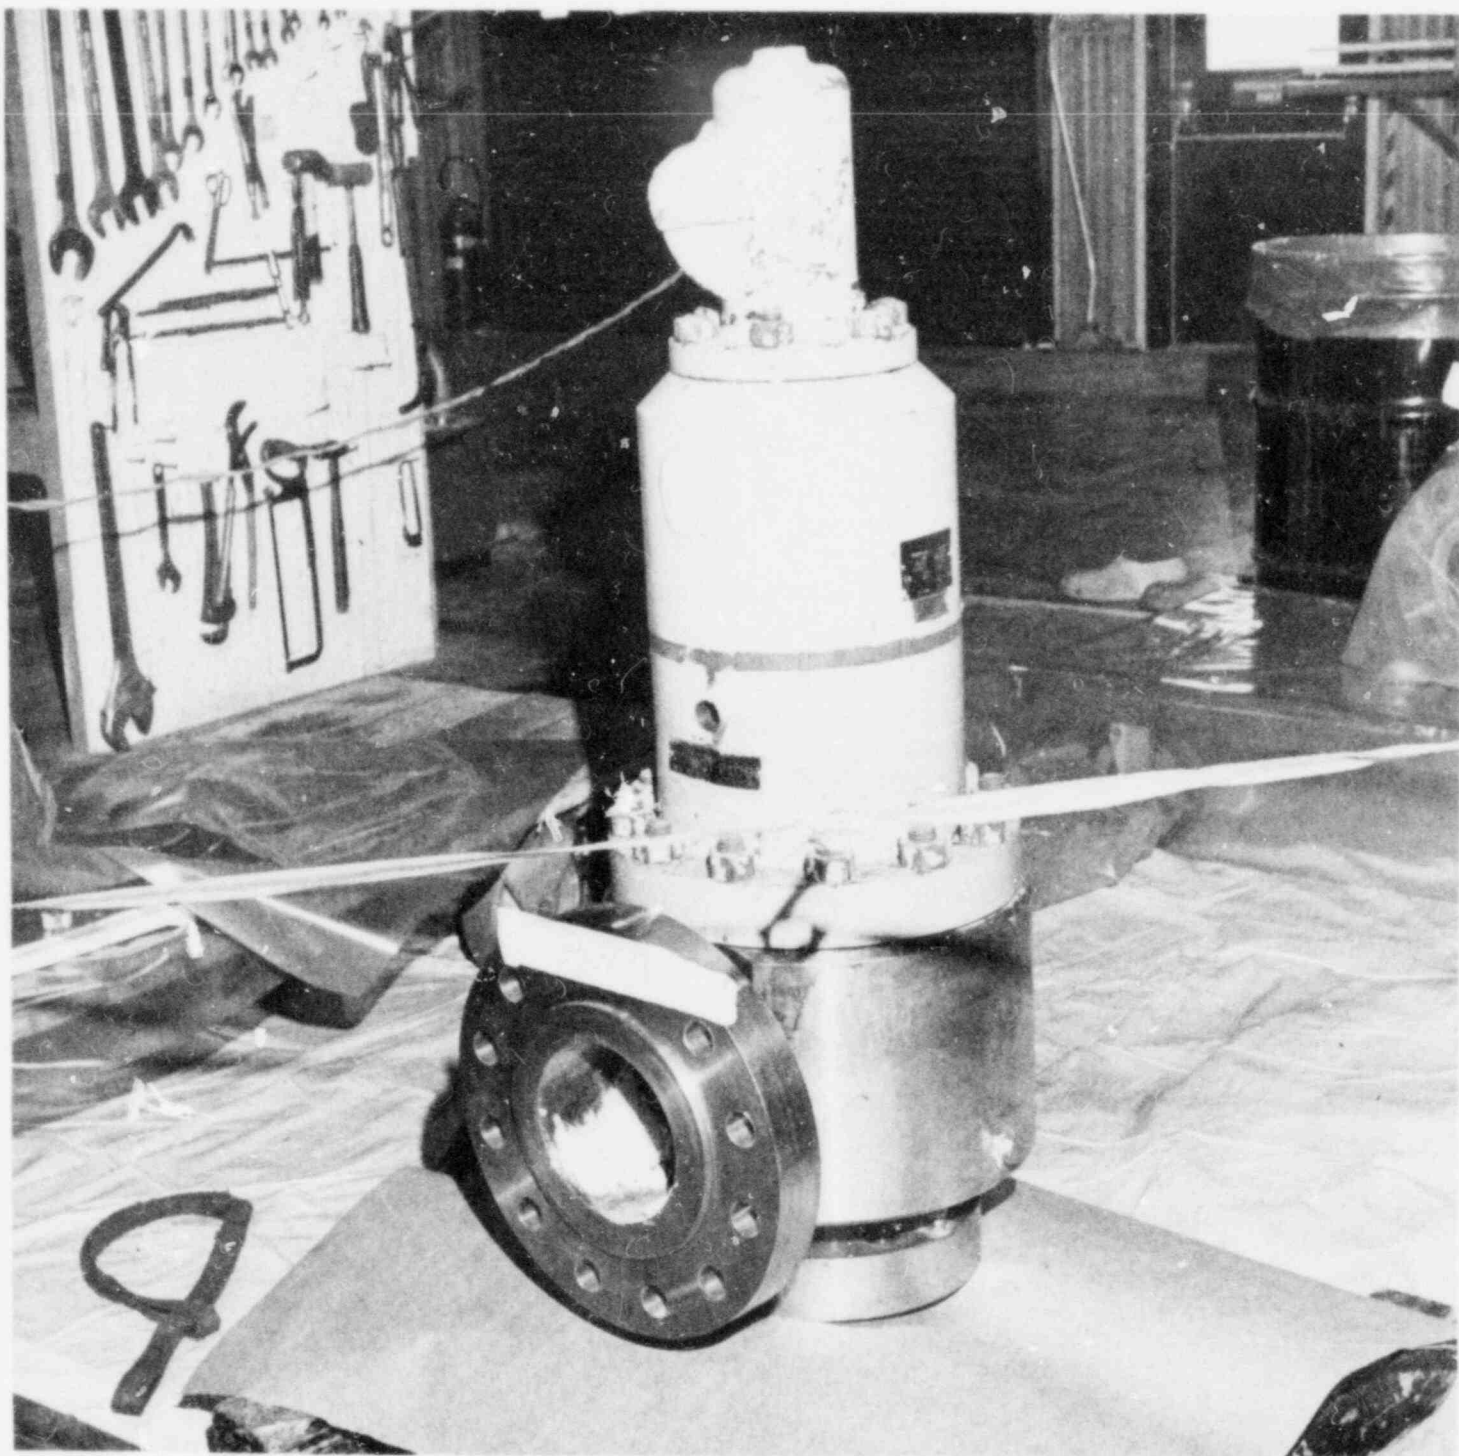
Safety valve RCV-9 was inspected and photographed as received and was installed on the test loop for set pressure test. Photographs of RCV-9 as received are shown in Figures 31 through 33. The test procedure and facility used were the same as for RCV-8. The tests of RCV-9 resulted in lift pressures of 2472 psig, 2466 psig and 2466 psig. There was no steam leakage before, during or after these tests. Operation of the valve was normal in every respect.

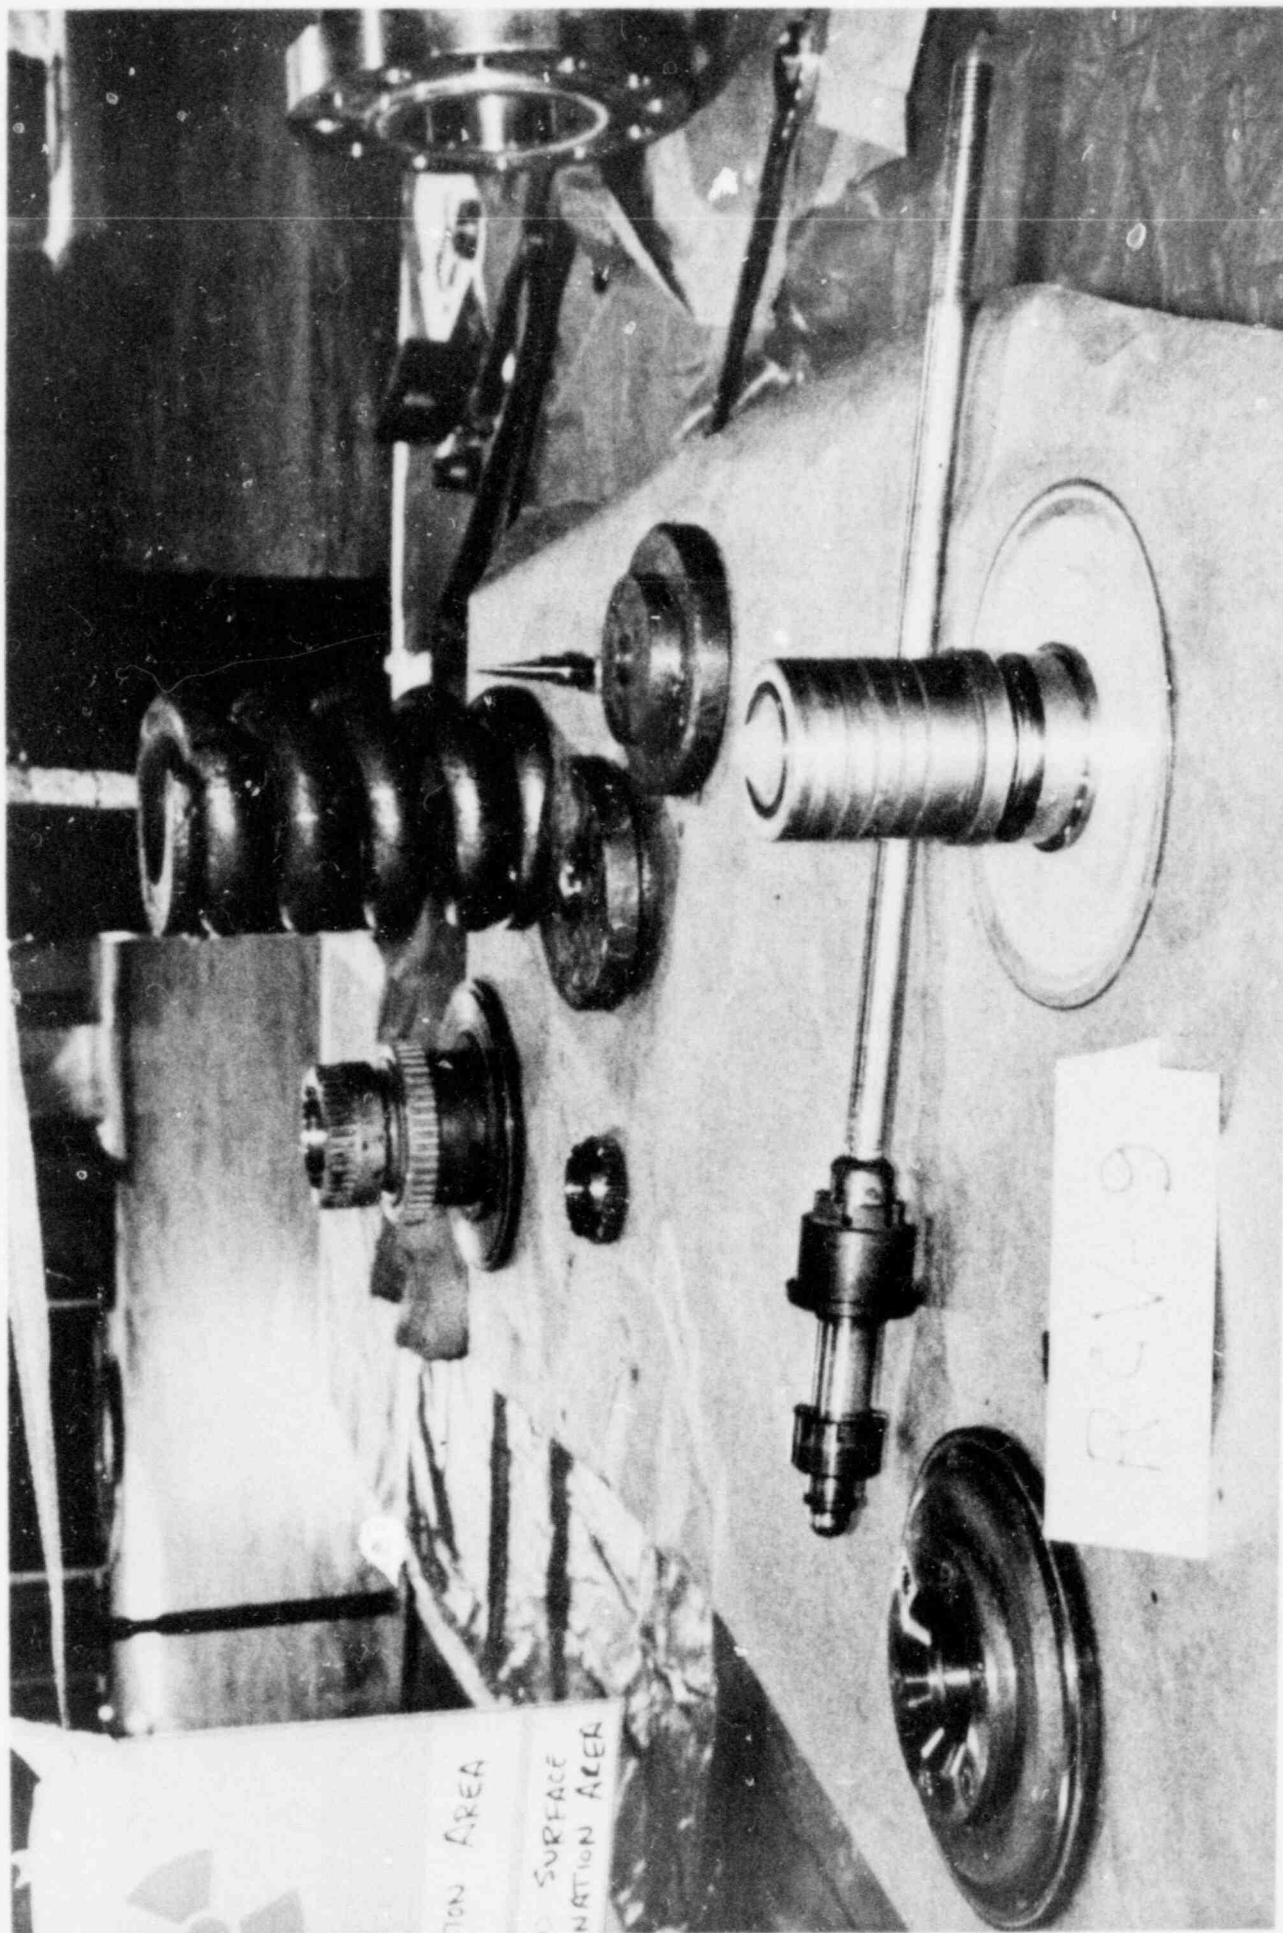
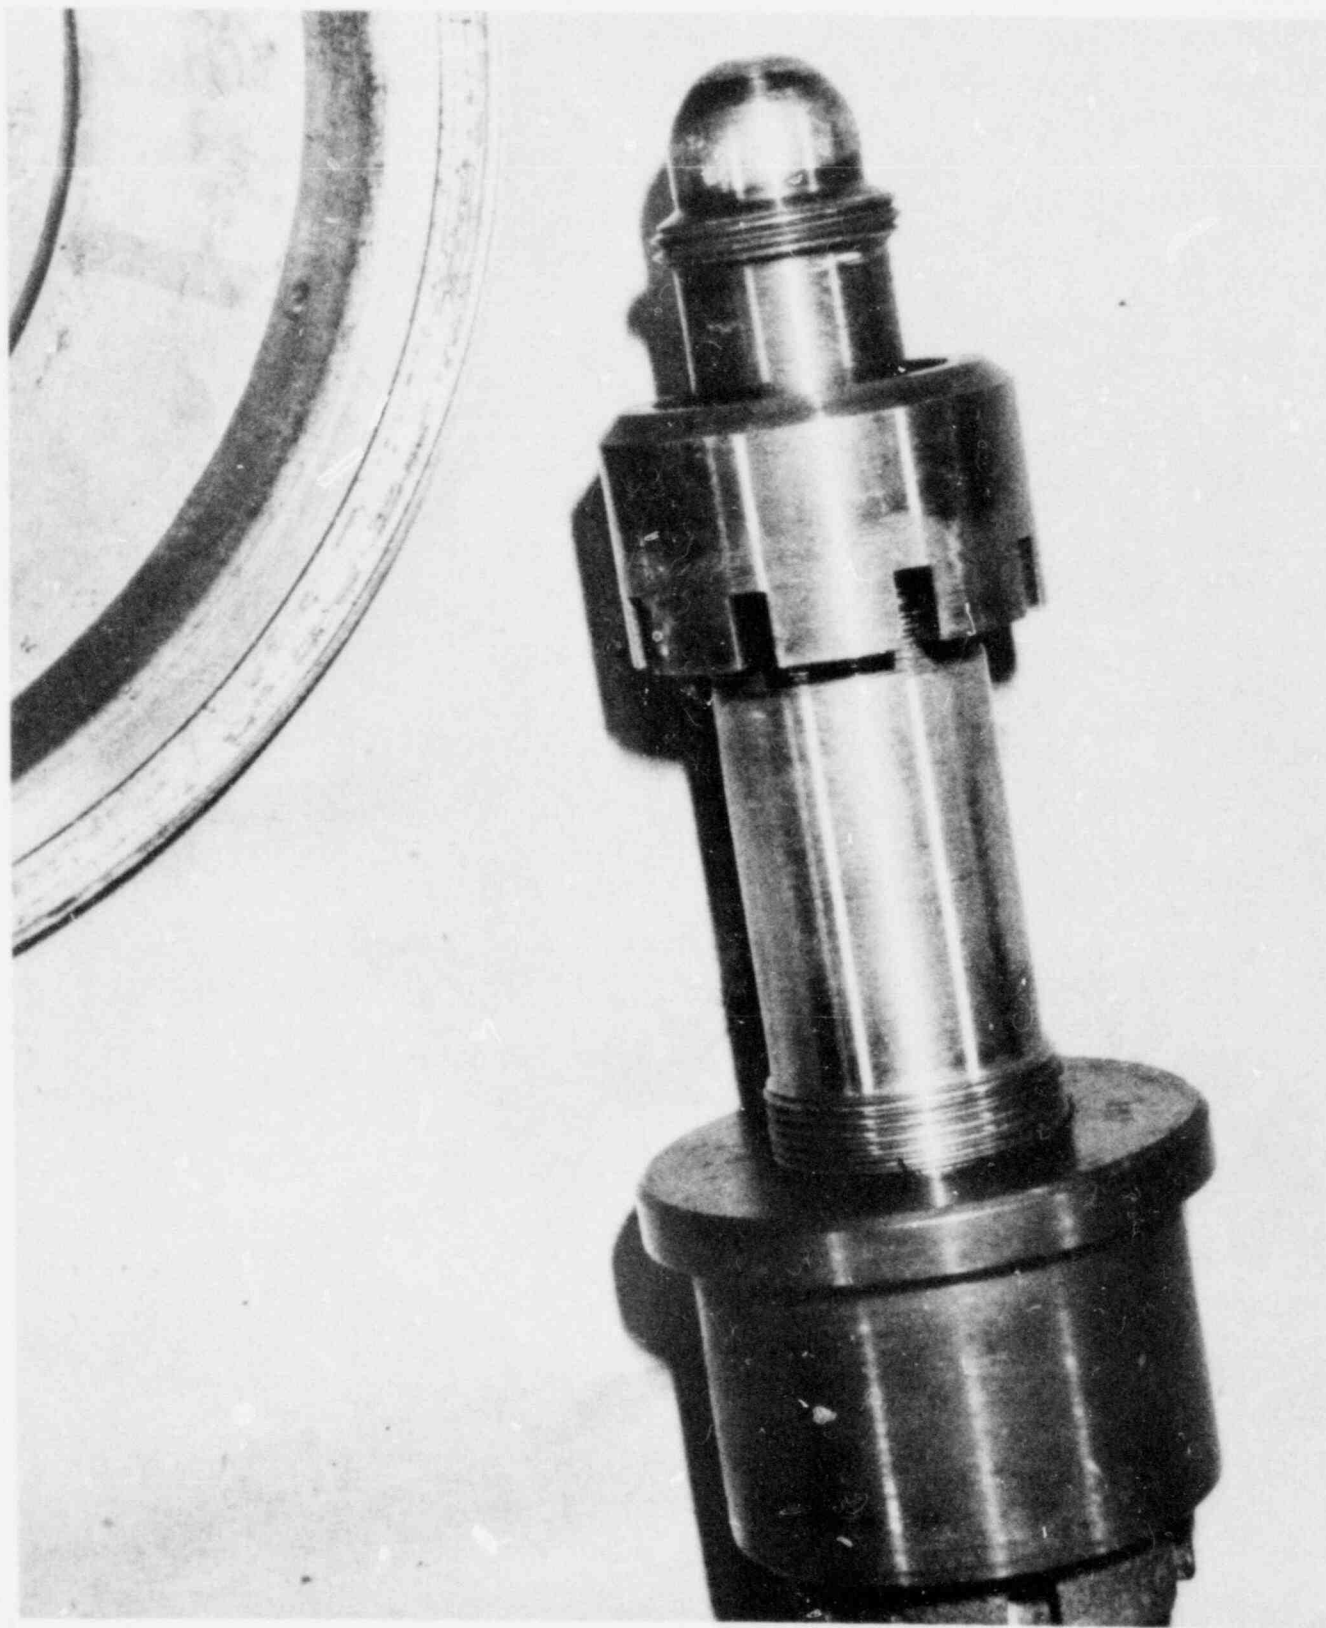
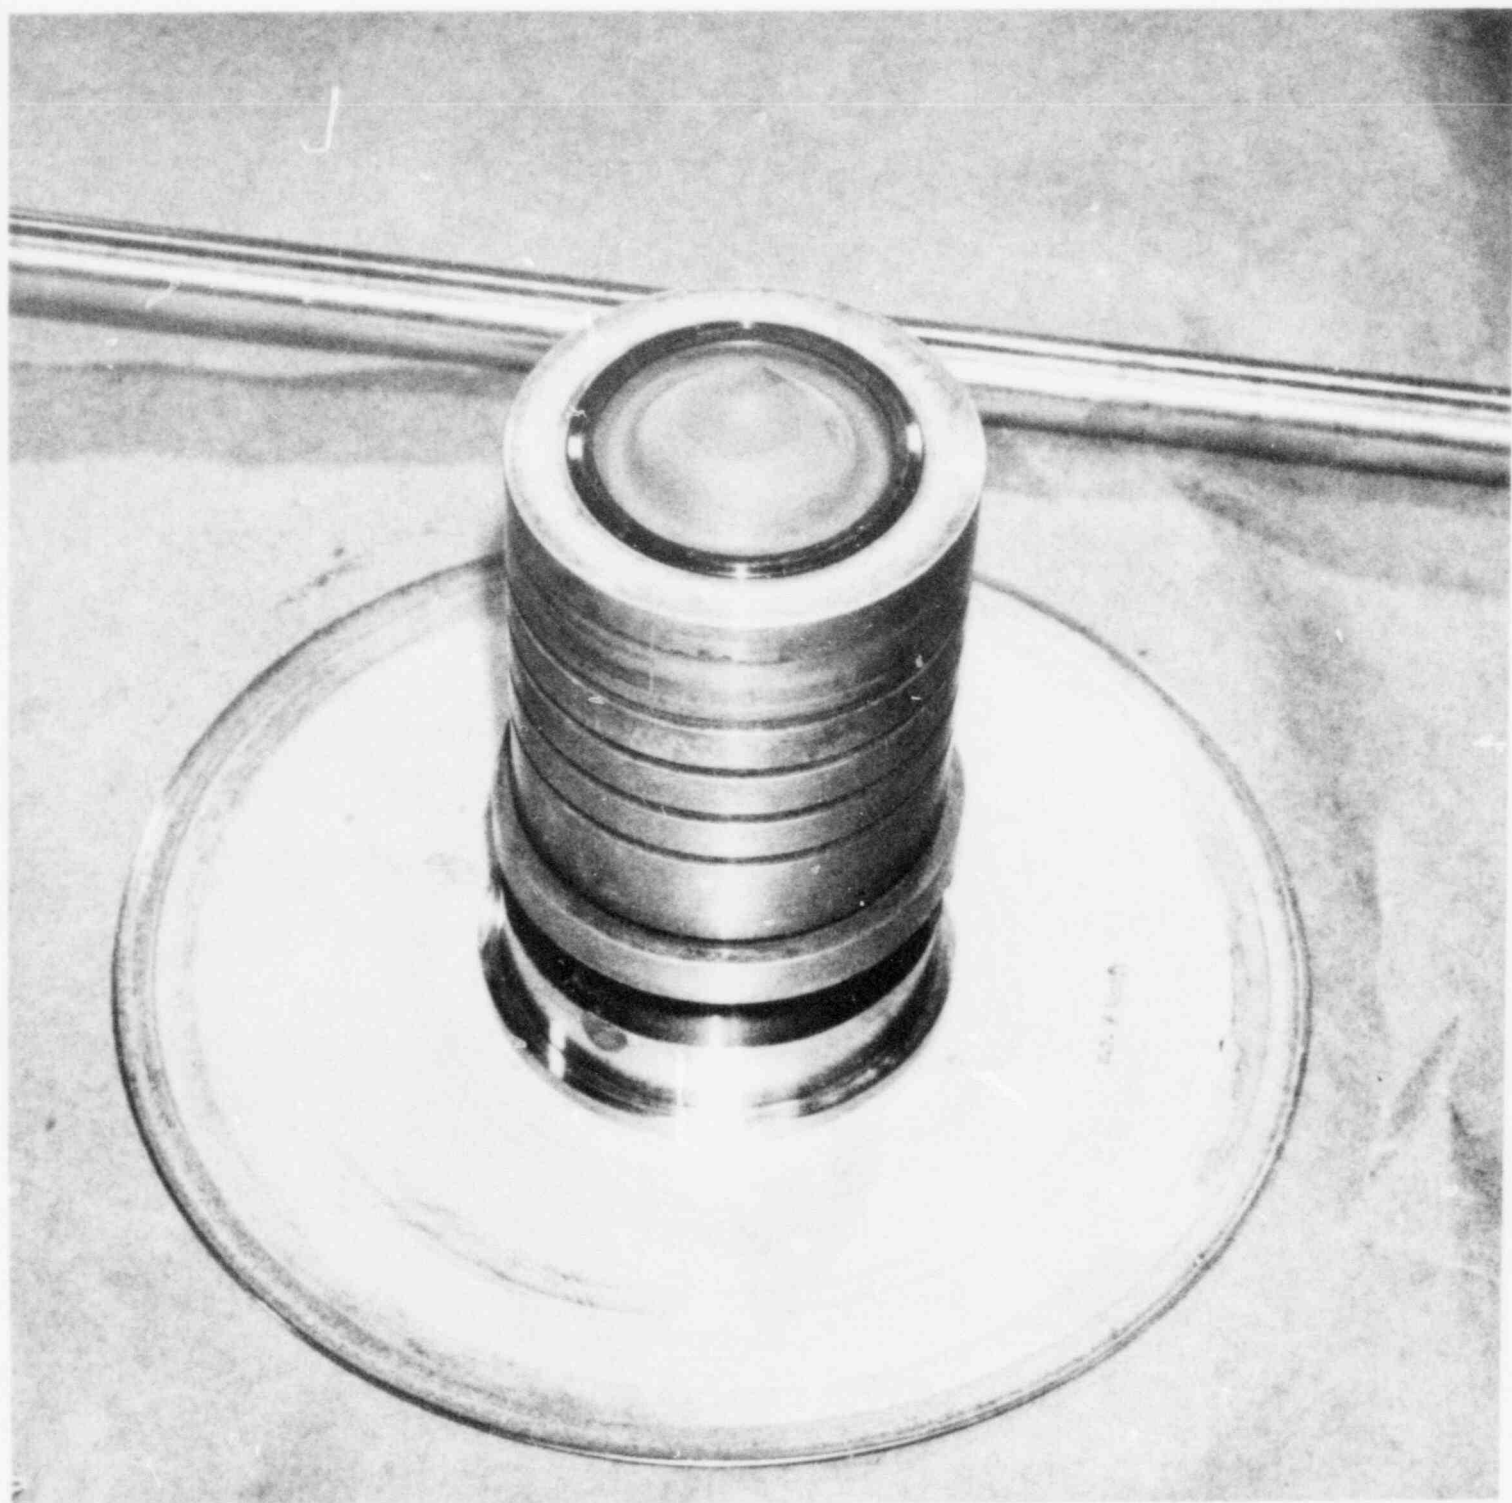
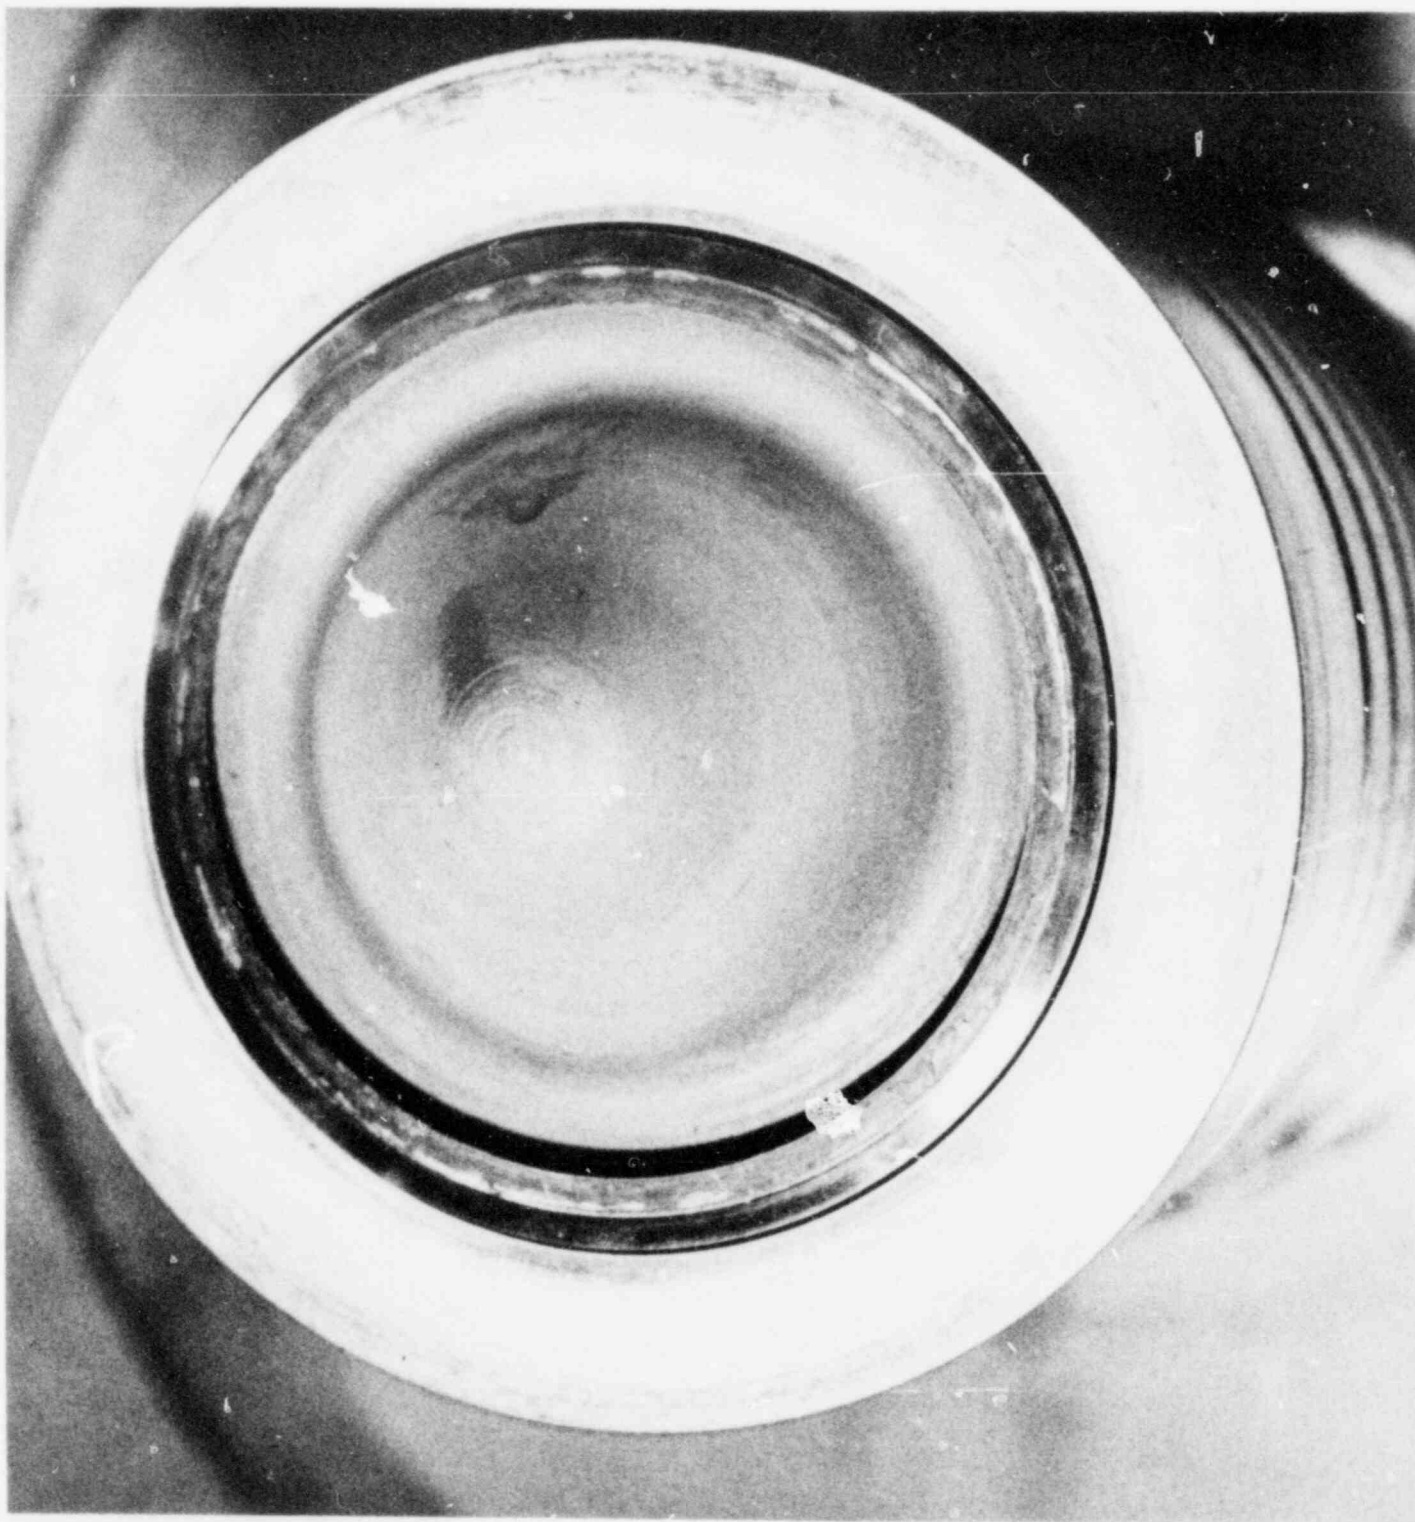
Safety valve RCV-9 was removed from the test facility, disassembled and inspected. Results of these inspections showed no evidence of distress, leakage or abnormal

operation. The one problem noted was that, similar to the situation in the case of valve RCV-8, the anti-rotation pin (Part 8D) was missing from the upper spring washer (Part 8C). While this pin could not be located, it was apparent from the elongation of the hole in the upper spring washer that this pin had also been bent and dislodged at some point, probably during assembly of the valve. The lack of this pin obviously had no effect on the performance of RCV-9. Following these inspections, valve RCV-9 was decontaminated, lightly lapped and reassembled for set pressure adjustment and verification tests. Photographs of RCV-9 parts after disassembly are shown in Figures 34 through 37.
