Public Service Company of Colorado

August 26, 1981
Fort St. Vrain
Unit No. 1
P-81212

REPORTABLE OCCURRENCE 81-046

REPORT NO. 50-267/81-046/03-L-0

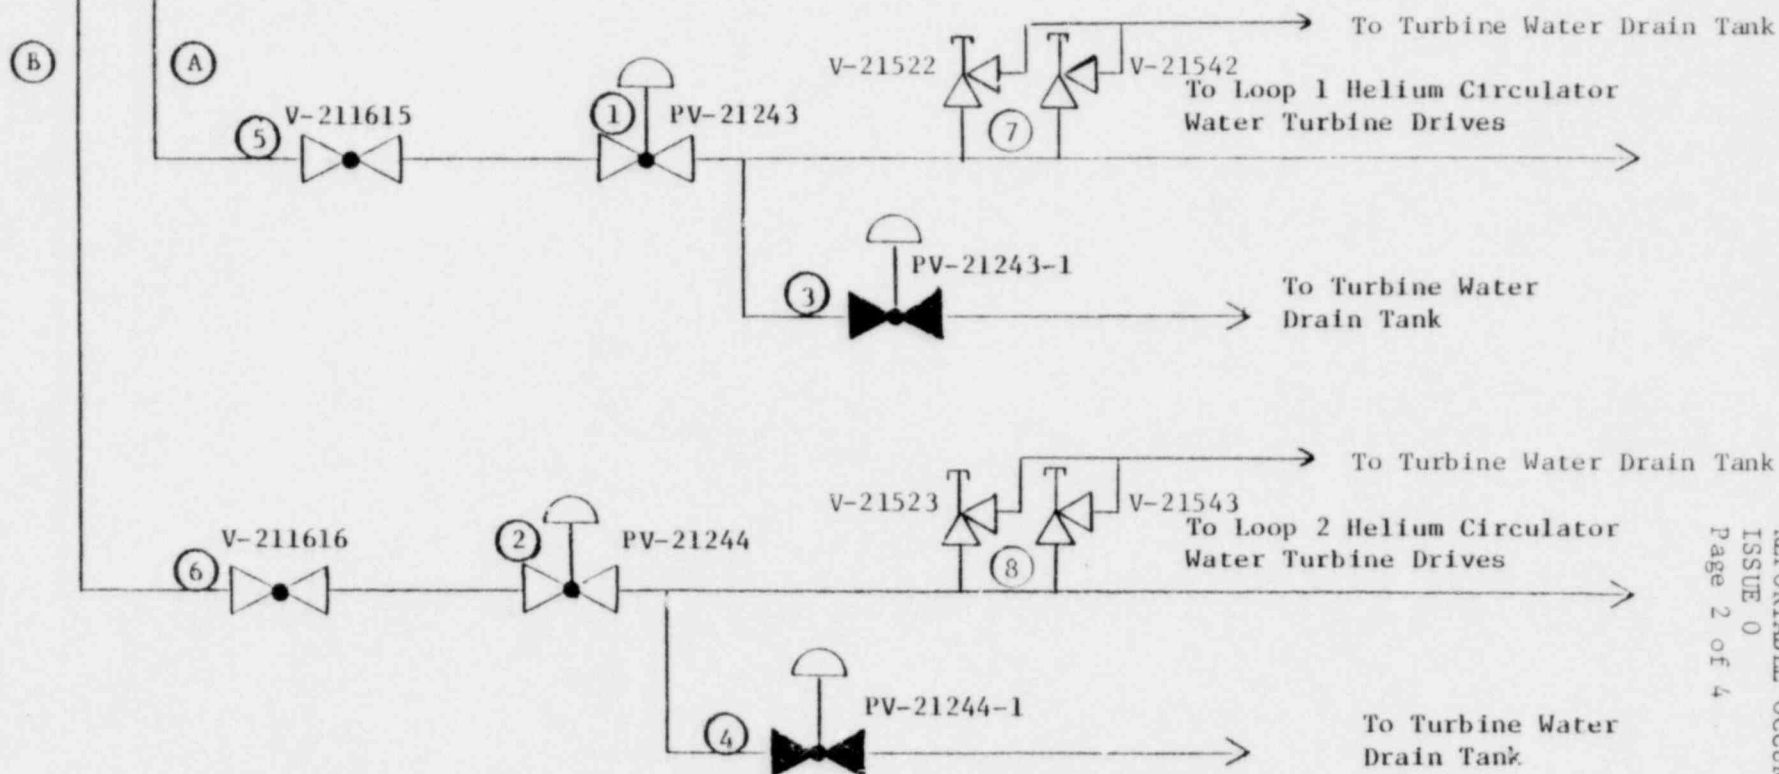
FIGURE 1

In this instance, under no-flow conditions, excessive leakage through relief valves 7 downstream of the main pressure control valve for Loop 1 caused erratic operation of the main pressure control valve. A Plant Trouble Report was initiated, and the emergency feedwater supply to Loop 1 was isolated 5 for repair of the relief valves at 0800 hours on July 28, 1981. The relief valves were repaired, and the system restored to service at 0140 hours on July 29, 1981, within the 24 hours allowed by LCO 4.2.2 without the affected helium circulators being considered inoperable.

Relief valve leakage downstream of main pressure control valves necessitated isolation for repair. The relief valve leakage is attributed to normal wear.

The relief valves were removed, rebuilt, bench tested, and re-installed. The emergency feedwater supply header to Loop 1 was restored to service.
