Docket No. 50-317  
License No. DPR 53

## LICENSEE EVENT REPORT (LER)

Calvert Cliffs, Unit 1

Missing Fire Protection Damper

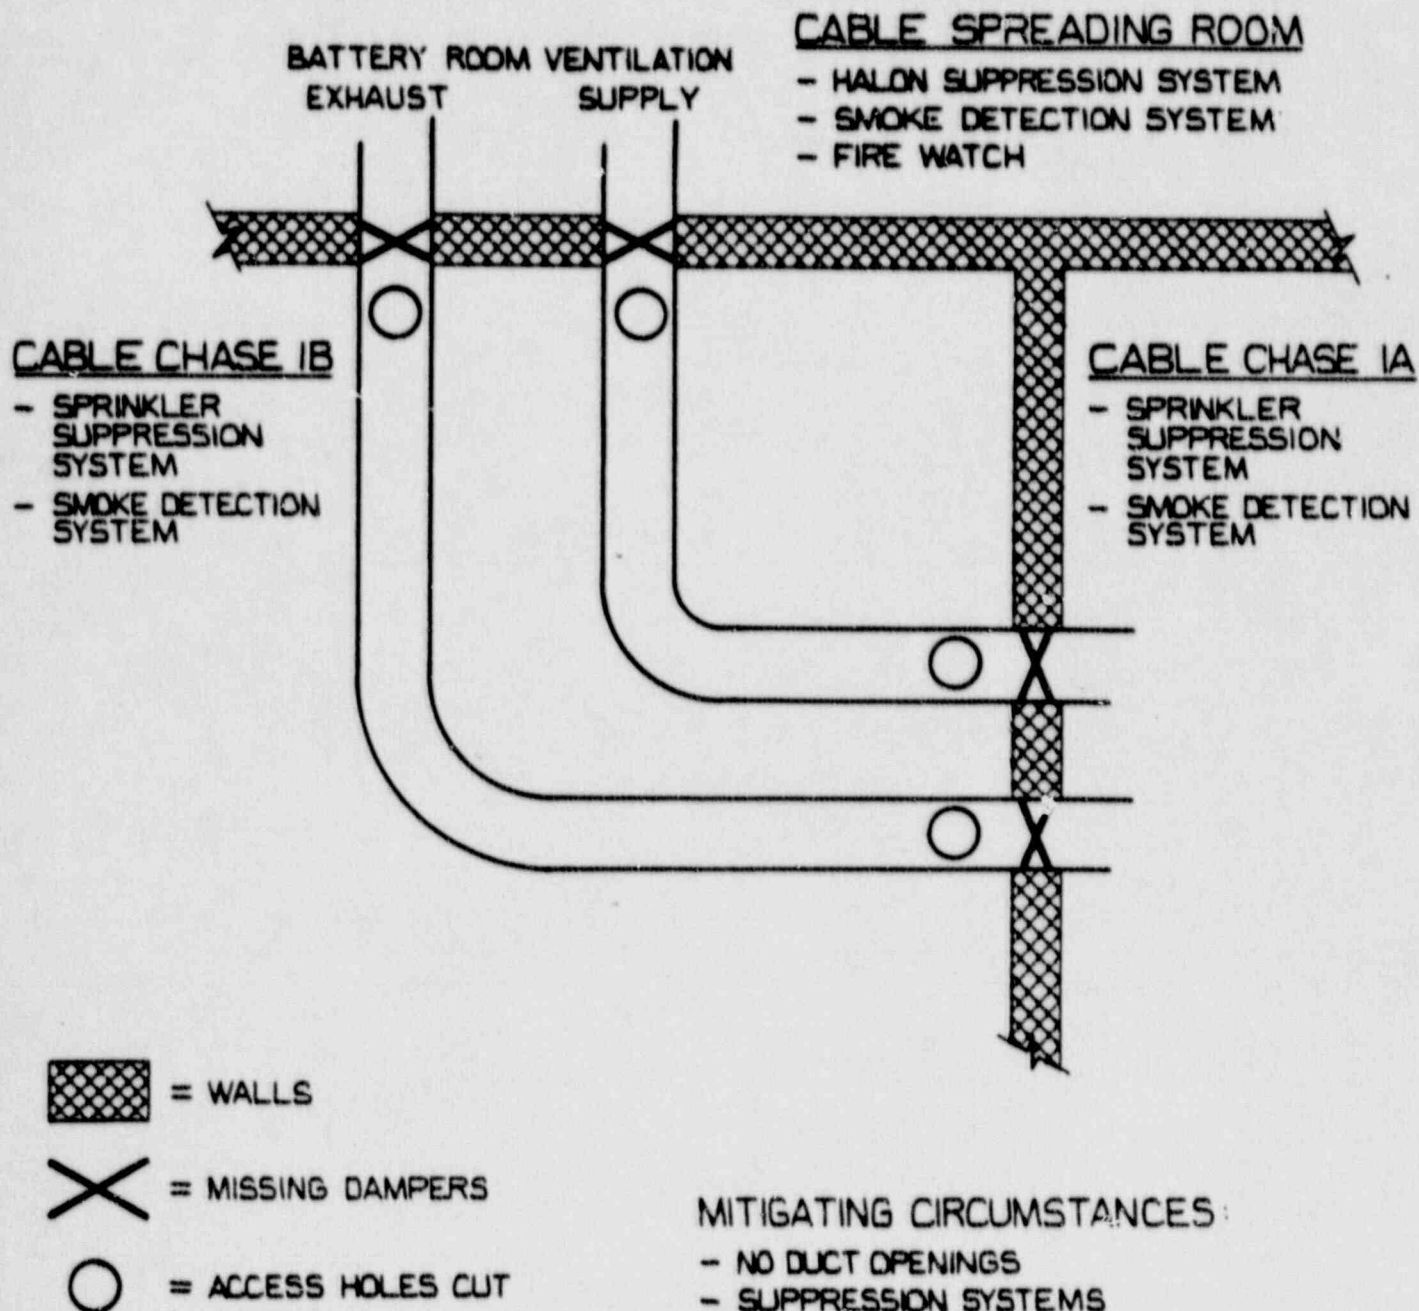
ARRANGEMENT OF CALVERT CLIFFS  
BATTERY ROOM VENTILATION DUCTING  
FROM THE CABLE SPREADING ROOM TO CABLE CHASE 1A.

The root cause of this event is that when the Fire Hazards Analysis of the plant was conducted, these four ventilation fire duct barriers were not identified as requiring fire dampers.

The supply and exhaust ducts for the Battery Room Ventilation Systems penetrate the wall between the Unit 1 Cable Spreading Room into Cable Chase 1B. The ducts then penetrate the wall between the 1B Cable Chase and the 1A Cable Chase. There are no fire dampers in the ventilation ducts. The fire barriers are 3-hour rated TS barriers.

- NO DUCT OPENINGS
- SUPPRESSION SYSTEMS
- SMOKE DETECTION
- CABLE INSULATION FIRE RESISTANT

2. A Facility Change Request has been initiated to install the missing fire dampers.
3. Plant drawings have been reviewed to identify ventilation ducts requiring fire dampers. All of the dampers have been inspected. The fire dampers are all accessible and inspected as part of our STP program.
