Subject: Supplemental Information Regarding Vermont Yankee Feedwater Check Valve  
V28B Flaws Evaluation

## Vermont Yankee Nuclear Power Station

## Feedwater Check Valve V28B

## Hardfacing/Casting Defects

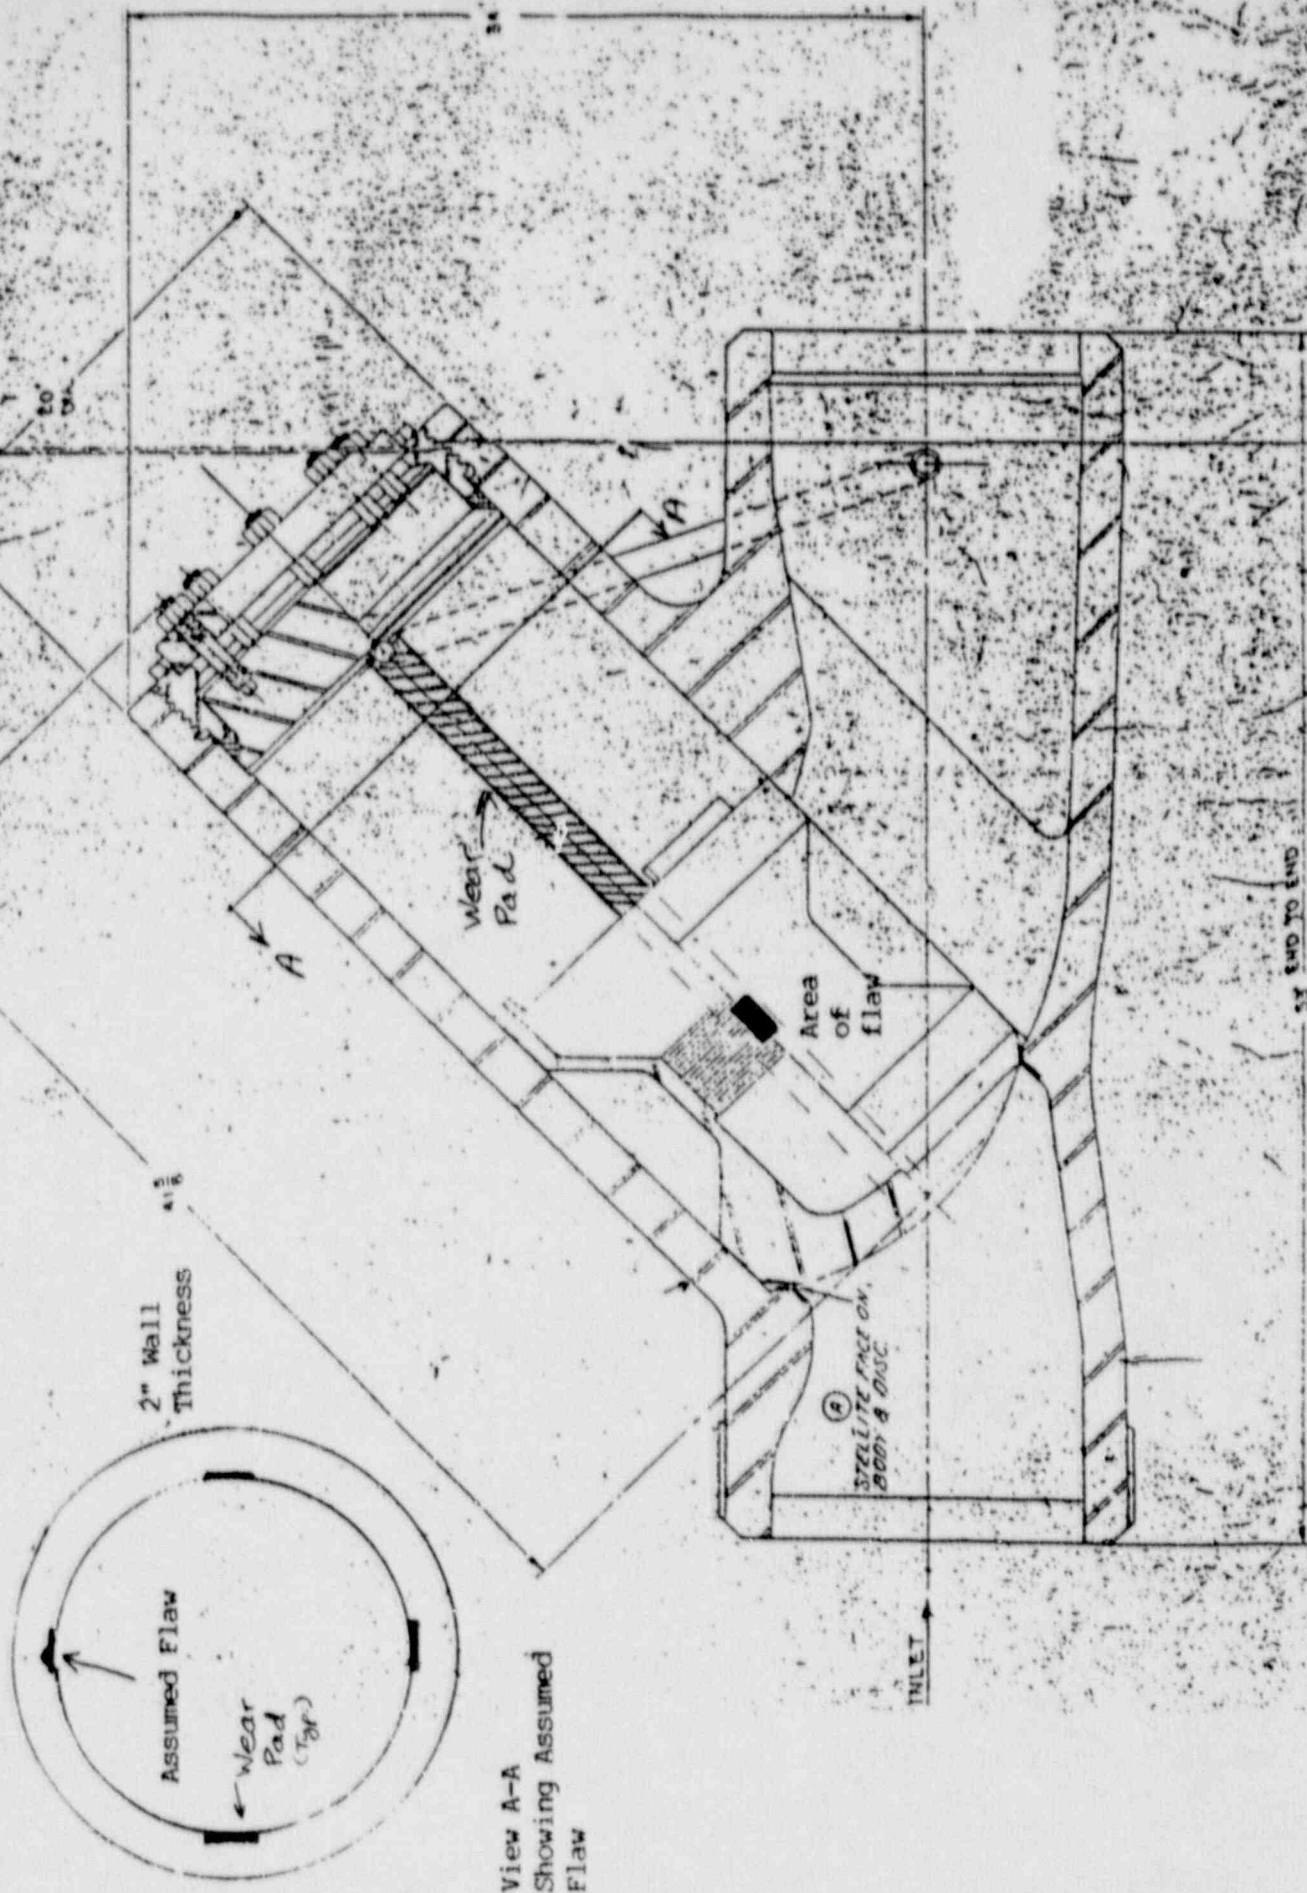
FIGURE 1

Feedwater check valve V28B is a 16 inch angle piston check valve manufactured by the Walworth Company (manufacturer's style 5386 PSB). The purpose of the valve is to prevent flow out of the reactor pressure vessel or reactor containment in the event of a feedwater piping failure. The valve is shown in Figure 1.

Visual cracking was observed in the Stellite wear pads in valve V28B. Ultrasonic examination indicated a flaw depth of 0.65 inches in one flaw and 0.40 inches in the second. The examination was hindered by the presence of internal casting defects, such that absolute determination of a continuous flaw depth was not possible. Since the actual flaw situation could not be determined it was conservatively assumed that the flaw was a continuous, surface connected semi-elliptical flaw.

The USNRC allowed plant startup without repair providing Vermont Yankee committed to repair or replace the valve at the next refueling outage (scheduled to begin in September 1990). After reviewing the options Vermont Yankee has decided to replace the valve.
