Subject: McGuire Nuclear Station Unit 2
Docket No. 50-370
Licensee Event Report 370/90-01

LICENSEE EVENT REPORT (LER)

FACILITY NAME (1)
McGuire Nuclear Station, Unit 2DOCKET NUMBER (2)
0 5 0 0 0 3 7 0 1 OF 0 9TITLE (4)
A Containment Isolation Valve Was Inoperable Due To Unanticipated Interaction Of Components And Erroneous Documentation

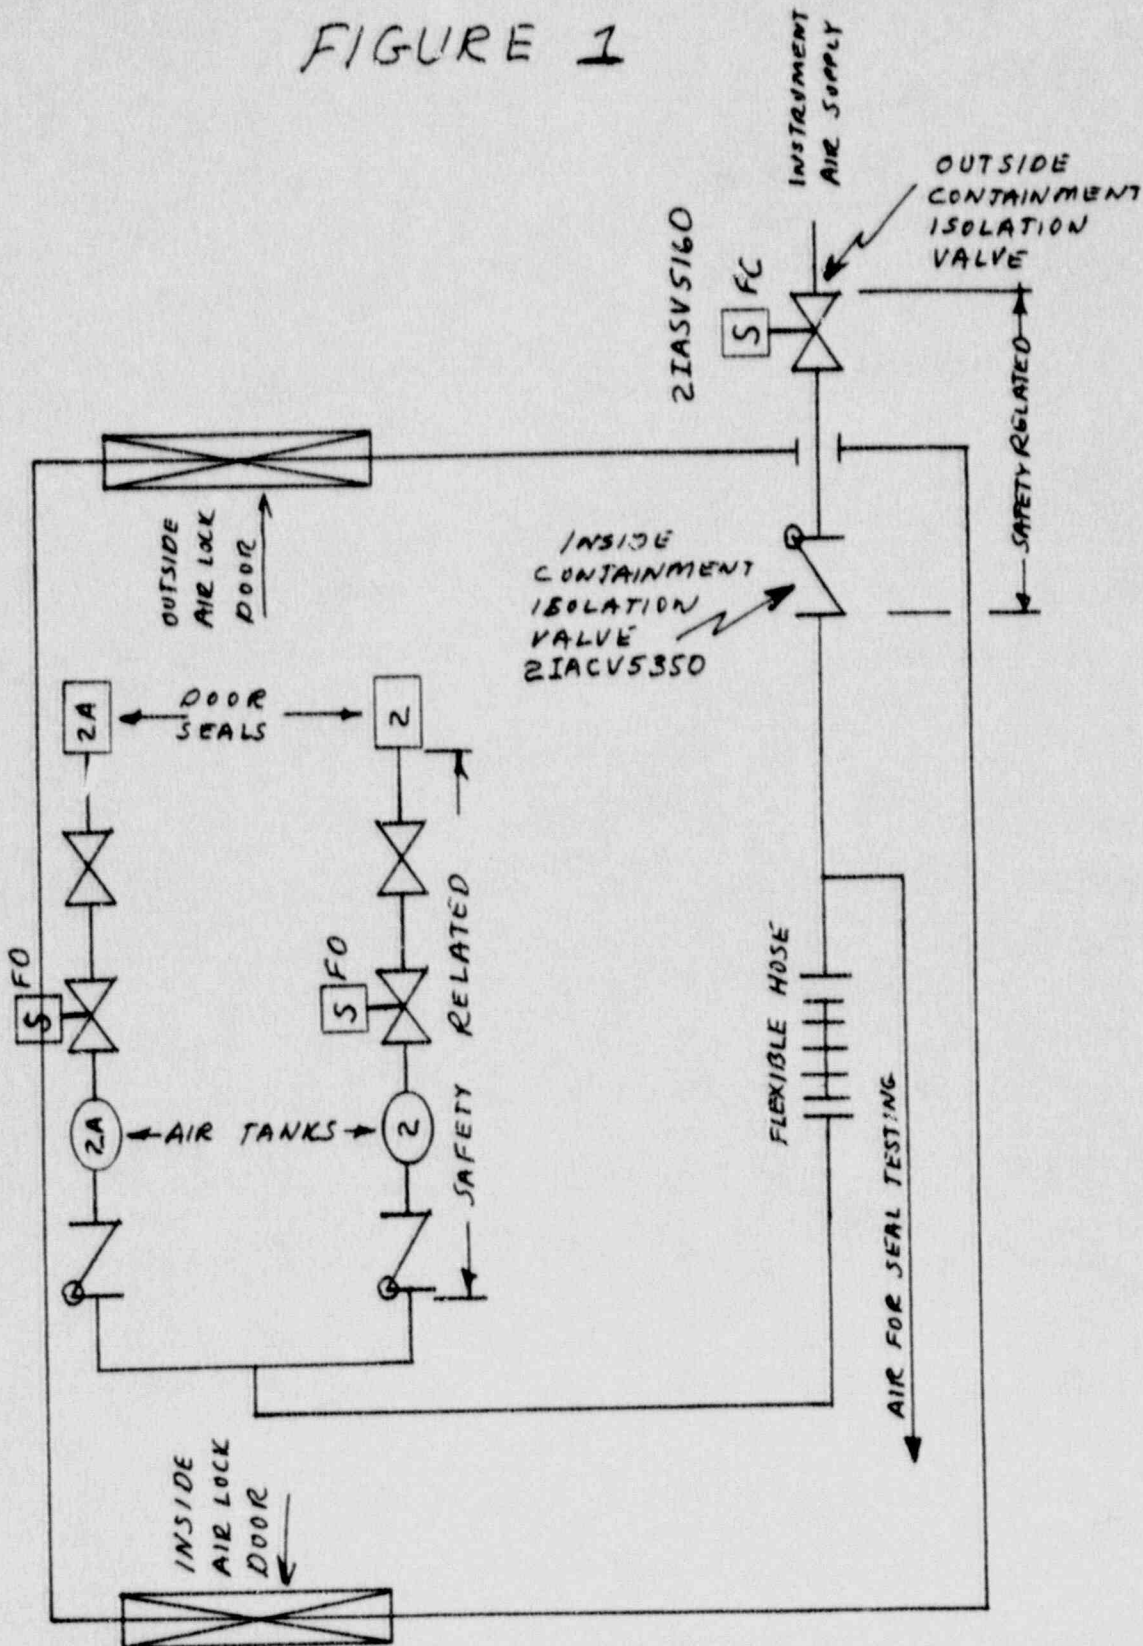
FIGURE 1

Solenoid valve 2IASV5160, Lower Personnel Air Lock Control, functions as an outside containment isolation valve, Figure 1 page 8. Valve 2IASV5160 was mounted on the Auxiliary Building [EIIS:Nf] side of the personnel air lock (PAL) barrel bulkhead. Displacement of the air lock bulkhead under postulated LOCA and seismic conditions are calculated in accordance with MCS 1108.00-00-0002, Specification For The Response Spectra And Seismic Displacements For Category 1 Structures, Revision 5. These displacements are 1.36 inches radially outward, 0.39 inches vertically and 0.21 inches laterally.

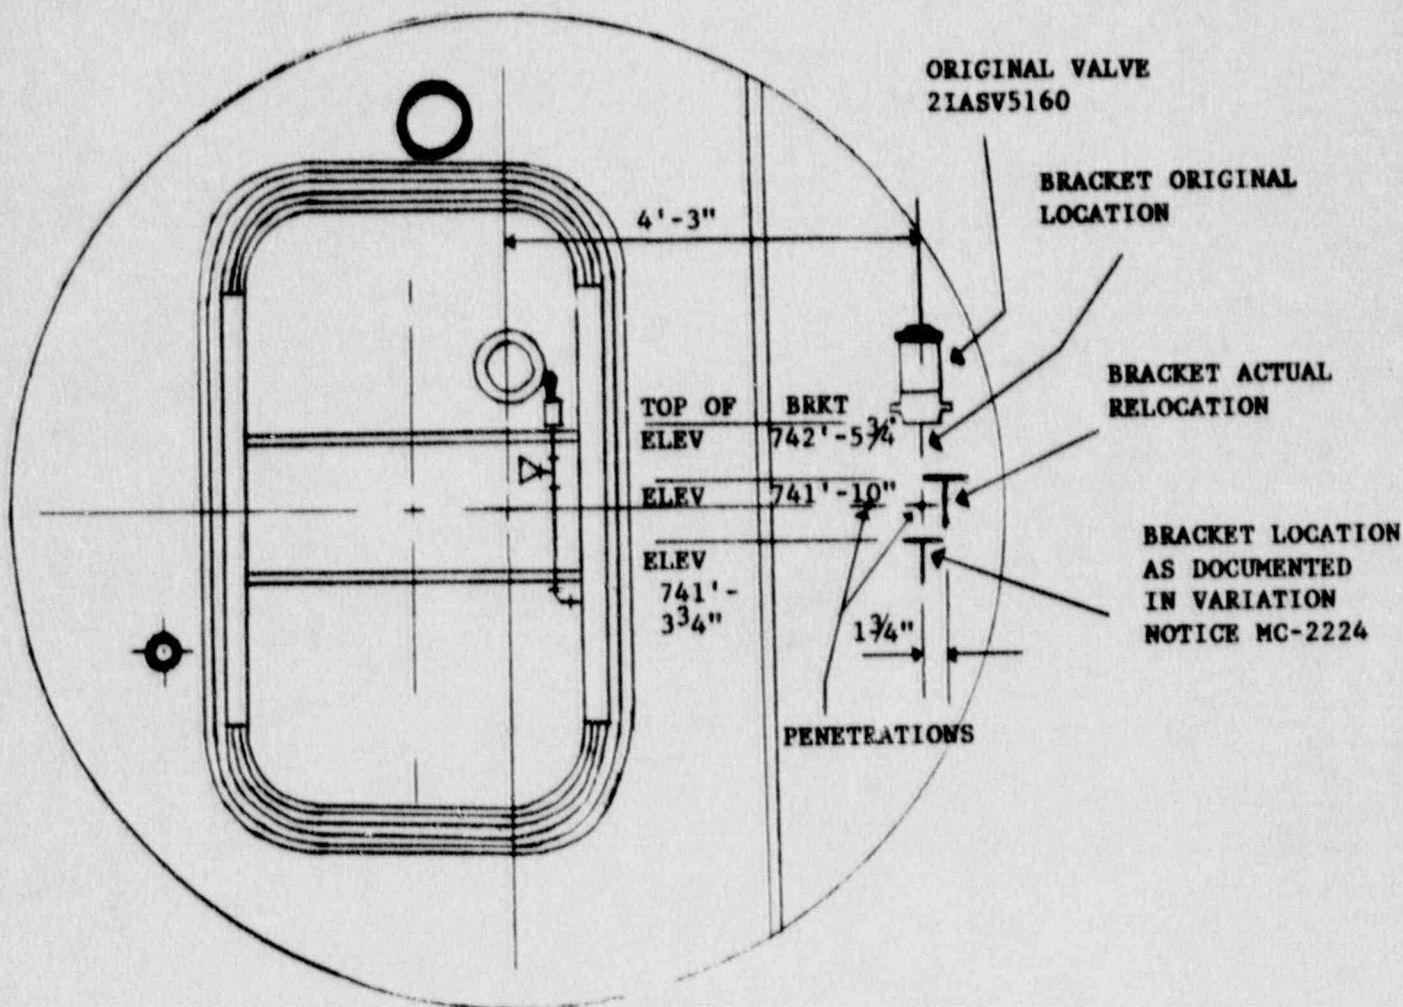
FIGURE 2
VALVE MOUNTING BRACKET
LOCATION DEPICTION

A second cause of Erroneous Documentation was assigned because variation notice MC-2224 did not reflect the actual location of the relocated valve bracket. Design Engineering personnel determined that the new location of the valve bracket/solenoid valve was acceptable based on the incorrect location information documented in the variation notice. The variation notice reflected the use of an extended bracket and a new elevation of approximately 730 feet 0 inches. The variation notice did not reflect any lateral relocation from the drawing specified 4 foot 3 inches PAL barrel center line to valve bracket center line. Design Engineer B took exception to the new bracket elevation since it represented a drop of over 12 feet. CMD personnel clarified the drop to be approximately 1 foot 2 inches versus 12 feet. Field surveys performed by Design Engineer B and CMD personnel on February 23 and 26, 1990, verified the actual bracket location. The new bracket was located approximately 1 3/4 inches laterally toward the outside of

the PAL barrel. Also, the bracket elevation was approximately 741 feet 10 inches versus approximately 741 feet 4 inches. Figure 2 Page 9 depicts graphic orientation of the different bracket locations. It could not be determined during this investigation how the incorrect location data was derived.

Subsequent: Solenoid valve 2IASV5160 was relocated to an Auxiliary Building column under variation notice MEVN-2185. This was implemented by 2/1/90.
