The attached LER 90-08, Revision 0, is being sent to you as required under 10 CFR 50.73 guidelines.

LICENSEE EVENT REPORT (LER)

FACILITY NAME (1) Calvert Cliffs, Unit 1										DOCKET NUMBER (2) 0 5 0 0 0 3 1 7 1 OF 0 6										PAGE (3) 1 OF 0 6																													
TITLE (4) Inadequate Hydrogen Analyzer Calibration Due to Deletion of Loop Check from Procedure																																																	
EVENT DATE (5)										LER NUMBER (6)										REPORT DATE (7)										OTHER FACILITIES INVOLVED (8)																			
MONTH			DAY			YEAR			YEAR			SEQUENTIAL NUMBER			REVISION NUMBER			MONTH			DAY			YEAR			FACILITY NAMES										DOCKET NUMBER(S)												
0 2			2 7			9 0			9 0			0 0 8			0 0			0 3			2 9			9 0			Calvert Cliffs, Unit 2										0 5 0 0 0 3 1 8												
0 2			2 7			9 0			9 0			0 0 8			0 0			0 3			2 9			9 0													0 5 0 0 0 3 1 8												
OPERATING MODE (9) 5										THIS REPORT IS SUBMITTED PURSUANT TO THE REQUIREMENTS OF 10 CFR 5. (Check one or more of the following) (11)

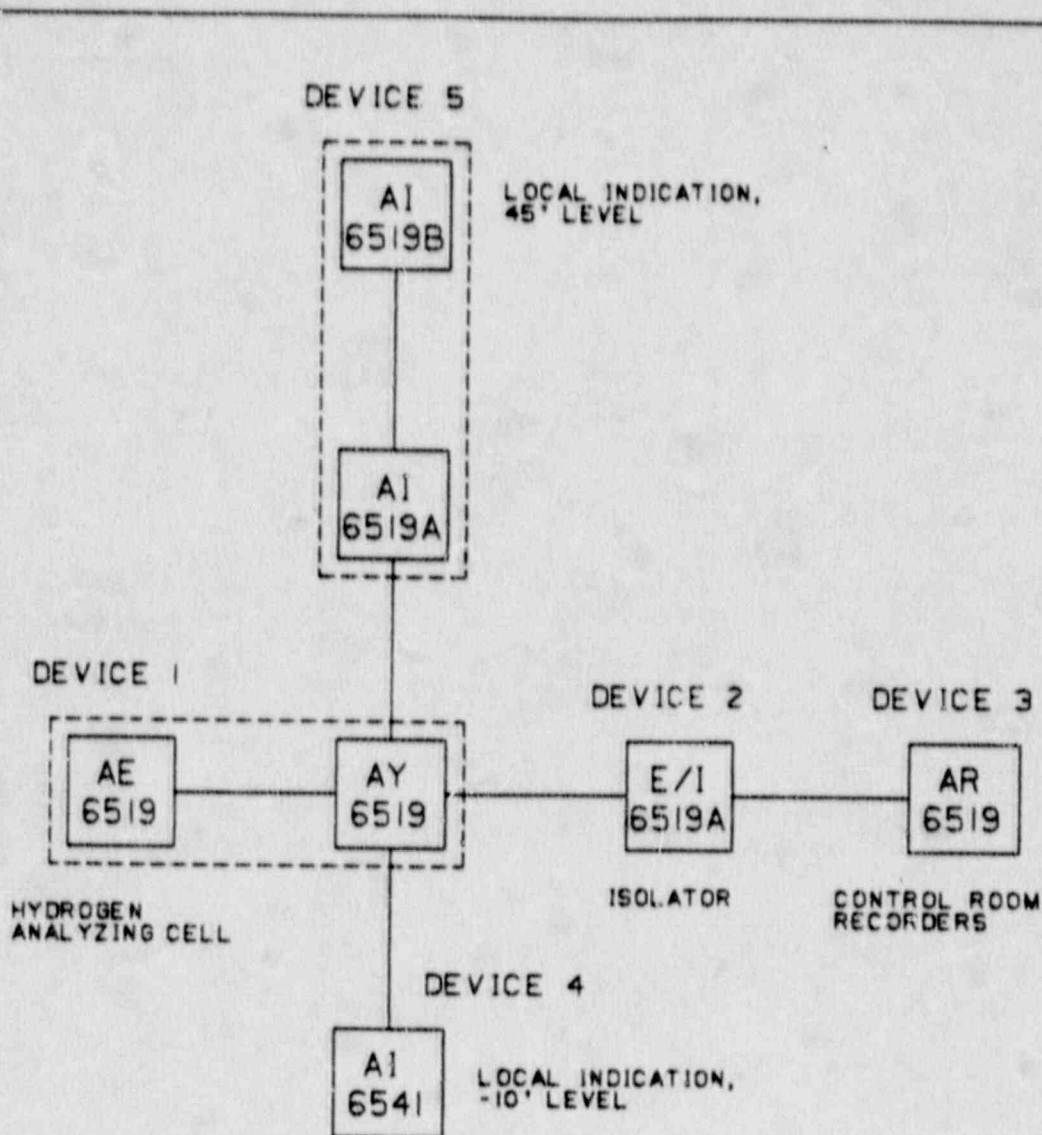
FIGURE 1
BLOCK DIAGRAM OF HYDROGEN ANALYZER SYSTEMS

Figure 1 is a block diagram of the hydrogen analyzer system. Device 1 is the hydrogen analyzing cell (AE-6519) and its associated electronics (AY-6519). Device 2 is the isolator (EIIS BB-AB) (E/I-6519A) feeding the output signal to Device 3, the control room recorder (AR-6519). Devices 4 and 5 are the local indicators in the 45 foot and -10 foot levels of the Auxiliary Building, respectively.

STP M-280-0 required that Devices 4 and 5, the local indicators, be in calibration with one another. The STP did not require measurement of the output voltage leading from the analyzing cell to the control room recorder. It was possible for this voltage to drift, causing inaccurate readings in the control room. This condition would not have been detected using STP-280-0 or the PM.

Both analyzer systems were recently calibrated using the revised STP M-280-0 and the newly written STP M-381-0, which together perform the loop check correctly (see Corrective Action 1 below). One system was found to be within tolerance, the other was not functioning due to an open slide link in its isolator. This open link would not have been found using the earlier, deficient revision of M-280-0 or the PM. After a LOCI, the recorder associated with the non-functioning analyzer would have read zero hydrogen concentration regardless of what the concentration actually was. The effects of this are mitigated by the availability of the other analyzer and the capability to obtain and analyze grab samples of containment atmosphere. However, there were no procedural controls in place requiring that both analyzers be on-line and providing indication in the Control Room. Had the non-functioning analyzer been the only one lined up, the Control Room operators would not have had accurate hydrogen indication. The analyzer system was found to be in calibration when the open link was closed and STPs M-280-0 and M-381-0 were performed.

1. STP M-381-0 was written on March 8, 1990 to include the complete loop calibration check. STP M-280-0 was revised on March 8, 1990 to make it compatible with STP M-381-0. Performance of both STPs was completed by March 20, 1990, as discussed above.
