The enclosed Licensee Event Report (LER) 90-003-00, "Automatic Closing of the Group 1 Isolation Valves Due to a False High Reactor Water Level Signal During Shutdown", is submitted in accordance with 10 CFR Part 50.73.

LICENSEE EVENT REPORT (LER)

Pilgrim Nuclear Power Station

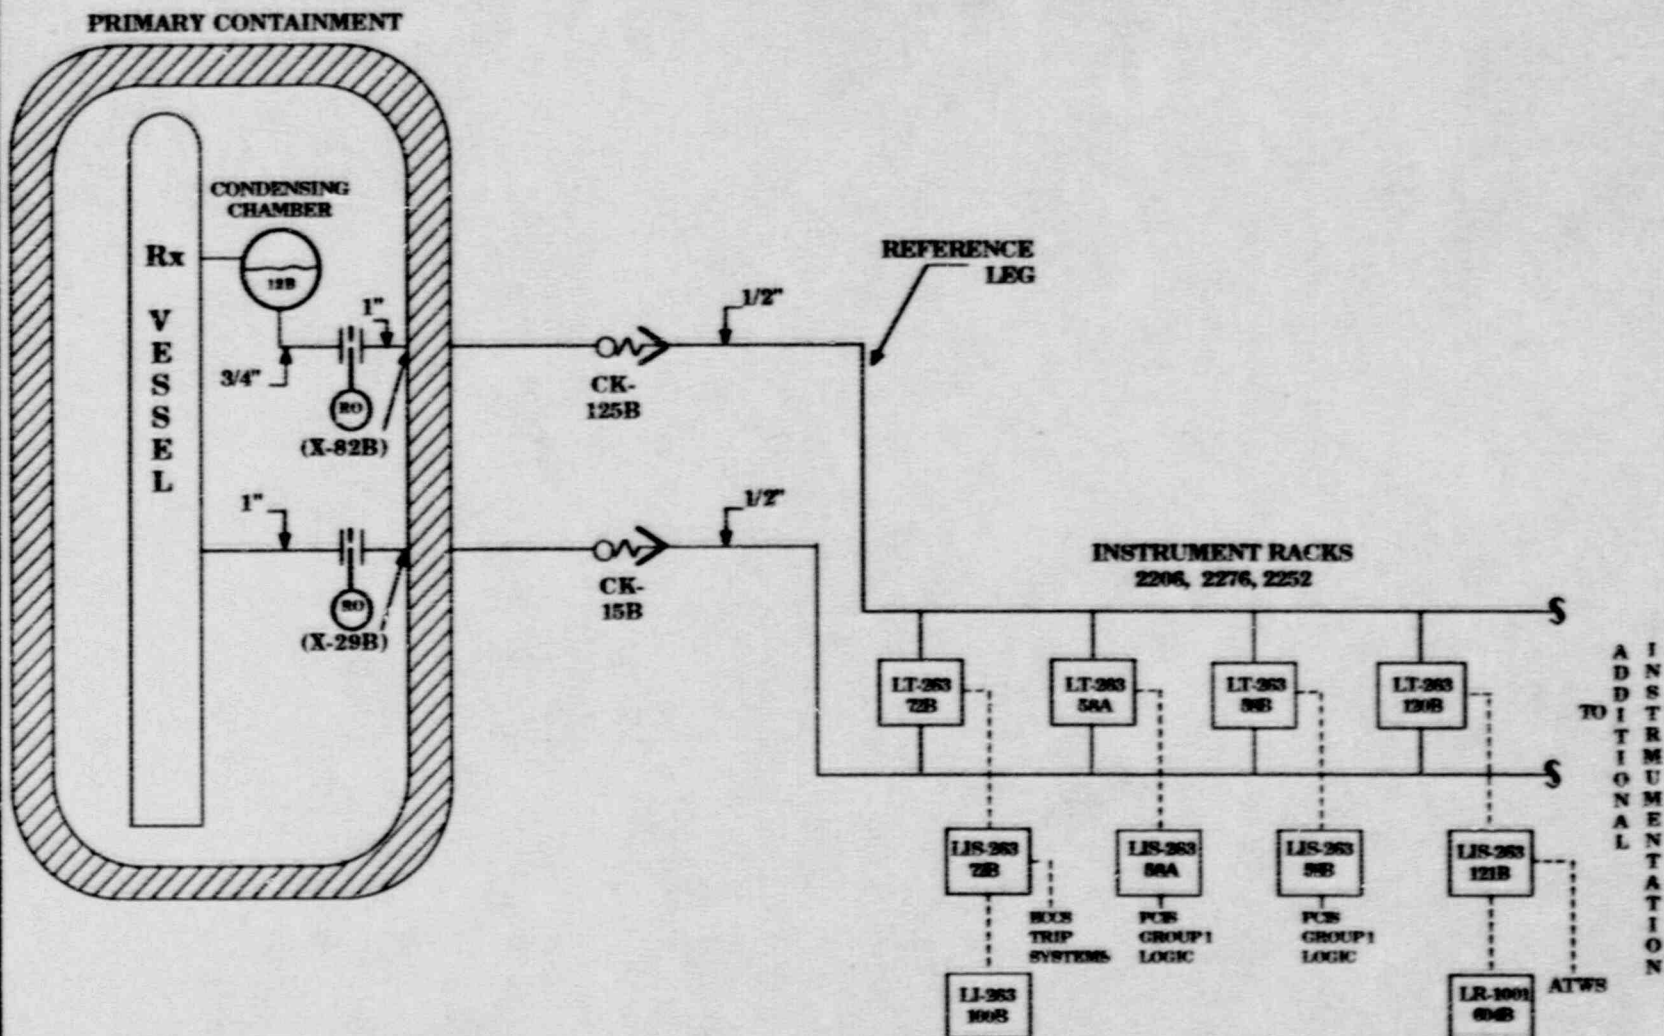
SIMPLIFIED DIAGRAM OF REACTOR VESSEL INSTRUMENTATION (‘B’ SIDE ONLY)

The actuation was initiated from the Reactor High Water Level trip units LIS-263-58A and LIS-263-58B. These trip units receive signals from level transmitters LT-263-58A and LT-263-58B which are both connected to a common condensing chamber 12B (commonly referred to as "B" reference leg). While the cause of the actuation cannot be confirmed with certainty, it is likely that air trapped inside instruments and/or instrument tubing gradually expanded as reactor pressure decreased, and migrated up through vertical sections of the tubing. This resulted in a slightly less positive pressure on the reference leg side for each level instrument sharing that common instrument line. The level instruments instantaneously reacted to the change in differential pressure and sensed a (false) higher than actual water level. Equipment downstream of condensing chamber 12B including level recorders, panel indicators and computer points recorded the instantaneous level increase and the appropriate trip units actuated. The "A" side instruments did not exhibit a similar increase. Valve MO-220-2 remaining open confirms that the "A" side instruments were not affected.

In addition, Control Room level recorders LR 1001-604A and LR 1001-604B strip charts were available for review. The false high water level is captured on the chart from LR 1001-604B where an increase to approximately +50 inches was recorded. The chart for LR 1001-604A did not have a similar indication. This further confirms that only the "B" side instruments were affected (see attached Diagram).

It appears that the cause of the high water level (i.e., actuation) was air in the "B" side reference leg sensing lines. Air most likely was present from either a previous calibration or some other prior maintenance activity which did not maintain waterfill. Analysis was performed to support this most probable cause. Recognizing the calibrated setpoints of the subject instruments, size and configuration of the instrument lines and calculating the time it would take a postulated air bubble to rise, it is highly likely that the high water level signal was due to trapped air in the reference leg. The analysis performed was also consistent with instrument response (time and output) as seen on the level recorder strip charts.

Sensing lines will be backfilled with demineralized water prior to restarting from the current outage. A station procedure has been developed to provide the necessary instructions for performance of the backfill. This should minimize the amount of trapped air in the sensing lines. The backfilling procedure will be reviewed by the training department and will be incorporated into the Instrumentation and Controls plant status update portion of the Continuing Training Program.
