Homestake Mining Company of California

13 January 2020

RE: Homestake Mining Company, Grants Reclamation Project, License Source Materials License SUA-1471, Docket Number 40-8903; NMED Discharge Permit DP-200: 15-Day Corrective Action Report for Unauthorized Discharge from Injection Wellfield

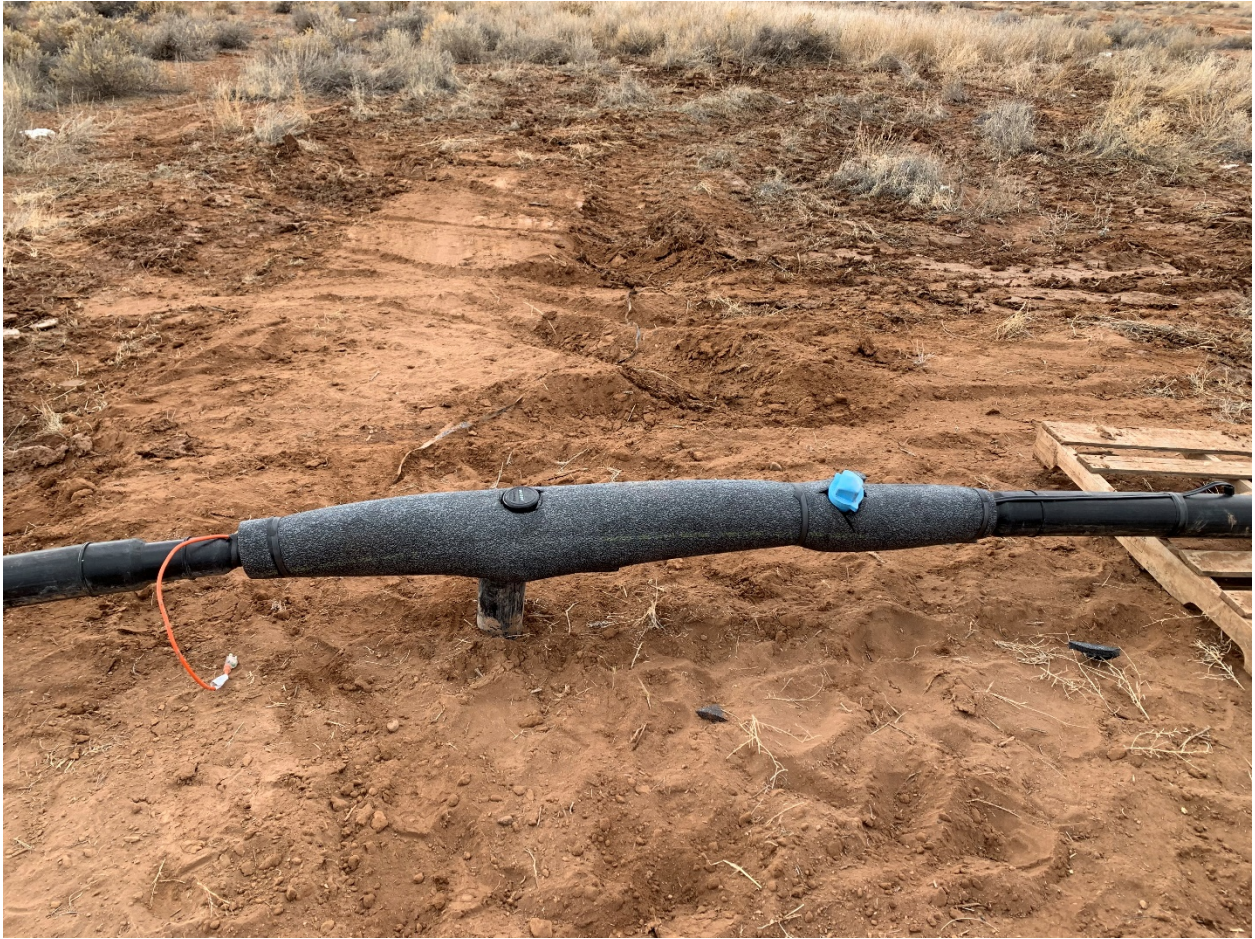
Attachment 1

During the night of December 31st, a flowmeter associated with the injection water in the "Q-Y" field froze and broke due to continued low temperatures at night. This injection line is the same line that froze and broke on December 20/21 (frozen flowmeter as before). The injection line was shutdown and repaired the same day (12/31) by temporarily removing the flowmeter. Adjacent 3-phase electrical was converted for use at this location and a final repair was made on January 9th. The final repair included replacing the flowmeter and adding insulation and heat tape to prevent the meter from freezing again. A photograph showing the insulated flowmeter is attached.

Photograph showing flowmeter after repair with heat tape and insulation
