Subject: Docket Nos. 50-361 and 50-362
San Onofre Nuclear Generating Station
Units 2 and 3

DEGRADATION OF THREADED FASTENERS
IN THE REACTOR COOLANT PRESSURE BOUNDARY
OF PWR PLANTS

VISUAL INSPECTION OF
STEAM GENERATOR MANWAY STUDS

SAN ONOFRE NUCLEAR GENERATING STATION
UNIT 2

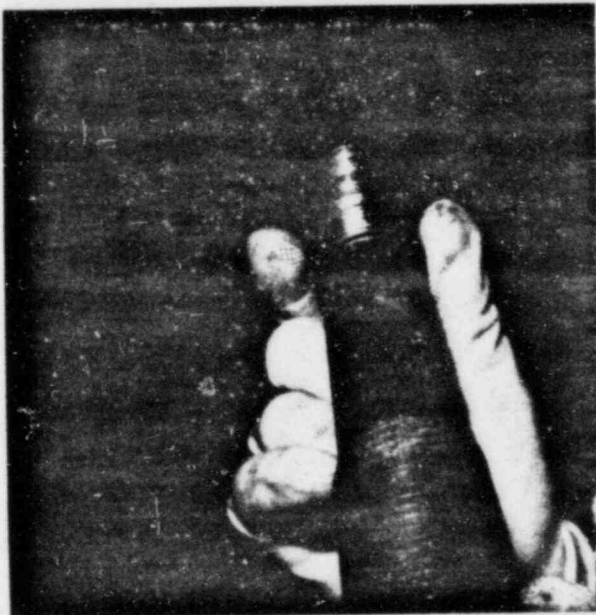
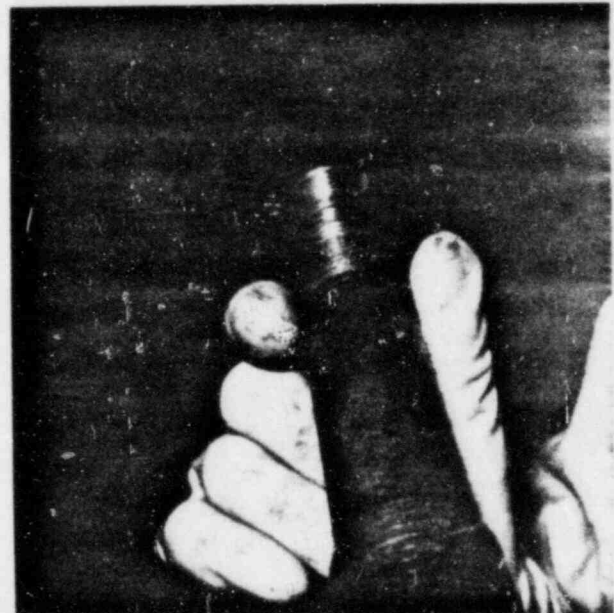
Stud 2-22 Hold Tag 007 NCR 2-205

The 1st five (5) threads from the shank $1\frac{1}{2}$ " wide area has thread reduction of $\frac{1}{8}$ " to $\frac{1}{2}$ " of the thread height. The shank is pitted $2\frac{1}{2}$ " by $1\frac{1}{2}$ " area. Pits are approximately .010 to .050 deep.

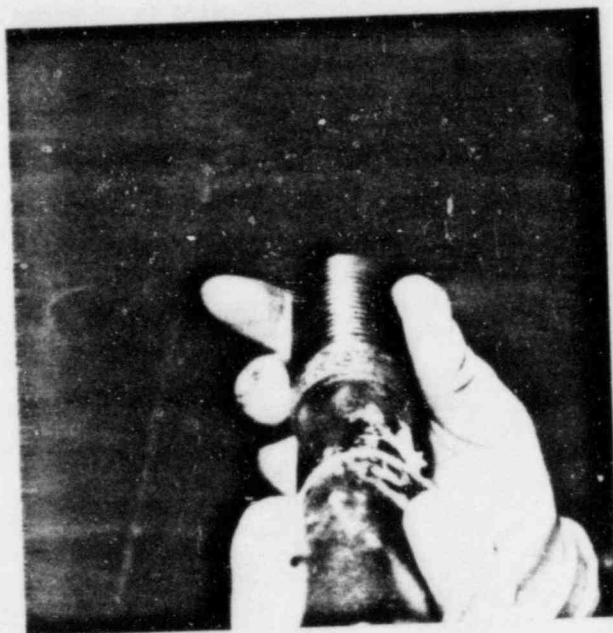
2-23

Stud 2-23, Hold tag 001, NCR-2-205
The 1st 3 threads from the shank
have an area $\frac{1}{4}$ " wide with a thread
reduction of $\frac{1}{2}$ the thread height.
The shank has pits of approximately
.015 to .020 depth.

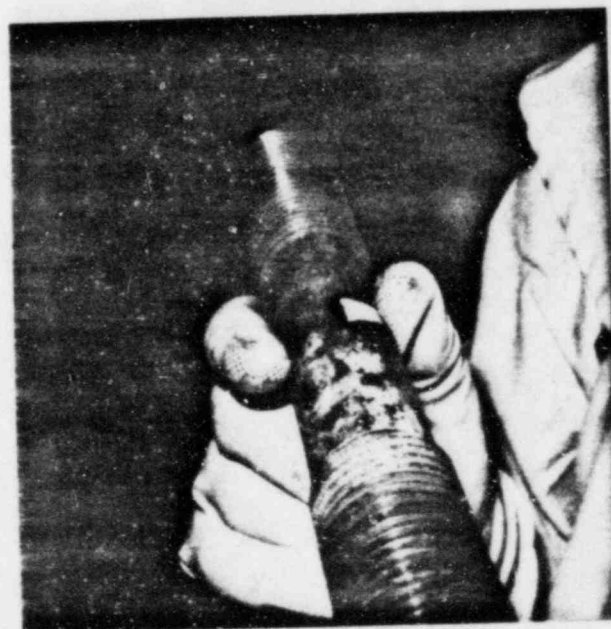
Stud 2-24 Hold tag 006, NCR-2-205
The 1st five (5) threads from the
shank have a reduction of $\frac{1}{4}$ to
 $\frac{1}{2}$ the thread height. Pitting on
the shank is approximately .010
to .040 depth.

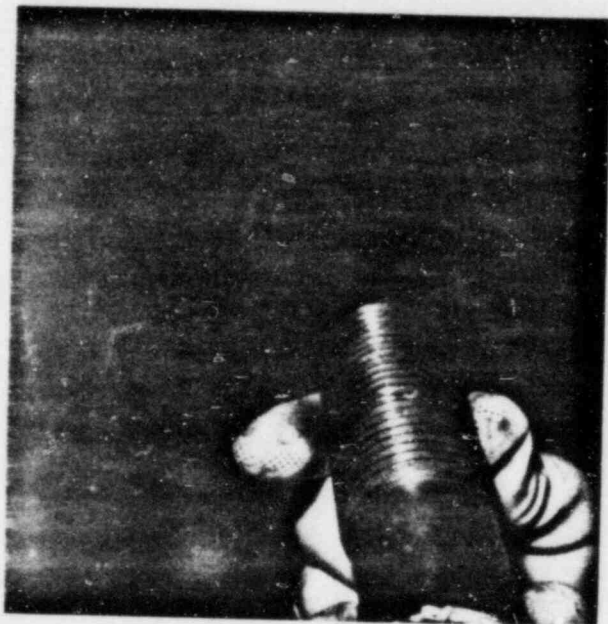
Stud 2-30 Hold tag 008, NCR-2-205
The 1st (3) three threads from the shank have pitting to approximately .002 on shank and threads. The ninth (9th) thread from the shank has physical damage of 1/2 the thread height.

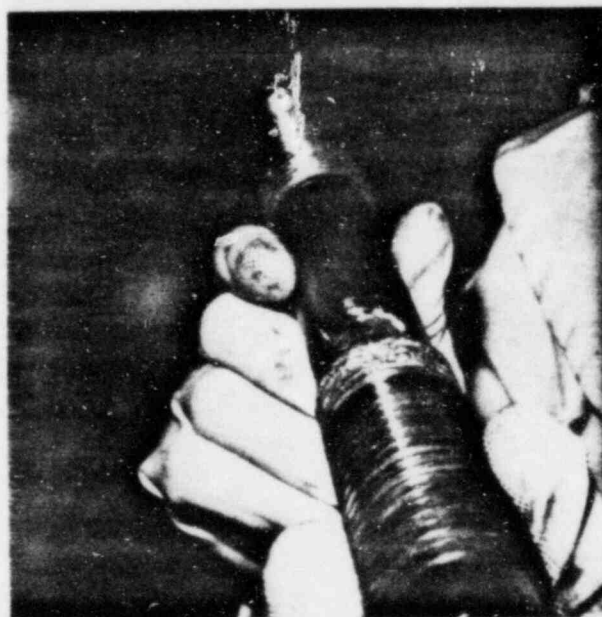
Stud 2-36 Hold tag 004 NCR-2-205
The 1st (5) five threads in an area approximately 1" wide have a reduction of 1/2 the thread height. The shank area has pitting of approximately .020 to .030 depth.

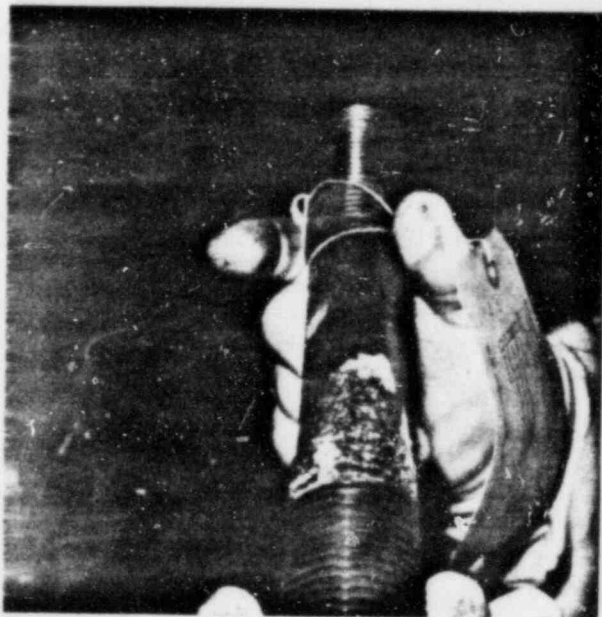
Stud 2-37 Hold tag 003, NCR-2-205
The 1st (6) six threads in a 2" wide
area have major thread and body
reduction to the depth of .050 to
.100. The shank has pitting to the
depth of .020.

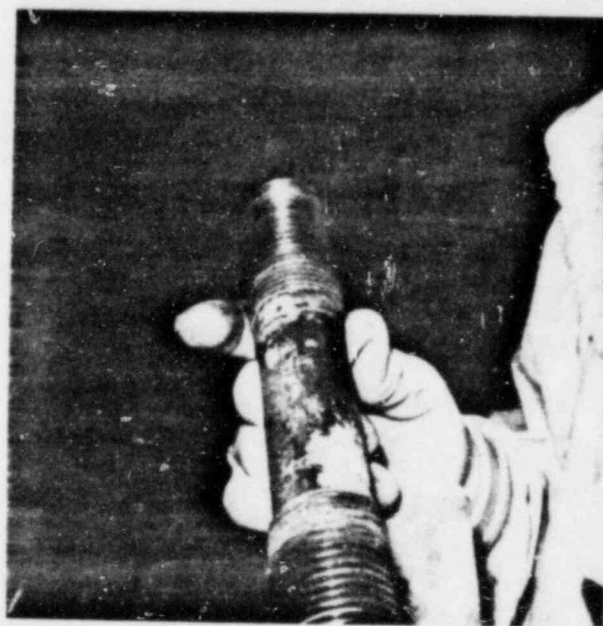
Stud 2-38 Hold tag 005 NCR-2-205
The 1st (4) four threads from the
shank reduced by 1/4 the thread
height. The shank has pitting over
005.

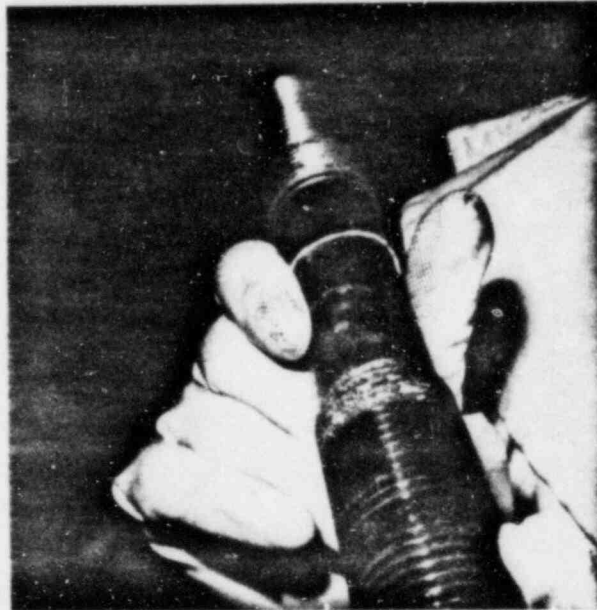
Stud 2-40 Hold tag 002, NCR-2-205

The 1st (4) four threads in an area $1\frac{1}{2}$ " wide has pitting from .003 to .015.
