DUKE POWER COMPANY
OCOONEE NUCLEAR STATION

Incident Investigation Report No. B-350

Incident 3RC-66 stuck in the open position resulting in RPS Low Pressure Trip. 3RC-66 opened due to a small pressure transient. Failure resulted in rapid depressurization of RCS and 1500 psi ES actuation.

Duke Power Company
Oconee Nuclear Station
Incident Report #B-350
Unit 3 Trip #12

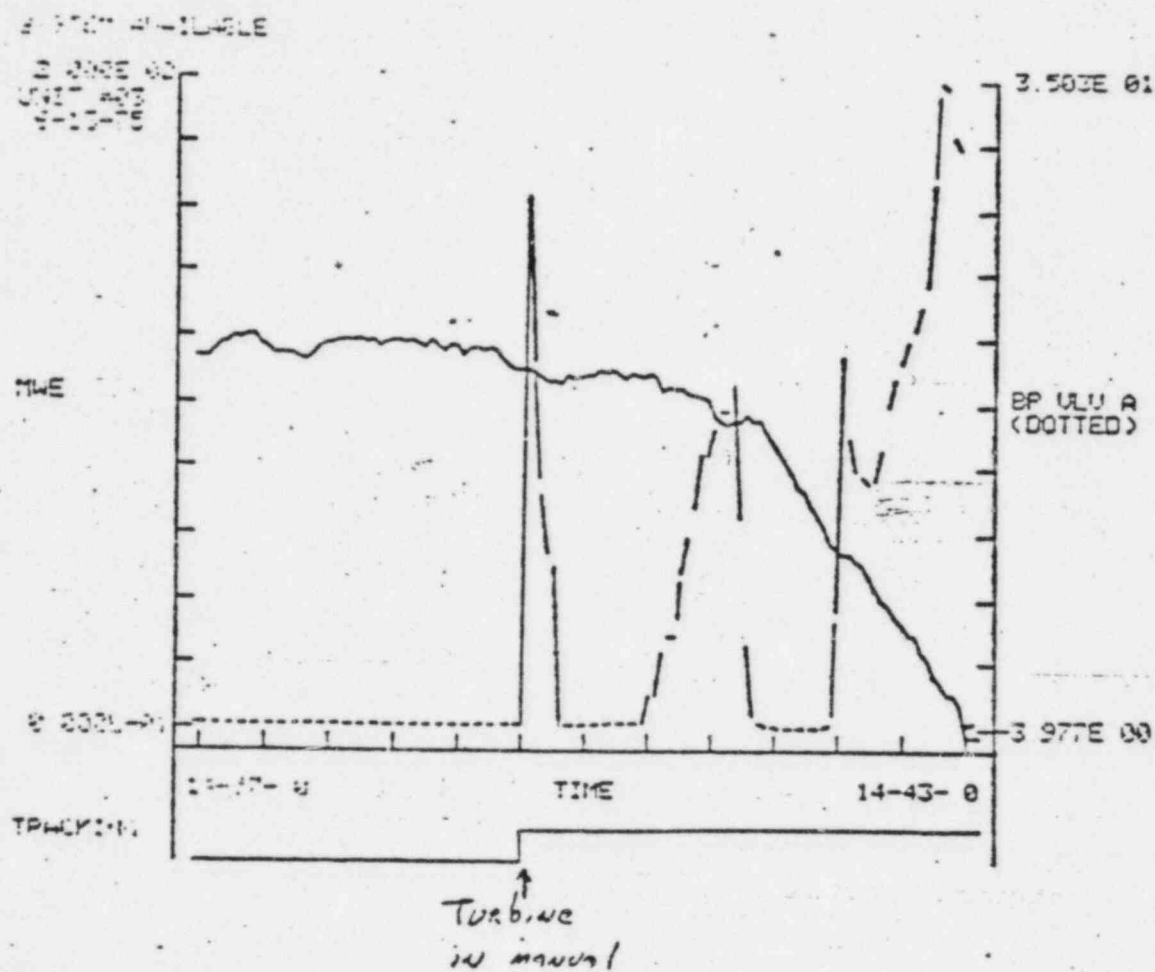
C

When the turbine was taken into manual, ULD was less than 90 MWe, so that MS pressure control was switched to the bypass valves. MS pressure was 910 psi, so MS 19 and MS 22 opened immediately. A rapid MS pressure drop to about 875 psi occurred, at which point the bypass valves closed. Meanwhile, ULD had automatically run up to match generated megawatts at about 115 MWe, so that MS pressure was no longer controlled by the bypass valves. The bypass valves were taken into manual before load went below 90 MWe. (See Enclosure 1; B, C, D, and E)

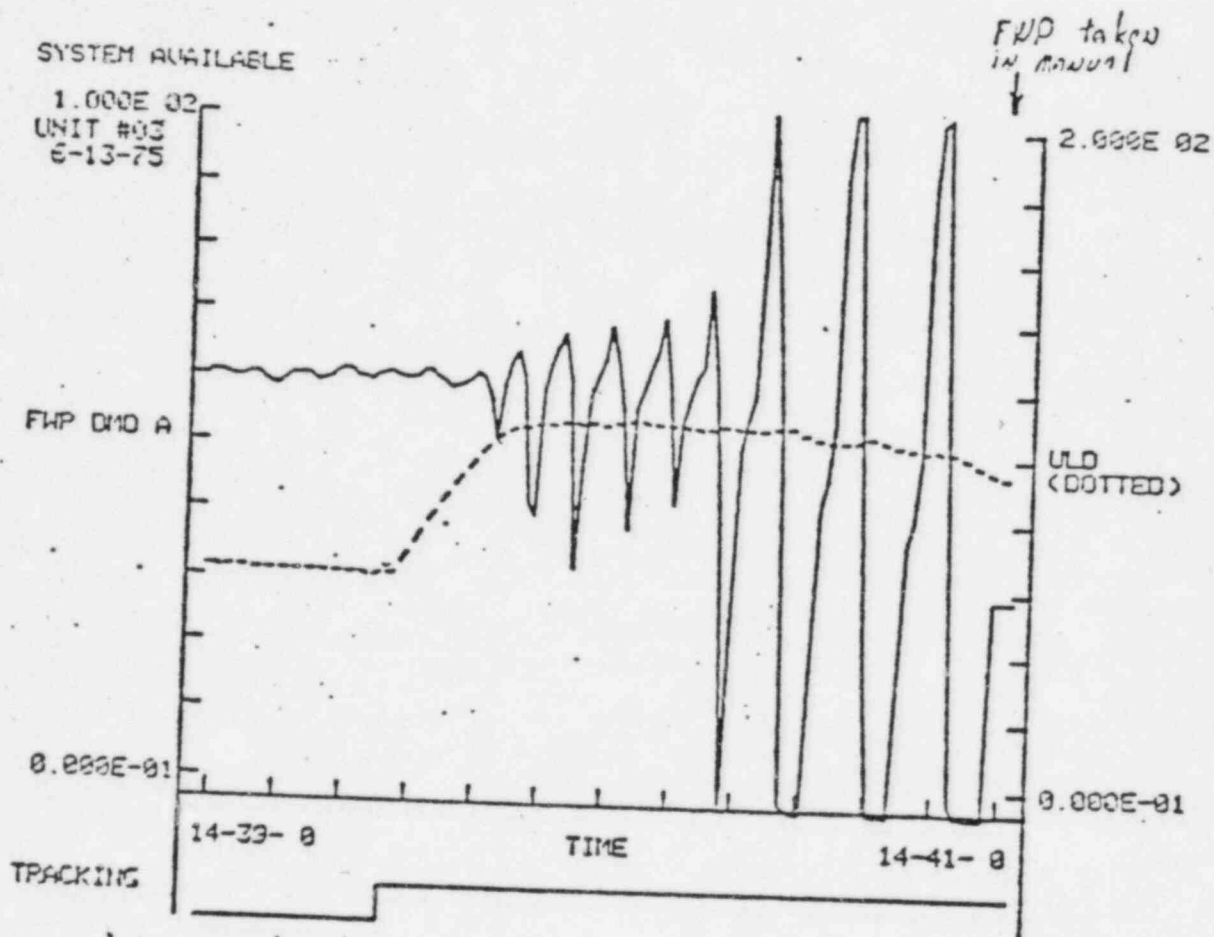
F

ICS FDW pump demand, which could not handle the rapid ULD increase, went into an oscillation which diverged after about 30 seconds. It was therefore necessary to take the feedwater pump (FWP A) into manual. Control of feedwater could not be reestablished well enough to stabilize OTSG level. OTSG level swings caused RCS temperature, pressure, and power swings; RCS pressure spiked to 2267 psi, opening 3RC66. (See Enclosure 1; F, G, H, I, and J)

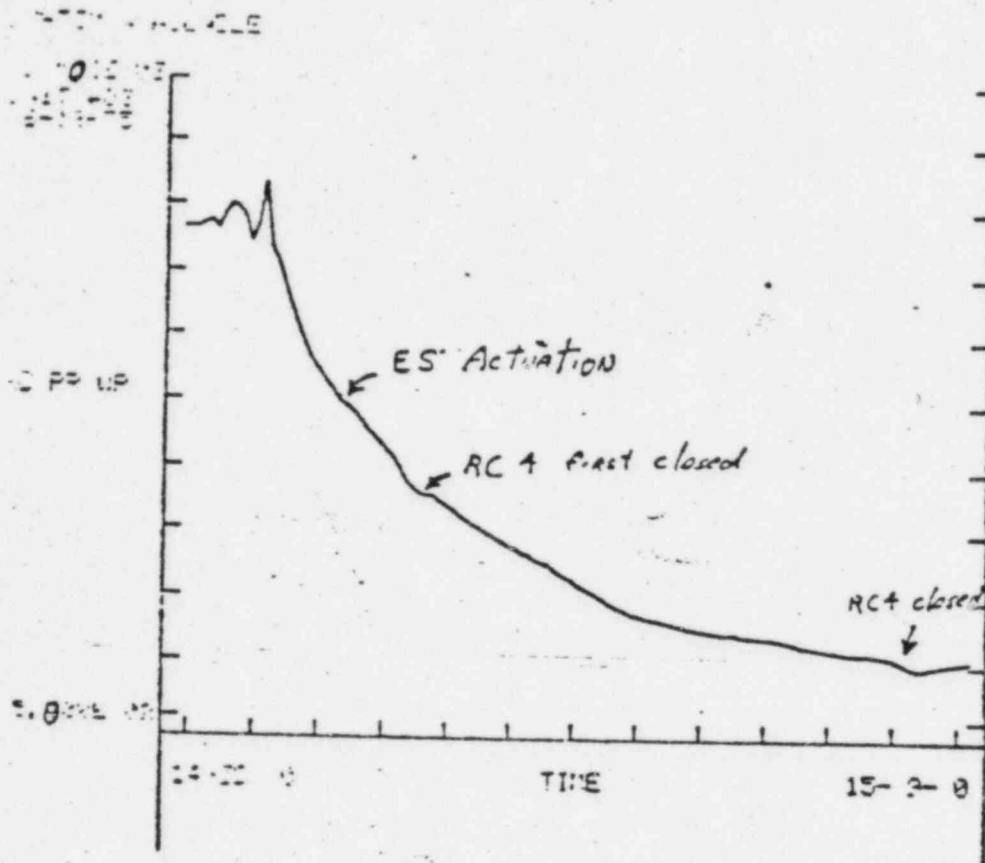
K

Because there was no control room indication that 3RC66 had stuck open, the reason for the rapid pressure loss was not obvious. 3RC4, the block valve to 3RC66 was closed for about 15 seconds when RC pressure had reached about 1300 psi. No change in the pressure transient was observable on the wide range RC pressure chart, and a rapidly rising pressurizer level prompted reopening 3RC4. 3RC4 was again closed at about 800 psi, and the pressure transient was brought under control after a total duration of 26 minutes. (See Enclosure 1; K, L, M, and N)

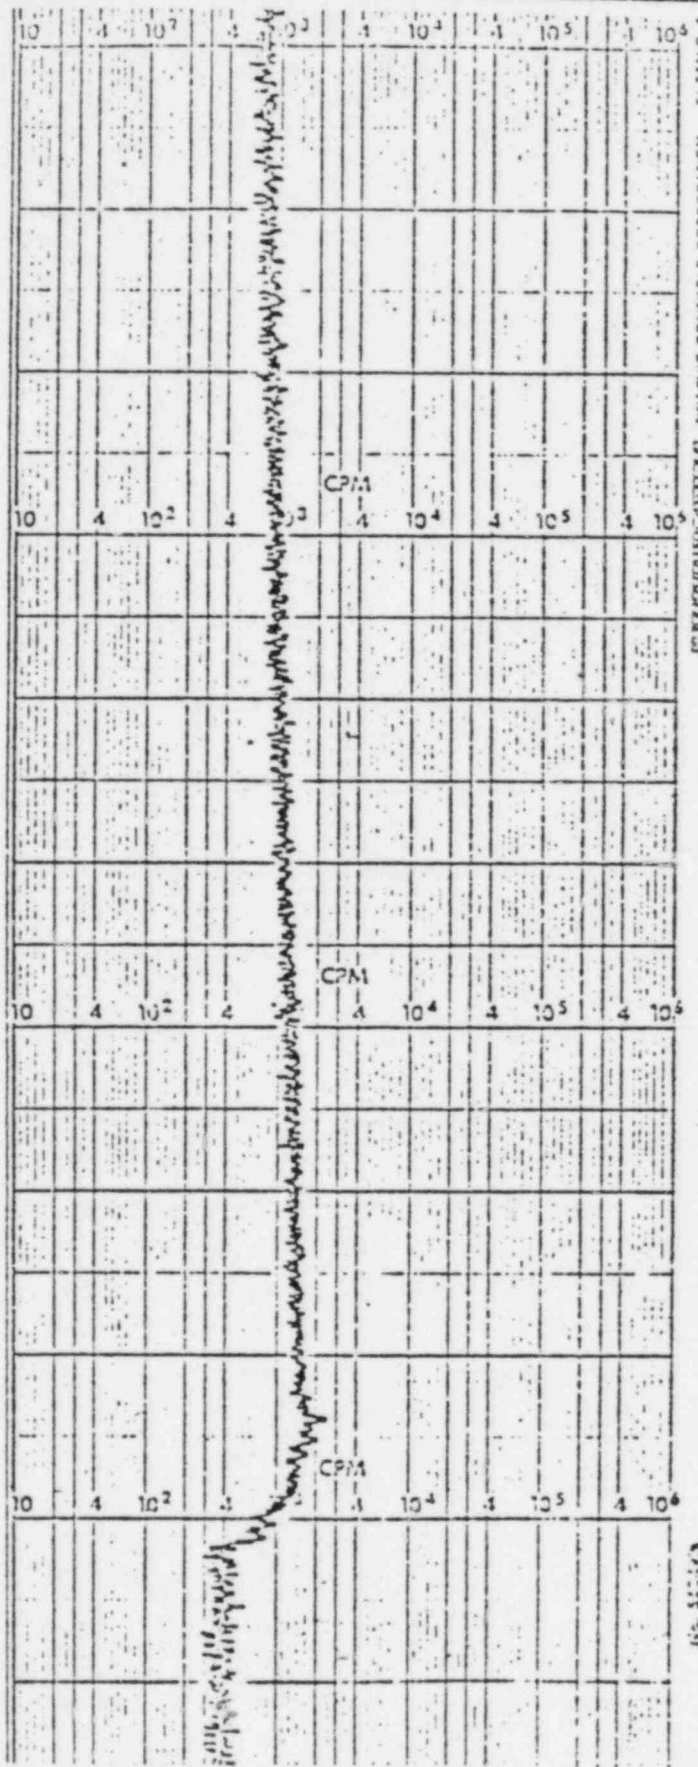
Activity increase in the reactor building was small, with none of the radiation monitoring recorders showing as much as a decade increase in counts. (See Enclosure 1; Q and R) Health Physics personnel sampled the reactor building activity and approved entry for inspection within an hour of the transient.

← Graph Tank
rupture disc
blown

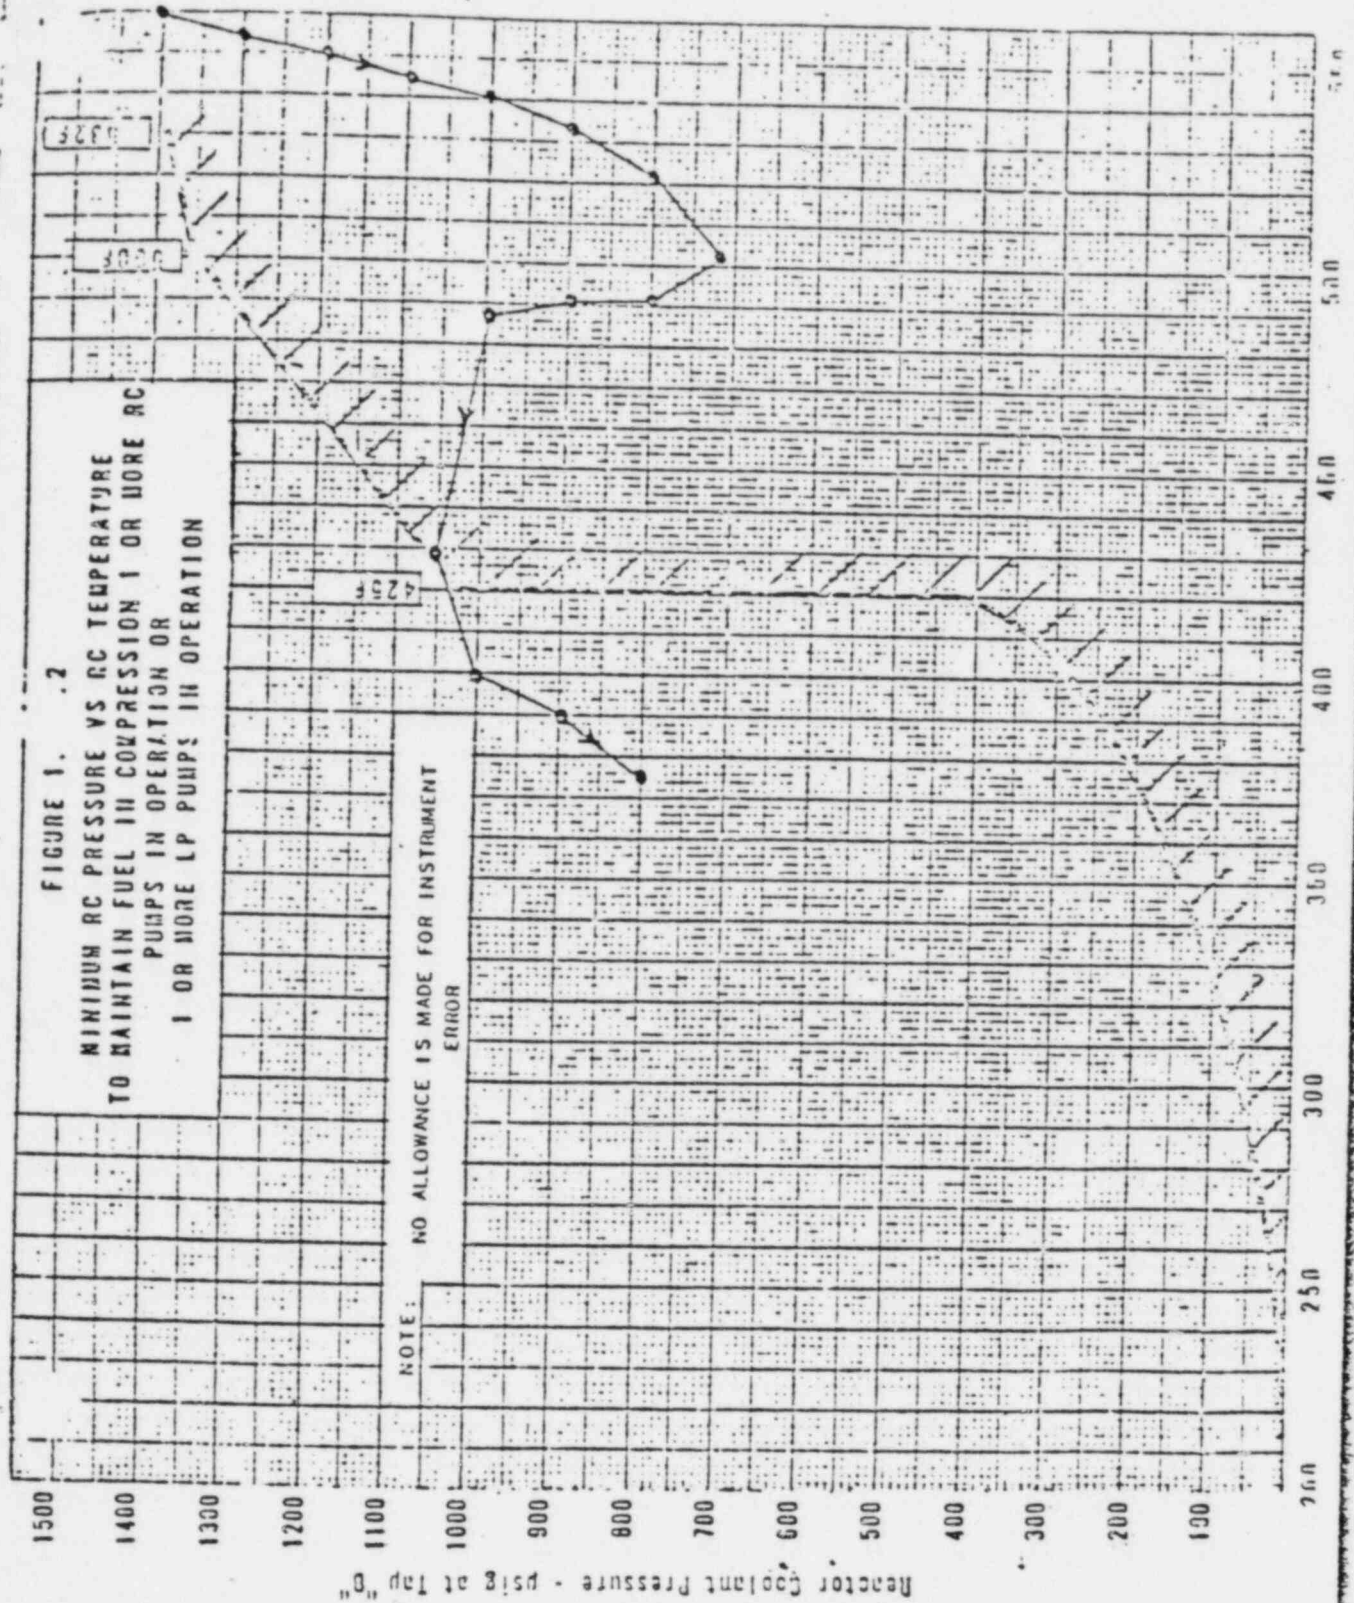
During the transient, ~~limits and precautions~~ *limits and precautions* NPSH and Fuel Compression curves were violated for 20 minutes, and 1 hr. and 20 minutes, respectively. (See Enclosure 2; A and B)

OUTSIDE
OF LIMIT
FOR
140, 20 min

Babcock & Wilcox representatives were informed of the cooldown rate, NPSH curve, and fuel compression curve violations by the general office.

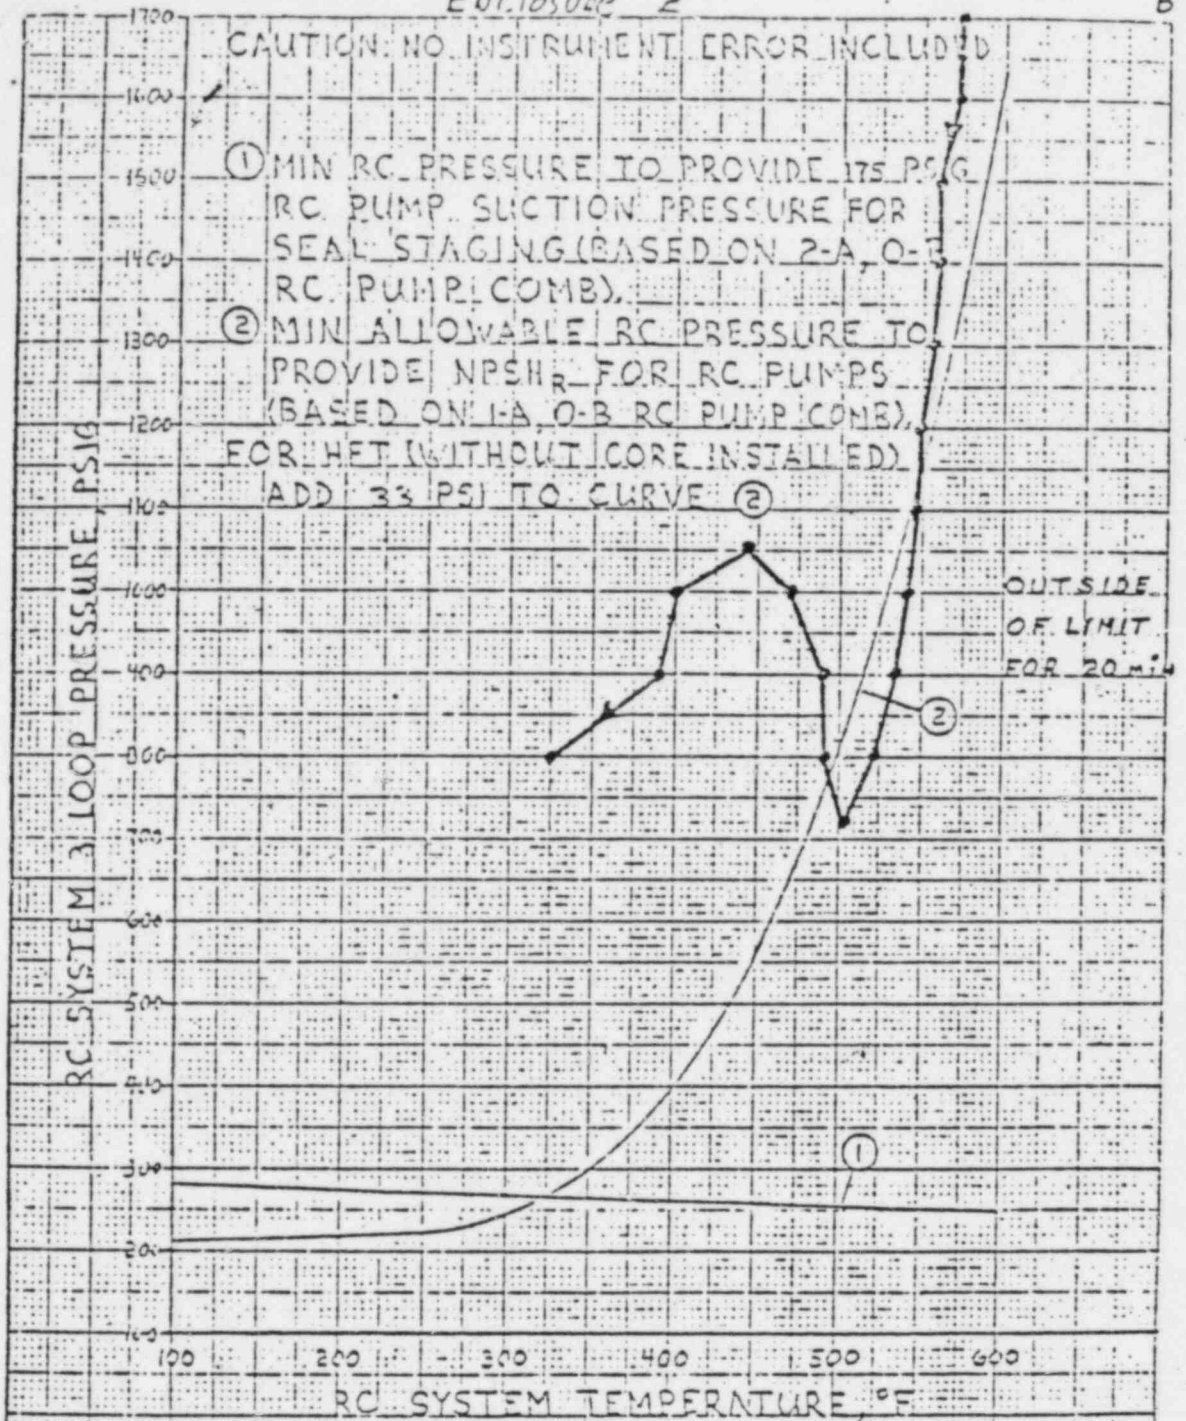
FIGURE 1.0-11.1

OUTSIDE OF LIMIT FOR 20 min
