ENGINEERING EVALUATION REPORT: INVESTIGATIONS AND  
GROUTING OF LEAKS ASSOCIATED WITH TENDON SHEATHS H32-009 AND H32-011  
UNIT 2 CONTAINMENT BUILDING  
PALO VERDE NUCLEAR GENERATING STATION

JOB NUMBER 10407  
BECHTEL POWER CORPORATION  
NORWALK, CALIFORNIA  
JUNE, 1983

DEFICIENCY EVALUATION REPORT 82-72

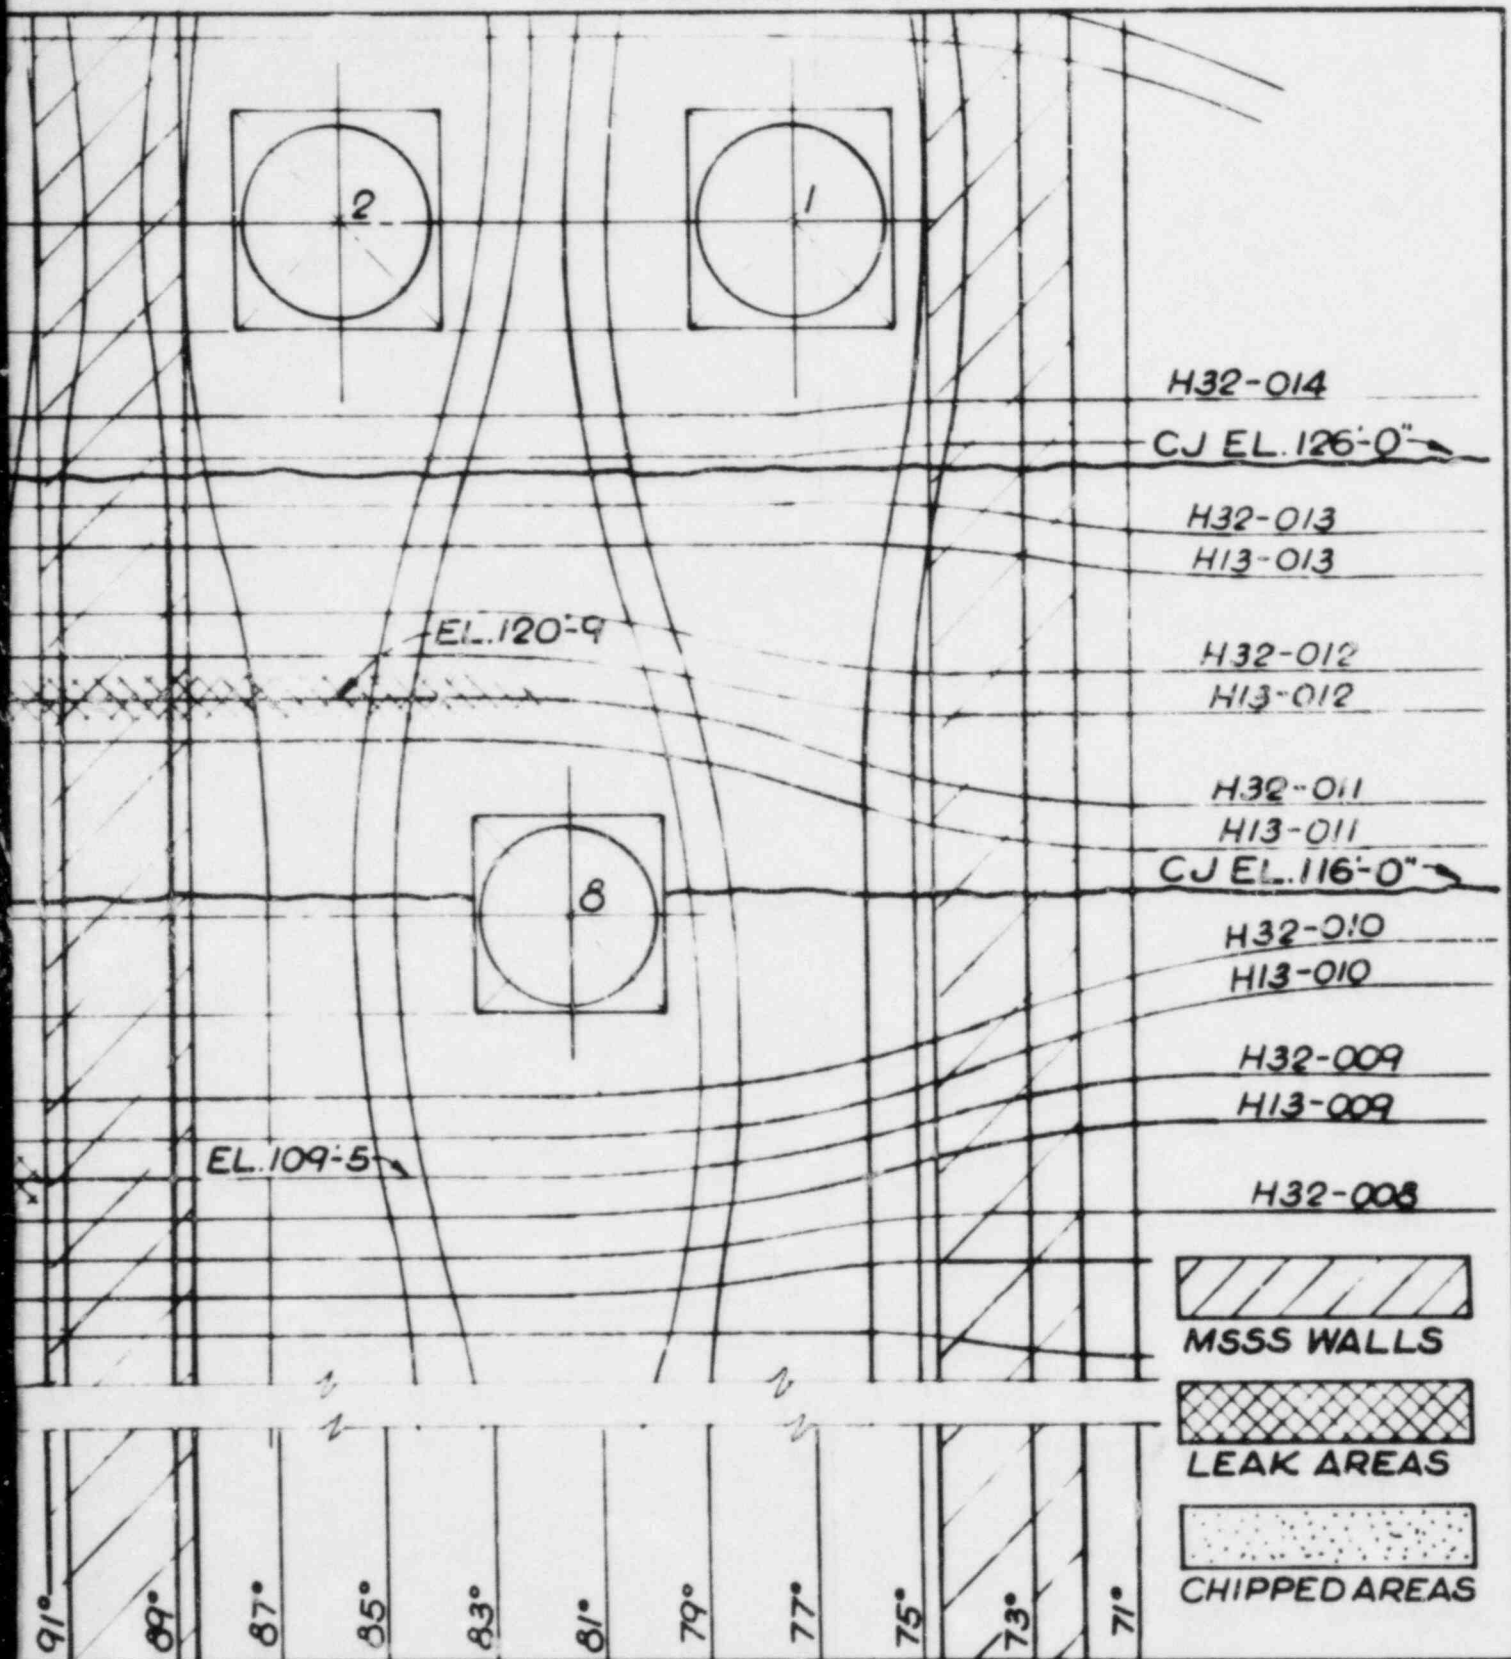
FIGURE 2

Tendons H32-009 and H32-011 are horizontal tendons which extend from buttress no. 3 to buttress no. 2. Figure 1 is a schematic plan of the layout. Figure 2 is an elevation view of these tendons in the area of the main steam pipe penetrations. When these tendons had been installed and tensioned, the preliminary air tests conducted prior to greasing showed that air was escaping from one sheath and emerging in the other, as well as escaping to the outside through a crack in the exterior surface of the concrete wall. The location of this crack was in the 6-inch seismic gap between the Containment wall and the Main Steam Support Structure (MSSS). The location of this crack is shown in figure 2. The same result was obtained when pumping air into either sheath.

The testing described in section 4.1.1 demonstrated the presence of a single leak in sheath H32-009, and a single leak in sheath H32-011. In sheath H32-009 a large leak begins at approximately  $91^{\circ} 30'$  (see figure 2), continues to  $94^{\circ}$ , then tapers to a small leak which terminates at approximately  $97^{\circ} 40'$ . In sheath H32-011, the leak begins as a small leak at  $81^{\circ} 15'$ , then increases to a large leak at approximately  $83^{\circ}$ . This large leak continues to approximately  $93^{\circ} 10'$ , where it decreases to a small leak terminating at about  $98^{\circ}$ .

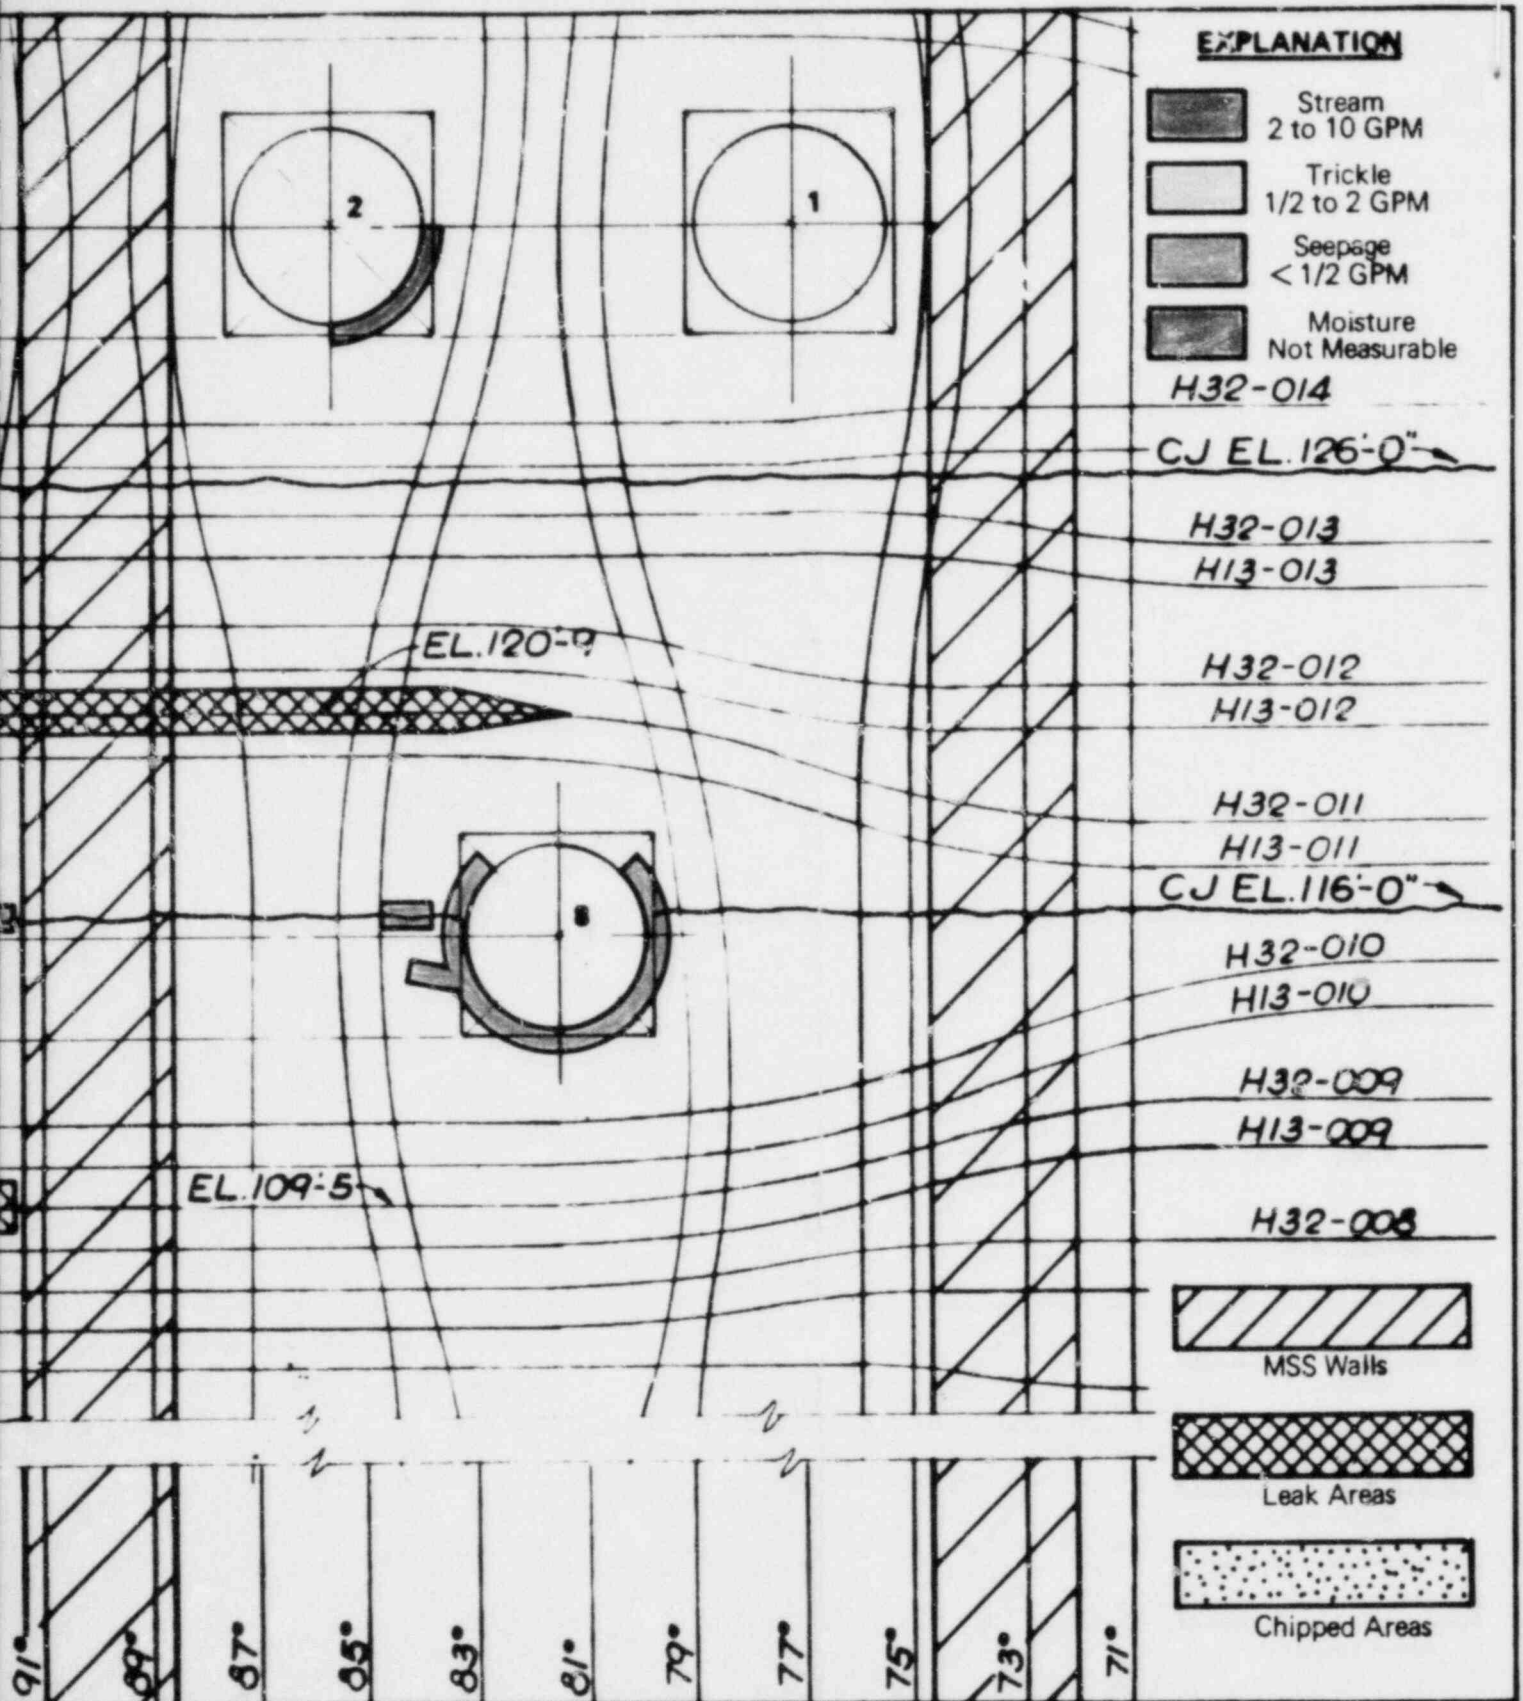
COMPOSITE DRAWING OF LEAK EXITS

- B. The leak system exited the Containment wall at several locations, the most significant being a visible crack in the chipped area (see figure 6).
- C. The testing conclusively demonstrated the absence of large voids in the leak system. The leaks were shown to be confined to narrow pathways.

Figure 6 is an elevation view similar to figure 2 which shows the locations of all leak exits on the Containment wall. Figure 6 is a composite of the results from all five tests. As is seen in figure 6, minor leakage occurred around the penetration sleeve at penetration no. 10 and along the construction joint in this area. Very minor seepage occurred around the sleeve at penetration no. 8. Major leakage occurred from the crack in the chipped area and from the core hole adjacent to penetration no. 3. Minor seepage occurred around the sleeves in penetrations no. 2 and no. 3.

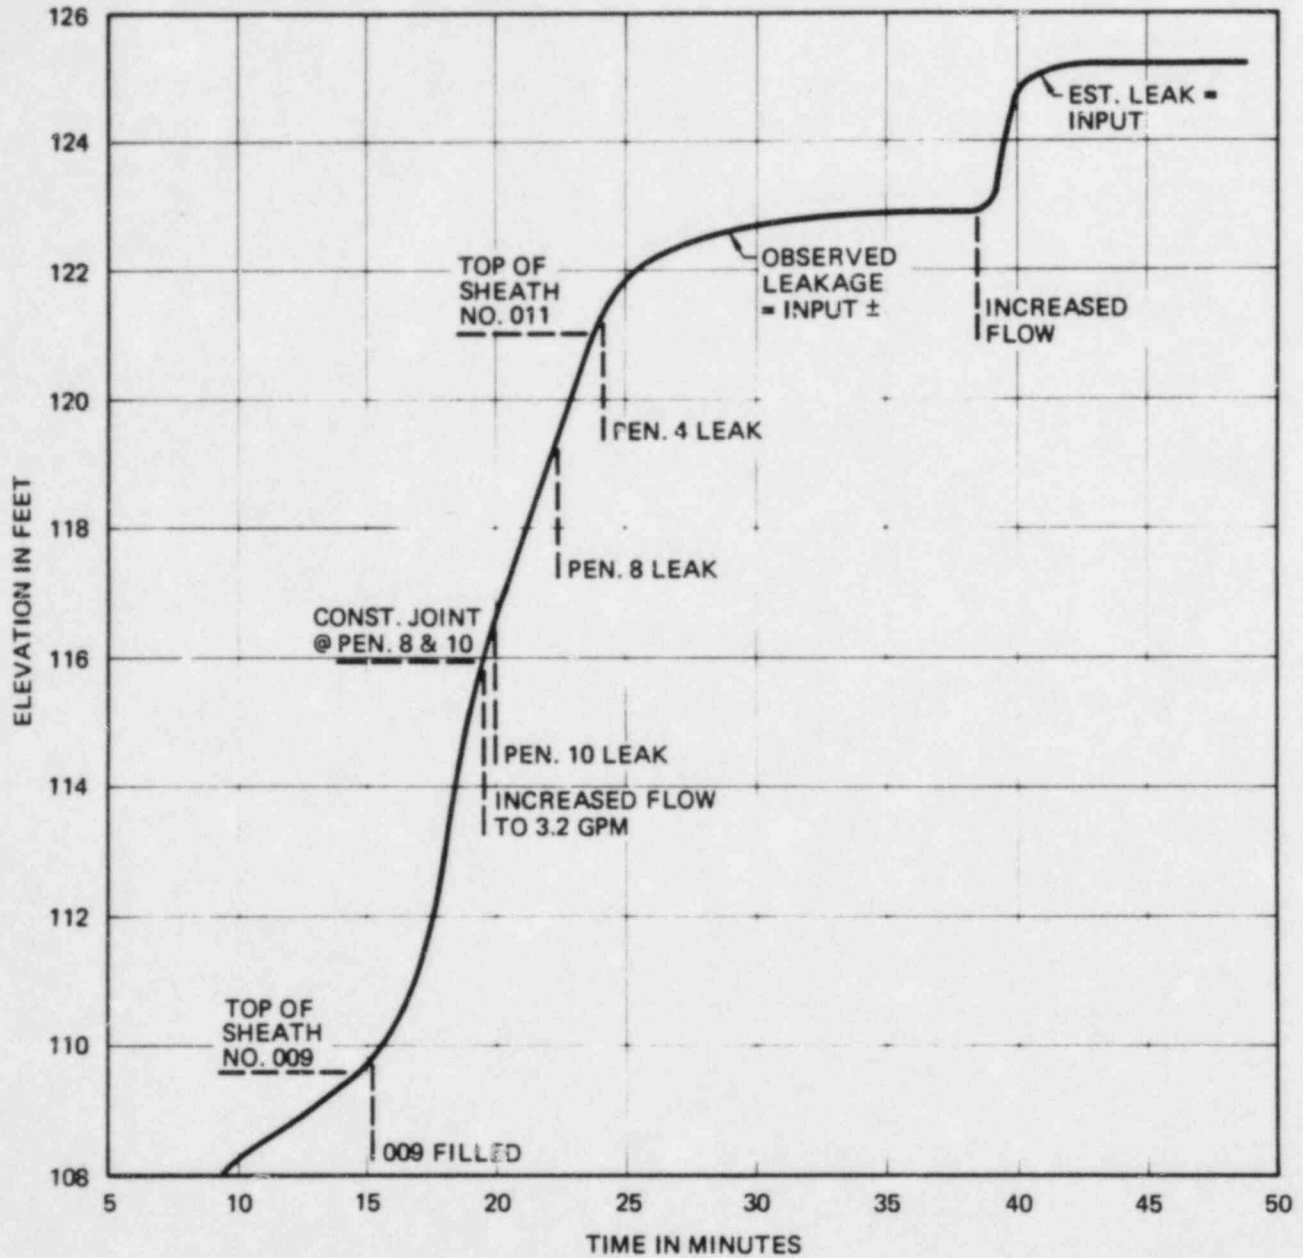
FIGURE 7

Tests 3, 4, and 5 conclusively demonstrated the absence of large voids in the leak system and showed that the leak system consisted of narrow, confined pathways. Figures 7, 8, and 9 show the graphs of manometer elevation versus time for sheath H32-009 in tests 3, 4, and 5. As can be seen from the curves, the history of rise between the filling of sheath H32-009 and the appearance of leakage in the chipped area is characterized by a steep, approximately straight line in all three tests. If a large void was present in the system, the curves would flatten for the time it took to fill the void, then resume a steep climb. This feature is not observed in any of the test plots. The curves do flatten following the appearance of leakage at the chipped area but this is due to the leakage itself.

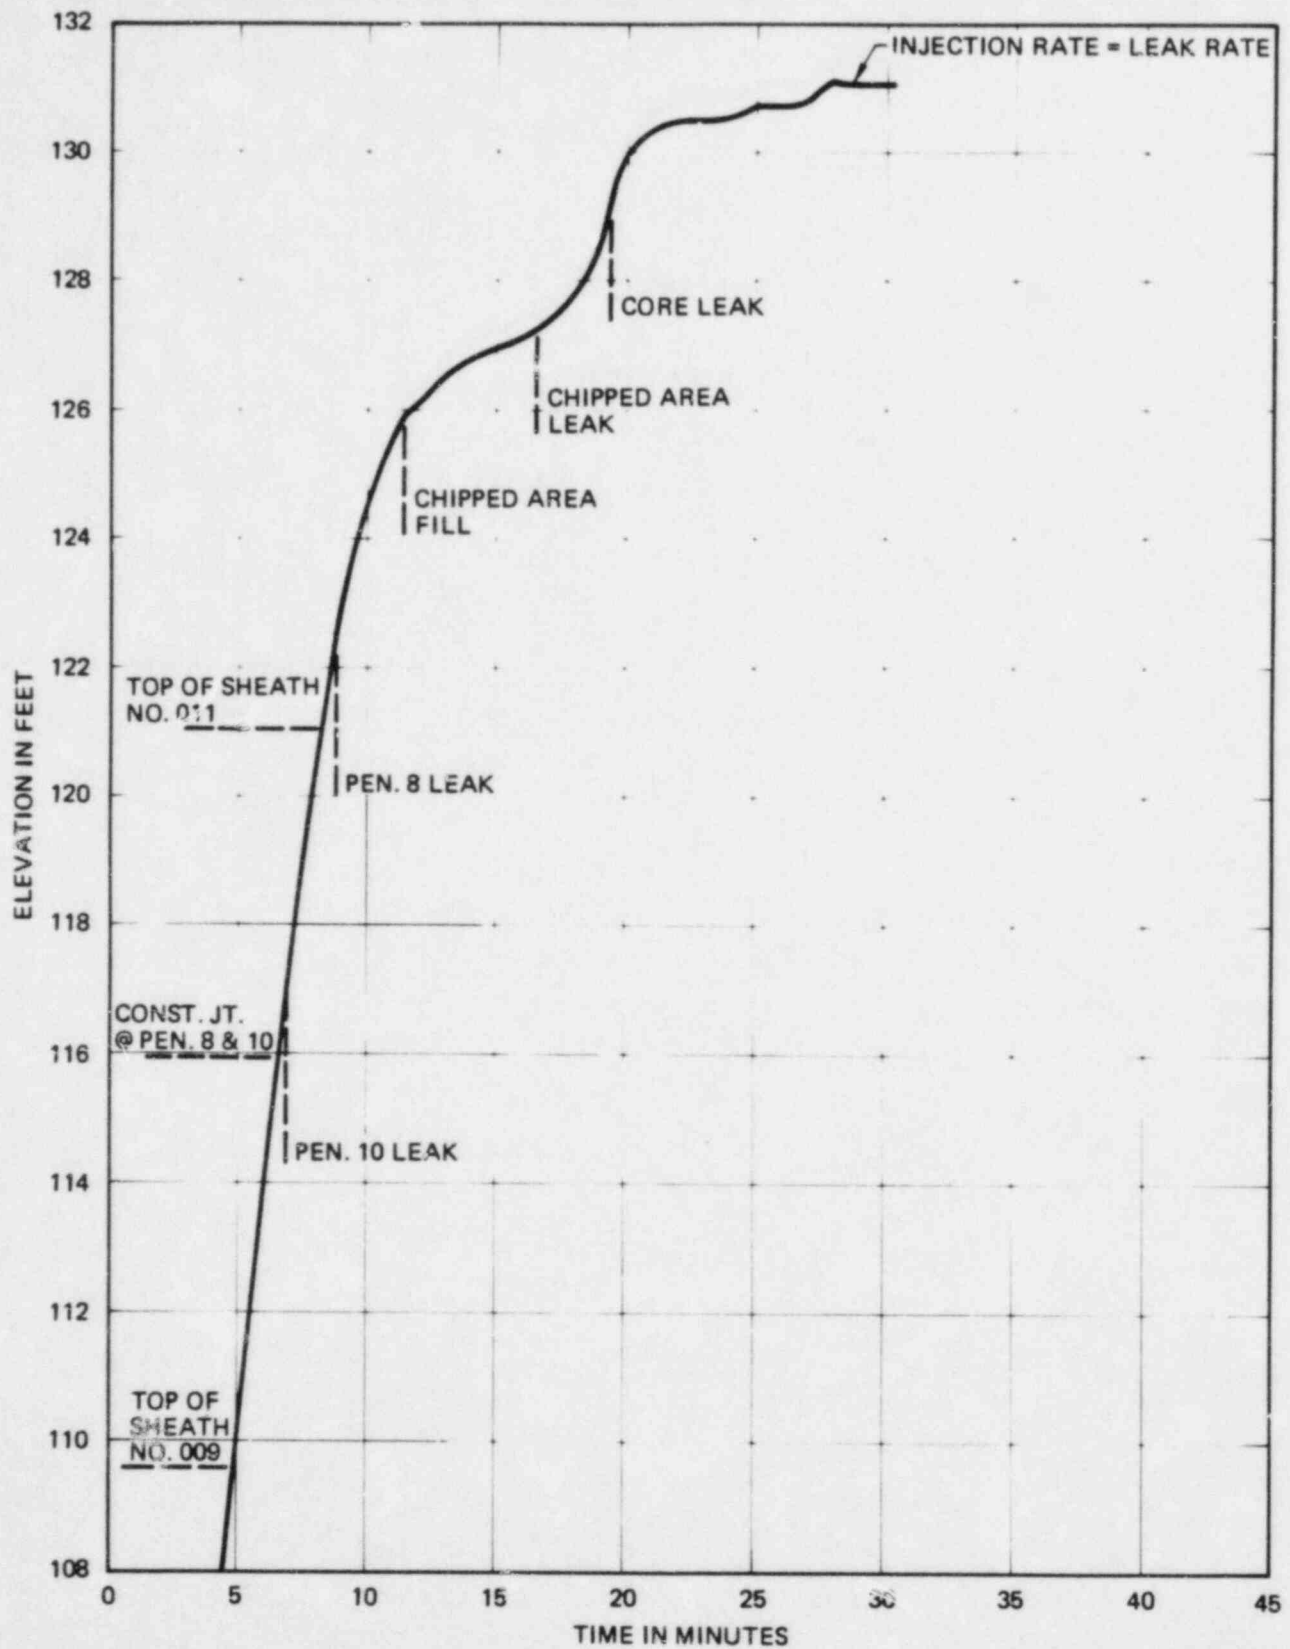
FIGURE 9

Test 5 was performed with this form in place. Although minor leakage did occur from the formwork, the objective of raising the water level was achieved. Water was caused to spill from the core hole adjacent to penetration no. 3. This core hole was then plugged and water continued to be pumped into the system with very careful monitoring of pressures. Almost immediately following the plugging of the core hole the leak system started to become pressurized, indicating the highest point in the system had been encountered. A slight amount of seepage was noted from around the sleeve in penetration no. 3 at an elevation slightly higher than the core hole. As the pressure continued to increase, flow increased from leaks already encountered lower down on the wall indicating that no additional pathways for leakage existed in the system. Following this, flow was reversed and the system drained.

Test 5 is considered to provide the most complete information and the most reliable characterization of the leak system. From the data collected in test 5, the total volume of the leak pathways is shown to be on the order of 5-3/4 cubic feet. This was determined by comparing the volume of water pumped in with the volume of water required to fill the sheaths between the packers, the volume of water retained behind the form over the chipped area (determined from figure 5), and the volume of water spilled through leaks.

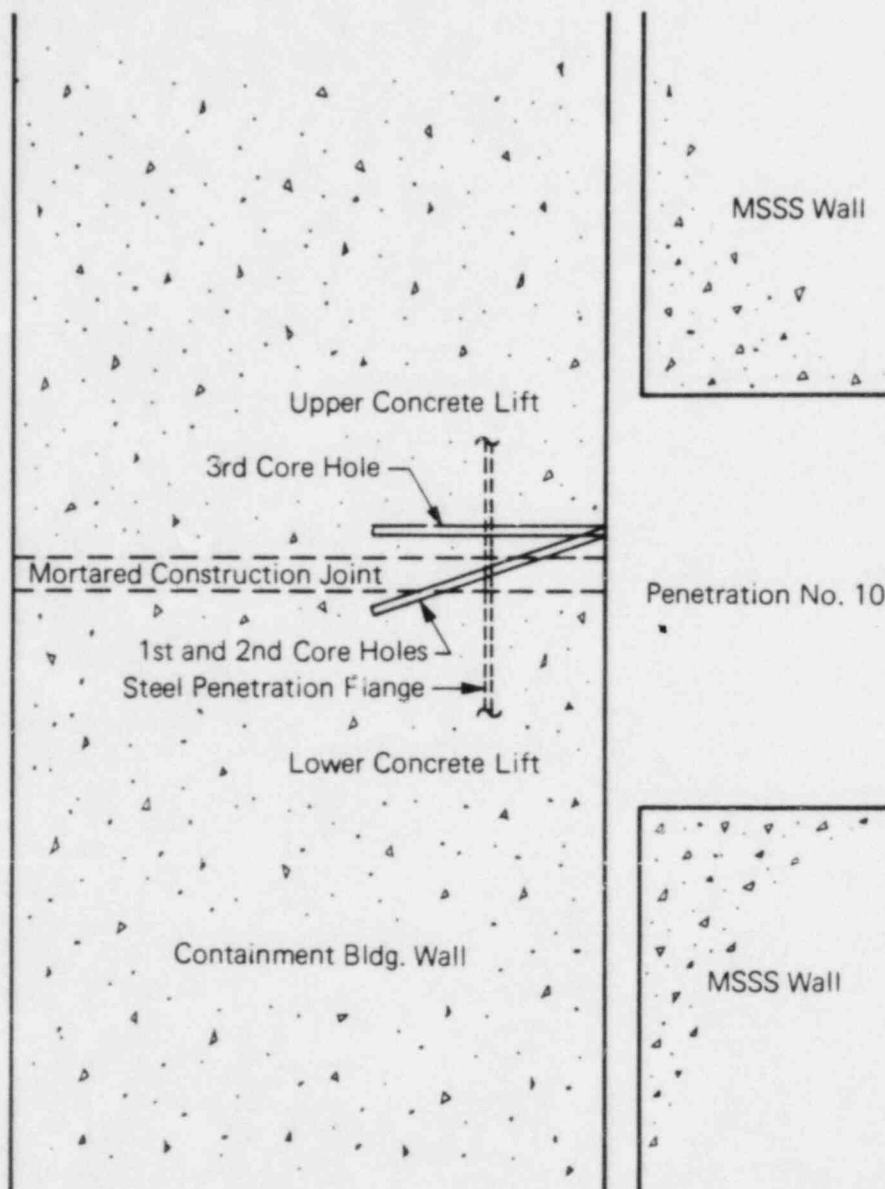
**FIGURE 11**

The core holes are shown schematically in the sketch in figure 11. The core sample taken from the first hole, drilled on a slight downward slope, revealed a system of rather confined and narrow leak pathways very close to the surface of the wall. Further into the wall, the core passed through the

From this information it was apparent that the hole would need to be sealed at the surface of the wall in order to force the grout into the near-surface leak pathways. To accomplish this a steel plate was fabricated to fit over all three core hole openings with an edge seal which would surround the openings. The plate was fitted with a grout nipple for simultaneous grouting of the three holes.

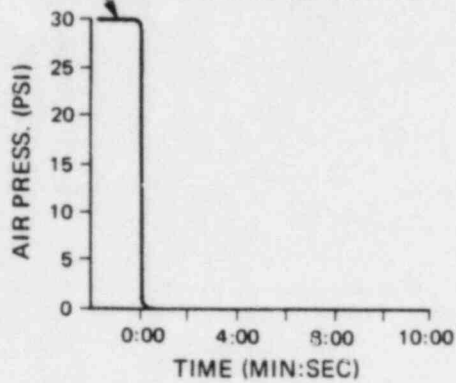
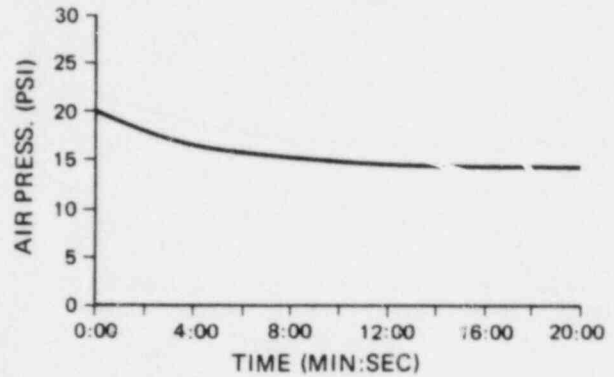
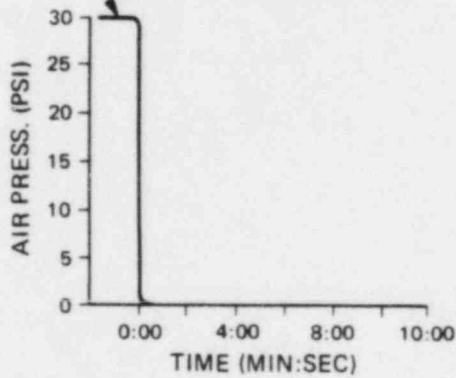
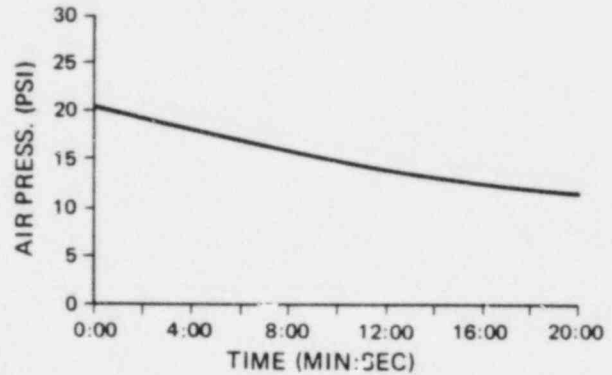
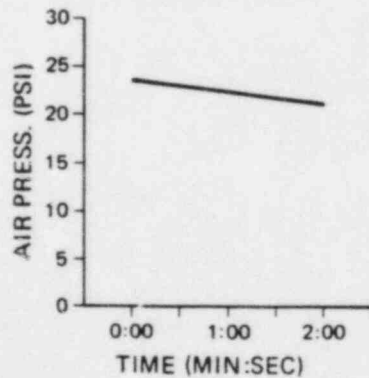
## COMPARISON OF PRE- AND POST-GROUTING AIR TESTS

SHEATH H32-011  
LEAKING INTERVAL  
AFTER GROUTING

SHEATH H32-009  
LEAKING INTERVAL  
AFTER GROUTING

REPRESENTATIVE TEST  
ON GOOD SECTION OF  
SHEATH H32-011

Following completion of grouting, and after sufficient cure time, air tests were performed on the previously leaking section of sheaths H32-009 and H32-011. These tests were performed by isolating the leaking sections of both sheaths with the packer assemblies described in section 4.2 and elsewhere, and pressurizing each sheath between the packers by introducing air from the control manifold. Air was pumped into sheath H32-009 through the sheath drain line, and into H32-011 through the sheath vent line (see figure 5).
