Subject: Significant Deficiency Report #5  
Cold Formed Back-to-Back Channel  
Shop Welding Deficiency - Final Report  
Limerick Generating Station - Units 1 and 2  
NRC Construction Permits Nos. CPPR-106, -107

FINAL REPORT  
COLD FORMED BACK-TO-BACK CHANNEL  
SHOP WELDING DEFICIENCY  
AT  
LIMERICK GENERATING STATION  
UNITS 1 & 2

Philadelphia Electric Company

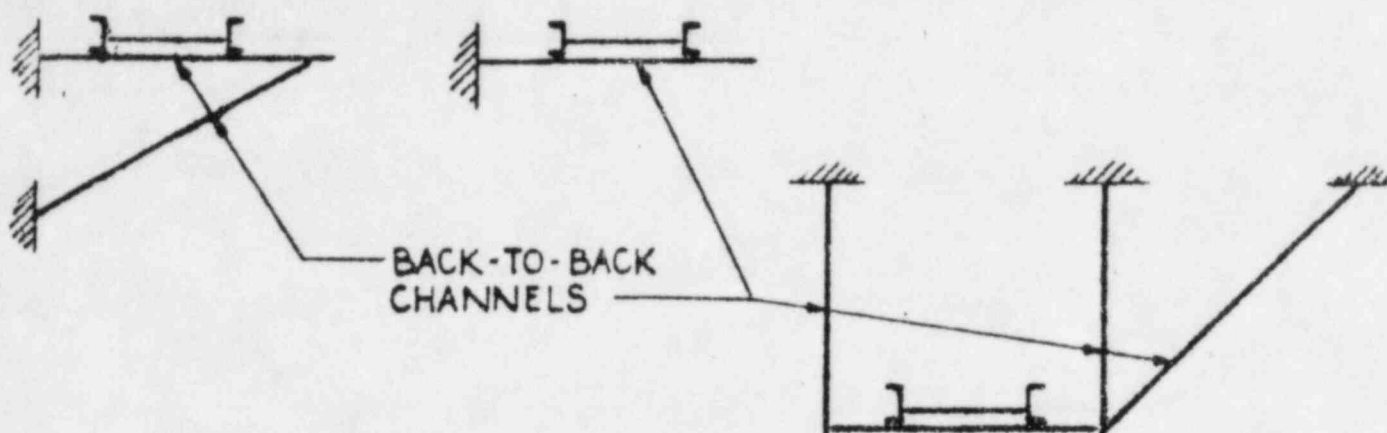
FIG. 1a TYPICAL CLASS I RACEWAY SUPPORTS

- 1.3 The material on which these weld deficiencies has occurred consists of cold formed, channel shaped members of material conforming to ASTM A-570-72, Grade C, hot dip galvanized per ASTM A-386-73 or ASTM A-153-73, after spot welding in a back-to-back configuration to form composite members. Class I electrical raceway supports are field fabricated from stock member lengths. Typical raceway support configurations are shown in Figure 1a, and Figure 1b shows a typical cross section of the members.

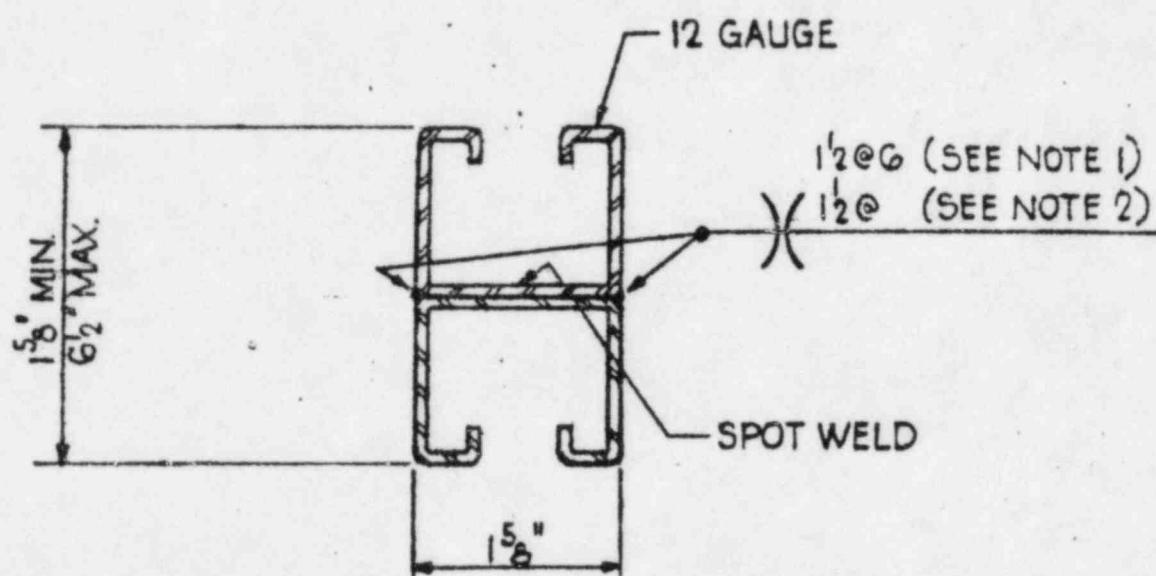
FIG. 1b BACK-TO-BACK CHANNEL CROSS SECTION

- 2.4 On about January 10, 1978, a support was observed to contain back-to-back channels which had failed spot welds. Another support was noted to include a member which did not contain any spot welds in a 12" length. The catalog description specifies spot welds spaced at 2" to 3". An unused 24" long section was observed to have separated as a result of weld failure. A qualitative review of the material at the site indicated sufficient evidence of weld deficiencies and weld spacing irregularities to warrant a more quantitative review. Accordingly, fifty-five samples, representing three sizes of back-to-back channels, were randomly taken from field stock of material furnished by Super-Strut, Inc. Specimens containing three spot welds were cut from these samples, and the welds were tested in tension to failure by an independent laboratory. Failures occurred at loads ranging from 550 pounds per 3 welds, to 11,450 pounds per 3 welds. Super-Strut's acceptance criteria had been set at 8000 pounds per 3 welds.

- 4.1 A site fabrication and erection hold was placed on all raceway supports on January 18, 1978. This hold was released on February 3, 1978, on the condition that any strut material used for fabrication of new supports, and strut in supports already installed, be stitch welded to develop adequate composite member strength, without dependence on existing spot welds. Maximum load capacity of the strut was used as the basis for determining weld spacing, pending completion of a more detailed analysis based on actual loading. (see Figure 1b, notes 1 and 2). Instructions were issued to the field describing the procedures to be used for this repair welding.
