**NORTHEAST UTILITIES**

July 27, 1983

Docket No. 50-423  
B10839

Millstone Nuclear Power Station, Unit No. 3,  
Reporting of Potential Significant  
Deficiencies in Design and Construction:  
Cracks Related to Embedments in  
the Containment Crane Wall (SD-29)

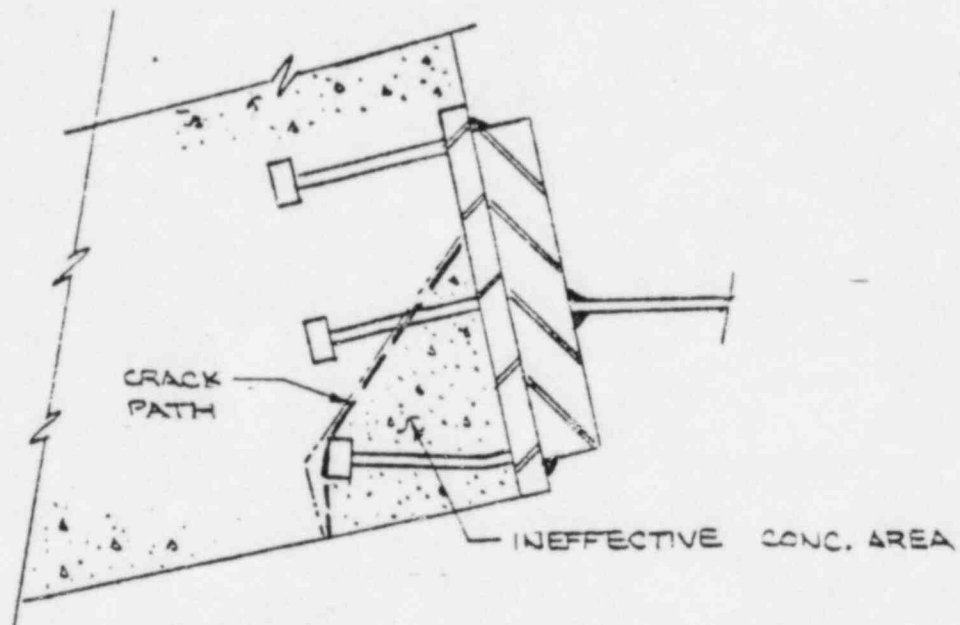
ATTACHMENT A

A clear indication of the direction of the cracks was established by chipping the concrete. The cracks extend from the face of the concrete to the heads of the first row of studs and then over at an angle of approximately 45 degrees towards the center of the plate (see Attachment A).

The capacity of the plates was calculated based on the cracked section shown on Attachment A, and using the appropriate safety factors. Analysis of critical sections of the pipe rack trusses was performed using current support load information. The resulting reactions at the plates are less than the calculated plate capacity. Structural repairs were found not to be necessary.
